**Zion Chapel**

**Flockton**

## Building Recording

Report no. 3069  
January 2018

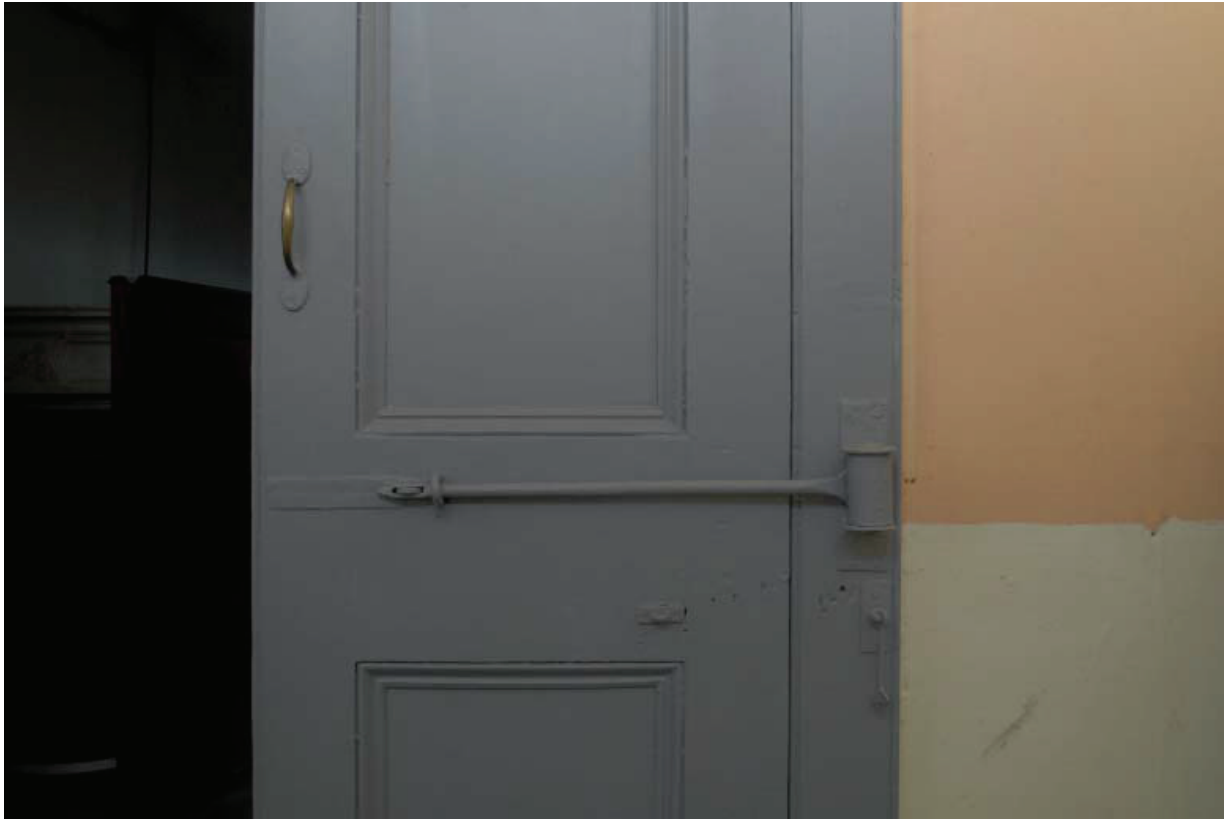
Photograph 25

W Lobby door closing mechanism

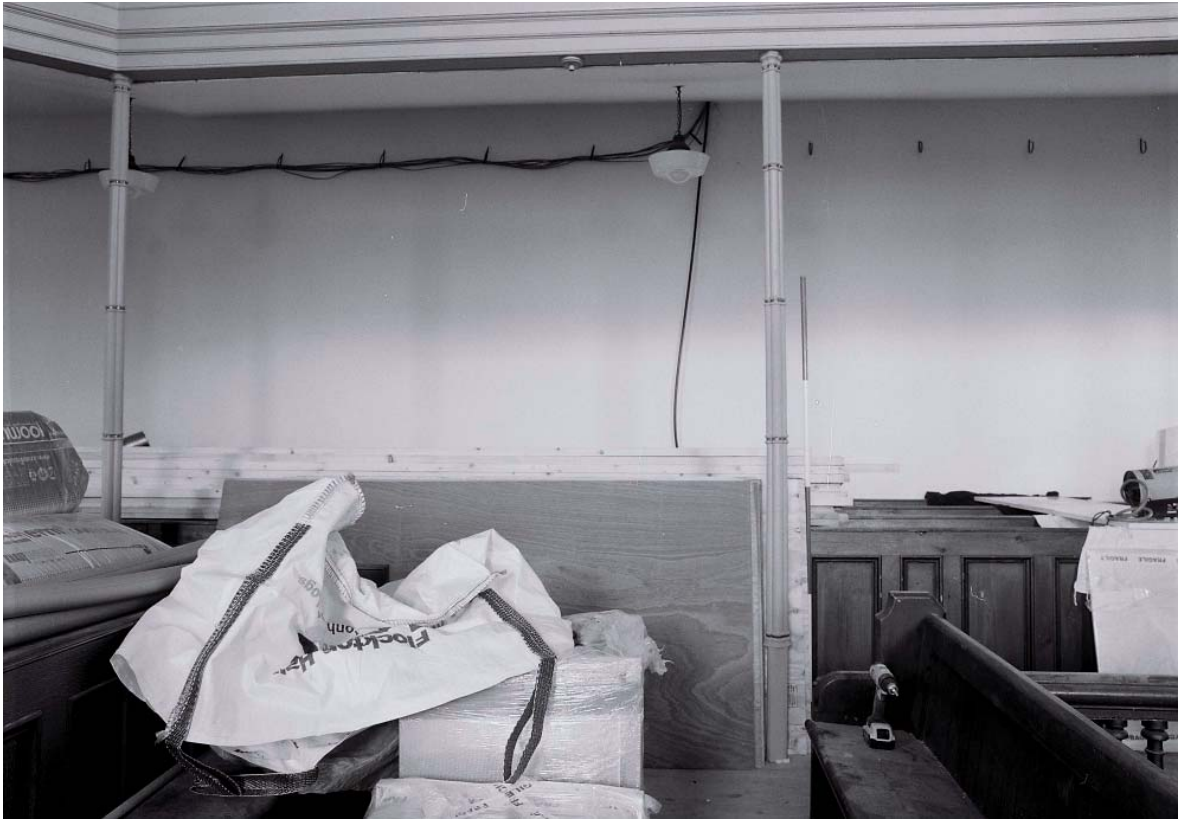
Photograph 27

Cast-iron columns supporting gallery

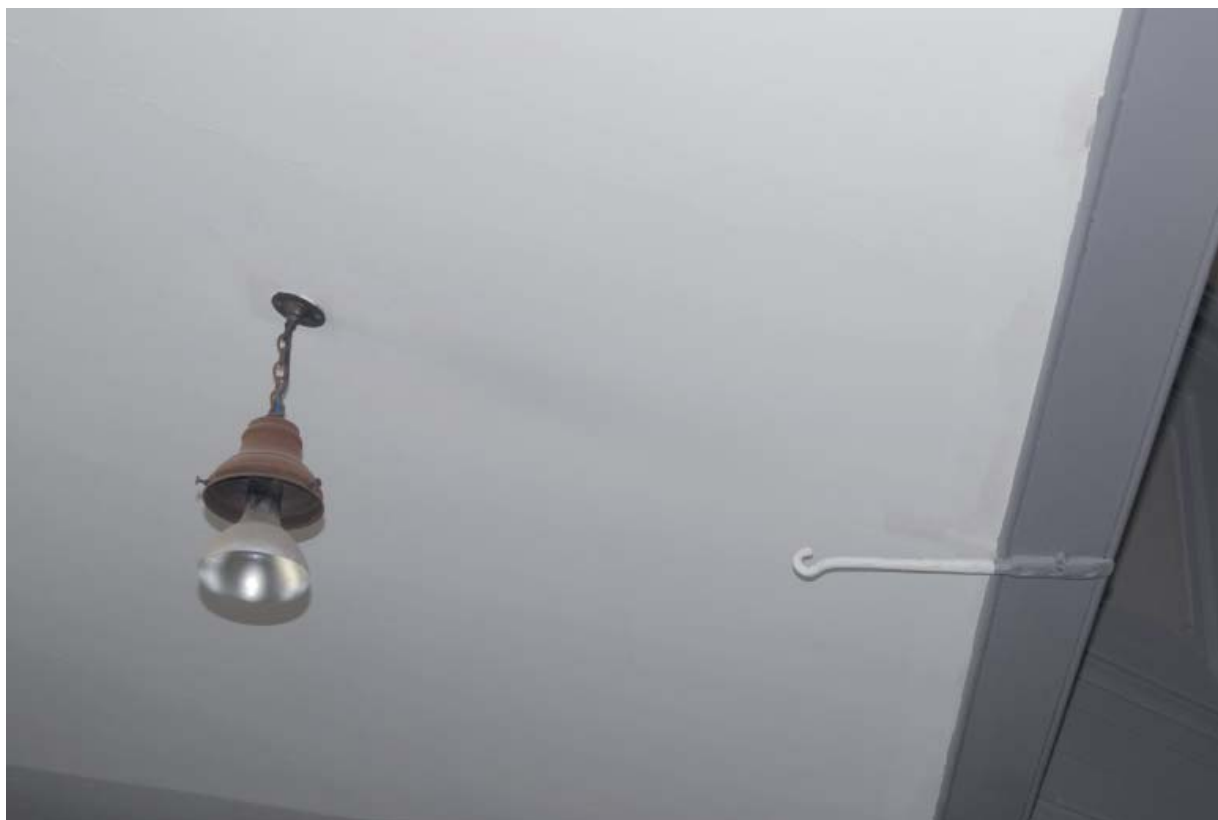
Photograph 50

Modern light & hook for earlier oil lamp(?)

gallery beam (Photos 048, 049, 050). The hooks may have been used to suspend oil lamps. They were replaced by the metal conduits and light fittings which may indicate gas lighting. These, too have since been replaced by electric lighting.

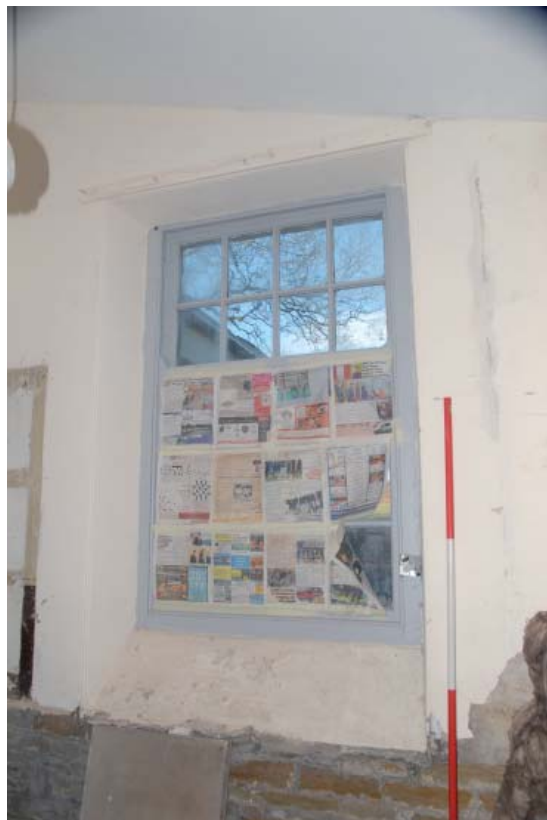
Replaced sash window in N wall

The lower window on the west side of the north gable wall contains a replacement sash window. The entrance to the boiler house is accessed via a flight of steps in the centre of the wall. These lead into an external brick basement room with sloping concrete roof (Photos 15,

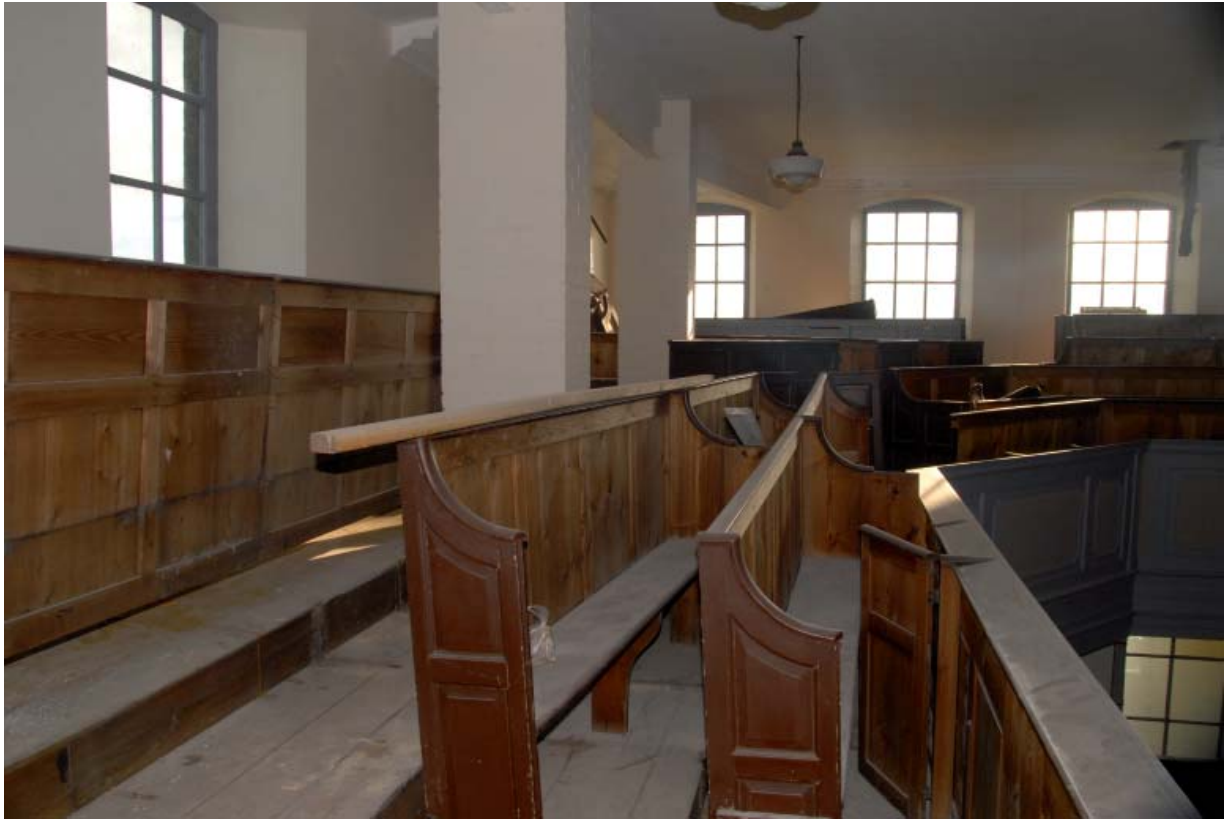
Photograph 77

E side pews interrupted by brick pillars

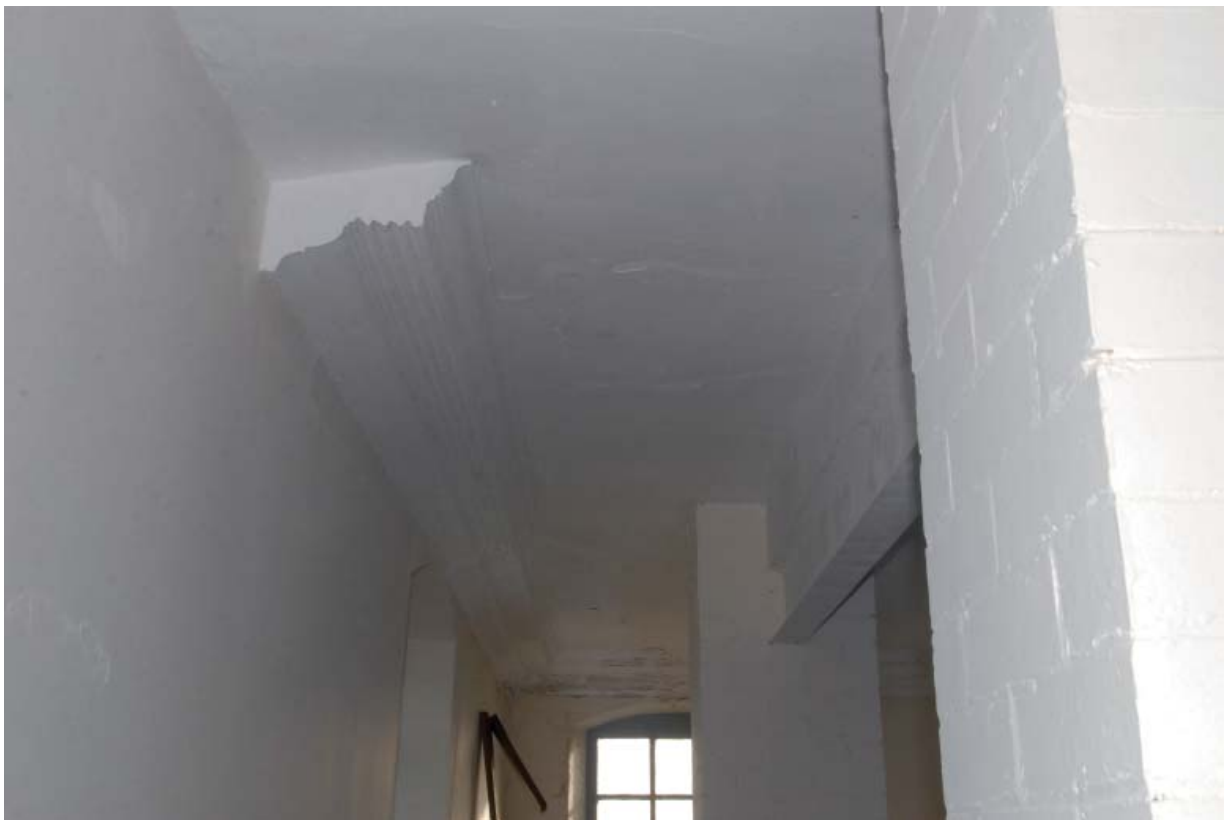
Photograph 78

End of heavily moulded cornice, E side

078). A further missing section of cornice, in the centre of the north wall, was probably removed when the organ was installed. Only one cast-iron heating pipe is visible at gallery level: it emerges vertically from the gallery flooring in the south-east corner (Photos 074, 078).

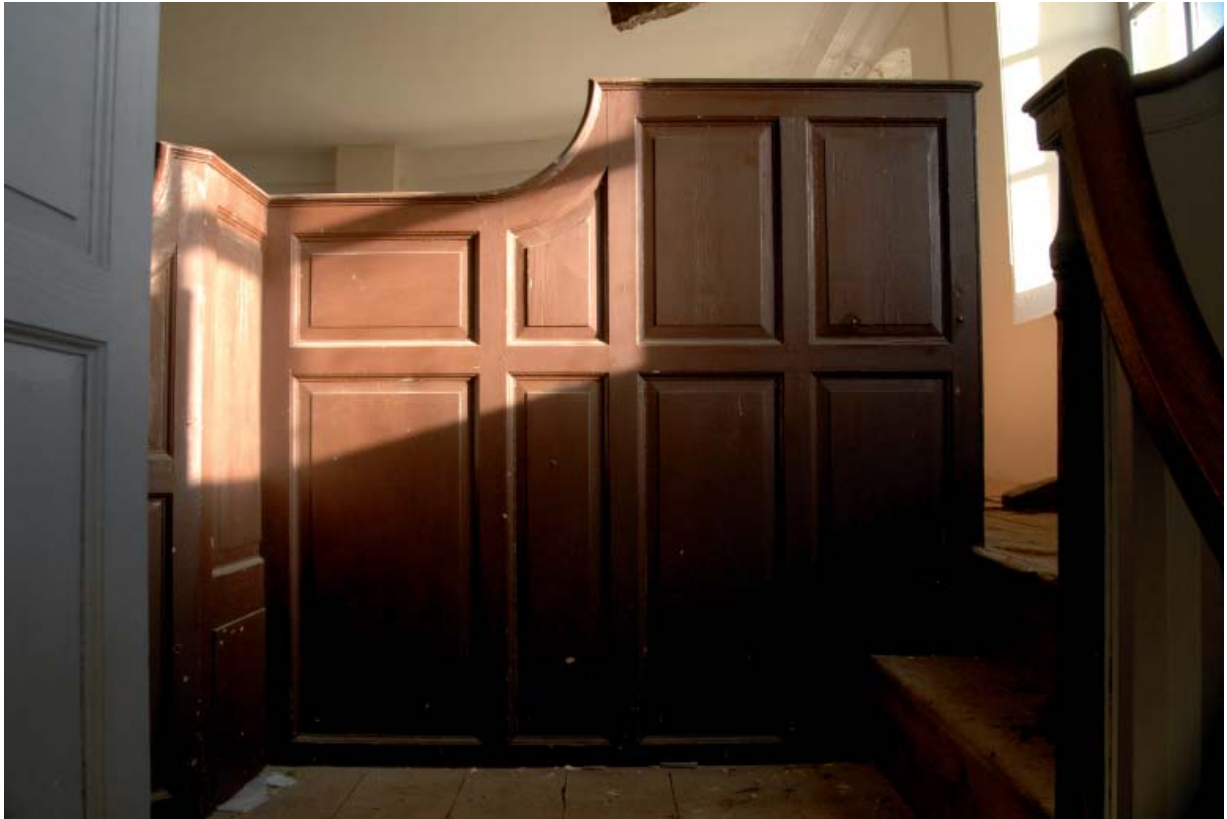
Photograph 85

Gallery pew panelling (see Fig. 7)

The character and construction of the gallery seating panelling is uniform throughout (Photos 077, 080, 081, 086, 090); a typical example is shown in elevation B-B1, in Figure 7 (see Photo 085). All the hinges and other fittings that could be observed were later replacements. Many of the pew front panels exhibited incised graffiti (e.g. Photos 079, 082), probably indicating that the galleries were, at least in later years, used to house younger members of the congregation.
