# Westfield Farm, Flockton

## Bat Survey Report

16<sup>th</sup> July 2019

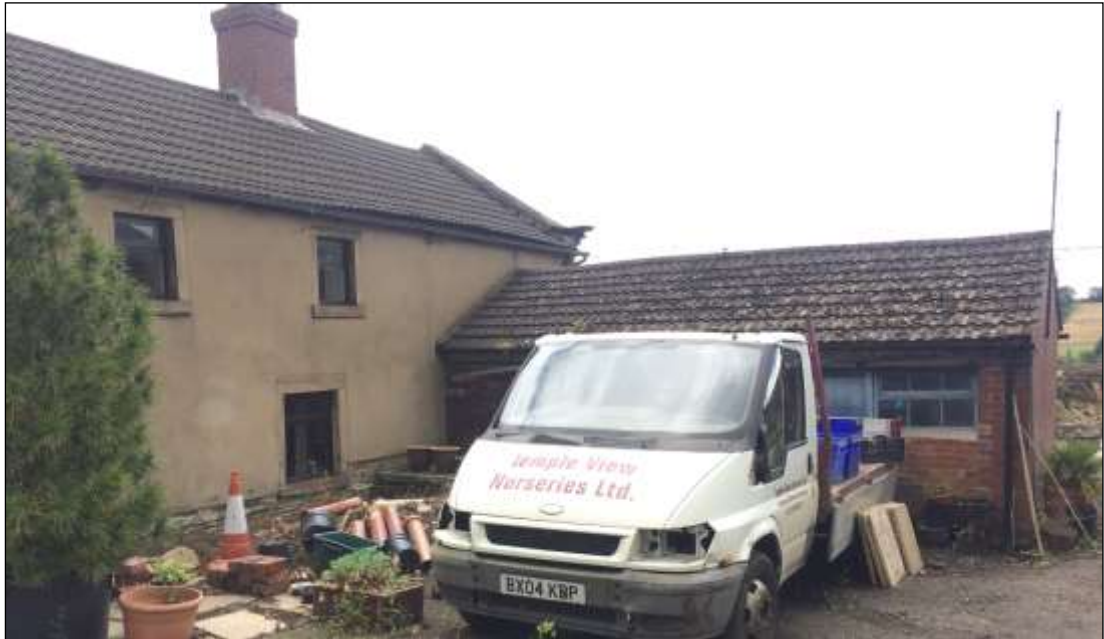
**Plate 1. Looking south-west at Building Sections 1 & 3**

- 5.2.5 Potential bat access points onto the wall top of Building Sections 1-3 were recorded across all elevations. In addition potential bat access points into the south stone wall of Building Section 3 were recorded. All three Building Sections were assessed as offering low bat roost potential.

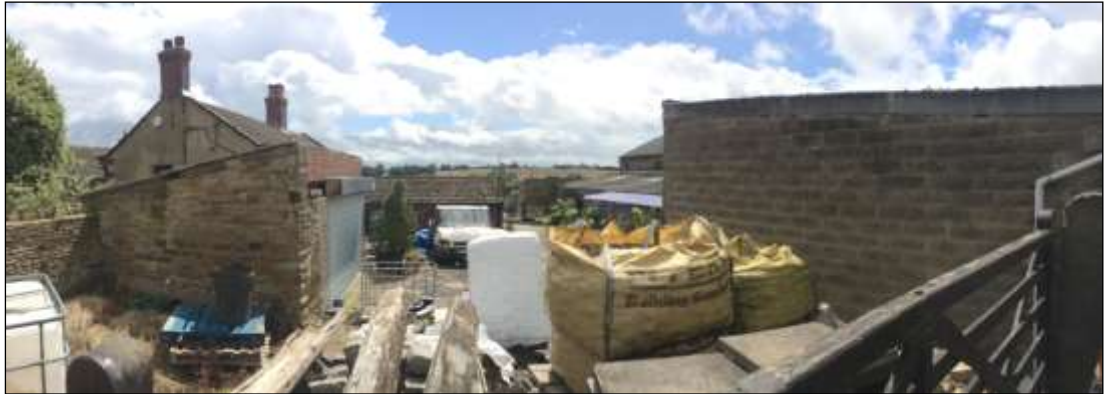
**Plate 3. Looking south with Building Section 4 on the right of the image and Building Section 2 on the left**

Building Sections 4, 6, 8 & 9 comprise the single storey lean-to extensions to the original barn (Building Sections 5 & 7). Building Section 4 comprises a modern stone built single storey garage with a sloping corrugated asbestos sheet roof and a metal

roller shutter door on the south elevation. Asbestos capping covers the verge. Potential bat roosting features on the building exterior included a crevice behind verge capping and an air brick.

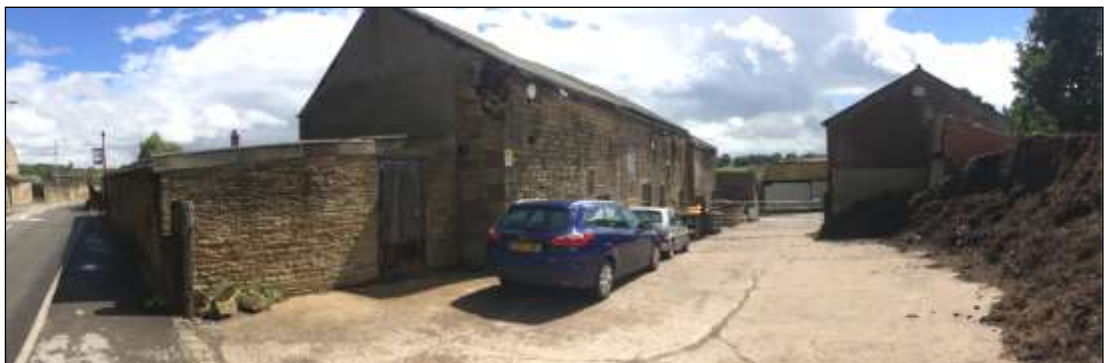
**Plate 4. Looking south, with Building Section 5, 7 & 8 on left of image and 10 on right of image**

Building Section 6 comprises a c1800s single storey stone built lean-to with a sloping corrugated metal sheet roof fitted with wooden fascia and barge boards. The eastern elevation is brick built. Potential bat roosting features on the building exterior included crevices between the timber wall plate and adjacent masonry, and voids within the masonry. Bat access into the interior of the building is possible as the east elevation is largely open.

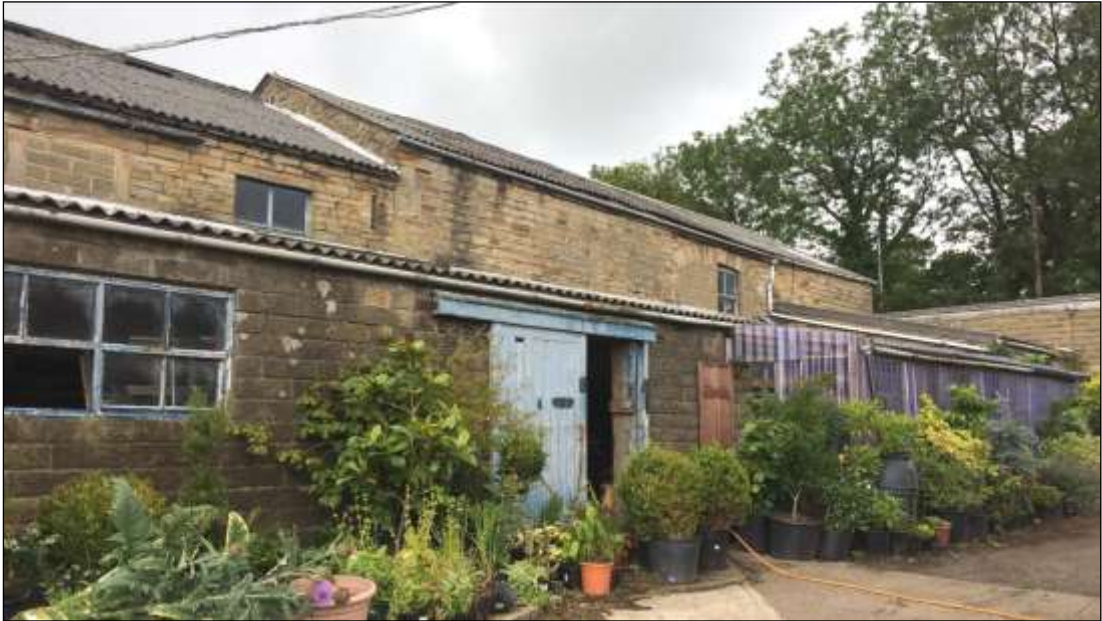
**Plate 5. East elevation of the barn building complex, with Building Section 9 in the foreground**

Building Section 9 comprises a c1960s single storey stone built building with a mono pitched asbestos sheet covered roof fitted with a wooden fascia. One section of the building is timber framed with plastic sheeting on the walls. Wood framed single pane windows are present. Bat access is present to the building exterior via gaps along the wall top.

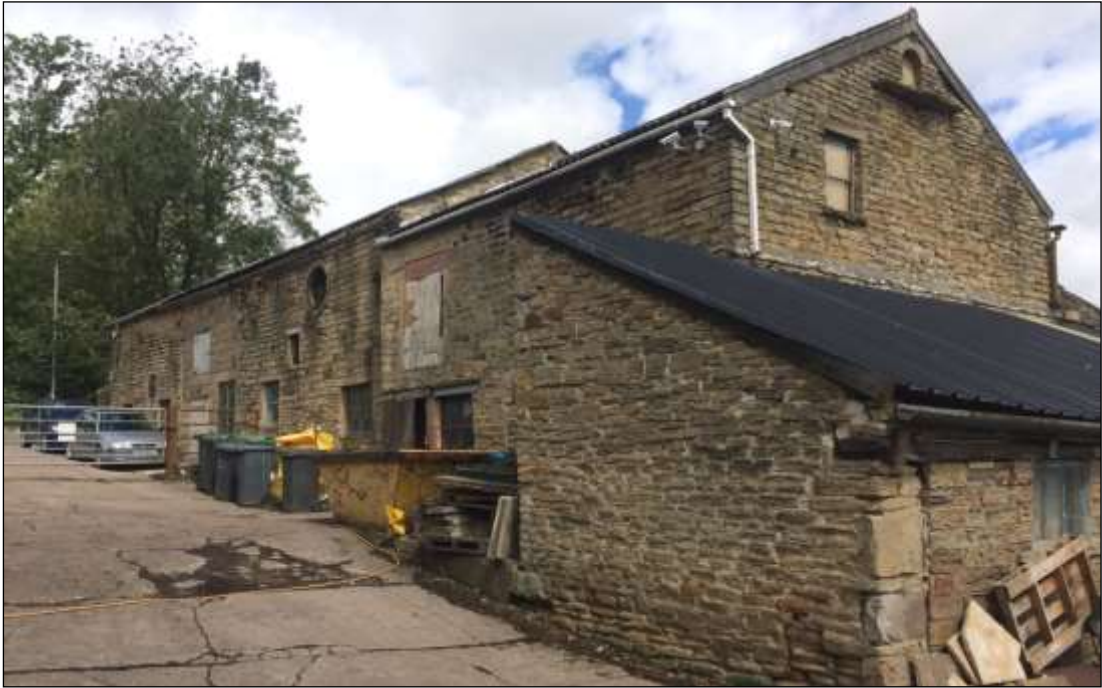
**Plate 6. South and west elevation of original two storey barn (Building Sections 5 & 7)**

- 5.2.9 Building Sections 5 and 7 comprise the original c1800s stone built two storey stone built barns in the centre of the site. The pitched roofs are covered with corrugated asbestos cement sheets with the roof-line of Building Section 7 being at a slightly higher elevation than the roof of Building Section 5 (see Plates 5 & 6). Asbestos capping covers the south facing verge on Building Section 5. Numerous wood framed single pane windows are present on the main barn, with a circular opening in the western elevation of Building Section 7, at first floor level. A wooden hatch in the western elevation also leads onto the first floor of Building Section 7, whilst a dove cote opening is present at the top of the south facing gable on Building Section 5. Numerous crevices lead into external stone walls, together with gaps along wall tops and beneath asbestos verge cappings.

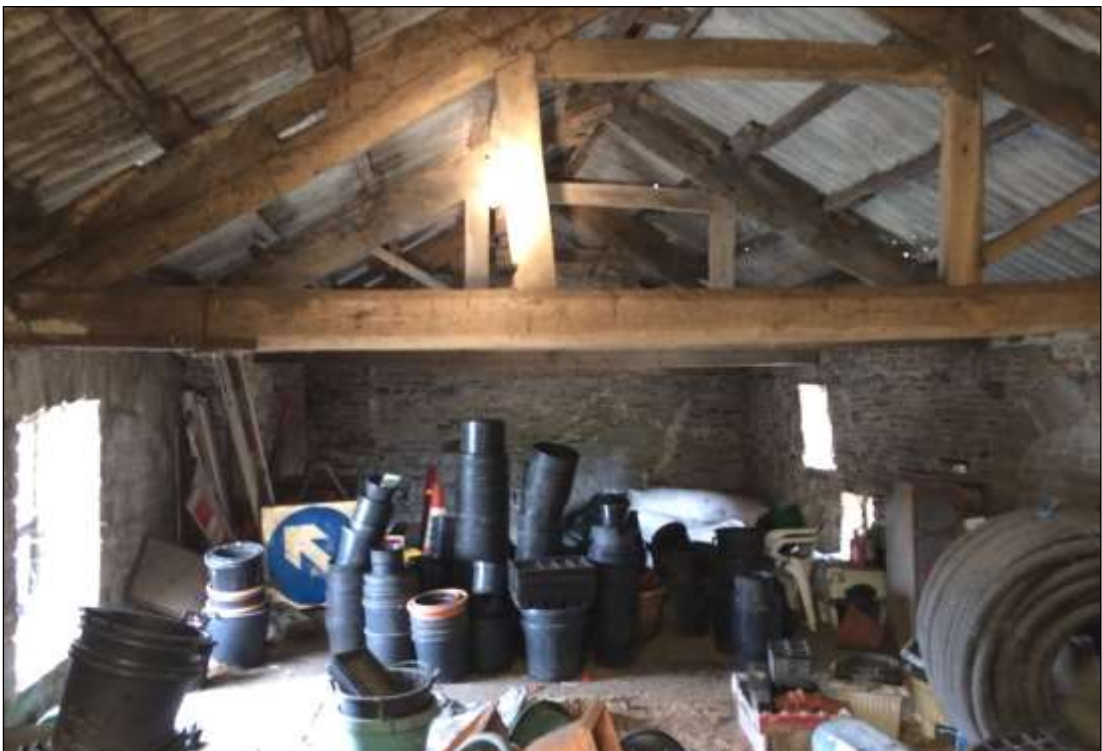
**Plate 7. Looking south within the first floor of Building Section 7**

- 5.2.11 The first floor of Building Section 7 is open to the underside of the asbestos sheet roof, with roof sheets suspended on a mix of king and queen post roof trusses and large timber purlins. Internal walls comprise exposed masonry. Evidence of roosting bats was recorded from three locations on the first floor of Building Section 7. A cluster of approximately 100 probable brown long-eared bat *Plecotus auritus* droppings was noted at the base of the southern internal wall, a cluster of 40 yellow underwing moth *Noctua* spp. wings and 10 probable brown long-eared bat droppings was recorded from the centre of the first floor and approximately 50 yellow underwing wings were recorded from the interior face of the northern gable. The central and the northern pile of moth wings are considered to comprise evidence of a brown long-eared bat feeding roosts, with the southern dropping pile comprising evidence of a probable brown long-eared bat day or night roost location.

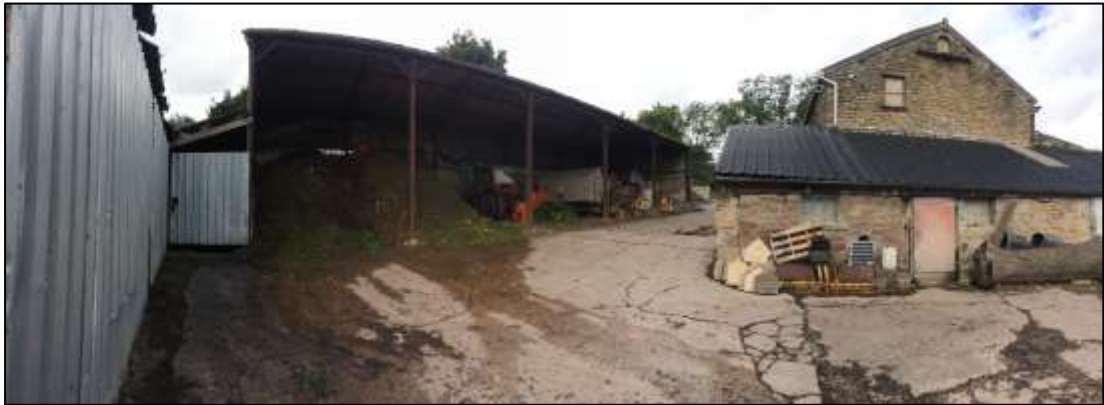
**Plate 9. Building Section 10 is shown on left of image, with Building Sections 5 and 6 on right**

- 5.2.15 Building Sections 10 and 11 comprise modern steel framed barns with corrugated asbestos sheet covered roofs. These buildings are open sided in places, with other sections having metal sheet single skin walls.
- 5.2.16 Building Sections 10 and 11 are considered to display negligible bat roosting potential.

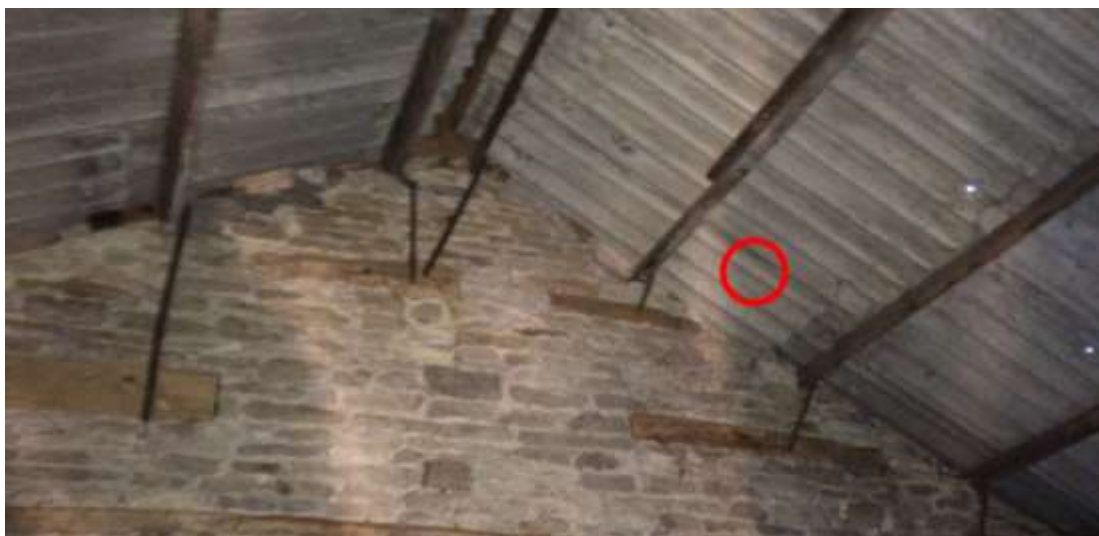
**Plate 10. Whiskered bat day roost location**

- 5.2.23 At 05:37 (24 minutes before sunrise) a single whiskered bat returned to roost between two asbestos roof sheets close to the southern gable in Building Section 7 (see Plate 10). A brown long-eared bat was recorded flying in the roof space of Building Section 7 at 04:46, 05:03 & 05:37 but no roosting behaviour was directly observed. The last bat recorded during the survey comprised a common pipistrelle which was heard only by the surveyor located south-west of Building Section 6 at 05:44. Occasional activity by common pipistrelle, brown long-eared bat, whiskered bat and noctule was recorded by the surveyor outside Building Section 6 during the survey.

- 6.1.2 A whiskered bat day roost was also recorded from a location between asbestos roof sheets towards the south-east end of Building Section 7. This roost was used by a maximum count of one bat during each of the three nocturnal surveys, with this bat also recorded accessing the building via the circular opening in the south-western wall.

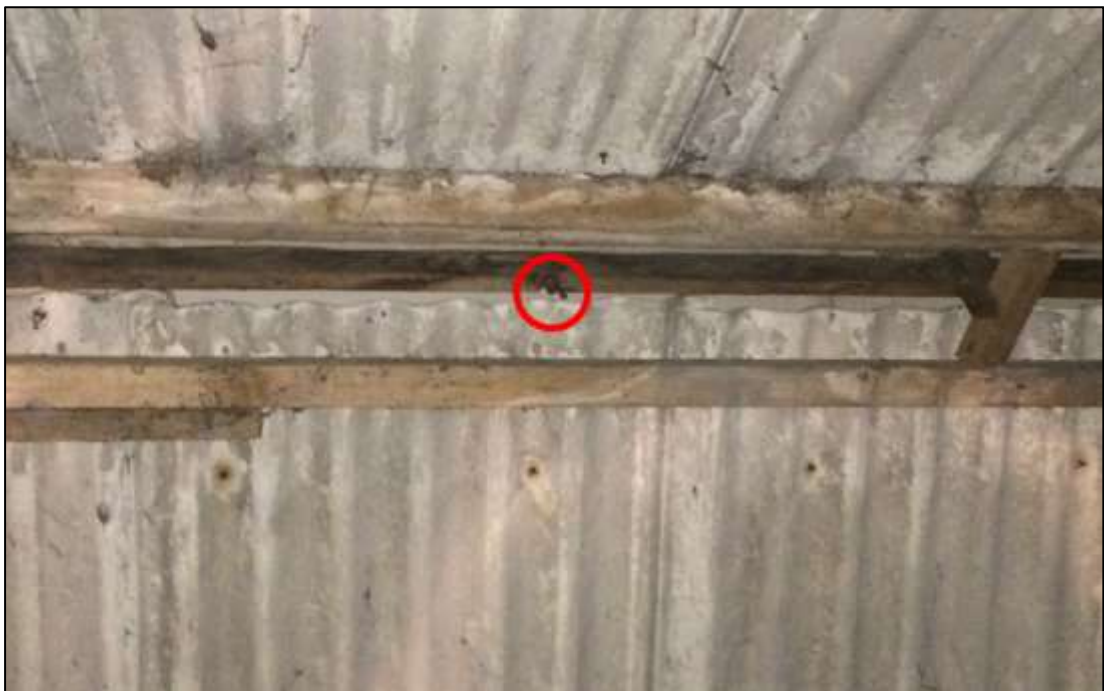
**Plate 11. Roosting brown long-eared bat in Building Section 7**

- 5.2.25 Before the nocturnal survey commenced the roof of Building Section 7 was subject to a repeat visual inspection, with a brown long-eared bat observed roosting on the ridge beam in the centre of Building Section 7 (see Plate 11). During the nocturnal survey a single common pipistrelle bat was recorded emerging from the circular opening in the wall of Building Section 7 at 19:23 (9 minutes after sunset). Between 19:40 and 19:59 (26-45 minutes after sunset), eight brown long-eared bats were recorded emerging from the circular opening in the wall of Building Section 7 with one brown long-eared bat recorded returning through this opening.

- 6.1.1 A maximum count of eight brown long-eared bats were recorded emerging from Building Section 7 on 19<sup>th</sup> September 2017. A brown long-eared bat was observed roosting on the ridge beam in the centre of this building, with no other roost locations known for this species. Bats from this roost emerge from the building via the circular first floor window opening in the western wall of the building. On the basis of the number of bats recorded roost, it is considered most likely that Building Section 7 supports a brown long-eared bat maternity roost. It has not been possible to catch the bats to assess the sex or breeding status of brown long-eared bat roosting on site.
