167 Heckmondwike Road

Phase II Interpretative Report

Project: 167 Heckmondwike Road
Client: Horizon Healthcare Homes Ltd
Job Number: RBG129

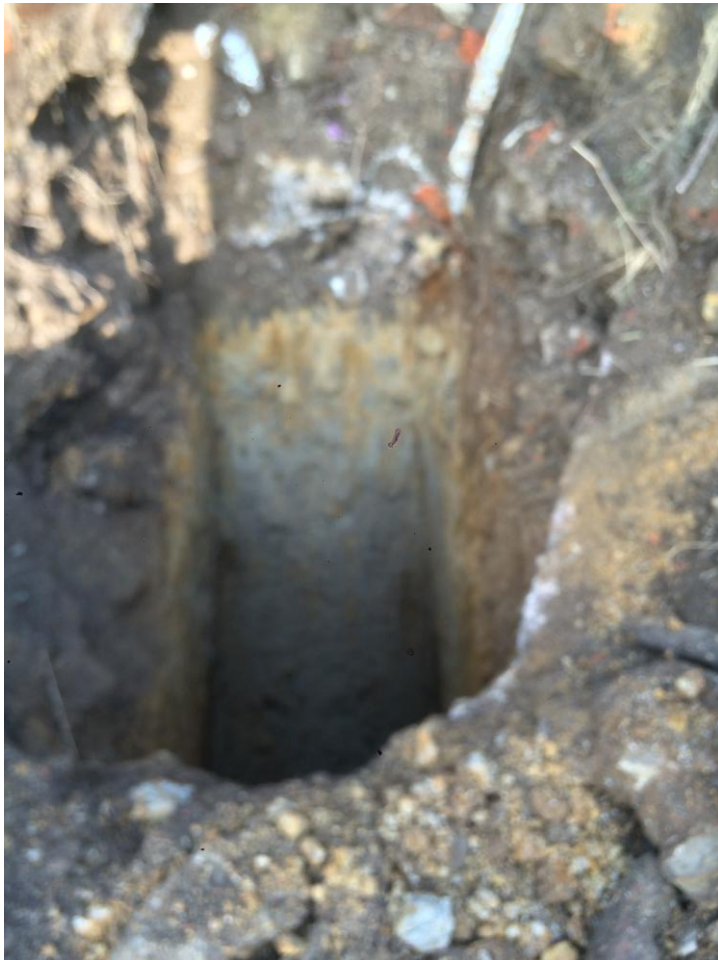
Trial Pit TP01 Exploratory Hole

0.00 – 0.10	-	-	-	0.10	MADE GROUND Grey rough concrete slab
0.10 – 0.50	-	-	ES1@0.30	0.40	MADE GROUND Brown, grey sandy gravel of fine to coarse brick, ash and concrete

0.50 – 0.90	-	-	D2@0.80	0.40	Firm to stiff light grey, orange slightly gravelly silty sandy CLAY. Gravel of fine to medium, sub angular mudstone
0.90 – 2.10	-	-	-	1.20	Light grey silty GRAVEL of fine to coarse, sub angular MUDSTONE
General Remarks					
<ul style="list-style-type: none"> • Trial Pit carried out into side of raised area. • Trial pit sides stable • No Groundwater encountered • ES = Environmental Sample. D = Disturbed Sample.

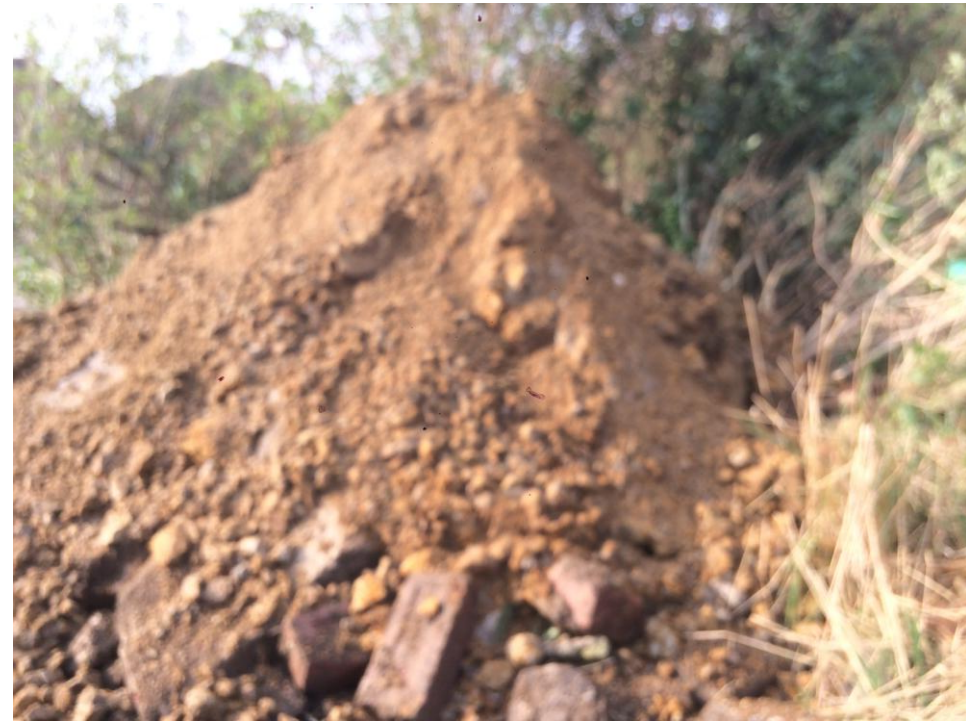
Trial Pit TP01 Spoil

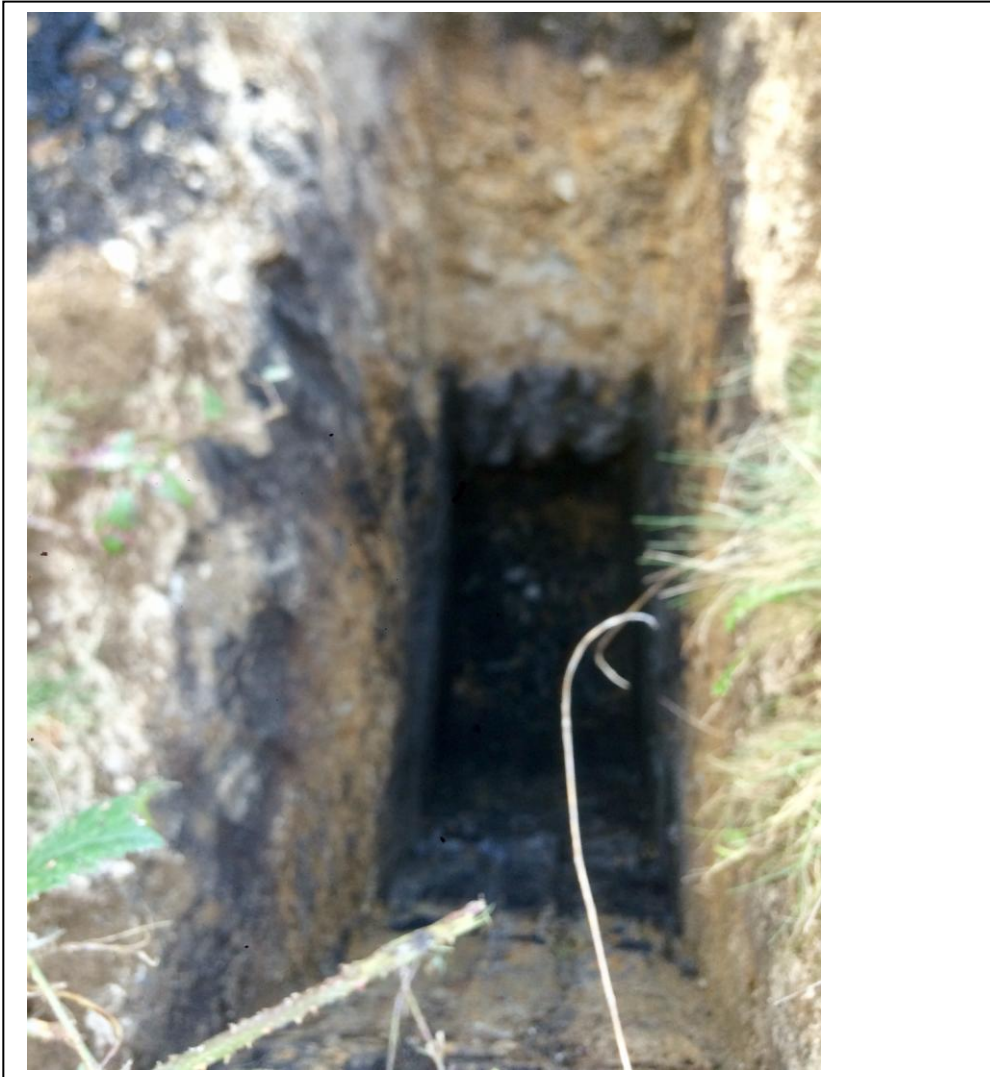
Trial Pit TP02 Exploratory Hole

1.10 – 1.50			-	0.40	Grey, brown clayey GRAVEL. Gravel of fine to coarse, sub angular MUDSTONE
1.50 – 1.90	-	-	D3@1.60	0.40	Firm dark grey slightly gravelly CLAY. Gravel of fine to medium, sub angular to sub rounded COAL and MUDSTONE

1.90 – 2.20	-	-	-	0.30	Loose black GRAVEL of fine to coarse COAL
General Remarks					
<ul style="list-style-type: none"> • Trial pit sides stable • No evidence of mine workings or voids/void migration • No Groundwater encountered • ES = Environmental Sample. D = Disturbed Sample.

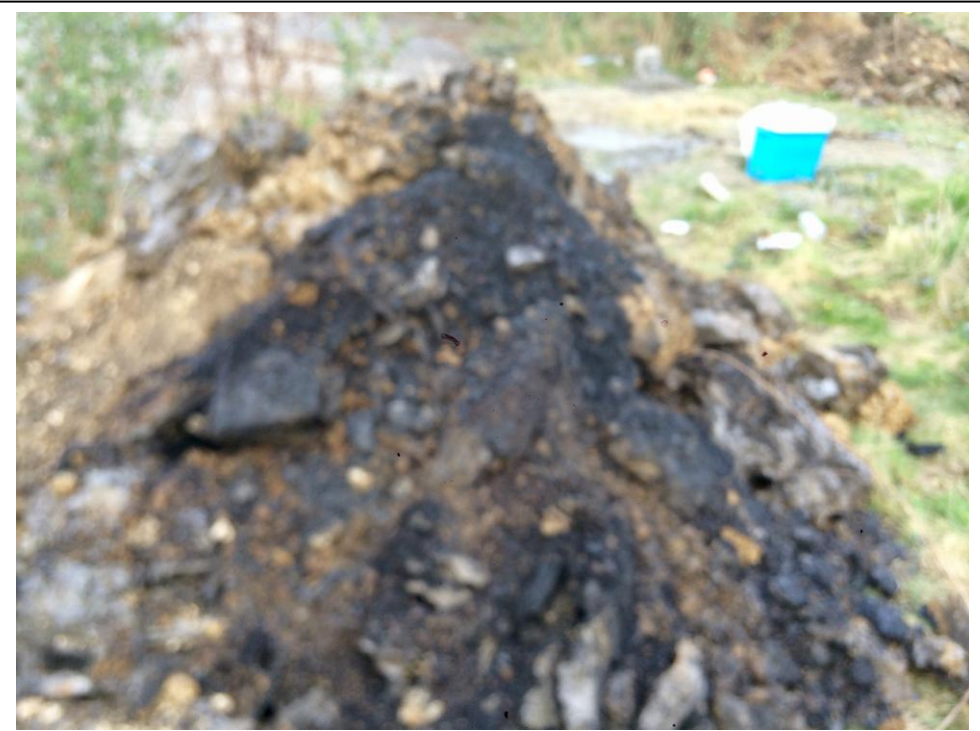
Project: Former Woolpack Inn, 167 Heckmondwike Road, Phase II Intrusive Investigation			Type: Trial Pit	Hole Number: TP02	
Date: 28 th March 2017				JCB3CX	Sheet Number: 2 of 10
TESTS			SAMPLES	STRATA	
Depth (m)	Test type and depth (m)	Test Result	Sample type and depth (m)	Thickness (m)	Description

Trial Pit TP02 Spoil

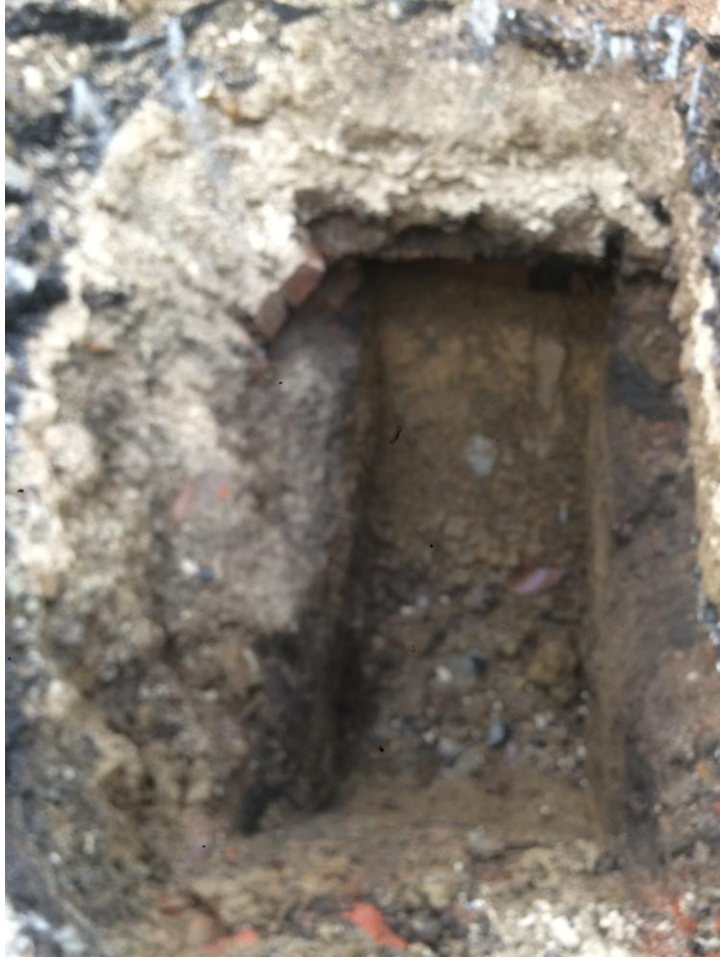
Trial Pit TP03 Exploratory Hole

Project: Former Woolpack Inn, 167 Heckmondwike Road, Phase II Intrusive Investigation			Type: Trial Pit	Hole Number: TP03	
Date: 28 th March 2017				JCB3CX	Sheet Number: 3 of 10
TESTS			SAMPLES	STRATA	
Depth (m)	Test type and depth (m)	Test Result	Sample type and depth (m)	Thickness (m)	Description
0.00 – 0.15	-	-	-	0.15	MADE GROUND Black TARMAC
0.15 – 0.30	-	-	-	0.15	MADE GROUND Light grey gravel of fine to coarse sub-angular limestone SUB-BASE
0.30 – 1.10	-	-	ES1@0.40	0.80	MADE GROUND Brown, red gravel of fine to coarse brick, concrete, ash and tarmac
1.10 – 1.50	-	-	D2@1.30	0.40	Stiff brown, grey gravelly CLAY. Gravel of fine to coarse, sub angular MUDSTONE
General Remarks					
<ul style="list-style-type: none"> • Trial pit sides stable • No Groundwater encountered • ES = Environmental Sample. D = Disturbed Sample.

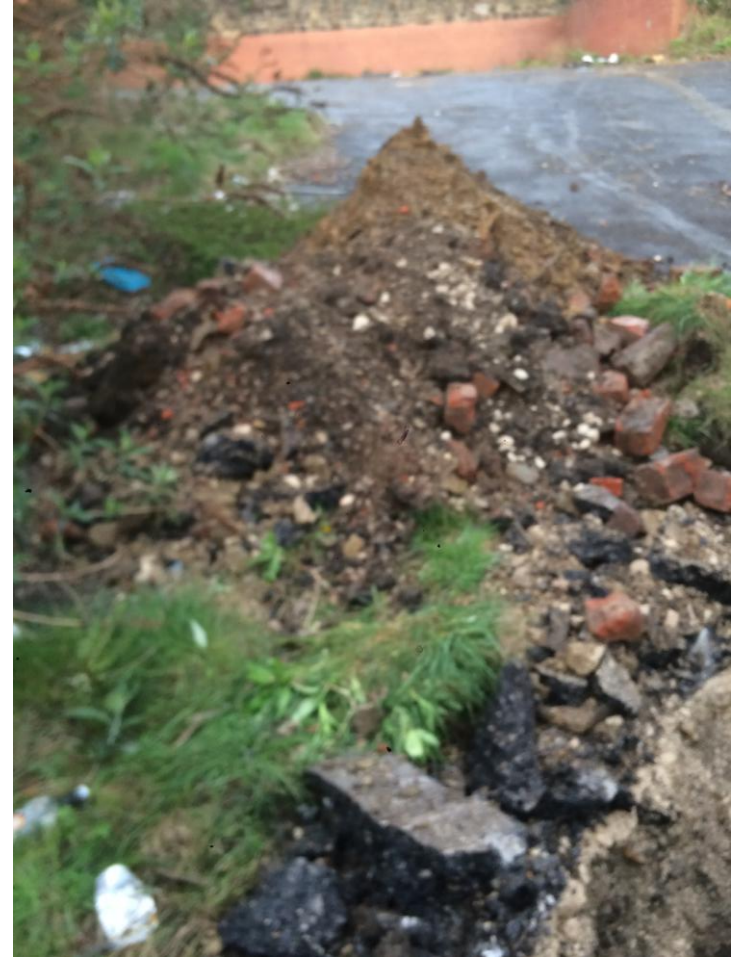
Trial Pit TP03 Spoil

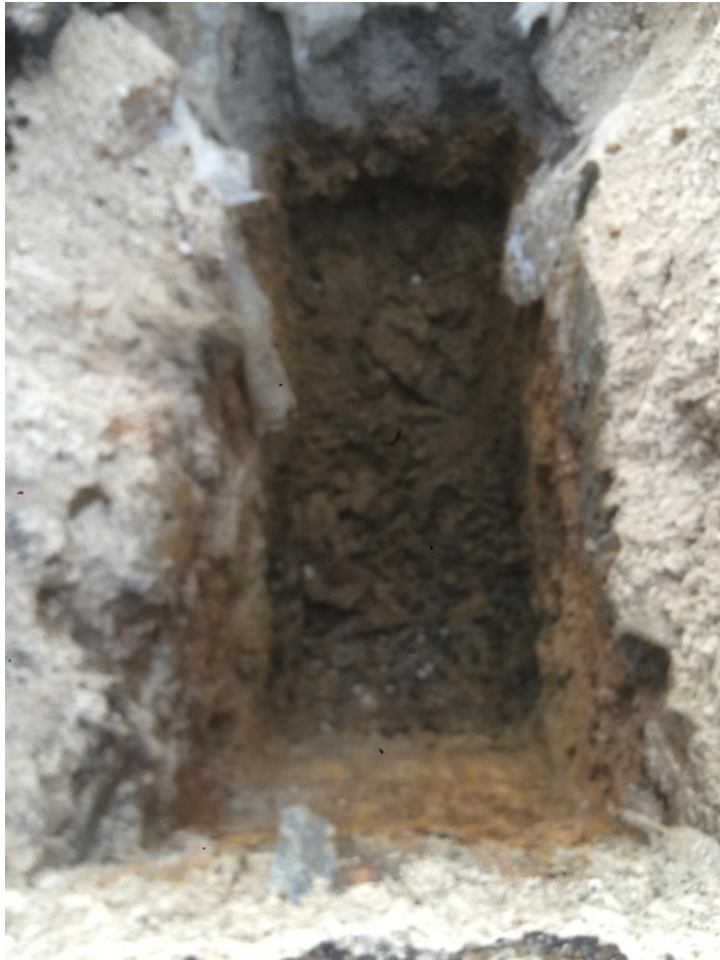
Trial Pit TP04 Exploratory Hole

Project: Former Woolpack Inn, 167 Heckmondwike Road, Phase II Intrusive Investigation			Type: Trial Pit	Hole Number: TP04	
Date: 28 th March 2017				JCB3CX	Sheet Number: 4 of 10
TESTS			SAMPLES	STRATA	
Depth (m)	Test type and depth (m)	Test Result	Sample type and depth (m)	Thickness (m)	Description
0.00 – 0.10	-	-	-	0.10	MADE GROUND Black TARMAC
0.10 – 0.40	-	-	ES1@0.30	0.30	MADE GROUND Light grey gravel of fine to coarse sub-angular limestone SUB-BASE
0.40 – 1.90	-	-	D2@1.0	1.50	Brown, grey clayey GRAVEL of fine to coarse, sub angular to sub rounded MUDSTONE and SANDSTONE
1.90+	-	-	-	-	Dark grey MUDSTONE
General Remarks					
<ul style="list-style-type: none"> • Trial pit sides stable • No Groundwater encountered • ES = Environmental Sample. D = Disturbed Sample.

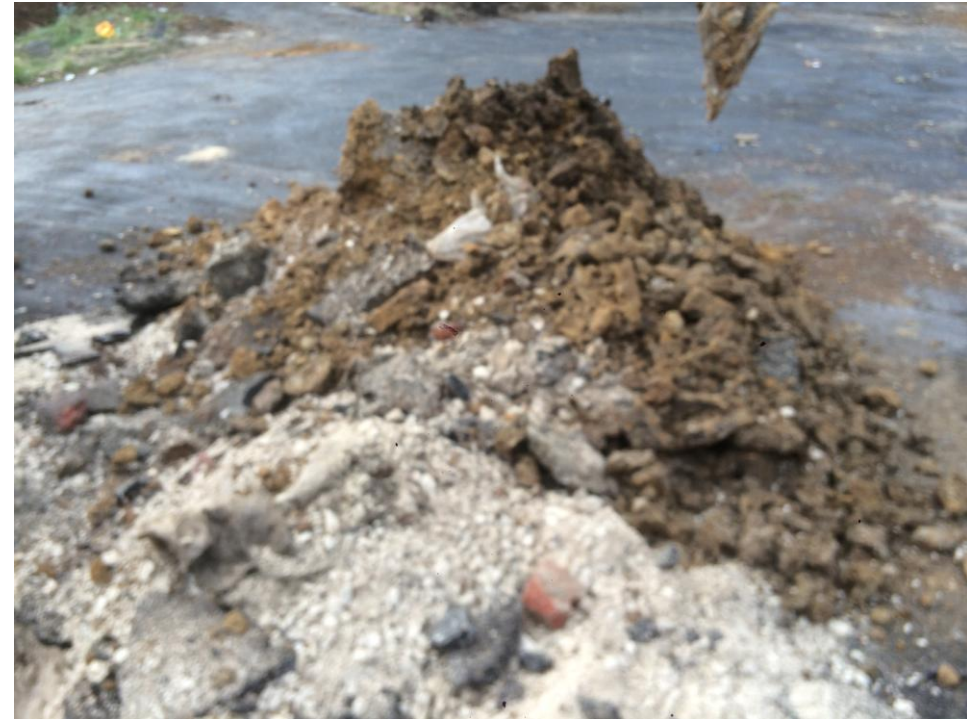
Trial Pit TP04 Spoil

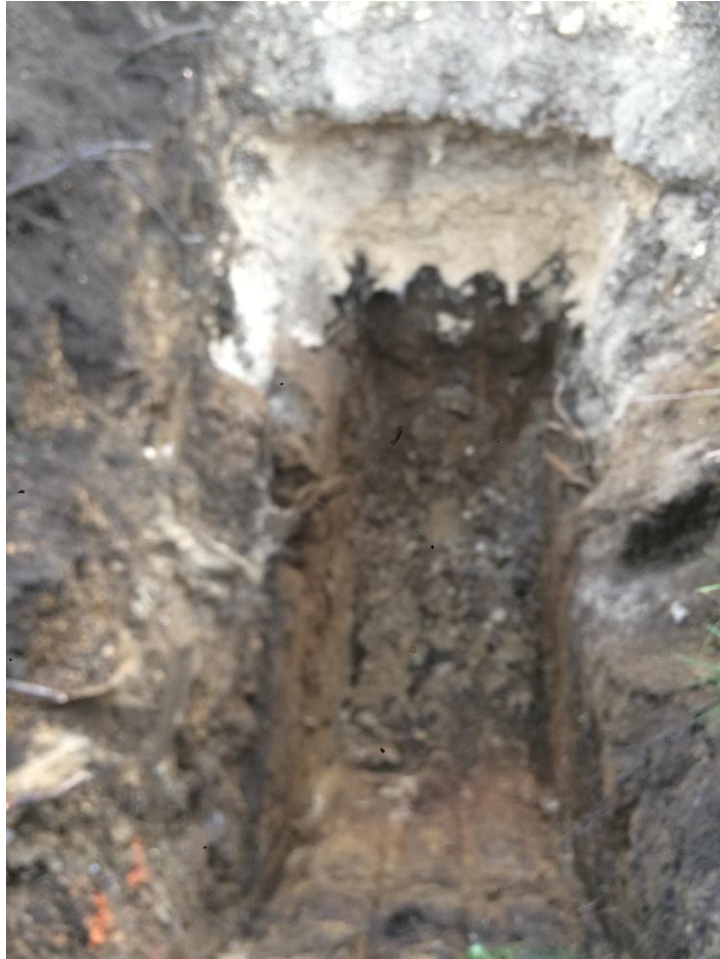
Trial Pit TP05 Exploratory Hole

Project: Former Woolpack Inn, 167 Heckmondwike Road, Phase II Intrusive Investigation			Type: Trial Pit	Hole Number: TP05	
Date: 28 th March 2017				JCB3CX	Sheet Number: 5 of 10
TESTS			SAMPLES	STRATA	
Depth (m)	Test type and depth (m)	Test Result	Sample type and depth (m)	Thickness (m)	Description
0.00 – 0.30	-	-	-	0.30	MADE GROUND Turf over brown silty clay TOPSOIL
0.30 – 1.10	-	-	ES1@0.40/0.50	0.80	MADE GROUND Black, brown slightly clayey sandy gravel of fine to coarse brick, limestone, ash and steel
1.10 – 1.70	-	-	D2@1.30	0.60	Stiff brown CLAY
1.70 – 2.10	-	-	-	0.40	Light grey GRAVEL of fine to coarse sub angular SANDSTONE
General Remarks					
<ul style="list-style-type: none"> • Trial pit sides stable • No Groundwater encountered • ES = Environmental Sample. D = Disturbed Sample.

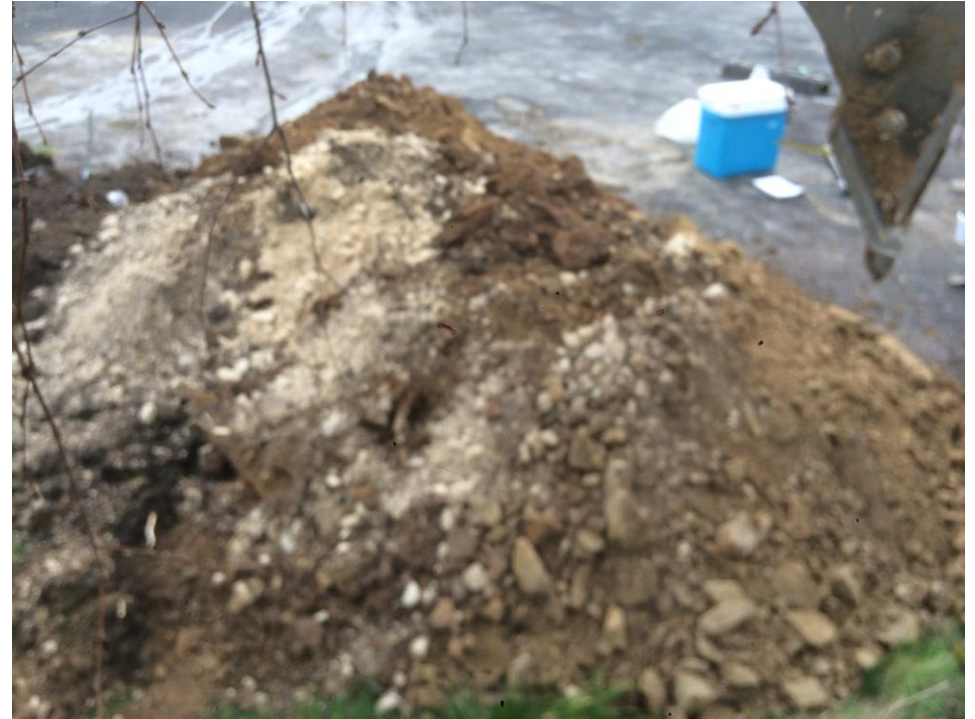
Trial Pit TP05 Spoil

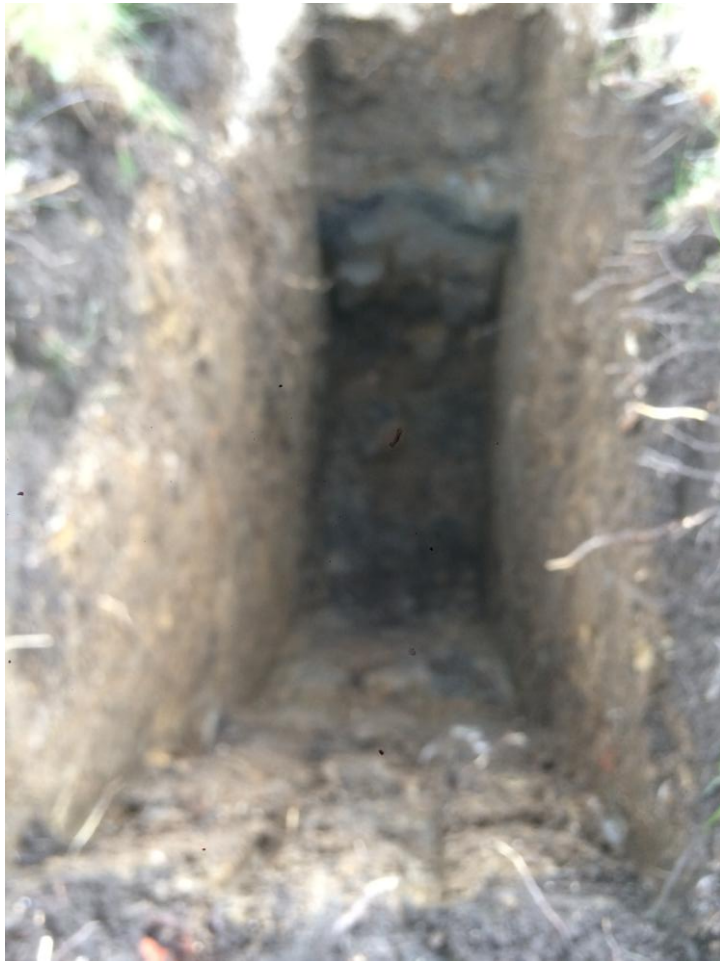
Trial Pit TP06 Exploratory Hole

Project: Former Woolpack Inn, 167 Heckmondwike Road, Phase II Intrusive Investigation			Type: Trial Pit	Hole Number: TP06	
Date: 28 th March 2017				JCB3CX	Sheet Number: 6 of 10
TESTS			SAMPLES	STRATA	
Depth (m)	Test type and depth (m)	Test Result	Sample type and depth (m)	Thickness (m)	Description
0.00 – 0.30	-	-	-	0.30	MADE GROUND Turf over brown silty clay TOPSOIL
0.30 – 1.40	-	-	ES1@0.60	1.10	MADE GROUND Black, brown slightly clayey sandy gravel of fine to coarse brick, limestone, ash and clinker
1.40 – 2.10	-	-	D2@1.50	0.70	Firm grey gravelly CLAY. Gravel of fine to coarse sub angular MUDSTONE
General Remarks					
<ul style="list-style-type: none"> • Trial pit sides stable • No Groundwater encountered • ES = Environmental Sample. D = Disturbed Sample.

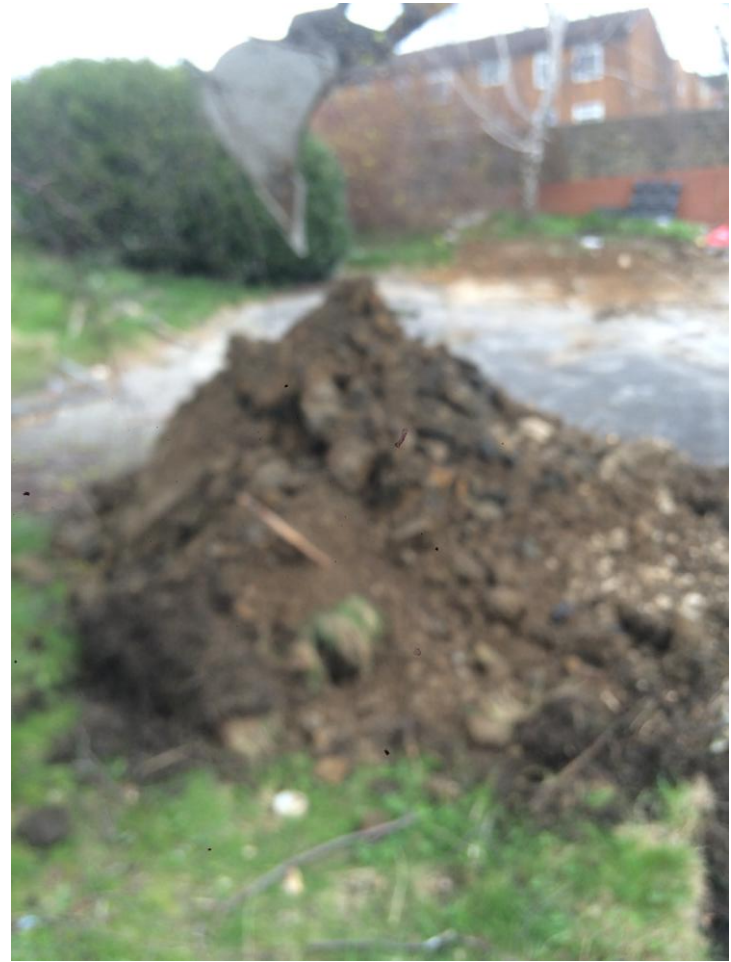
Trial Pit TP06 Spoil

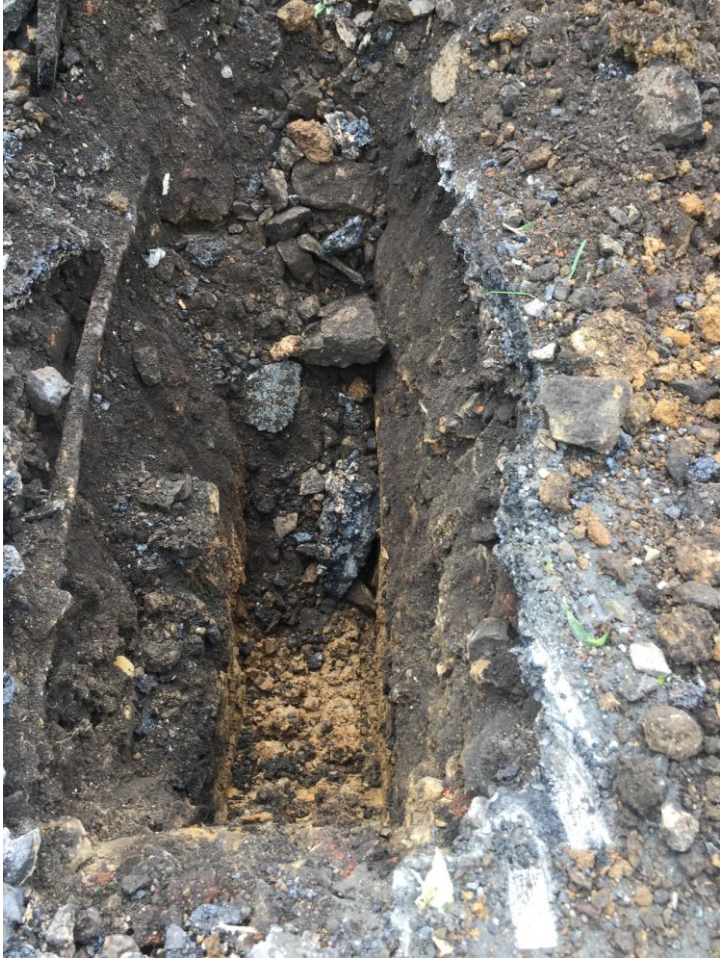
Trial Pit TP07 Exploratory Hole

Project: Former Woolpack Inn, 167 Heckmondwike Road, Phase II Intrusive Investigation			Type: Trial Pit	Hole Number: TP07	
Date: 30 th May 2017				JCB3CX	Sheet Number: 7 of 10
TESTS			SAMPLES	STRATA	
Depth (m)	Test type and depth (m)	Test Result	Sample type and depth (m)	Thickness (m)	Description
0.00 – 0.10	-	-	-	0.10	MADE GROUND Black Tarmac
0.10 – 0.70	-	-	ES1@0.30 – 0.70	0.60	MADE GROUND Black, brown slightly clayey sandy gravel of fine to coarse brick, limestone, ash and clinker
0.70 – 1.10	-	-		0.40	Firm grey gravelly CLAY. Gravel of fine to coarse sub angular MUDSTONE
General Remarks					
<ul style="list-style-type: none"> • Trial pit sides stable • Trial pit carried out in raised area 1.0m higher than rest of site. • No Groundwater encountered • ES = Environmental Sample. D = Disturbed Sample.

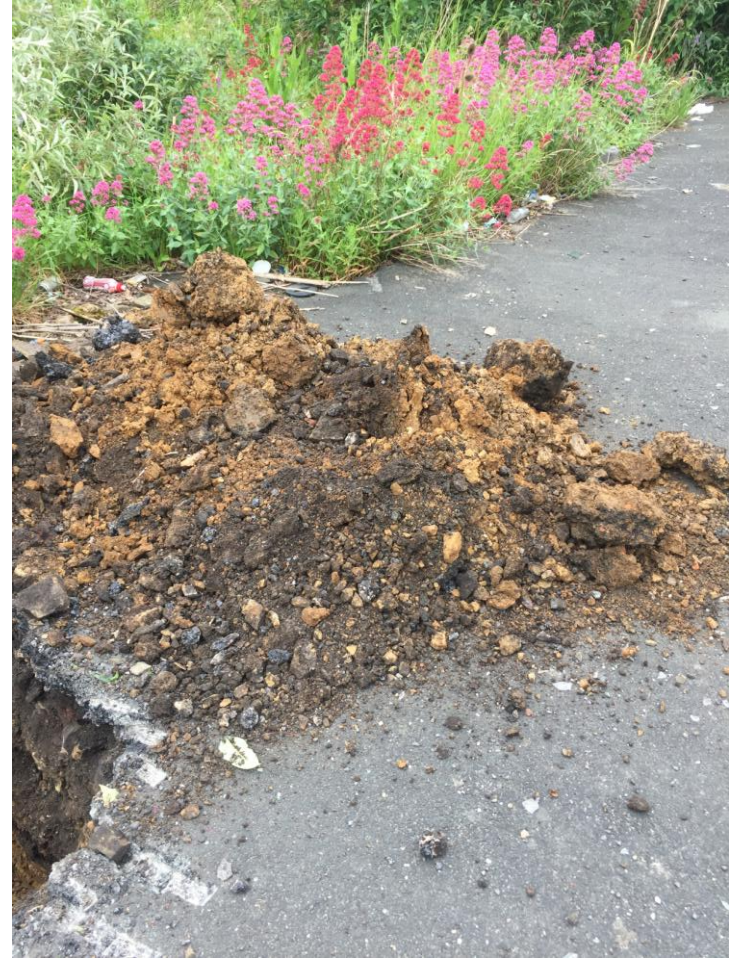
Trial Pit TP07 Spoil

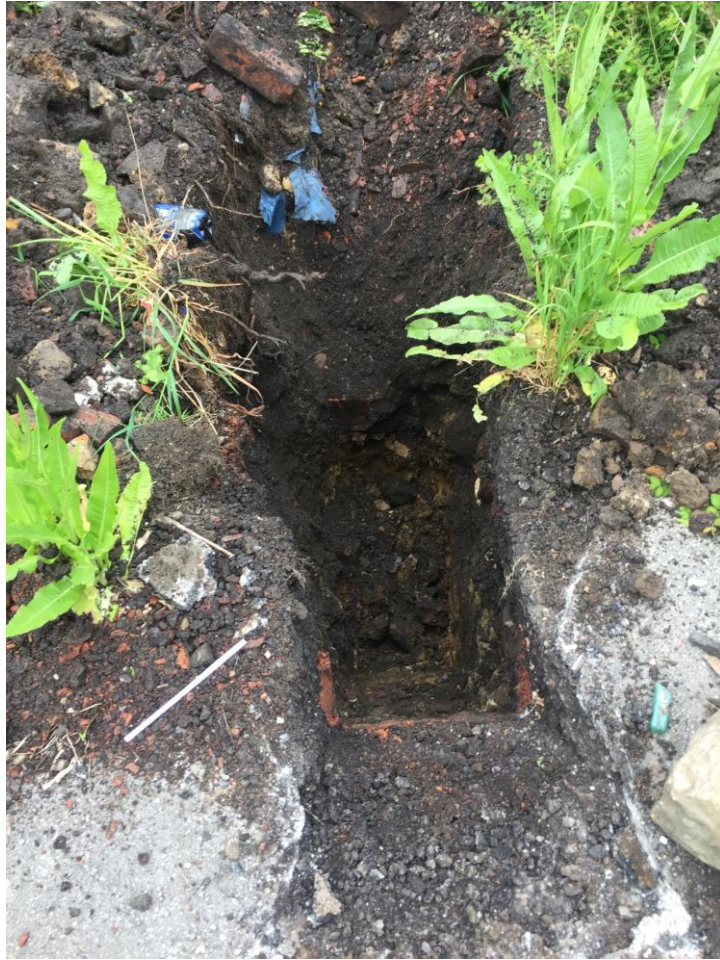
Trial Pit TP08 Exploratory Hole

Project: Former Woolpack Inn, 167 Heckmondwike Road, Phase II Intrusive Investigation			Type: Trial Pit	Hole Number: TP08	
Date: 30 th May 2017				JCB3CX	Sheet Number: 8 of 10
TESTS			SAMPLES	STRATA	
Depth (m)	Test type and depth (m)	Test Result	Sample type and depth (m)	Thickness (m)	Description
0.00 – 0.05	-	-	-	0.05	MADE GROUND Black Tarmac
0.05 – 1.30	-	-	ES1@0.70 – 1.0	1.25	MADE GROUND Black, brown slightly clayey sandy gravel of fine to coarse brick, limestone, ash and clinker
1.30 - 1.40	-	-		0.10	Grey, brown clayey fine to coarse MUDSTONE Gravel
General Remarks					
<ul style="list-style-type: none"> • Trial pit sides stable • Trial pit carried out in raised area 1.0m higher than rest of site. • No Groundwater encountered • ES = Environmental Sample. D = Disturbed Sample.

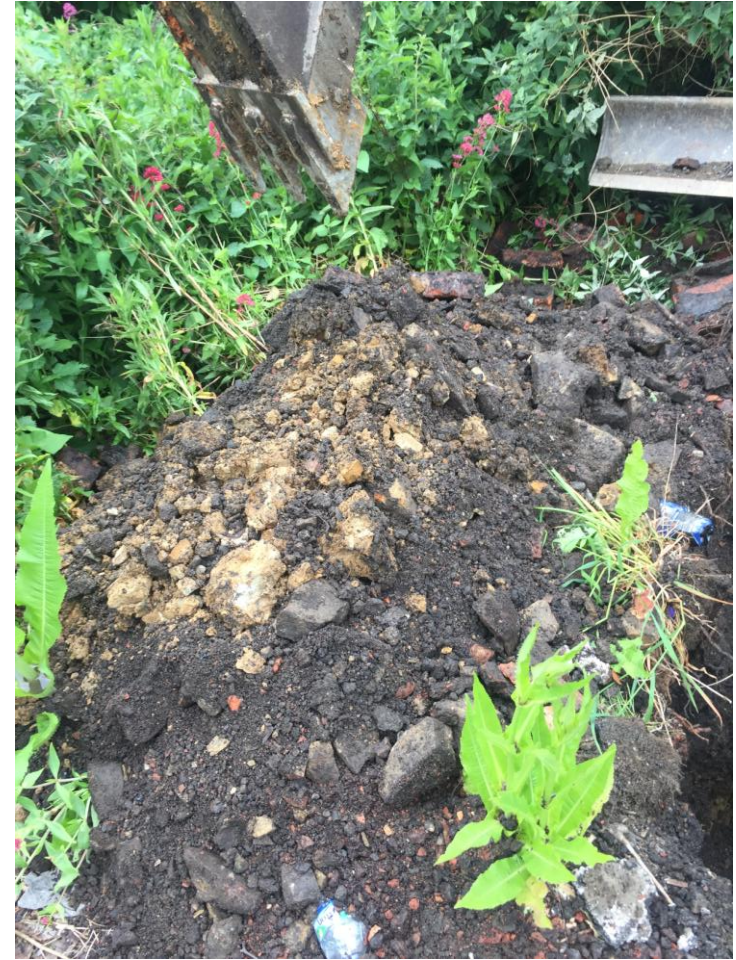
Trial Pit TP08 Spoil

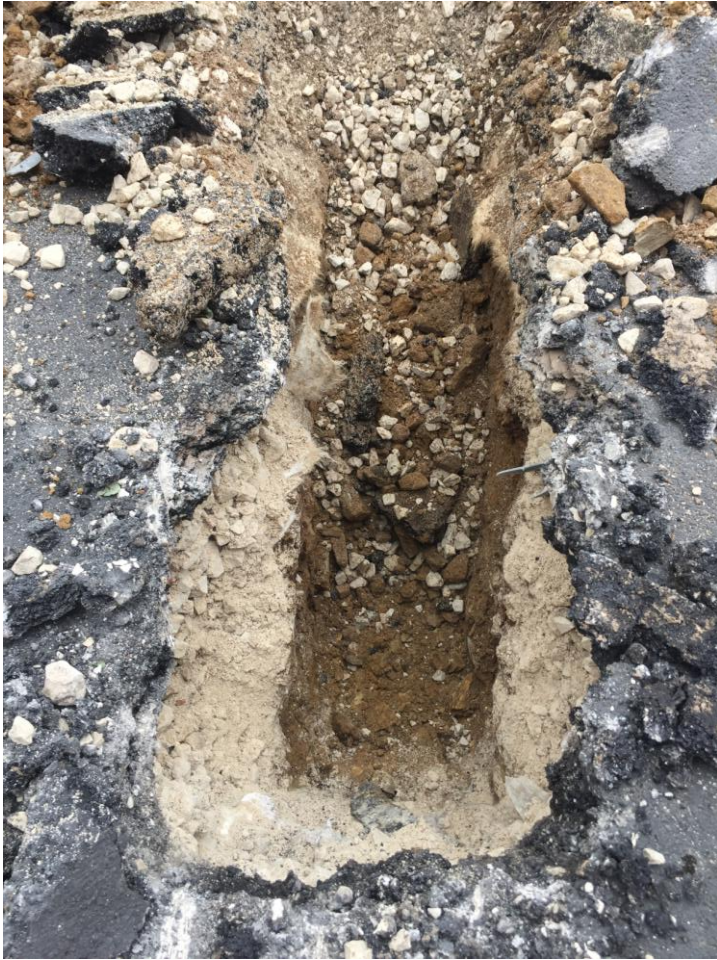
Trial Pit TP09 Exploratory Hole

Project: Former Woolpack Inn, 167 Heckmondwike Road, Phase II Intrusive Investigation			Type: Trial Pit	Hole Number: TP09	
Date: 30 th May 2017				JCB3CX	Sheet Number: 9 of 10
TESTS			SAMPLES	STRATA	
Depth (m)	Test type and depth (m)	Test Result	Sample type and depth (m)	Thickness (m)	Description
0.00 – 0.10	-	-	-	0.10	MADE GROUND Black Tarmac
0.10 – 0.40	-	-	-	0.30	MADE GROUND Light grey gravel of fine to coarse sub-angular limestone SUB-BASE
0.40 – 0.80	-	-	ES1@0.50	0.40	Firm brown, grey sandy gravelly CLAY. Gravel of fine to coarse, sub angular MUDSTONE
General Remarks					
<ul style="list-style-type: none"> • Trial pit sides stable • No Groundwater encountered • ES = Environmental Sample. D = Disturbed Sample.

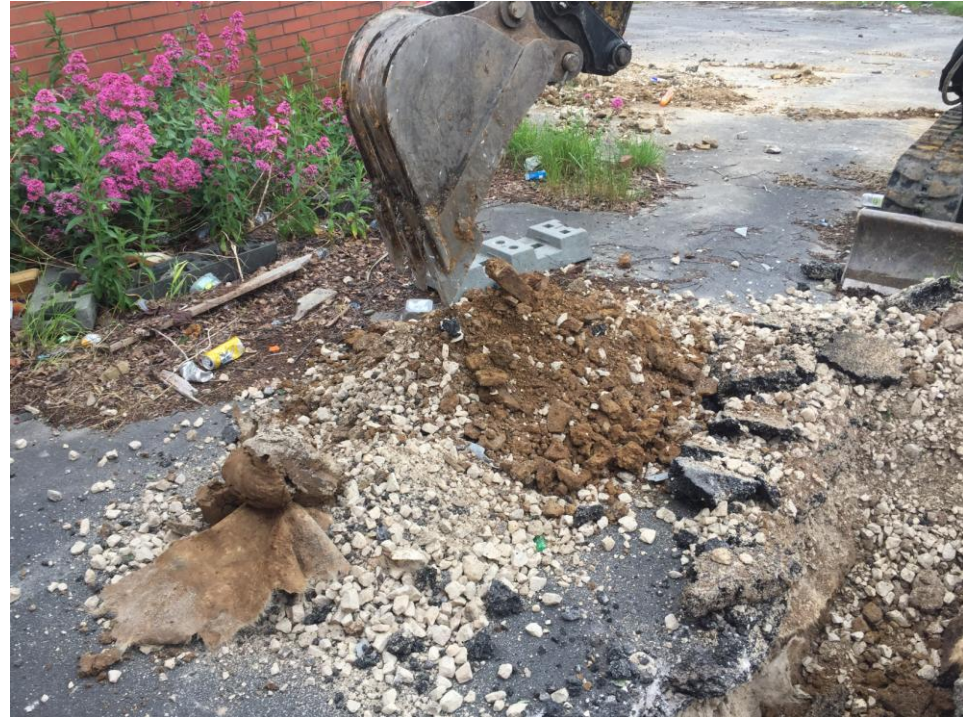
Trial Pit TP09 Spoil

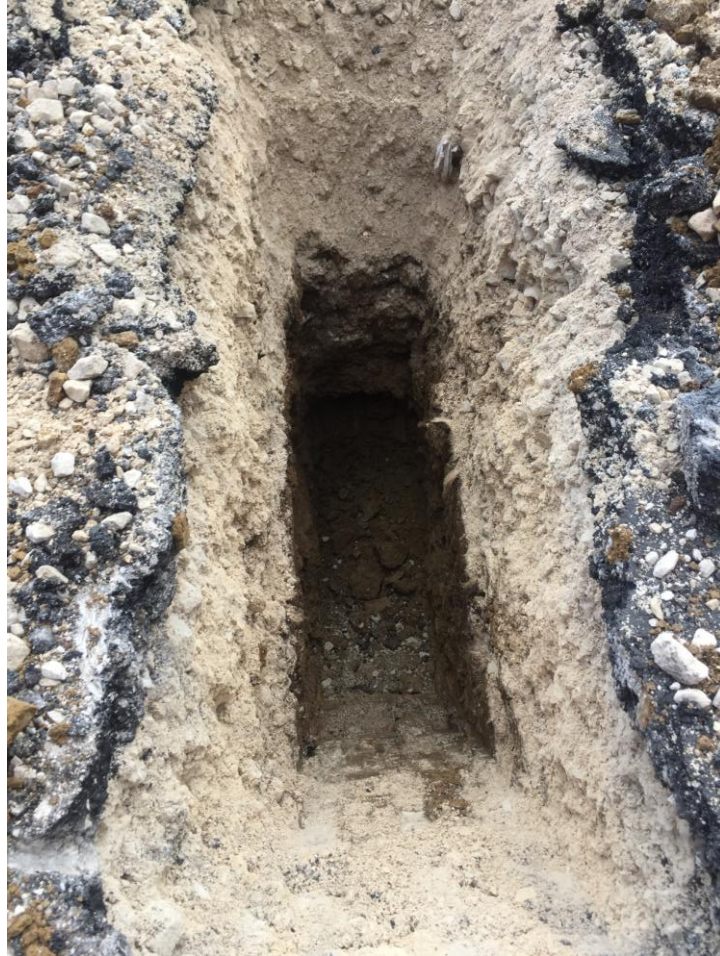
Trial Pit TP10 Exploratory Hole

Project: Former Woolpack Inn, 167 Heckmondwike Road, Phase II Intrusive Investigation			Type: Trial Pit	Hole Number: TP10	
Date: 30 th May 2017				JCB3CX	Sheet Number: 10 of 10
TESTS			SAMPLES	STRATA	
Depth (m)	Test type and depth (m)	Test Result	Sample type and depth (m)	Thickness (m)	Description
0.00 – 0.10	-	-	-	0.10	MADE GROUND Black Tarmac
0.10 – 0.70	-	-	-	0.60	MADE GROUND Light grey gravel of fine to coarse sub-angular limestone SUB-BASE
0.70 – 1.40	-	-	ES1@0.80	0.70	REWORKED MADE GROUND Firm brown slightly gravelly clay. Gavel of fine to medium MUDSTONE
1.40 – 1.60	-	-	ES2@1.50	0.20	Firm brown, grey sandy gravelly CLAY. Gravel of fine to coarse, sub angular MUDSTONE
General Remarks					
<ul style="list-style-type: none"> • Trial pit sides stable • No Groundwater encountered • ES = Environmental Sample. D = Disturbed Sample.

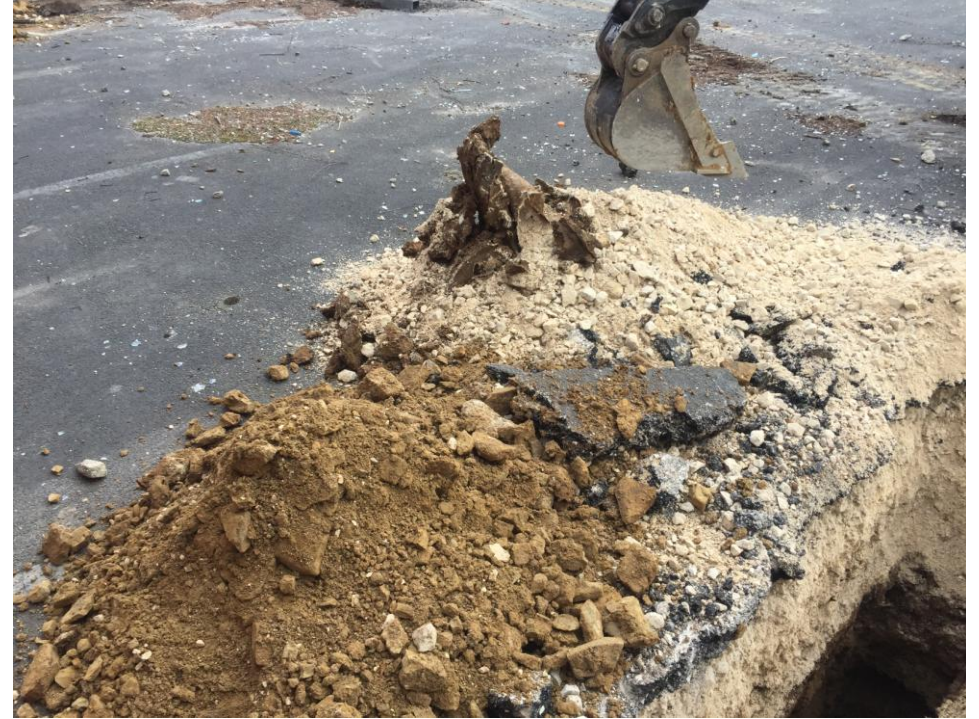
Trial Pit TP10 Spoil

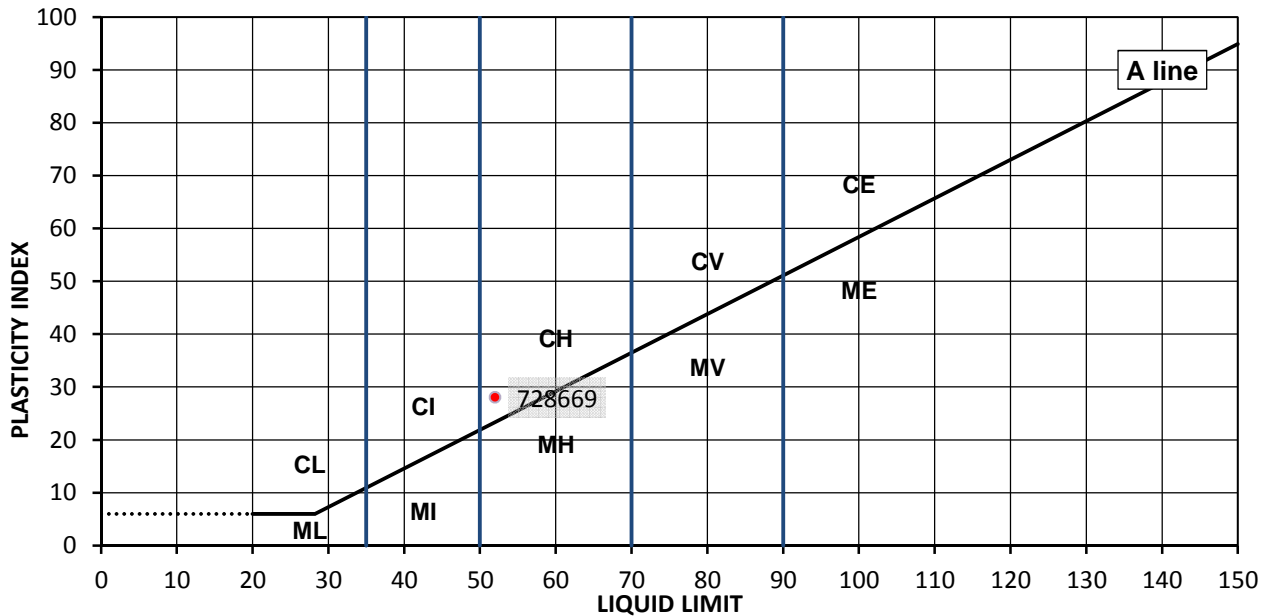
Sample Type: D
Depth Top [m]: 0.8
Depth Base [m]: Not Given

As Received Moisture Content [%]	Liquid Limit [%]	Plastic Limit [%]	Plasticity Index [%]	% Passing 425µm BS Test Sieve
33	52	24	28	100

Atterberg Limit testing was carried out on four samples of this stratum at depths ranging from 0.80mbgl to 1.50mbgl. Measured Moisture Contents ranged from 19% to 33%, Liquid Limits ranged from 35% to 52%, Plastic Limits from 20% to 27% and Plasticity Indices from 15% to 28%. These results indicate a clay material of Intermediate to High Plasticity, with a Low to Medium Volume Change Potential (After NHBC 2008, Chapter 4, Building Near Trees).

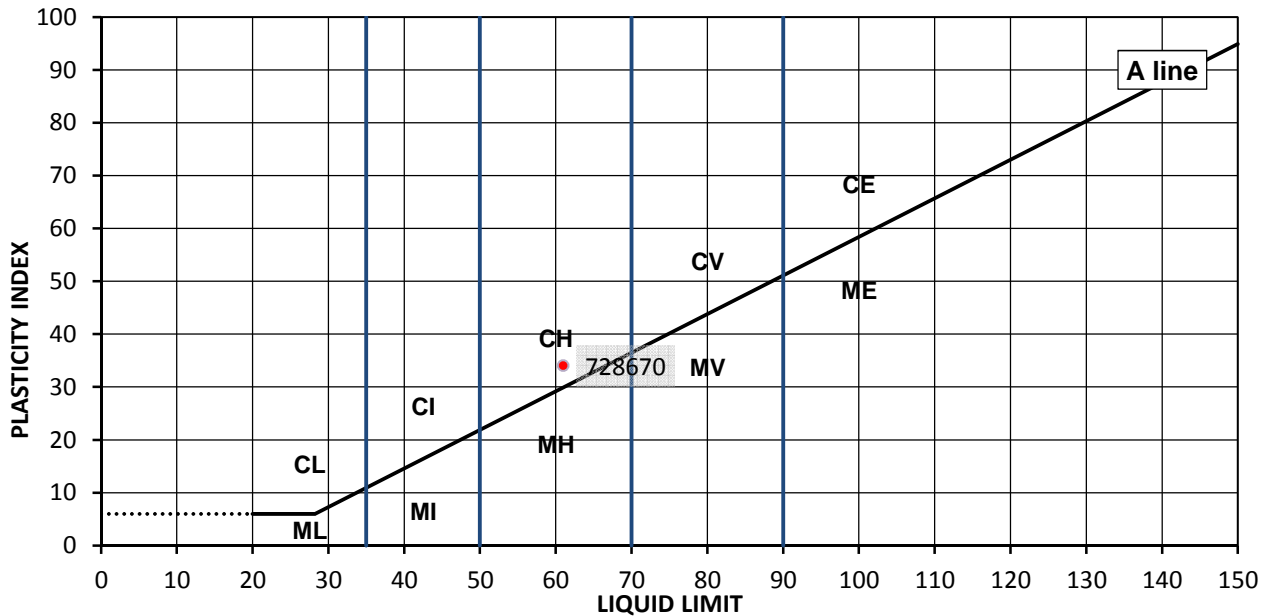
Sample Type: D
Depth Top [m]: 1.6
Depth Base [m]: Not Given

As Received Moisture Content [%]	Liquid Limit [%]	Plastic Limit [%]	Plasticity Index [%]	% Passing 425µm BS Test Sieve
27	61	27	34	100

One Atterberg Limit test was carried out on a sample of the shallow weathered coal seam encountered in TP02, with a measured Moisture Content of 27%, Liquid Limit of 61%, Plastic Limit of 27% and a Plasticity Index of 34%, classifying it as a stratum of High Plasticity, with a Medium Volume Change Potential.

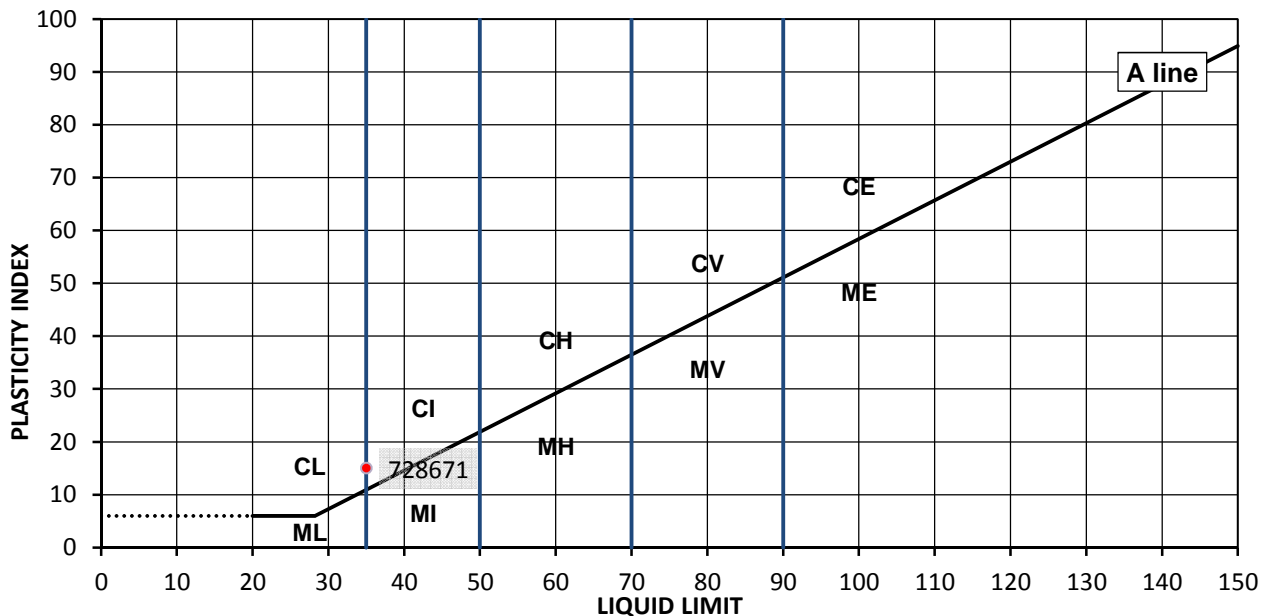
As Received Moisture Content [%]	Liquid Limit [%]	Plastic Limit [%]	Plasticity Index [%]	% Passing 425µm BS Test Sieve
24	35	20	15	76

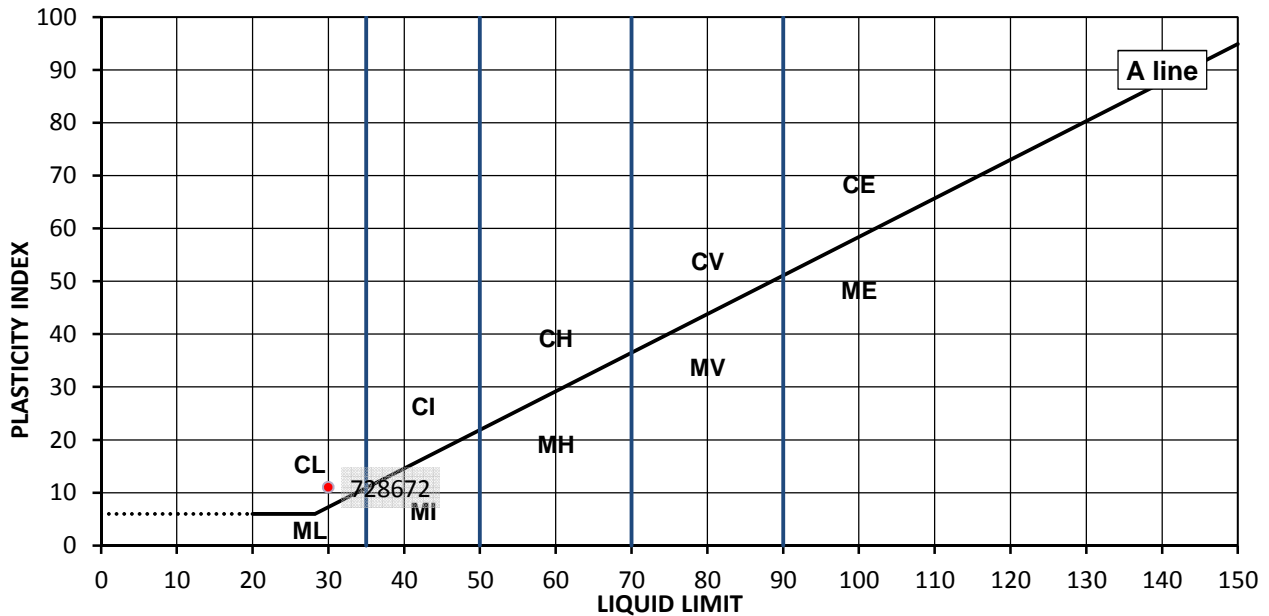
Sample Type: D
Depth Top [m]: 1
Depth Base [m]: Not Given

As Received Moisture Content [%]	Liquid Limit [%]	Plastic Limit [%]	Plasticity Index [%]	% Passing 425µm BS Test Sieve
15	30	19	11	75

One Atterberg Limit test was carried out on a sample of this material, with a measured Moisture Content of 15%, Liquid Limit of 30%, Plastic Limit of 19% and Plasticity Index of 11%. These results classify the clay parts of this stratum as being of a Low Plasticity, with a Low Volume Change Potential.

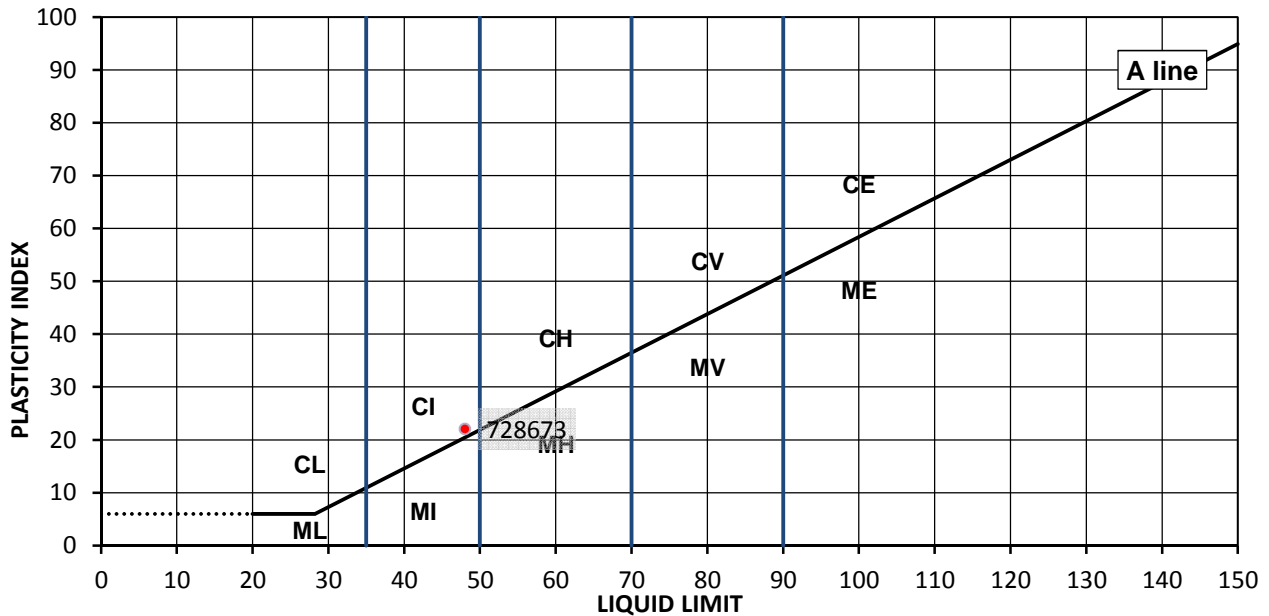
As Received Moisture Content [%]	Liquid Limit [%]	Plastic Limit [%]	Plasticity Index [%]	% Passing 425µm BS Test Sieve
19	48	26	22	96

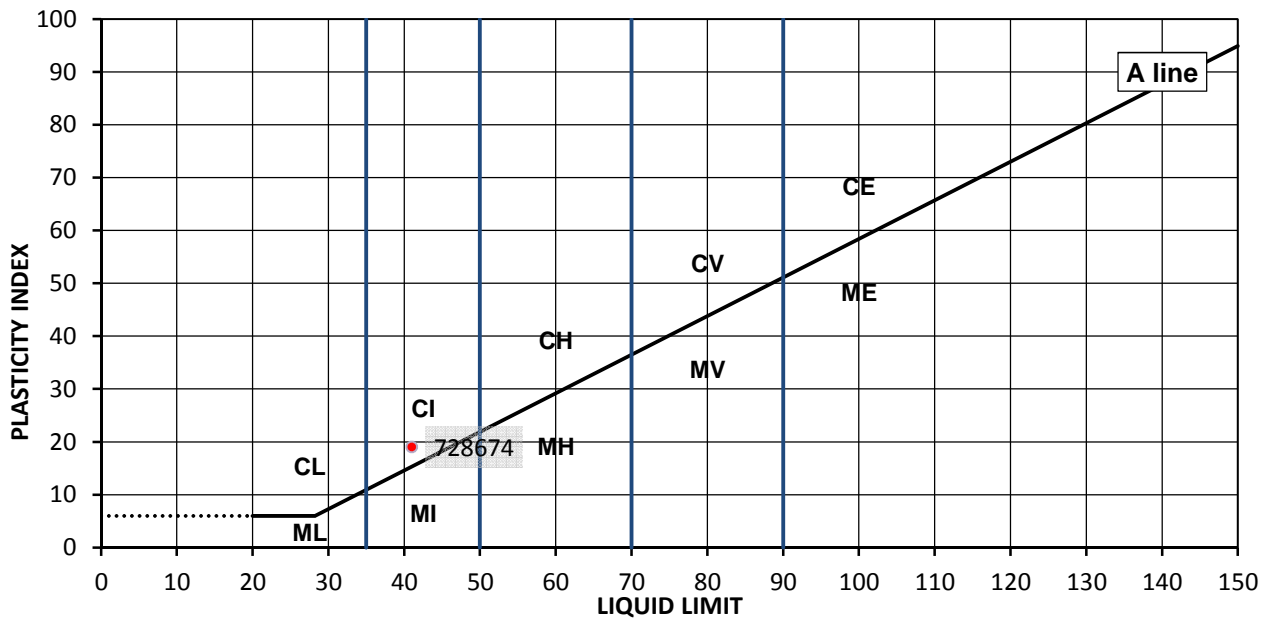
As Received Moisture Content [%]	Liquid Limit [%]	Plastic Limit [%]	Plasticity Index [%]	% Passing 425µm BS Test Sieve
22	41	22	19	89
