# Bat Mitigation Strategy

Wheelwright Centre, Kirklees College, Dewsbury

Presented to **MMR Construction Limited**

Delta-Simons Project No. 19-0651.06

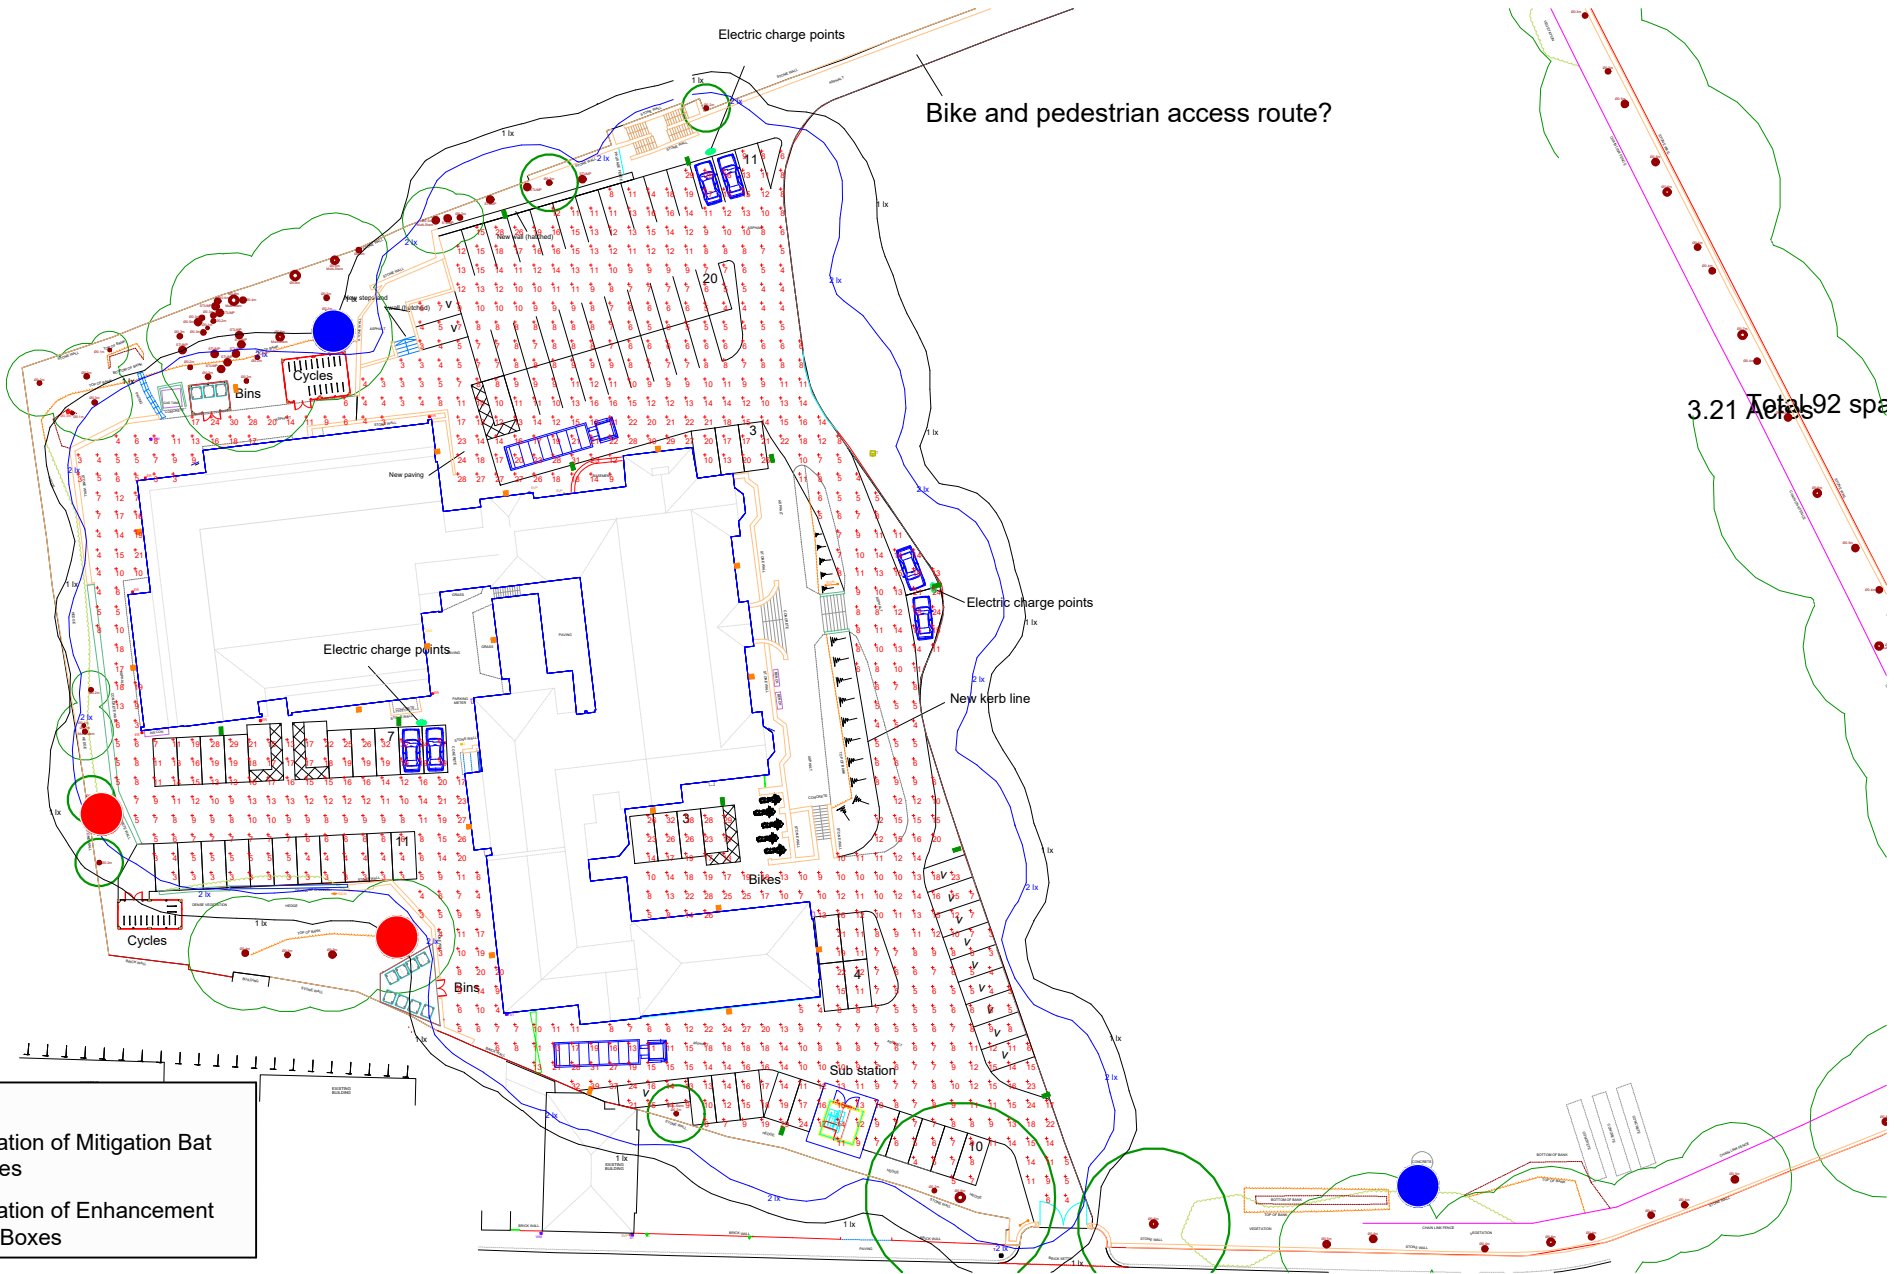
## Figure 3 – Lighting Strategy

- Location of Mitigation Bat Boxes
- Location of Enhancement Bat Boxes

TITLE:  
 Lighting Plan  
 Wheelwright Centre  
 Dewsbury

The proposed lighting plan, see Figure 3, indicates that there will be no light spill from the development onto the two roost locations, nor onto the proposed compensatory and enhancement roosts that will be installed on trees for bats at the western Site boundary. However, there will be light spill from the proposed car park onto the existing car park and adjacent buildings, which are currently lit for security, therefore, this will have no increased adverse impact on commuting or foraging bats to that currently. It is anticipated that light spill to the south and east of the building will be minimal and will, therefore, have a limited impact on any commuting and/ or foraging bats associated with the trees on Birkdale and Halifax Roads.

The lighting strategy has been designed to use the Italo lantern and Quarto bulkheads which are available in 2700°K. It is understood that there will be no upward light spill, and the design will give an average light level of 1 - 2 lux on the vegetation to that forms the western and northern Site boundaries.
