## PRELIMINARY BAT SURVEY REPORT

### **Outbuilding Demolition / Plot Development Proposal**

**3 Cote Close**

| Report Title | Preliminary Bat Survey Report |

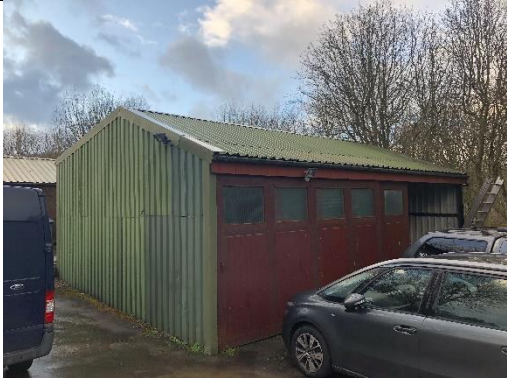
#### Structure One:

| | <ul style="list-style-type: none"><li>• Single storey detached structure.</li><li>• Currently used as a garage/storage shed.</li><li>• Constructed with corrugated steel walls.</li><li>• Roof constructed with structural steel internal framework.</li><li>• Timber sliding door allows access.</li></ul> |

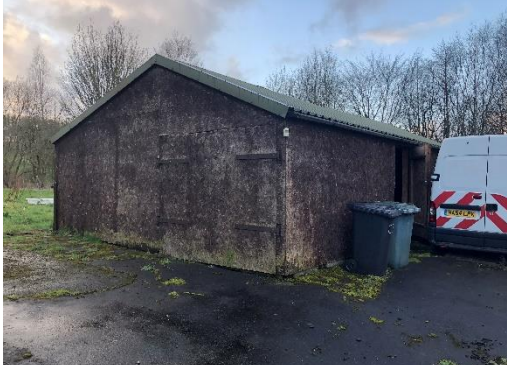
### Structure Two:

| | <ul style="list-style-type: none"> <li>• Single storey detected structure.</li> <li>• Currently used for storage.</li> <li>• Constructed with corrugated steel roof.</li> <li>• Structural timber framework.</li> <li>• Chip-board outer and internal walls.</li> <li>• Access gained by large barn doors to south elevation and single door to east elevation.</li> </ul> |

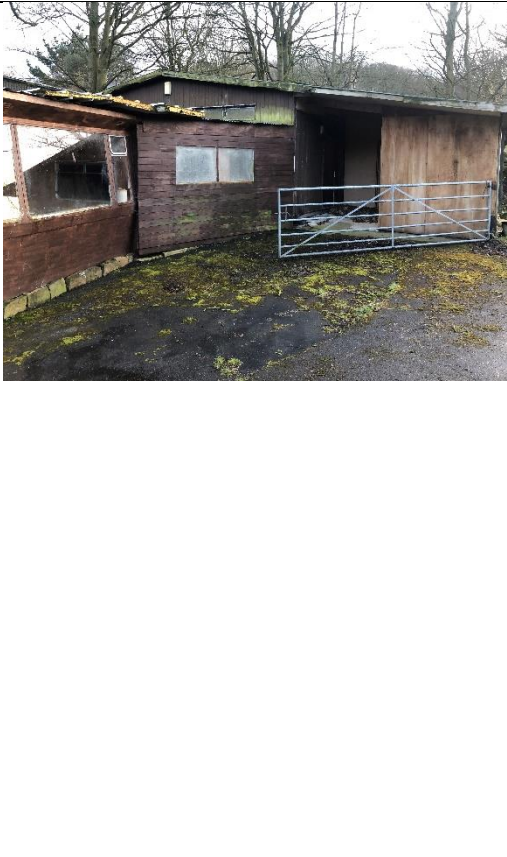
### Structure Three:

| | <ul style="list-style-type: none"> <li>• Large single storey structure.</li> <li>• Structure is comprised of various additions; <ol style="list-style-type: none"> <li>a) Central structure (largest) - timber framed, timber clad and corrugated steel roof.</li> <li>b) Single storey timber lean-to structure adjoining north-west elevation of structure 'a'.</li> <li>c) Timber clad static caravan adjoined to north-east elevation of structure 'a'.</li> <li>d) Open sided lean-to structure adjoining south-east elevation of structure 'a'.</li> <li>e) Timber structure adjoined to north-east elevation of structure 'a', linking with structure 'c'.</li> </ol> </li> <li>• Roof areas of items 'b', 'c' and 'e' have insulated corrugated steel roofing panels installed.</li> <li>• Roof area of structure 'd' is a single-ply corrugated steel sloped roof.</li> <li>• Roof area of item 'a' is a corrugated steel sheet roofing panels.</li> <li>• Structures 'c' and 'e' are severely dilapidated.</li> </ul> |

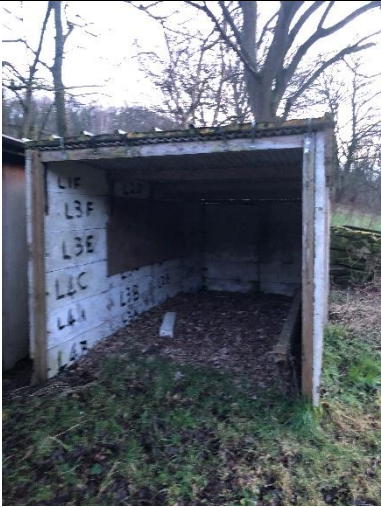
**Structure Four:**

| | <ul style="list-style-type: none"><li>• Small single storey garage structure.</li><li>• Constructed with a prefabricated concrete structural framework.</li><li>• Prefabricated concrete wall panels.</li><li>• Insulated corrugated steel roofing panels laid over corrugated Asbestos (presumed) panels.</li><li>• Timber roofing purlins.</li></ul> |

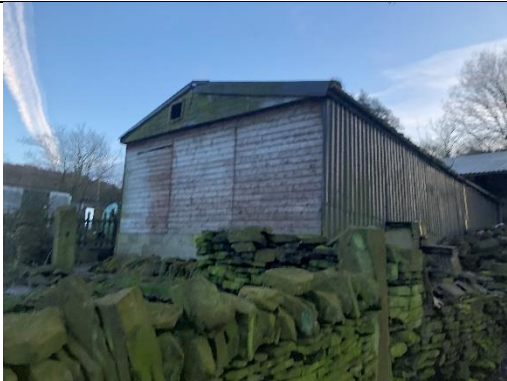
**Structure Five (Demolition TBC):**

| | <ul style="list-style-type: none"><li>• Large detached single storey workshop structure.</li><li>• Constructed with timber clad walls and structural timber framework, including roof framework.</li><li>• Corrugated steel roofing panels overlaid over original timber cladding and bitumen roofing felt roof.</li></ul> |

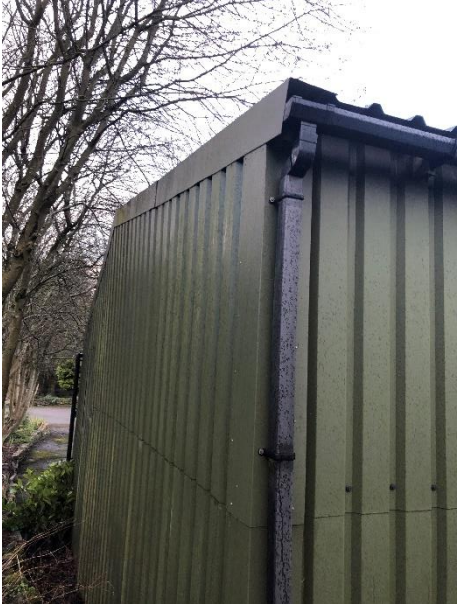
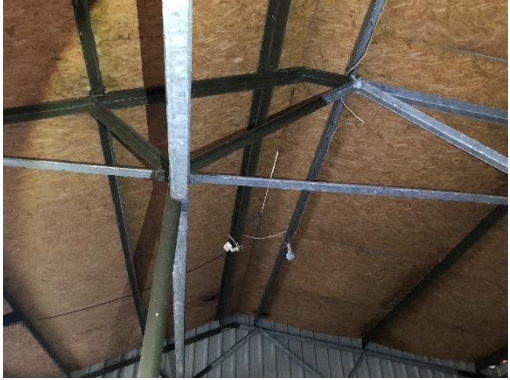
#### Structure One:

| <p><b>3.2.1</b><br/>Constructed using corrugated steel panels – considered undesirable for roosting bats due to poor thermal retention properties and surface properties for bats to grip onto while at roost.</p> | <p><b>3.2.2</b><br/>Underside of roofing clad with timber boards on structural steel framework – negligible roost potential features between external corrugated steel cladding and timber boards.</p> |

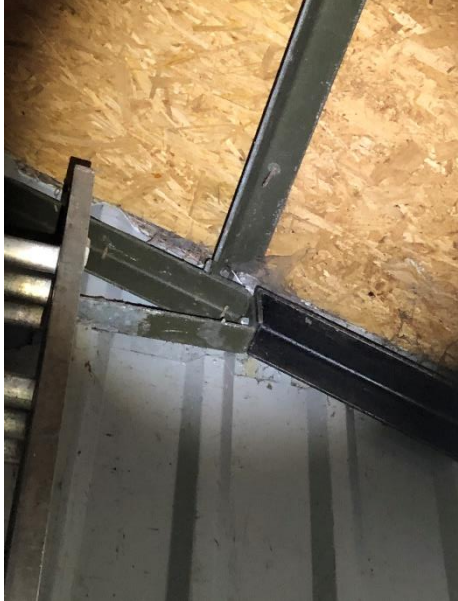
| <p><b>3.2.3</b><br/>Internal timber boarding very tightly fitted together and with steel purlins, providing limited openings for roosting bats to access.</p> | <p><b>3.2.4</b><br/>Heavy build-up of cobwebs around structural steel throughout internal roof space, suggesting bats roosting within the structure is unlikely.</p> |

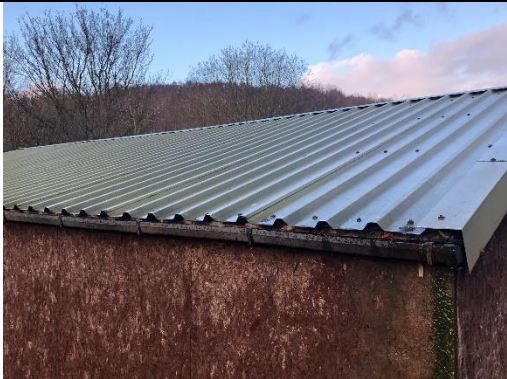
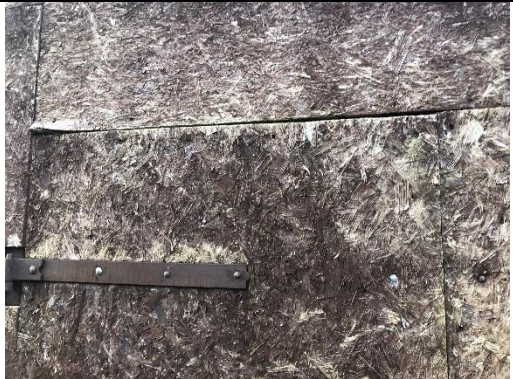
**Structure Two:**

| <p><b>3.2.5</b><br/>Single ply corrugated steel roof panels installed over timber boards – negligible roost potential for same justifications explained in 3.2.1.</p> | <p><b>3.2.6</b><br/>Small opening (potentially too narrow) above door to south elevation into structure – low roost access potential.</p> |

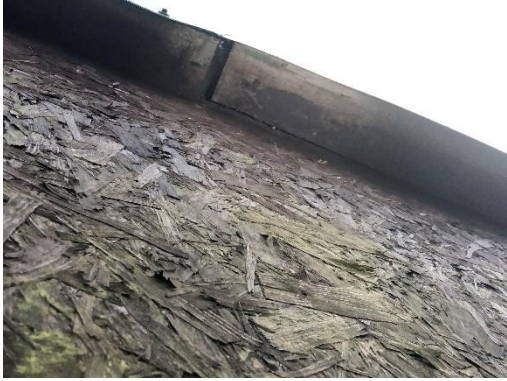
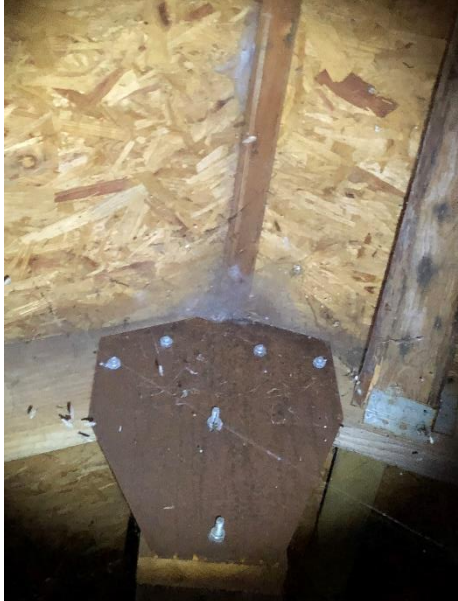
| <p><b>3.2.7</b><br/>North elevation roof rake edge – several low-moderate potential roost features between timbers installed under roof cladding edge trim and possible access into the structure / wall cavity.</p> | <p><b>3.2.8</b><br/>Extremely heavy build-up of cobwebs around internal structural timber framework suggesting it is unlikely bats are utilising the internal elements of the structure for roosting and/or internal flight.</p> |

Following the preliminary roost assessment, it was not possible confidently ascertain the status of bats utilising several of the structures (structures 'two', 'three' & 'five'). Due to the high number of potential roost features within the structures, outlined in Section 3.2, and the optimum habitat surrounding the plot, these structures have been categorised as having higher than negligible potential for roosting bats and therefore further survey is recommended.

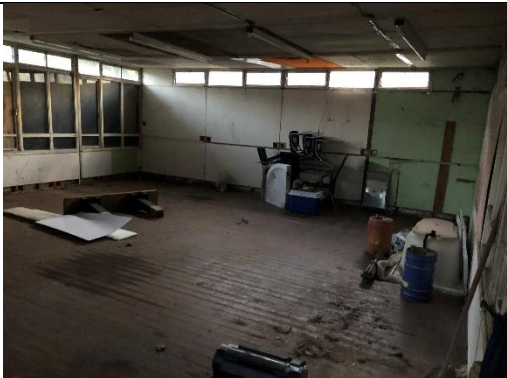
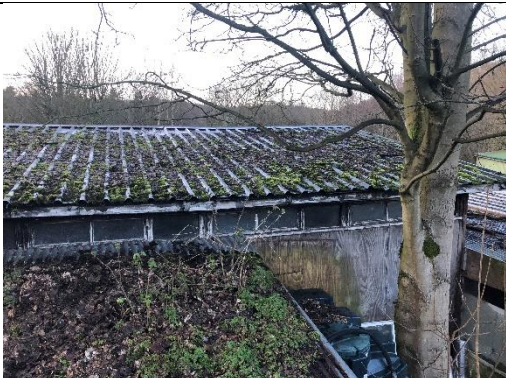
### Structure Three: Element 'a' (Central Large Structure)

| <p><b>3.2.9</b><br/>No evidence of bat activity within internal space of the workshop area was identified. No access point into this structure was found.</p> | <p><b>3.2.10</b><br/>Roof area appeared to be clad with a single-ply corrugated steel roofing system. Inspection to the underside of roofing could not be undertaken due to ceiling installed to inside of structure 'a'. See 3.2.9.</p> |

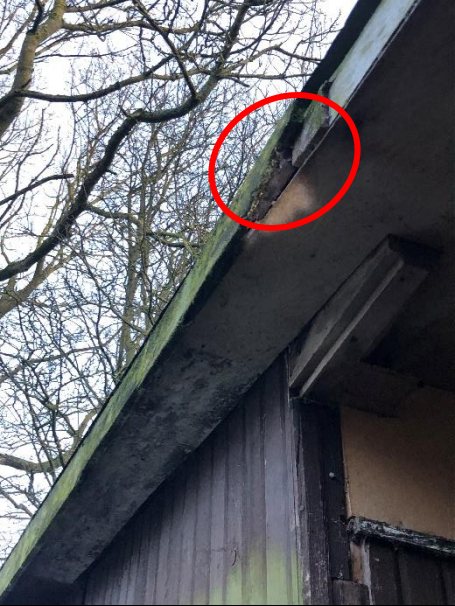
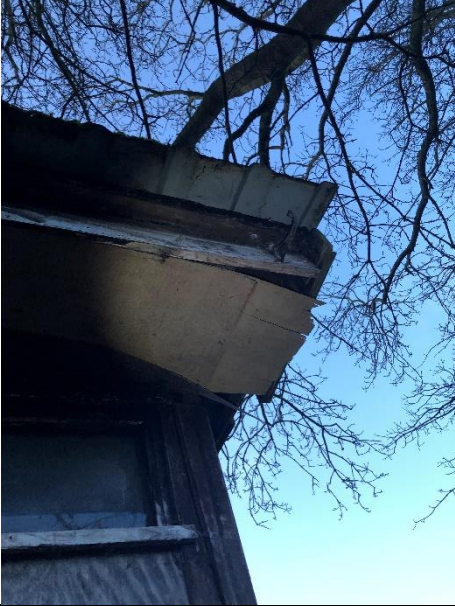
| <p><b>3.2.11</b><br/>Opening in timber fascia board on north-east elevation – moderate-high potential roost feature</p> | <p><b>3.2.12</b><br/>Displaced/loose timber soffit board – moderate – high potential roost feature</p> |

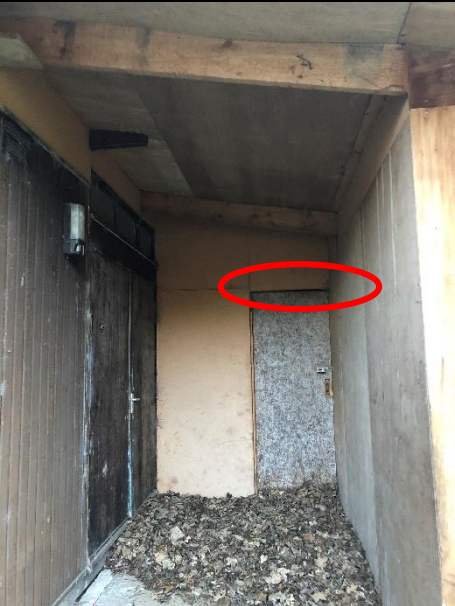
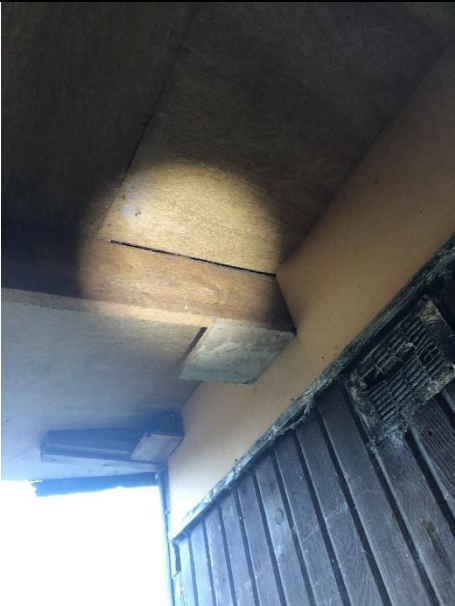
**Structure Three: Element 'b' (Timber Clad Lean-to Structure)**

| <p><b>3.2.12</b><br/>Access into structure remains closed for security. Small opening above access door – low potential roost access feature.</p> | <p><b>3.2.13</b><br/>Several openings between timber soffit boards and rafters of structures access porch – moderate potential roost features.</p> |

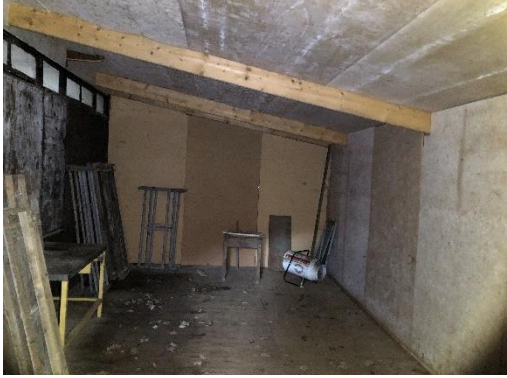
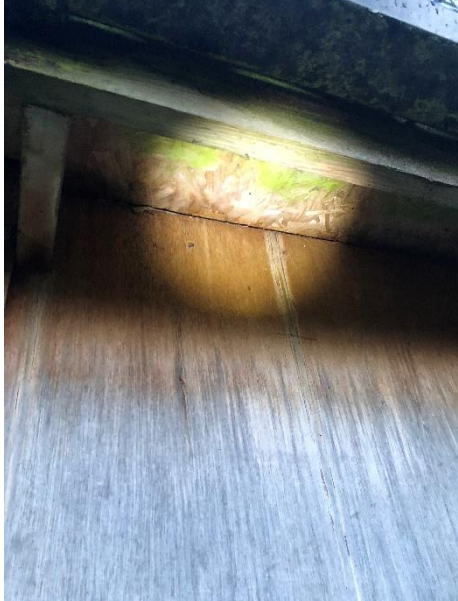
| <p><b>3.2.14</b><br/>Clad with timber board and exposed timber rafters – considered highly suitable for roosting bats. Particularly suitable of BLE species as structure allows for internal flight. Numerous openings allowing access into wall cavity.</p> | <p><b>3.2.15</b><br/>Opening along top edge of north-west elevation external timber boarding considered a suitable access point for roosting bats – moderate potential roost feature.</p> |

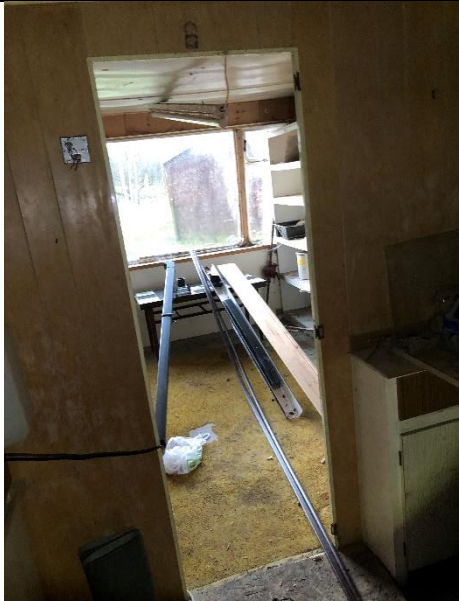
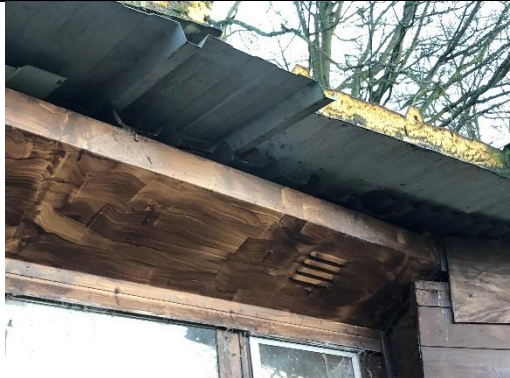
**Structure Three: Element 'c' (Caravan Structure)**

| <p><b>3.2.14</b><br/>Inside of caravan structure – negligible roost potential.</p> | <p><b>3.2.15</b><br/>Openings between corrugated steel roofing panels – negligible roost potential.</p> |

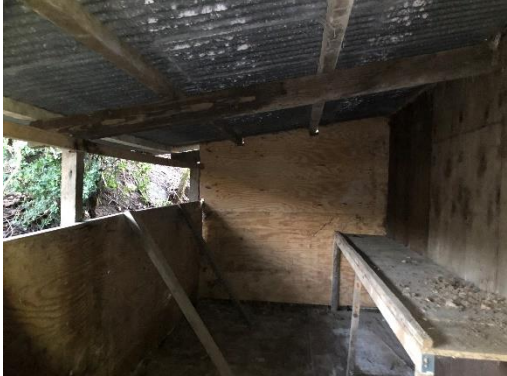
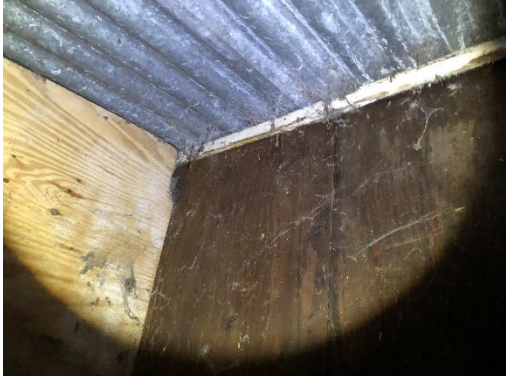
**Structure Three: Element 'd' (Corrugated Roof Lean-to Structure)**

| <p><b>3.2.16</b><br/>Open-sided lean-to structure offers limited concealment and protection for roosting bats – negligible potential roost structure. Structure is likely to be favourable for internal flight and providing feeding perches for bats such as BLE – no evidence of such usage was identified however.</p> | <p><b>3.2.17</b><br/>Heavy build-up of cobwebs along back edge of structure suggests bats are unlikely to have previously used the structure for roosting.</p> |

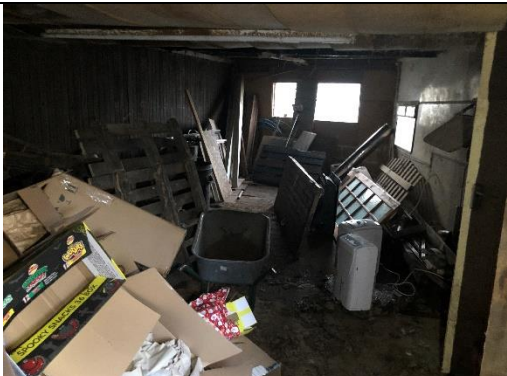
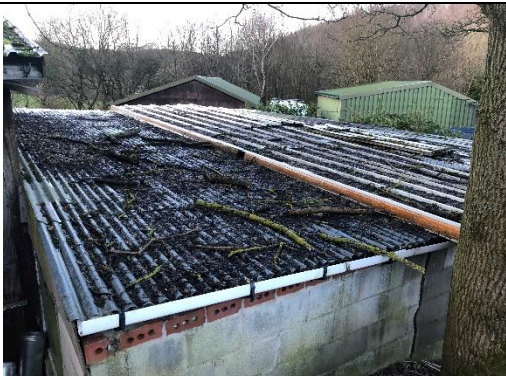
**Structure Three: Element 'e'**

| <p><b>3.2.18</b><br/>Currently used for storage the structure has several access points, some allowing free flight access and some smaller. There are numerous features suitable for roosting bats throughout the structure with timber ceiling and crevice like features throughout the inside and outside of the structure.</p> | <p><b>3.2.19</b><br/>The structures roof is comprised of single-ply corrugated steel panels - considered unfavourable for roosting bat due to poor thermal retention properties.<br/><br/>Collectively the structure is considered to have low potential for roosting bats.</p> |

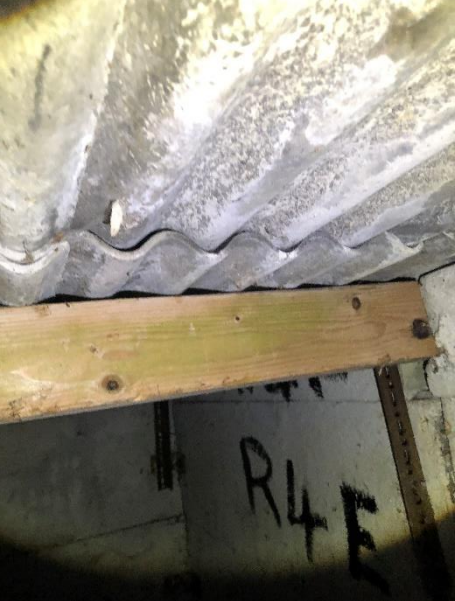
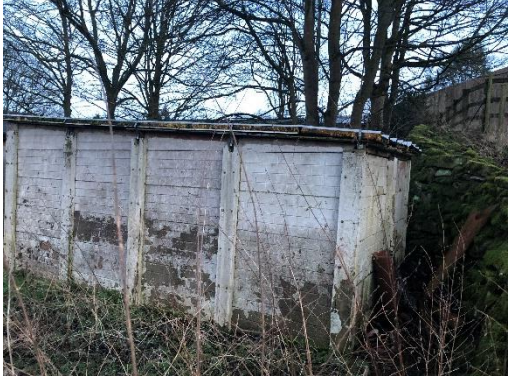
**Structure Four:**

| <p><b>3.2.20</b><br/>Roof area is constructed of corrugated Asbestos (presumed) and insulated corrugated steel panels laid over timber rafters – internal features considered to have low-negligible roost potential.</p> | <p><b>3.2.21</b><br/>Walls are constructed with prefabricated concrete panels – negligible roost potential. Roof is constructed with multiple layers of corrugated sheet roofing materials providing numerous openings between layers – materials considered undesirable for roosting bats and collectively considered to have negligible roost potential.</p> |

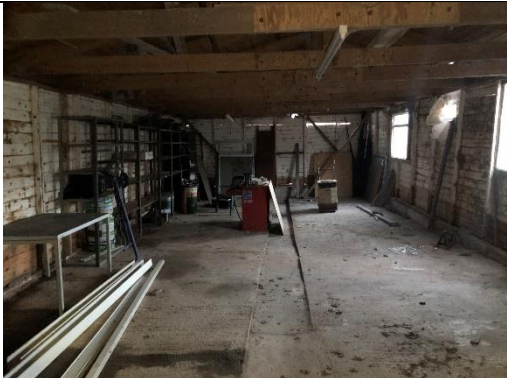
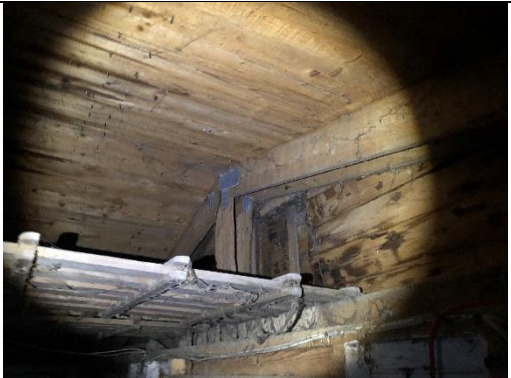
**Structure Five: Demolition TBC**

| <p><b>3.2.22</b><br/>Inside of structure has previously been used as a workshop. No evidence of bat activity, such as droppings, was identified during the survey undertaken.</p> | <p><b>3.2.23</b><br/>Internal features within the structure are considered to be optimal for roosting bats. However, a heavy build-up of cobwebs to underside of timber roof and timber rafters suggests bats roosting internally is unlikely.</p> |

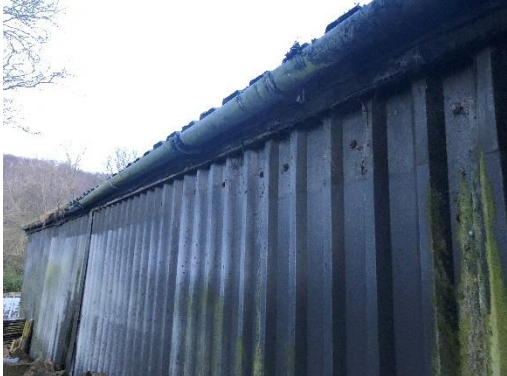
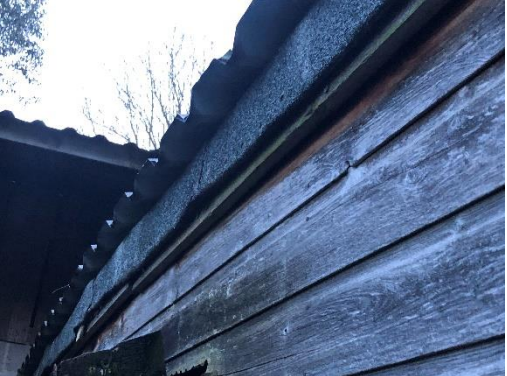
| <p><b>3.2.24</b><br/>Corrugated steel cladding to north-west elevation - considered low suitability for roosting bats.<br/>Timber fascia board behind PVC guttering - considered to have low potential for roosting bats.</p> | <p><b>3.2.25</b><br/>South-east elevation is timber clad with a timber fascia board and overlapping bitumen membrane along the top edge – numerous moderate potential roost features throughout.<br/>Gaps beneath corrugated steel roofing panels - negligible roost potential.</p> |

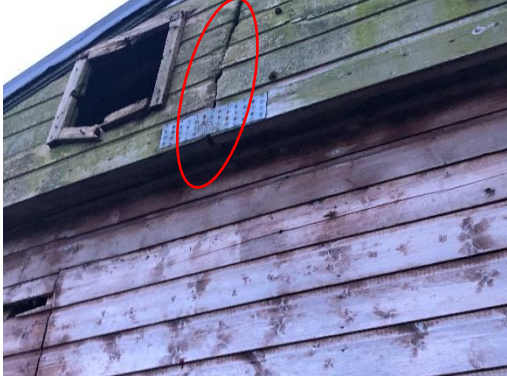
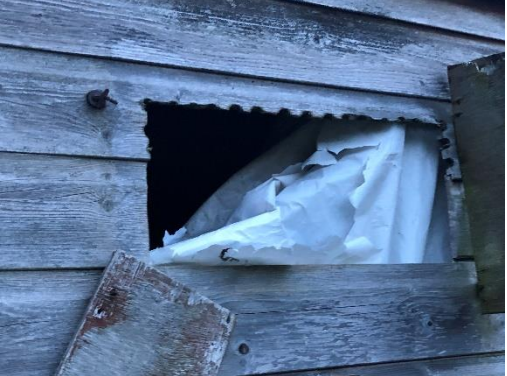
| <p><b>3.2.26</b><br/>Free flight access point into structure on north east elevation – no evidence of bat activity, such as droppings adhered to wall near opening on inside and outside were identified. Feature considered to be a moderate potential roost access feature.<br/>Gap to underside of protruding gable allowing access into timber cladding. Also, vertical fracture through timber cladding allowing access within – features in this location considered to be high potential roost features.</p> | <p><b>3.2.27</b><br/>Free flight access point into structure on south east elevation – no evidence of bat activity, such as droppings adhered to wall near opening on inside and outside, were identified. Feature considered to be a low potential roost access feature.</p> |
