Phase 2: Site Investigation

Spaines Road Mosque, Huddersfield

Ahmadiyya Muslim Association UK

PHASE 2 SITE INVESTIGATION REPORT

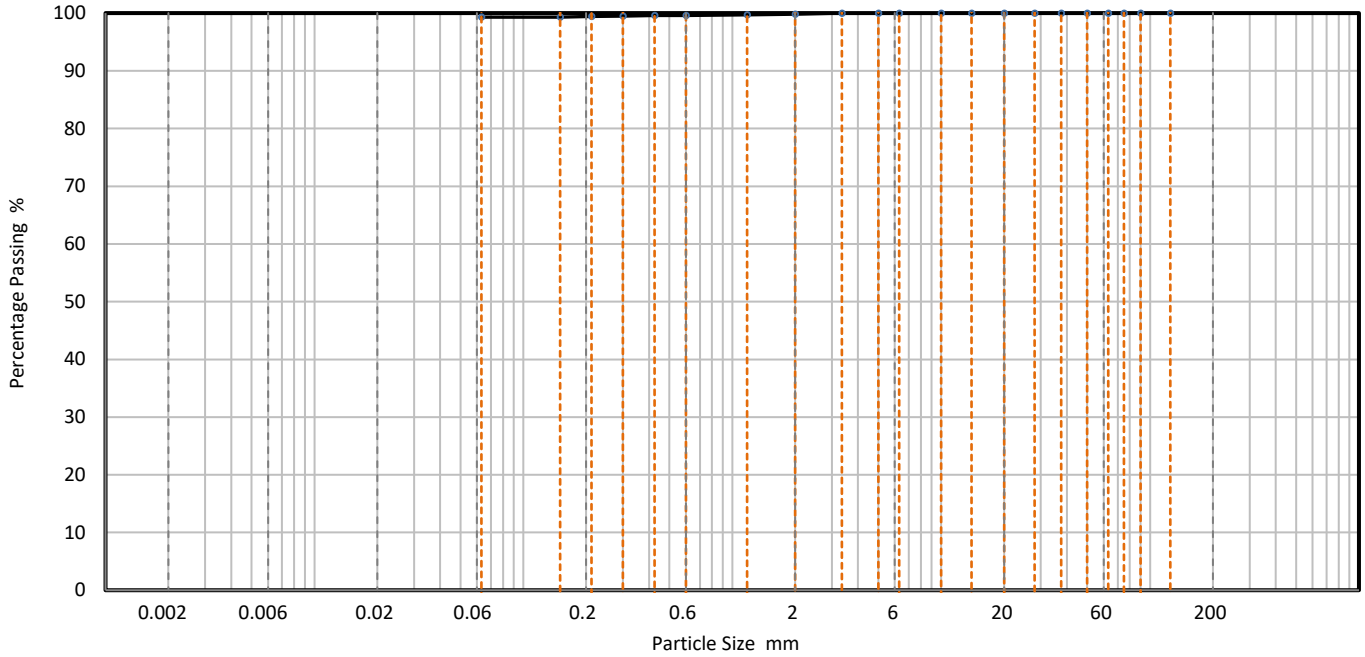
Hole	BH1	Lab sample ID	SLMK201906130
Depth (Top) m	0.80	Test Method	BS 1377 - 2 : 1990 Clause 9.2
Depth (Base) m	1	Soil Description	Brown, CLAY
Sample type	B

Sieving		Sedimentation	
Particle Size mm	% Passing	Particle Size mm	% Passing
125	100		
90	100		
75	100		
63	100		
50	100		
37.5	100		
28	100		
20	100		
14	100		
10	100		
6.3	100		
5	100		
3.35	100		
2	100		
1.18	100		
0.6	100		
0.425	100		
0.3	100		
0.212	99		
0.15	99		
0.063	99

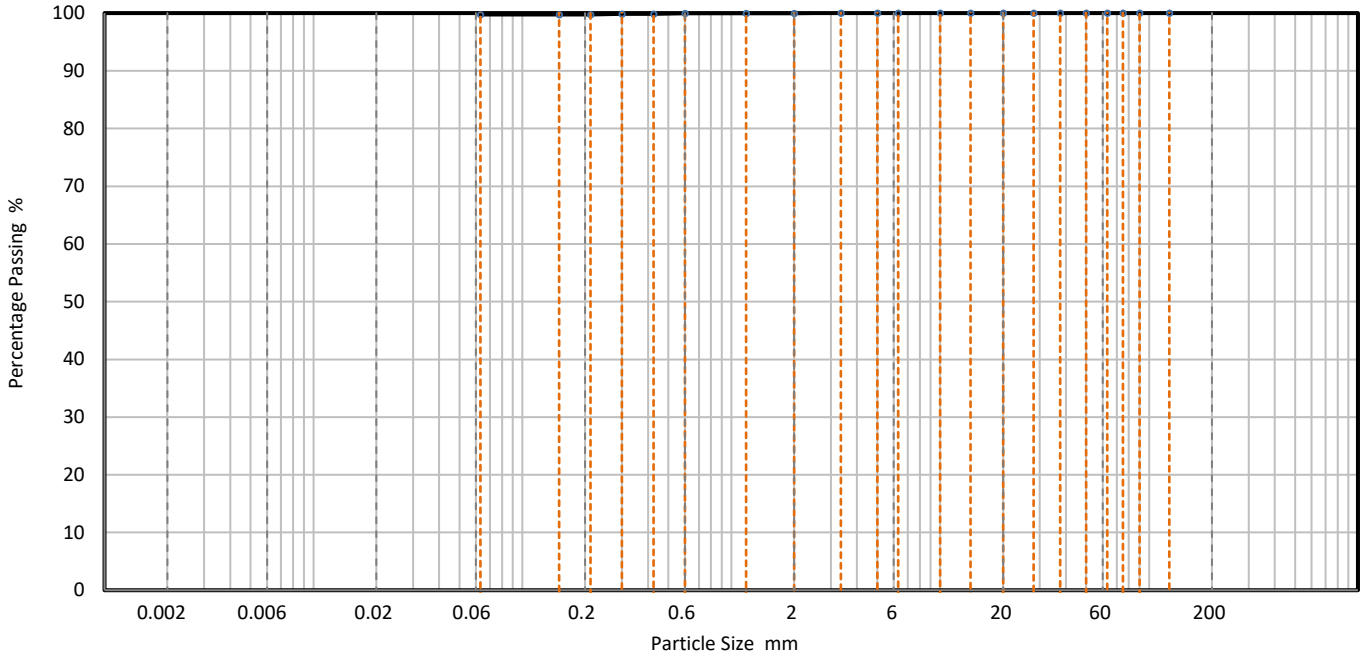
Hole	BH3	Lab sample ID	SLMK201906132
Depth (Top) m	1.80	Test Method	BS 1377 - 2 : 1990 Clause 9.2
Depth (Base) m	2	Soil Description	Brown CLAY
Sample type	B

Sieving		Sedimentation	
Particle Size mm	% Passing	Particle Size mm	% Passing
125	100		
90	100		
75	100		
63	100		
50	100		
37.5	100		
28	100		
20	100		
14	100		
10	100		
6.3	100		
5	100		
3.35	100		
2	100		
1.18	100		
0.6	100		
0.425	100		
0.3	100		
0.212	100		
0.15	100		
0.063	100

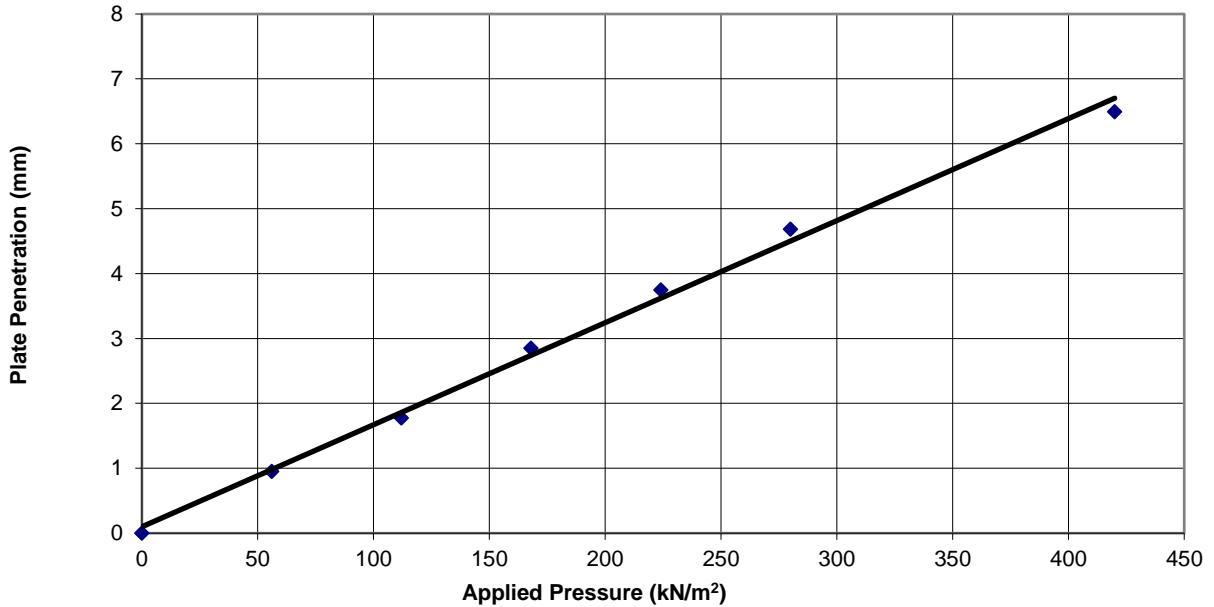
PLATE BEARING TEST		Date:	05/06/2019
Project Number:	S190527	Test No:	TP1
Project Name:	Spaines Road, Huddersfield	Test Level:	0.30mbgl
Test Method: BS 1377 : Part 9 : 1990 (Incremental Method)		Weather:	Dry, still
Plate Diameter:	0.305 m	Load Applied:	420 kPa
Kentledge Type:	JCB 3CX + Jack	Remarks:	Clay

Pressure (kN/m ²)	Plate Penetration (mm)
Initial	0	0
Stage 1	56	0.95
Stage 2	112	1.78
Stage 3	168	2.85
Stage 4	224	3.75
Stage 5	280	4.68
Stage 6	420	6.50
Stage 7		
Stage 8		
Stage 9		
Stage 10

Conversion Factor	0.45	Produced by:	J Currie
Stress Applied @ 1.25mm	73.21 kN/m ²		
Total Plate Deflection	6.50 mm	Checked by:	R Woods
Plate Diameter	305 mm		
k305	58570

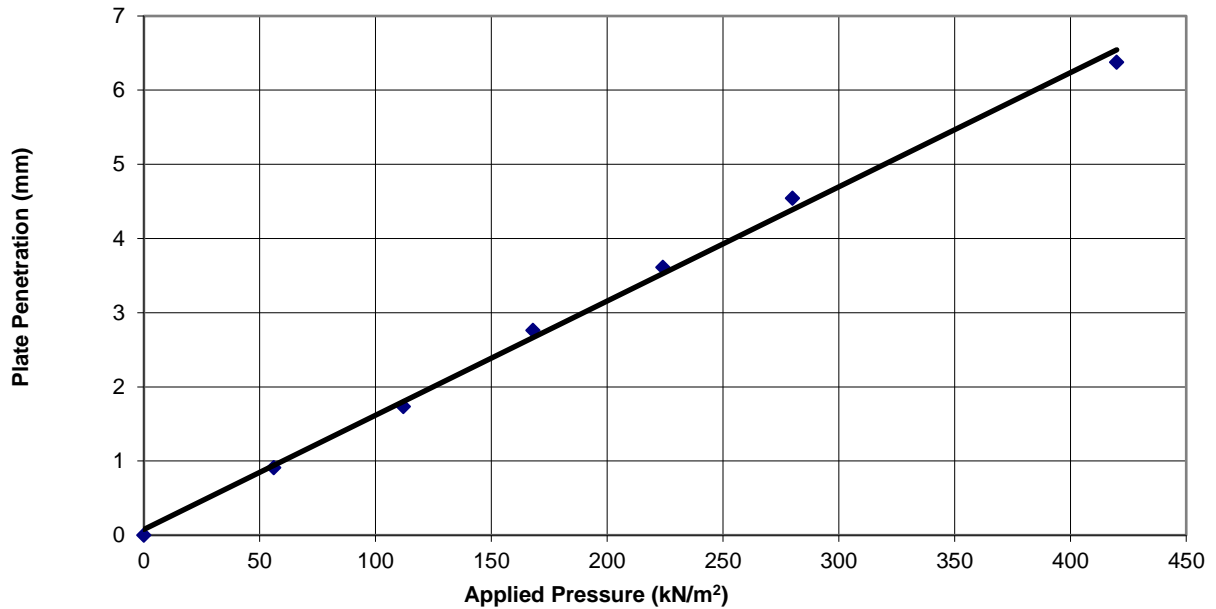
PLATE BEARING TEST		Date:	05/06/2019
Project Number:	S190527	Test No:	TP2
Project Name:	Spaines Road, Huddersfield	Test Level:	0.30mbgl
Test Method: BS 1377 : Part 9 : 1990 (Incremental Method)		Weather:	Dry, still
Plate Diameter:	0.305 m	Load Applied:	420 kPa
Kentledge Type:	JCB 3CX + Jack	Remarks:	Clay

Pressure (kN/m ²)	Plate Penetration (mm)
Initial	0	0
Stage 1	56	0.91
Stage 2	112	1.74
Stage 3	168	2.76
Stage 4	224	3.61
Stage 5	280	4.54
Stage 6	420	6.38
Stage 7		
Stage 8		
Stage 9		
Stage 10

Conversion Factor	0.45	Produced by:	J Currie
Stress Applied @ 1.25mm	76.15 kN/m ²		
Total Plate Deflection	6.38 mm	Checked by:	R Woods
Plate Diameter	305 mm		
k305	60916

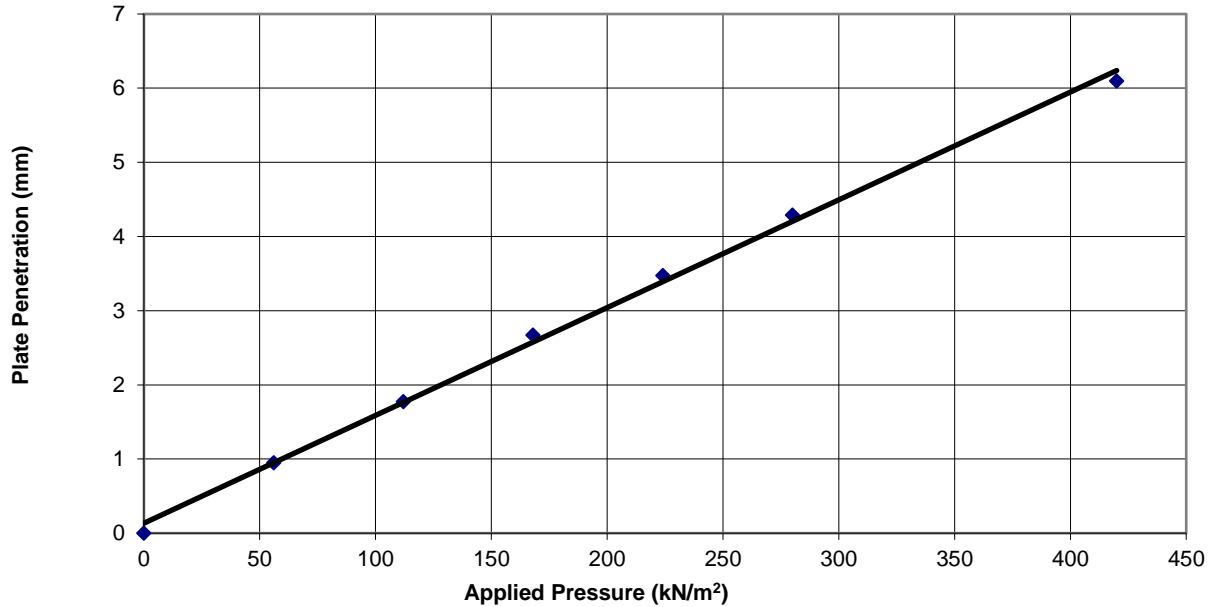
PLATE BEARING TEST		Date:	05/06/2019
Project Number:	S190527	Test No:	TP3
Project Name:	Spaines Road, Huddersfield	Test Level:	0.30mbgl
Test Method: BS 1377 : Part 9 : 1990 (Incremental Method)		Weather:	Dry, still
Plate Diameter:	0.305 m	Load Applied:	420 kPa
Kentledge Type:	JCB 3CX + Jack	Remarks:	Clay

Pressure (kN/m ²)	Plate Penetration (mm)
Initial	0	0
Stage 1	56	0.95
Stage 2	112	1.78
Stage 3	168	2.67
Stage 4	224	3.48
Stage 5	280	4.29
Stage 6	420	6.10
Stage 7		
Stage 8		
Stage 9		
Stage 10

Conversion Factor	0.45	Produced by:	J Currie
Stress Applied @ 1.25mm	76.74 kN/m ²		
Total Plate Deflection	6.10 mm	Checked by:	R Woods
Plate Diameter	305 mm		
k305	61389

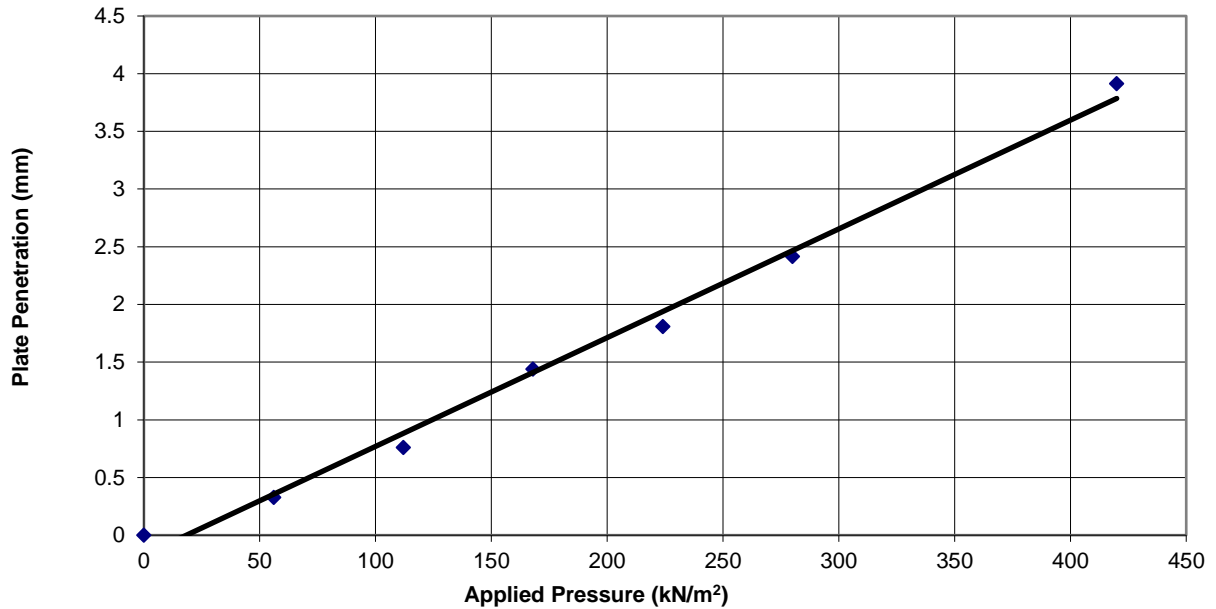
PLATE BEARING TEST		Date:	05/06/2019
Project Number:	S190527	Test No:	TP4
Project Name:	Spaines Road, Huddersfield	Test Level:	0.30mbgl
Test Method: BS 1377 : Part 9 : 1990 (Incremental Method)		Weather:	Dry, still
Plate Diameter:	0.305 m	Load Applied:	420 kPa
Kentledge Type:	JCB 3CX + Jack	Remarks:	Sand fill

Pressure (kN/m ²)	Plate Penetration (mm)
Initial	0	0
Stage 1	56	0.33
Stage 2	112	0.76
Stage 3	168	1.44
Stage 4	224	1.81
Stage 5	280	2.42
Stage 6	420	3.91
Stage 7		
Stage 8		
Stage 9		
Stage 10

Conversion Factor	0.45	Produced by:	J Currie
Stress Applied @ 1.25mm	150.97 kN/m ²		
Total Plate Deflection	3.91 mm	Checked by:	R Woods
Plate Diameter	305 mm		
k305	120778

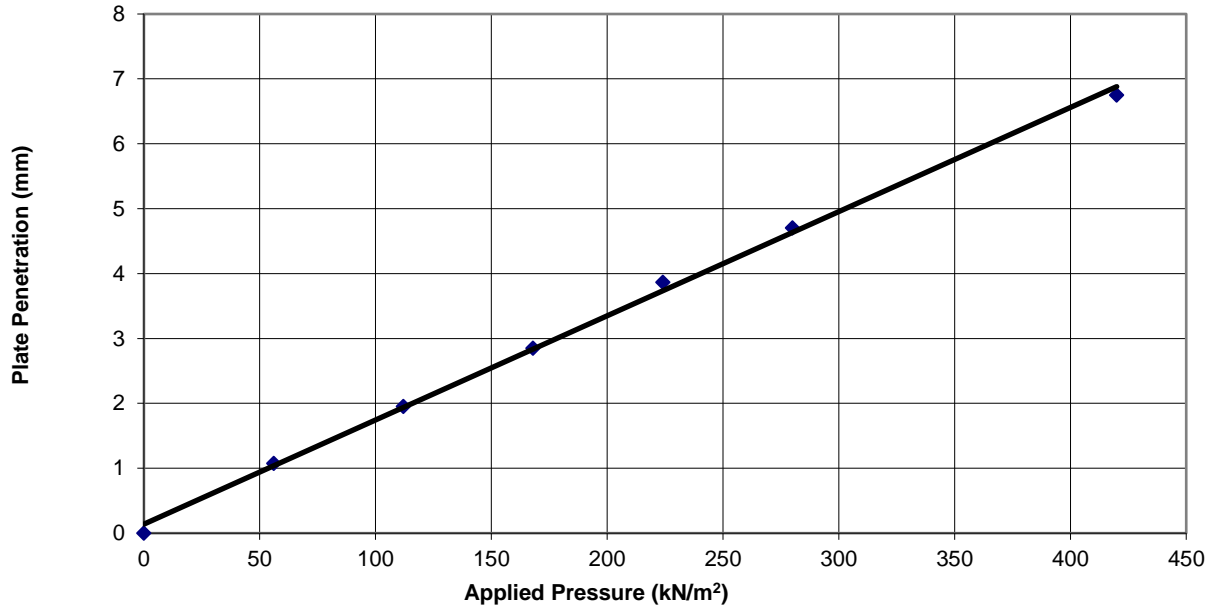
PLATE BEARING TEST		Date:	05/06/2019
Project Number:	S190527	Test No:	TP5
Project Name:	Spaines Road, Huddersfield	Test Level:	0.30mbgl
Test Method: BS 1377 : Part 9 : 1990 (Incremental Method)		Weather:	Dry, still
Plate Diameter:	0.305 m	Load Applied:	420 kPa
Kentledge Type:	JCB 3CX + Jack	Remarks:	Clay

Pressure (kN/m ²)	Plate Penetration (mm)
Initial	0	0
Stage 1	56	1.08
Stage 2	112	1.96
Stage 3	168	2.85
Stage 4	224	3.87
Stage 5	280	4.70
Stage 6	420	6.75
Stage 7		
Stage 8		
Stage 9		
Stage 10

Conversion Factor	0.45	Produced by:	J Currie
Stress Applied @ 1.25mm	69.20 kN/m ²		
Total Plate Deflection	6.75 mm	Checked by:	R Woods
Plate Diameter	305 mm		
k305	55356

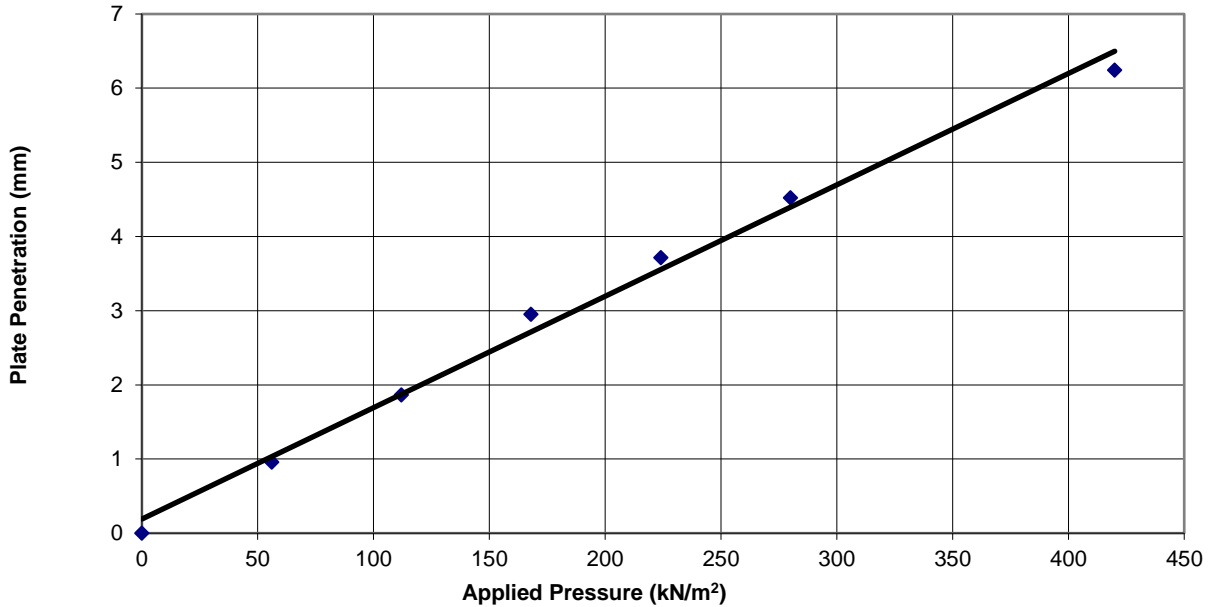
PLATE BEARING TEST		Date:	05/06/2019
Project Number:	S190527	Test No:	TP6
Project Name:	Spaines Road, Huddersfield	Test Level:	0.30mbgl
Test Method: BS 1377 : Part 9 : 1990 (Incremental Method)		Weather:	Dry, still
Plate Diameter:	0.305 m	Load Applied:	420 kPa
Kentledge Type:	JCB 3CX + Jack	Remarks:	Clay

Pressure (kN/m ²)	Plate Penetration (mm)
Initial	0	0
Stage 1	56	0.96
Stage 2	112	1.87
Stage 3	168	2.95
Stage 4	224	3.72
Stage 5	280	4.52
Stage 6	420	6.25
Stage 7		
Stage 8		
Stage 9		
Stage 10

Conversion Factor	0.45	Produced by:	J Currie
Stress Applied @ 1.25mm	70.54 kN/m ²		
Total Plate Deflection	6.25 mm	Checked by:	R Woods
Plate Diameter	305 mm		
k305	56435
