**ARBORICULTURAL REPORT  
AND  
ARBORICULTURAL IMPACT ASSESSMENT  
to BS 5837:2012  
at  
1 The Copse  
Scholes Lane  
Cleckheaton  
West Yorkshire  
BD19 6NE**

**JCA Ref:**  
15617a/TP

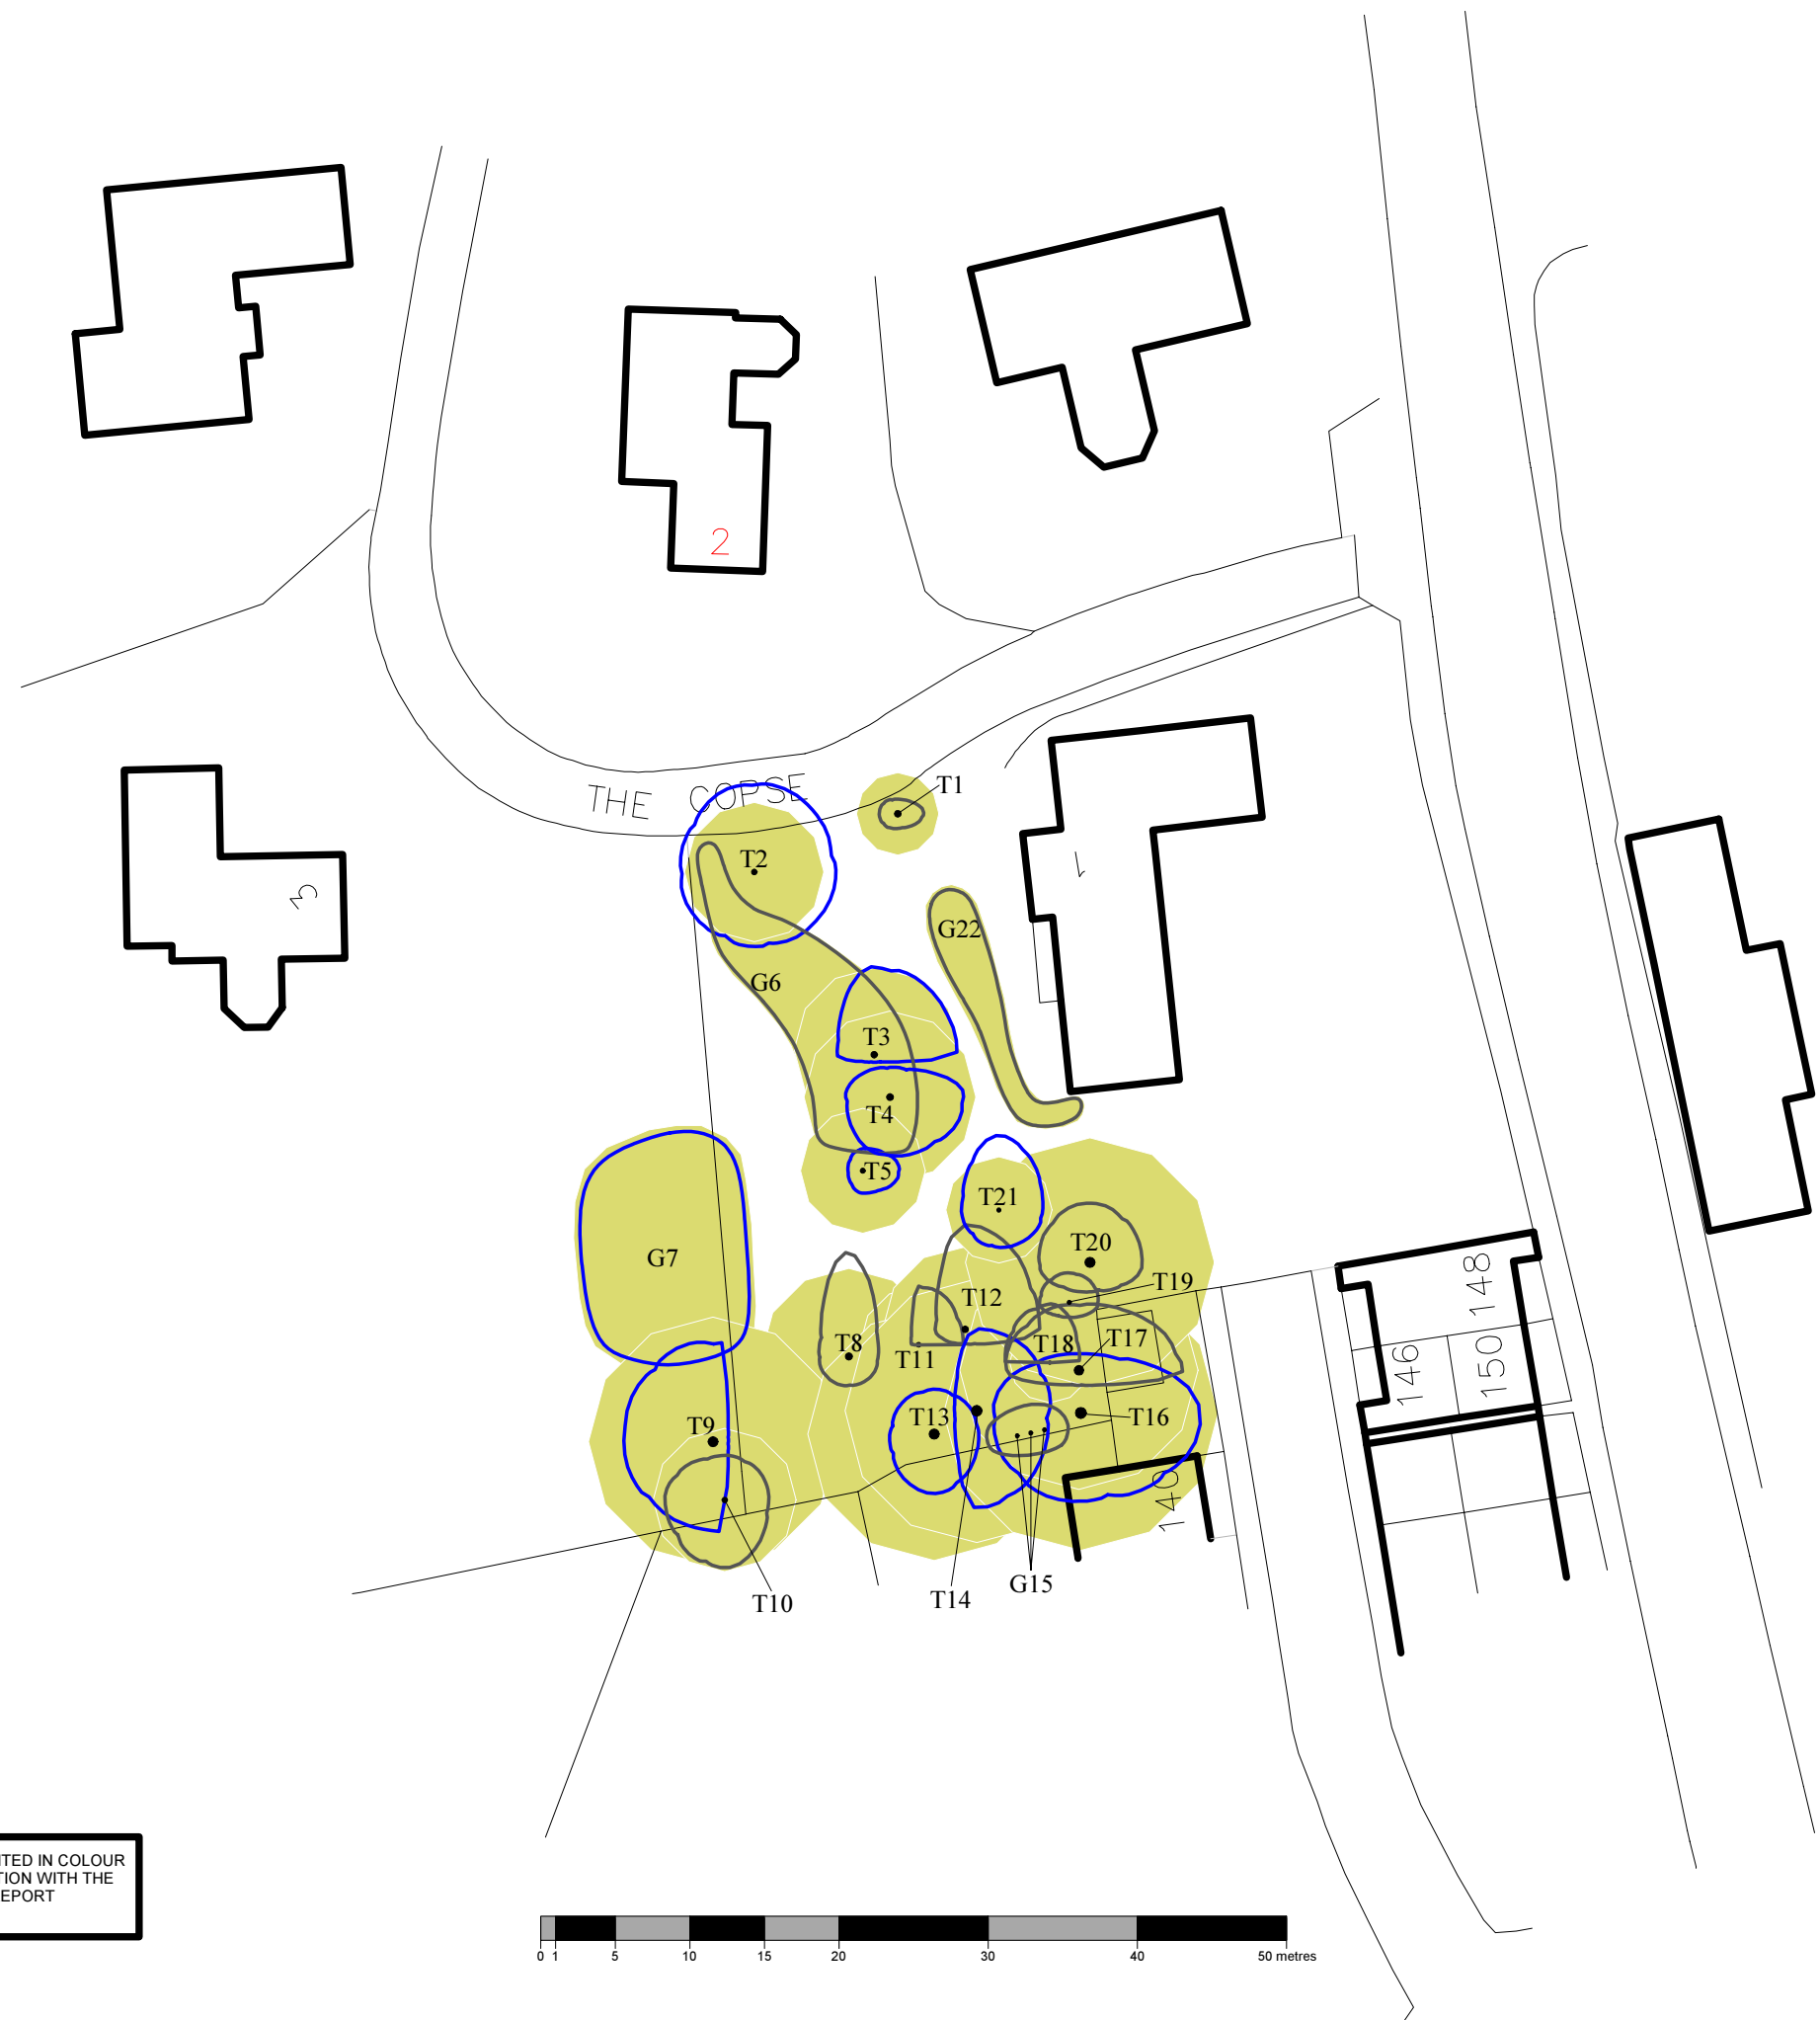
### Appendix 6: Tree Constraints Plan

BRITISH STANDARD 5837:2012: 4.5  
RETENTION CATEGORIES  
Detailed definitions of these categories are at Appendix 2 of our report. N.B. These categories do not necessarily represent or correspond to recommendations for action made in this report.

IF IT IS NECESSARY FOR THE DEVELOPMENT TO ENCRUSH INTO THE RPA OF A TREE WHICH IS TO BE RETAINED THEN SPECIALIST CONSTRUCTION TECHNIQUES AND MATERIALS MUST BE CONSIDERED.

- 4.1 Full details of all individual trees surveyed are recorded in the tables at **Appendix 1**. A full explanation of the tables can be found at **Appendix 2**. Please refer also to the Tree Constraints Plan at **Appendix 6** for tree locations.

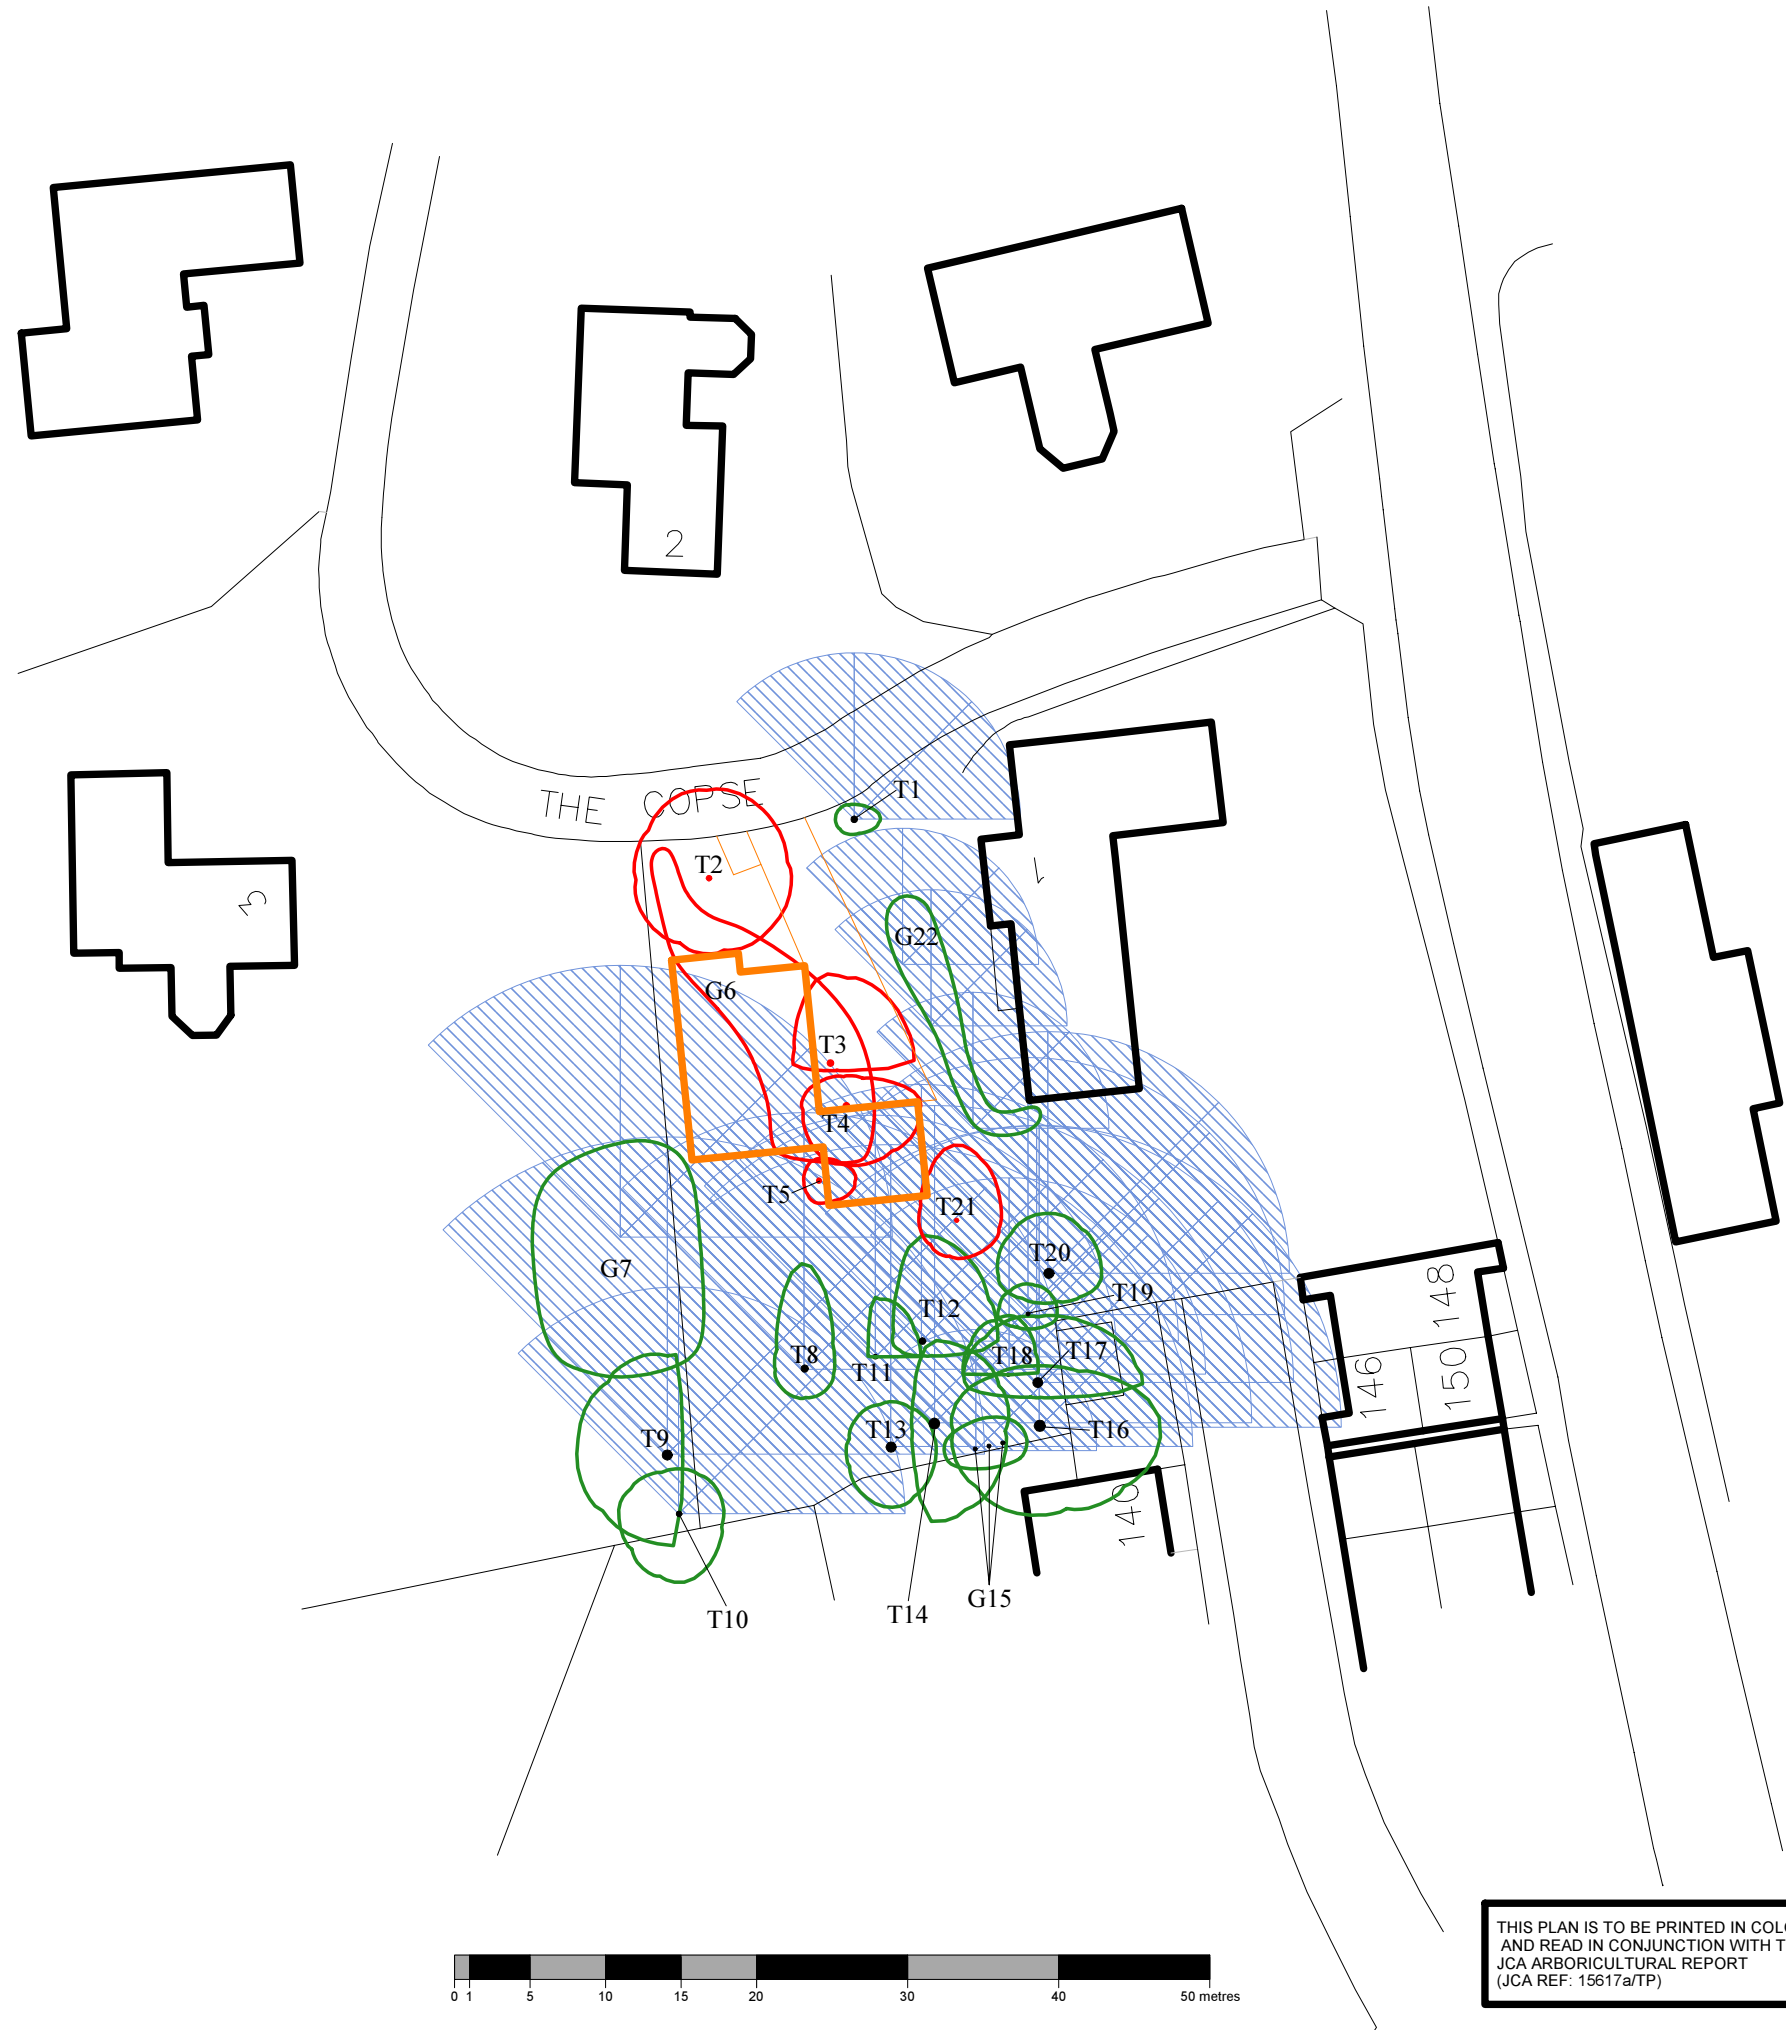
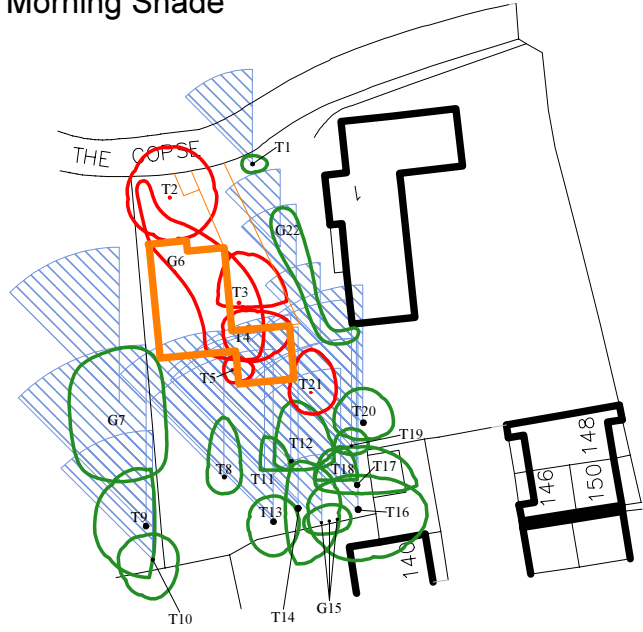
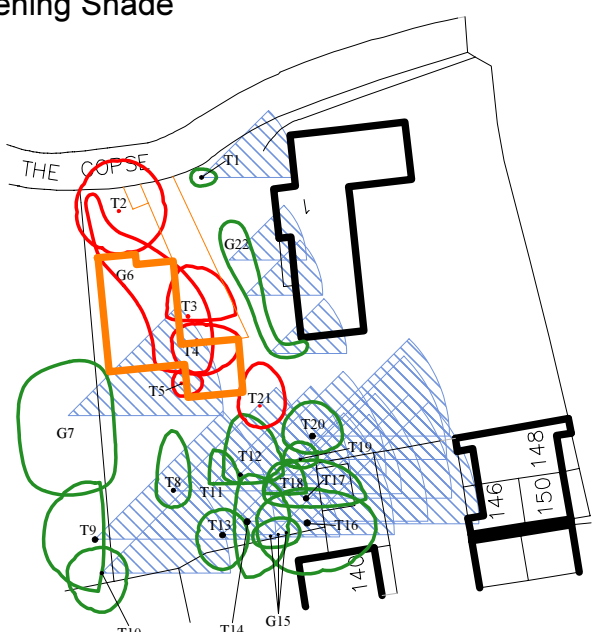
**Appendix 8:  
Tree Shadows Plan**

Morning Shade

Afternoon Shade

Evening Shade

- 6.4.5.1 A tree shade plan has been prepared for this site and is included at **Appendix 8** of this report.
- 6.4.5.2 The plan suggests that the retained trees to the south of the proposed dwelling will cast shade over the rear garden area, as well as the southern section of the dwelling itself.
