Factual Report on the Remediation of Coal Workings

Location: Red House, Bristfield Road,
Dewsbury, WF12 0NX.

Report No. J4785/19/E/F

Report date: November 2019

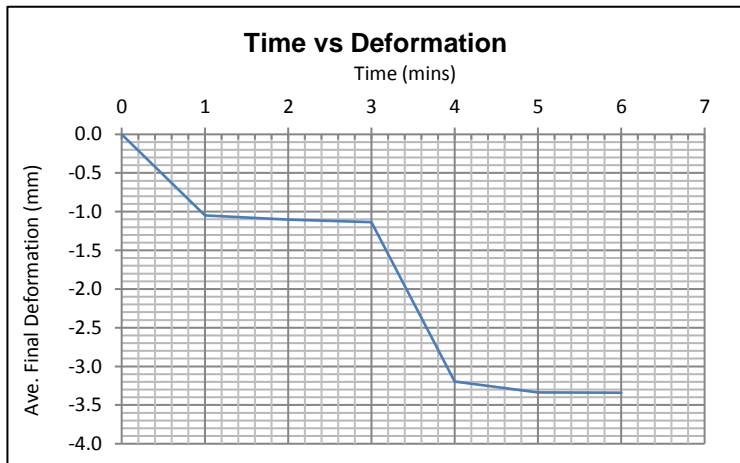
Test subject	22T Tracked Excavator		
Test Depth	m	Material under test	Compacted aggregate
Description of reaction		Moisture Content of material	- %
Plate Diameter	450 mm	In-situ density of material	- kN/m ³
Plate Area	0.159 m ²	Groundwater level	- m
Mass of test apparatus	43 kg	Weather Conditions	Overcast
Distance between the edge of the loaded plate and the edge of excavation or platform			m

Load Cell	Applied Load	Applied Stress	Average Final Deformation
(kN)	(kN)	(kN/m ²)	(mm)
0	0.42	2.65	0.00
2.5	2.92	18.37	-1.14
5	5.42	34.09	-3.34

Original data shown as dashed line. Solid line shows adjusted applied stress which has been considered due to initial unrepresentative movements. Derived CBR value based on applied stress that has been adjusted by 2.65kN/m²

Conversion Factor to a 762mm dia. plate :	0.62
Applied Stress at 1.25 mm Deformation:	17 kN/m ²
Modulus of Subgrade Reaction (k ₇₆₂):	8 MN/m ² /m
Equivalent CBR by Plate Loading :	0 %
Moisture Content :	- %

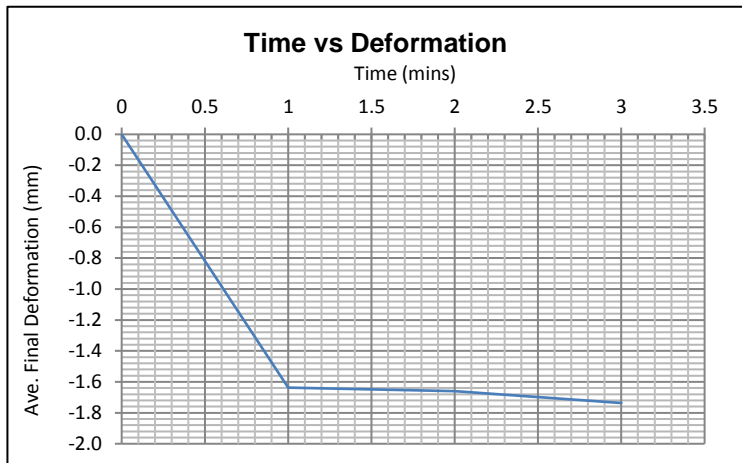
Test subject	21.4T Dozer		
Test Depth	m	Material under test	Compacted aggregate
Description of reaction		Moisture Content of material	- %
Plate Diameter	450 mm	In-situ density of material	- kN/m ³
Plate Area	0.159 m ²	Groundwater level	- m
Mass of test apparatus	43 kg	Weather Conditions	Overcast
Distance between the edge of the loaded plate and the edge of excavation or platform			m

Load Cell	Applied Load	Applied Stress	Average Final Deformation
(kN)	(kN)	(kN/m ²)	(mm)
0	0.42	2.65	0.00
2.5	2.92	18.37	-1.74

Original data shown as dashed line. Solid line shows adjusted applied stress which has been considered due to initial unrepresentative movements. Derived CBR value based on applied stress that has been adjusted by 2.65kN/m²

Conversion Factor to a 762mm dia. plate :	0.62
Applied Stress at 1.25 mm Deformation:	11 kN/m ²
Modulus of Subgrade Reaction (k ₇₆₂):	6 MN/m ² /m
Equivalent CBR by Plate Loading :	0 %
Moisture Content :	- %

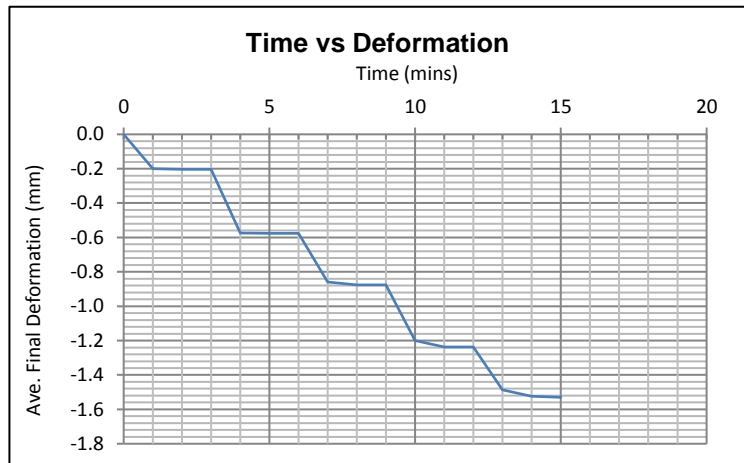
Test subject	18.3T Tracked Excavator			
Test Depth	Second visit	m	Material under test	Compacted aggregate
Description of reaction			Moisture Content of material	- %
Plate Diameter	450	mm	In-situ density of material	- kN/m ³
Plate Area	0.159	m ²	Groundwater level	- m
Mass of test apparatus	43	kg	Weather Conditions	Overcast
Distance between the edge of the loaded plate and the edge of excavation or platform				m

Load Cell (kN)	Applied Load (kN)	Applied Stress (kN/m ²)	Average Final Deformation (mm)
0	0.42	2.65	0.00
2.5	2.92	18.37	-0.20
5	5.42	34.09	-0.58
7.5	7.92	49.81	-0.88
10	10.42	65.53	-1.24
12.5	12.92	81.25	-1.53

Original data shown as dashed line. Solid line shows adjusted applied stress which has been considered due to initial unrepresentative movements. Derived CBR value based on applied stress that has been adjusted by 2.65kN/m²

Conversion Factor to a 762mm dia. plate :	0.62
Applied Stress at 1.25 mm Deformation:	64 kN/m ²
Modulus of Subgrade Reaction (k ₇₆₂):	32 MN/m ² /m
Equivalent CBR by Plate Loading :	4 %
Moisture Content :	- %

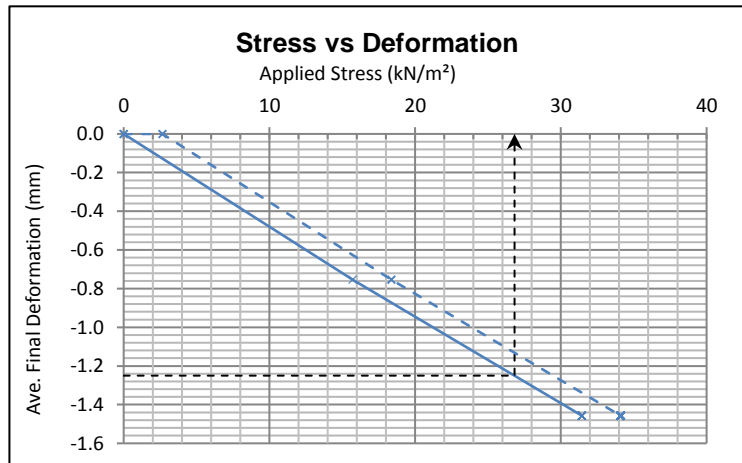
Test subject	22T Tracked Excavator			
Test Depth	Second visit	m	Material under test	Compacted aggregate
Description of reaction			Moisture Content of material	- %
Plate Diameter	450	mm	In-situ density of material	- kN/m ³
Plate Area	0.159	m ²	Groundwater level	- m
Mass of test apparatus	43	kg	Weather Conditions	Overcast
Distance between the edge of the loaded plate and the edge of excavation or platform				m

Load Cell	Applied Load	Applied Stress	Average Final Deformation
(kN)	(kN)	(kN/m ²)	(mm)
0	0.42	2.65	0.00
2.5	2.92	18.37	-0.75
5	5.42	34.09	-1.46

Original data shown as dashed line. Solid line shows adjusted applied stress which has been considered due to initial unrepresentative movements. Derived CBR value based on applied stress that has been adjusted by 2.65kN/m²

Conversion Factor to a 762mm dia. plate :	0.62
Applied Stress at 1.25 mm Deformation:	27 kN/m ²
Modulus of Subgrade Reaction (k ₇₆₂):	13 MN/m ² /m
Equivalent CBR by Plate Loading :	1 %
Moisture Content :	- %

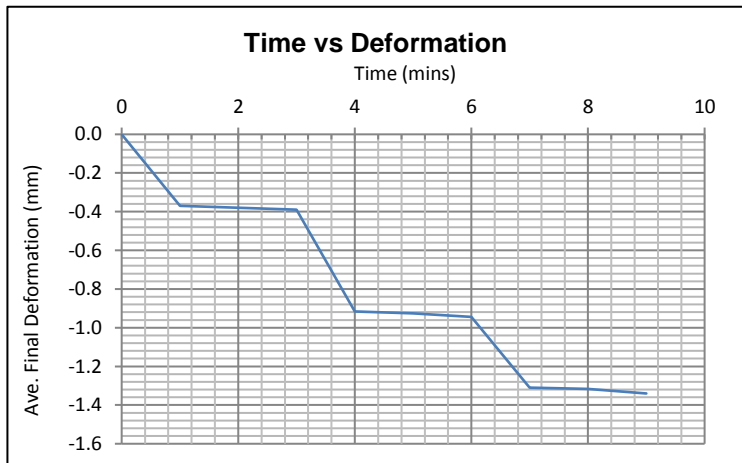
Test subject	18.3T Tracked Excavator		
Test Depth	Third visit	Material under test	Compacted aggregate
Description of reaction		Moisture Content of material	- %
Plate Diameter	450 mm	In-situ density of material	- kN/m ³
Plate Area	0.159 m ²	Groundwater level	- m
Mass of test apparatus	43 kg	Weather Conditions	Sunny but cold
Distance between the edge of the loaded plate and the edge of excavation or platform			m

Load Cell (kN)	Applied Load (kN)	Applied Stress (kN/m ²)	Average Final Deformation (mm)
0	0.42	2.65	0.00
2.5	2.92	18.37	-0.39
5	5.42	34.09	-0.94
7.5	7.92	49.81	-1.34

Original data shown as dashed line. Solid line shows adjusted applied stress which has been considered due to initial unrepresentative movements. Derived CBR value based on applied stress that has been adjusted by 2.65kN/m²

Conversion Factor to a 762mm dia. plate :	0.62
Applied Stress at 1.25 mm Deformation:	44 kN/m ²
Modulus of Subgrade Reaction (k ₇₆₂):	22 MN/m ² /m
Equivalent CBR by Plate Loading :	2 %
Moisture Content :	- %

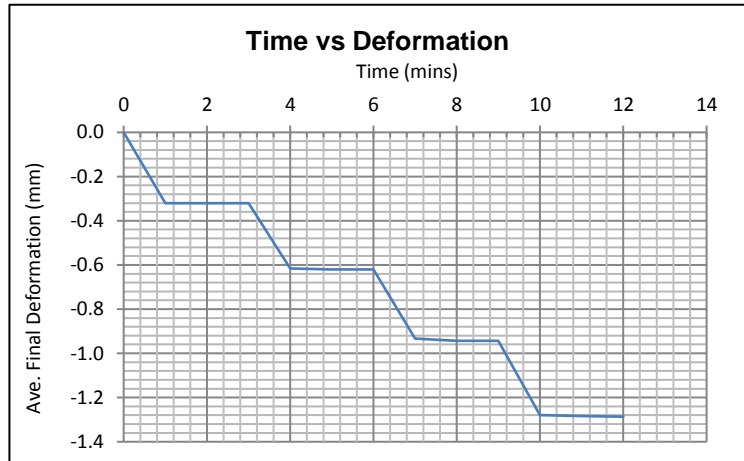
Test subject	18.3T Tracked Excavator			
Test Depth	4th visit	m	Material under test	Compacted sandstone aggregate
Description of reaction			Moisture Content of material	- %
Plate Diameter	450	mm	In-situ density of material	- kN/m ³
Plate Area	0.159	m ²	Groundwater level	- m
Mass of test apparatus	43	kg	Weather Conditions	Overcast
Distance between the edge of the loaded plate and the edge of excavation or platform				m

Load Cell (kN)	Applied Load (kN)	Applied Stress (kN/m ²)	Average Final Deformation (mm)
0	0.42	2.65	0.00
2.5	2.92	18.37	-0.32
5	5.42	34.09	-0.62
7.5	7.92	49.81	-0.94
10	10.42	65.53	-1.29

Original data shown as dashed line. Solid line shows adjusted applied stress which has been considered due to initial unrepresentative movements. Derived CBR value based on applied stress that has been adjusted by 2.65kN/m²

Conversion Factor to a 762mm dia. plate :	0.62
Applied Stress at 1.25 mm Deformation:	61 kN/m ²
Modulus of Subgrade Reaction (k ₇₆₂):	31 MN/m ² /m
Equivalent CBR by Plate Loading :	4 %
Moisture Content :	- %

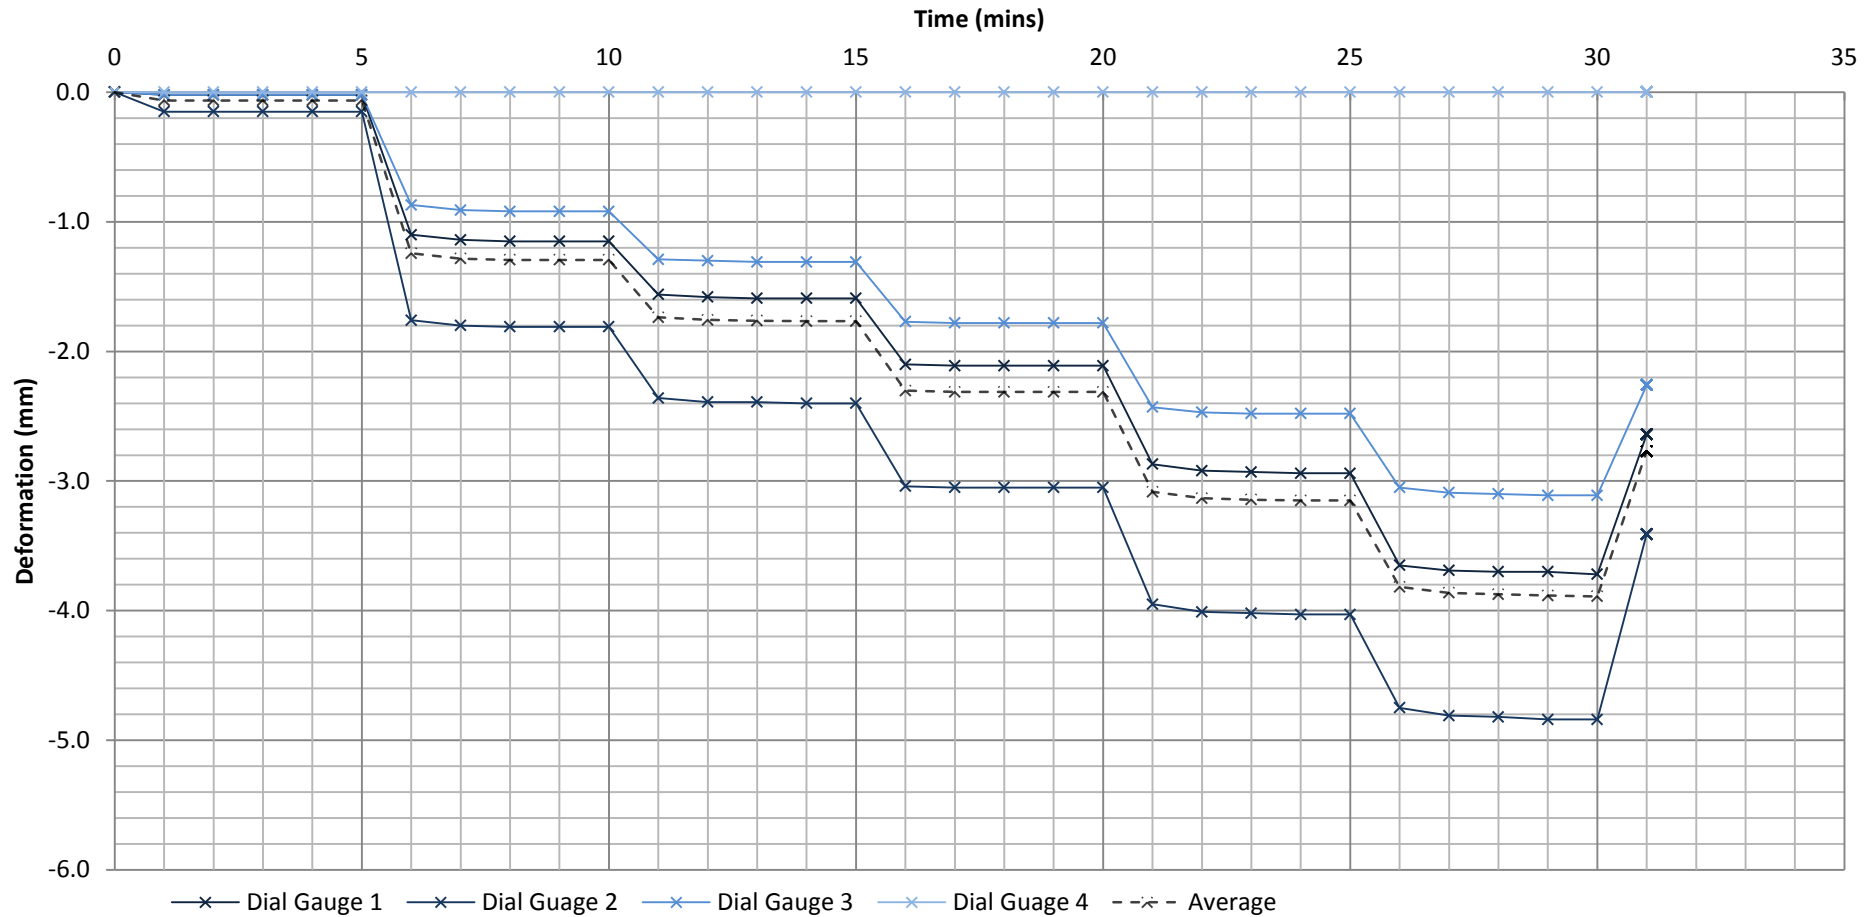
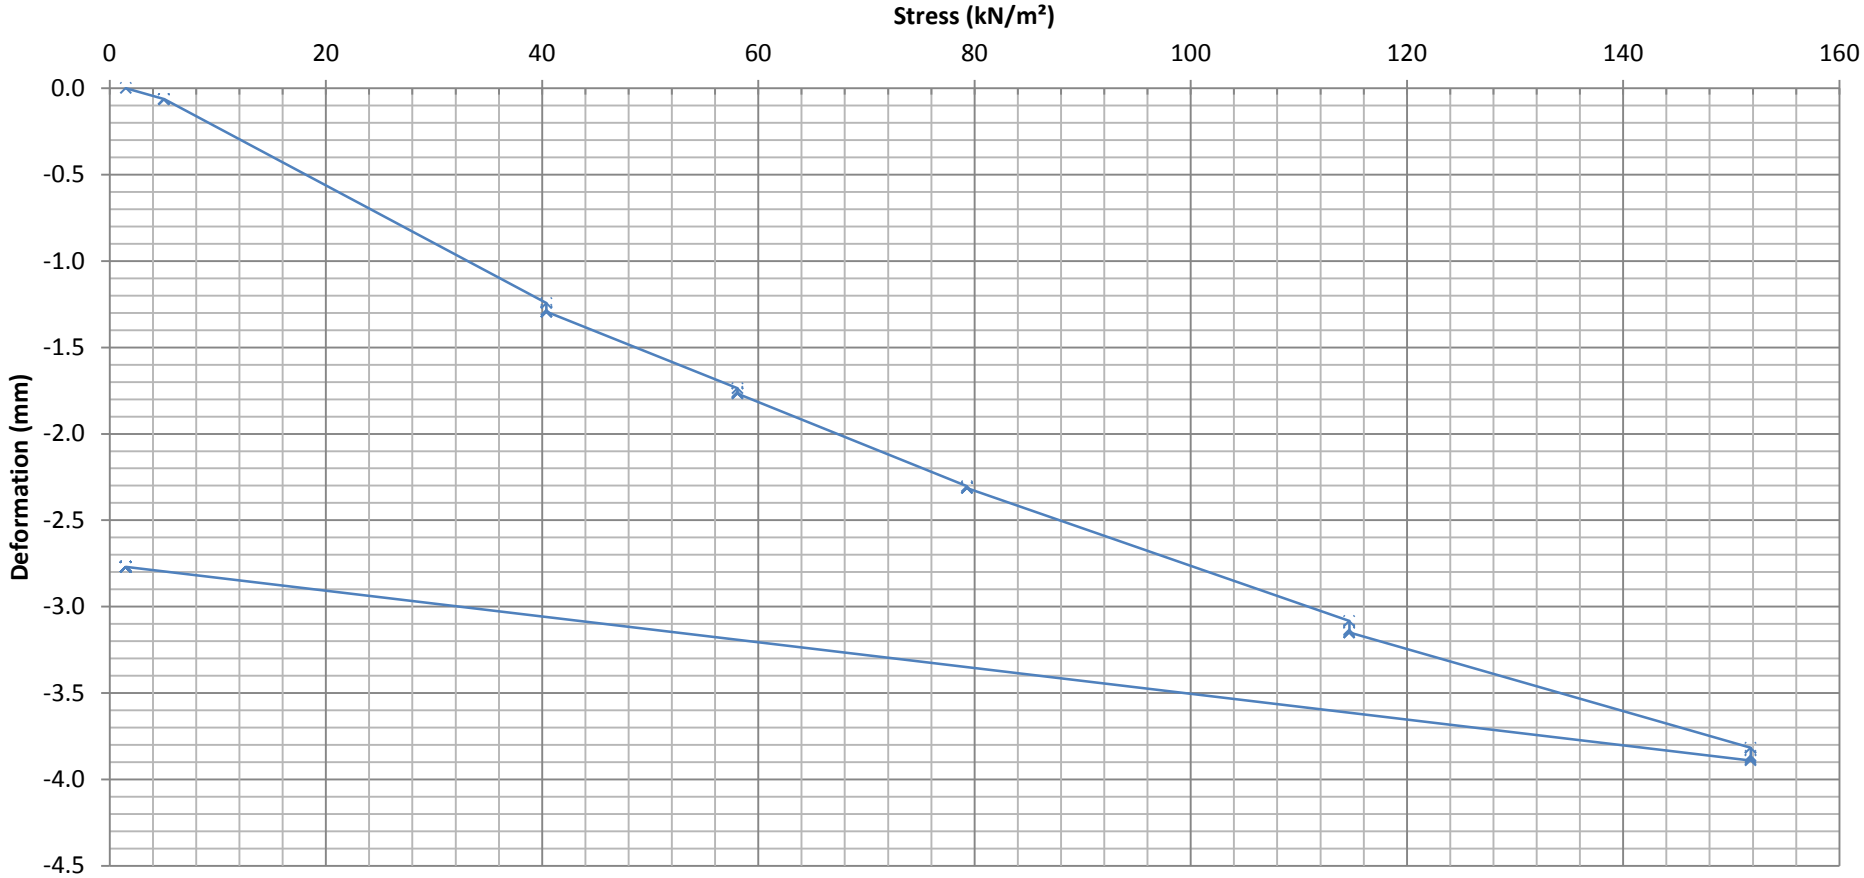
Time vs Deformation

Job No.	J4785/19/E	Test Identification	PL 1 (Maintained)	Remarks:	Dryer material than previous visits due to less fines.
Site	Briestfield Road	Test Date	25/10/2019		
Client	Abode Builders

Time vs Average Deformation

Stress vs Average Deformation

Time vs Stress/Deformation

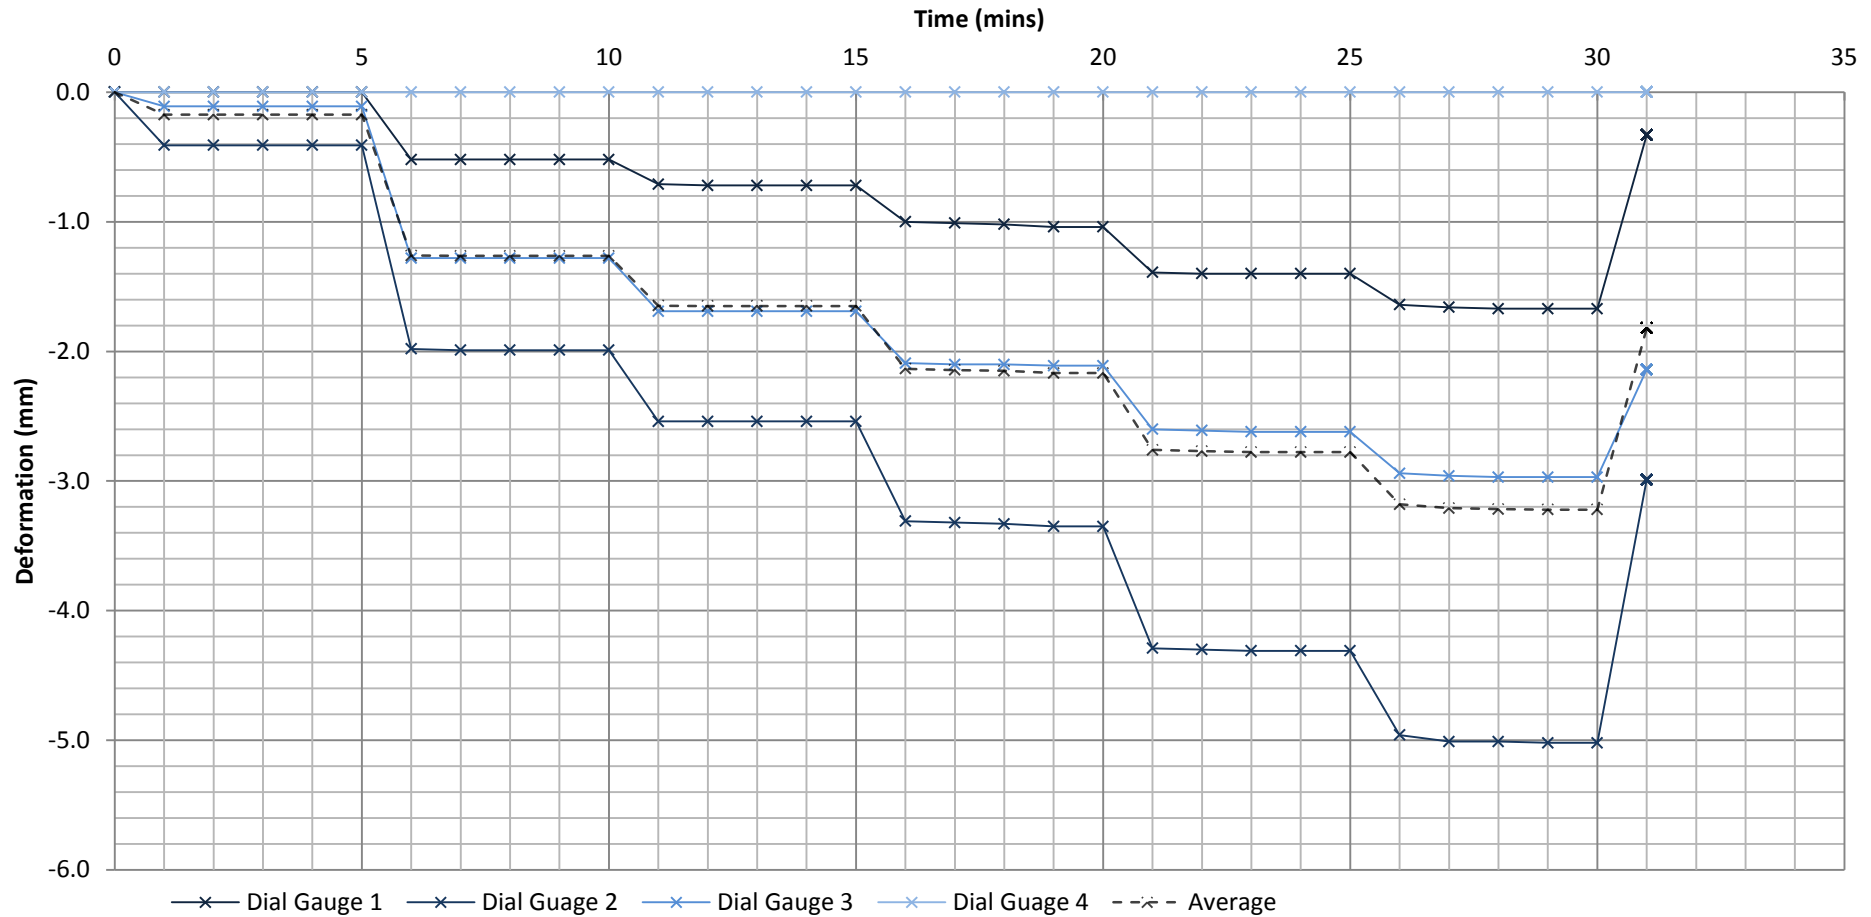
Time vs Deformation

Job No.	J4785/19/E	Test Identification	PL 2 (Maintained)	Remarks:	Dryer material than previous visits due to less fines.
Site	Briestfield Road	Test Date	25/10/2019		
Client	Abode Builders

Time vs Average Deformation

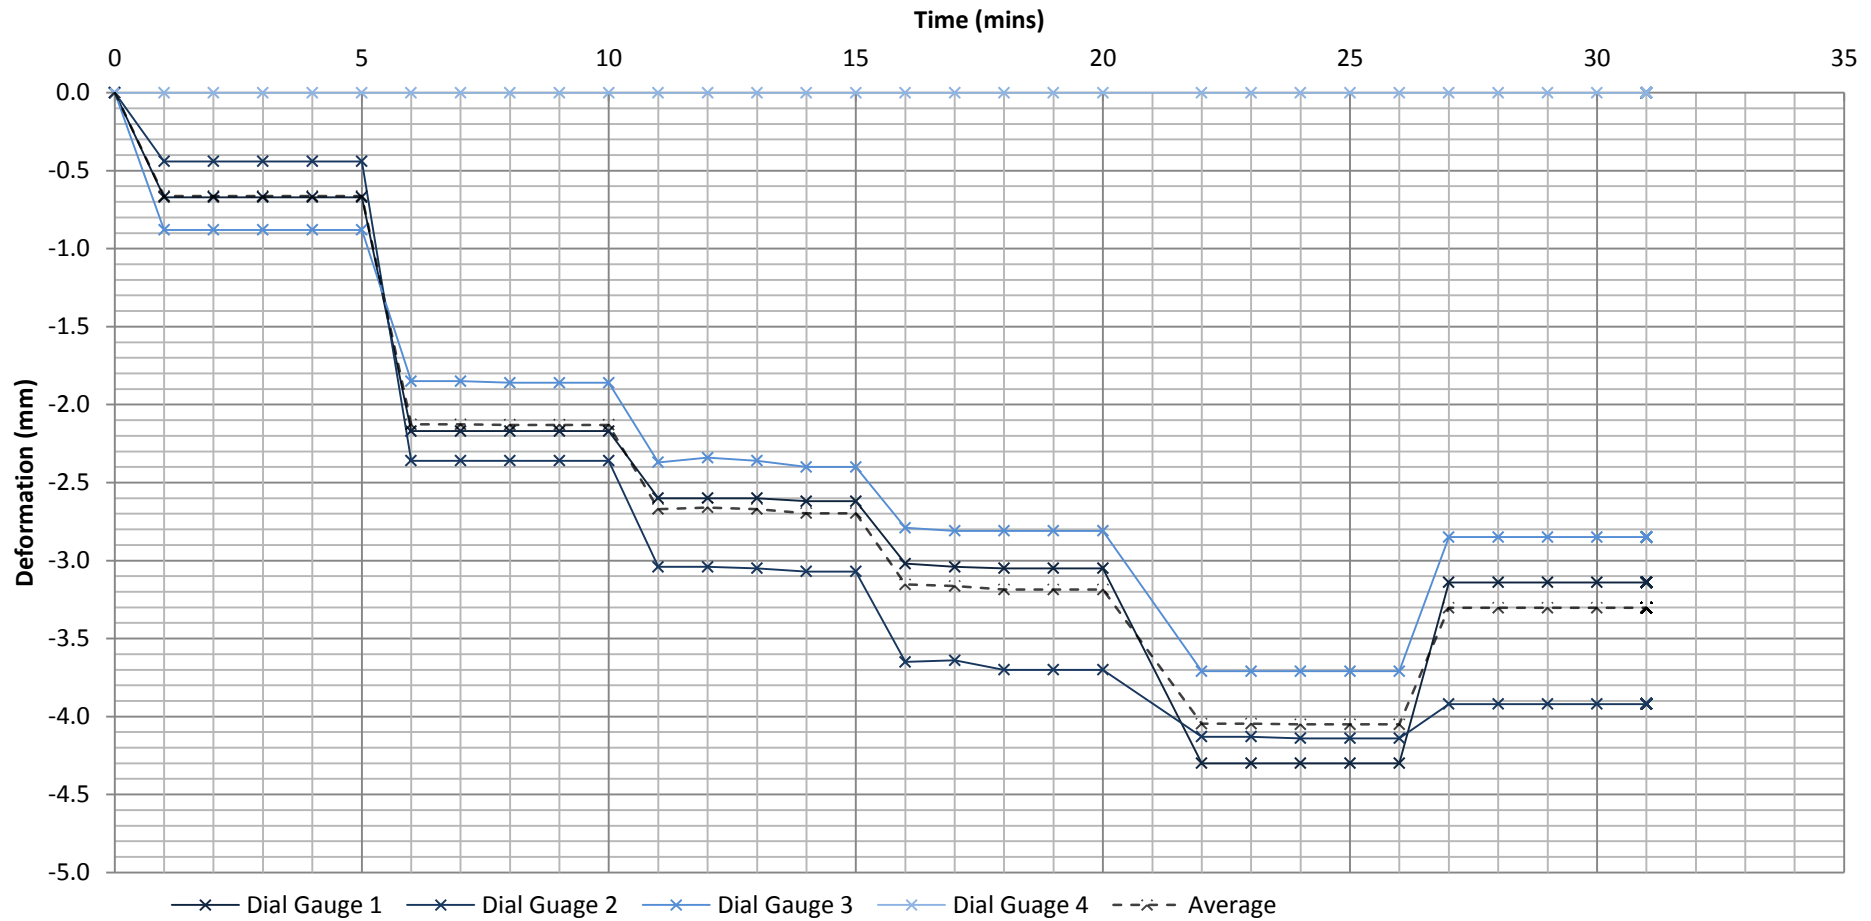
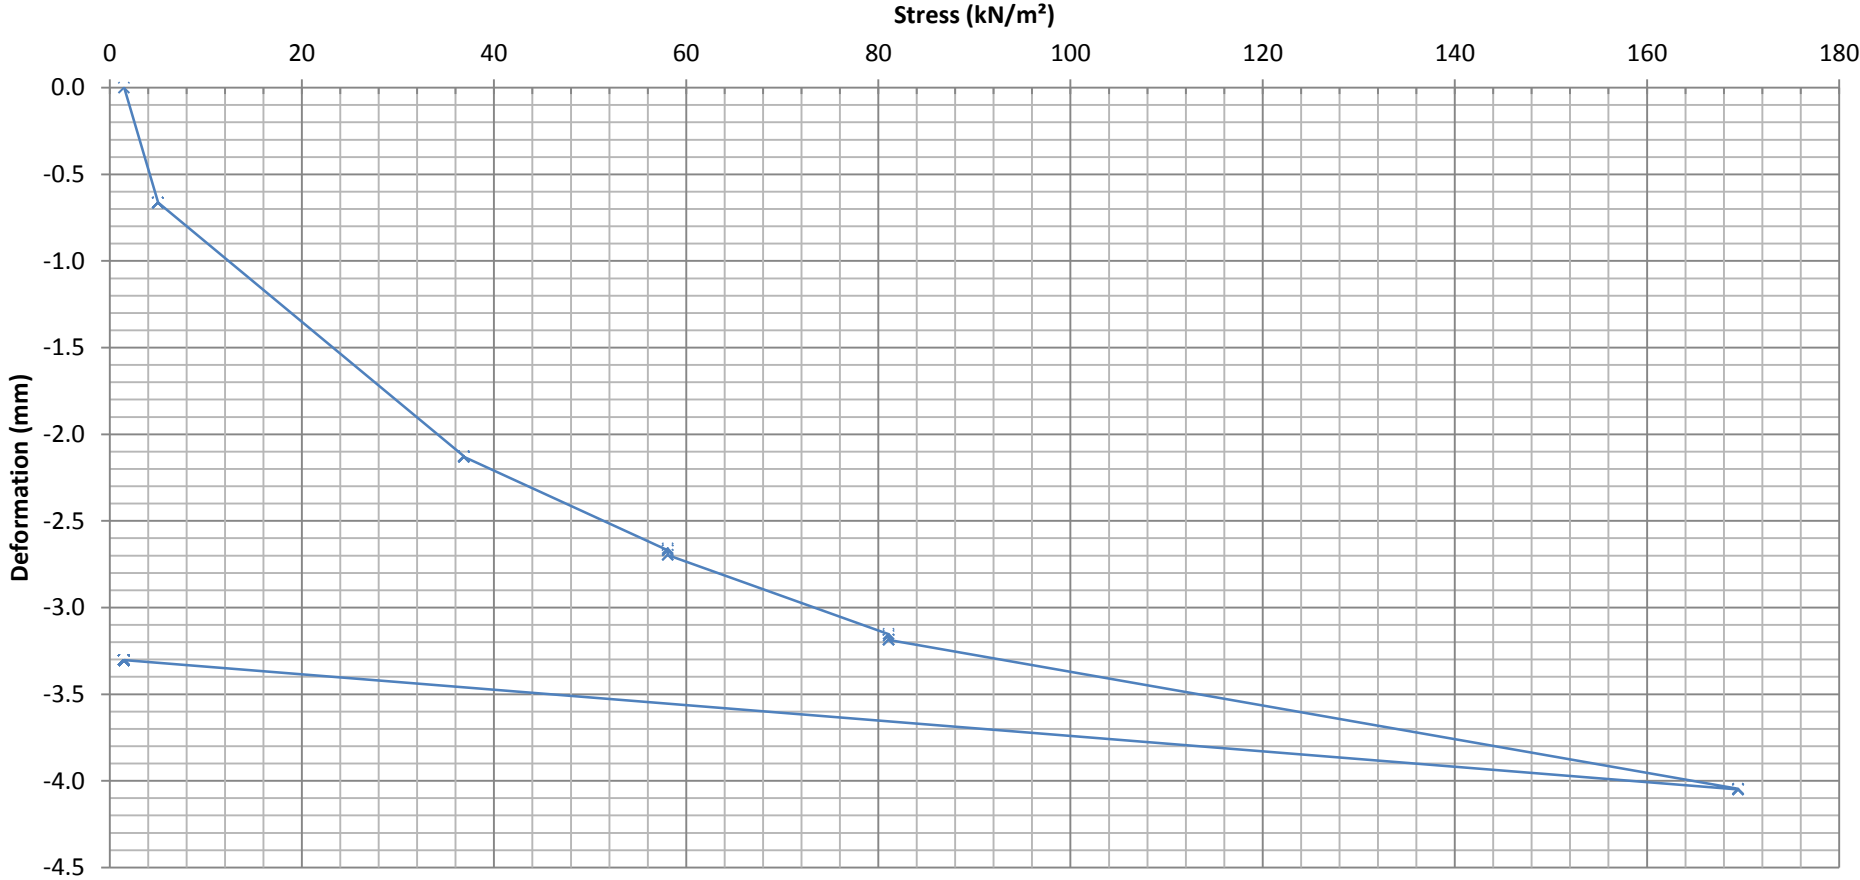
Job No.	J4785/19/E	Test Identification	PL 1 (Maintained)	Remarks:
Site	Briestfield Road	Test Date	05/11/2019	
Client	Abode Builders

The results of the in-situ testing have concluded that the in-filling of the excavation up to the formation level of the dwelling has taken place in accordance with the recommendations provided by RGS. Moreover, tolerable settlements are likely to occur below a suitably designed raft foundation.

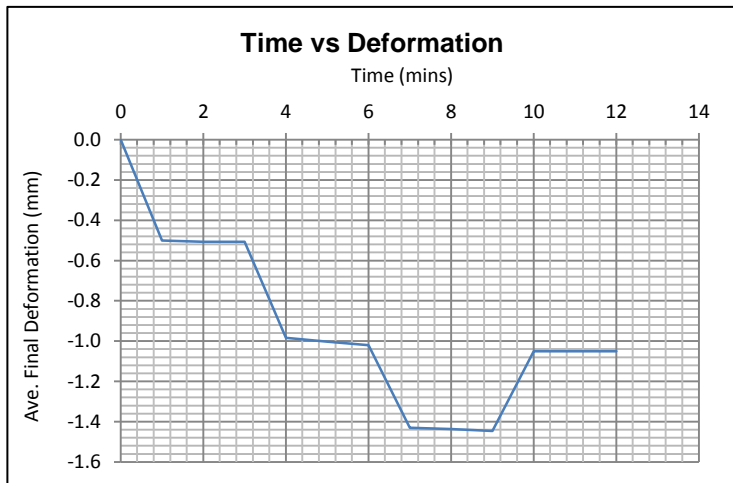
Original data shown as dashed line. Solid line shows adjusted applied stress which has been considered due to initial unrepresentative movements. Derived CBR value based on applied stress that has been adjusted by 2.65kN/m²

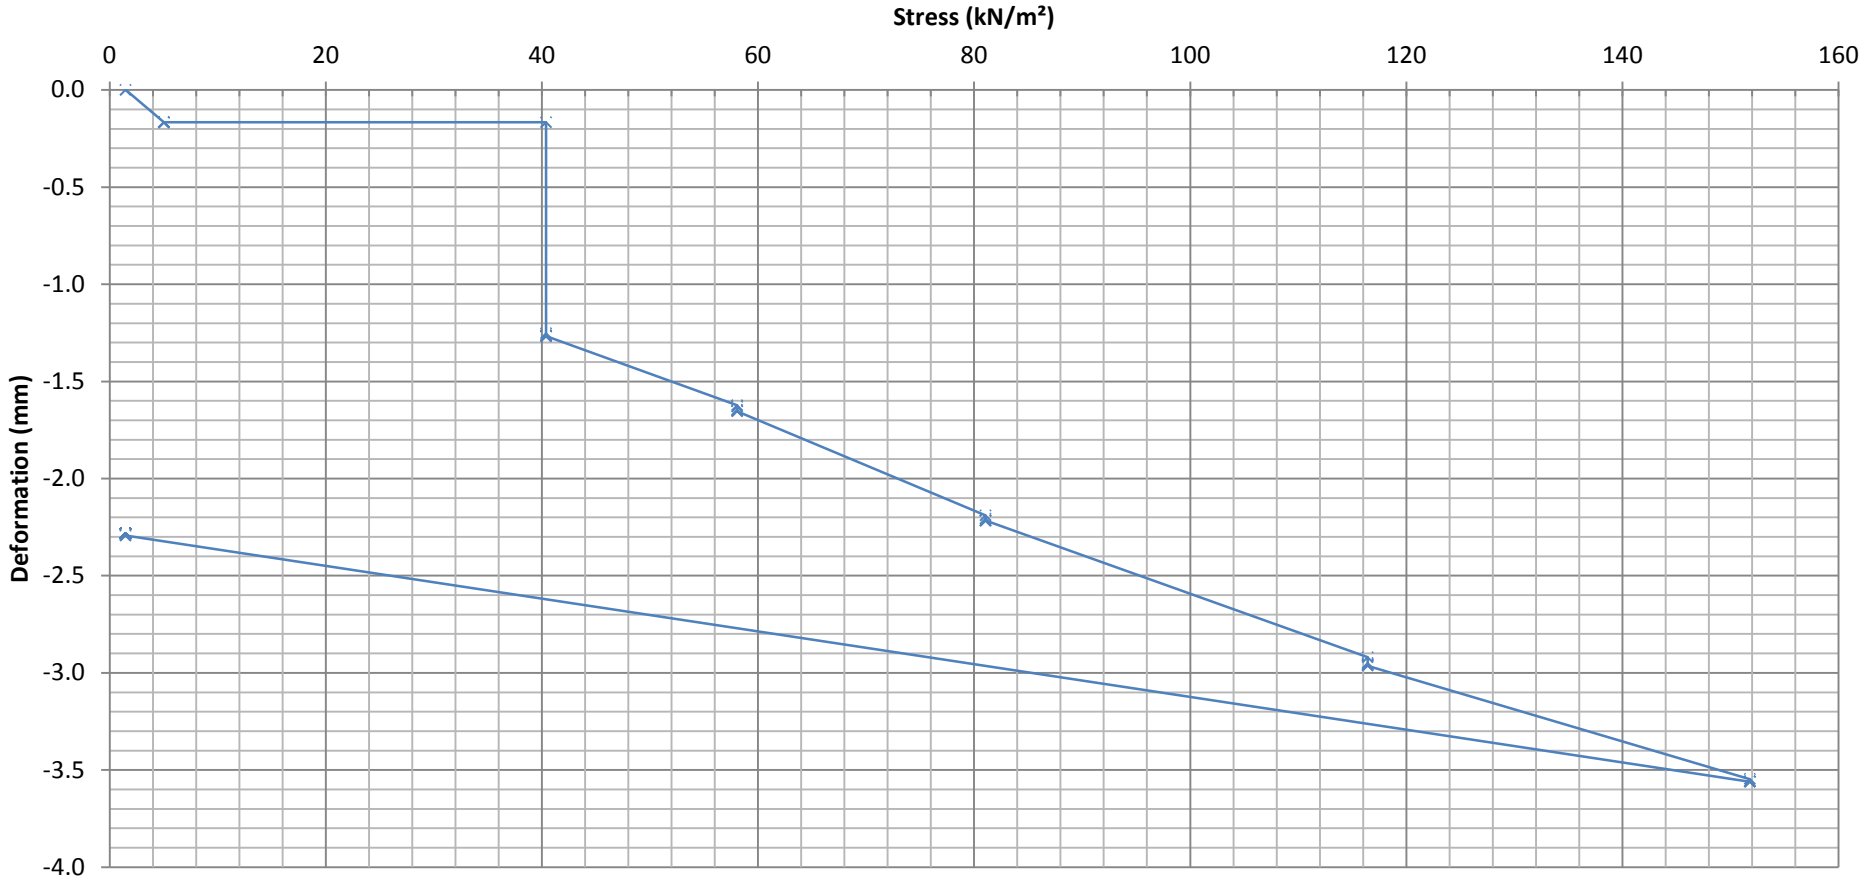
Job No.	J4785/19/E	Test Identification	PL 2 (Maintained)	Remarks:
Site	Briestfield Road	Test Date	05/11/2019	
Client	Abode Builders
