# COAL MINING RISK ASSESSMENT SITE INVESTIGATION

## REPORT ON A PROPOSED EXTENSION TO THE DUNKIRK PUBLIC HOUSE, UPPER DENBY

Job No. 20-07-1599

**Mining Report for the Extension of the Dunkirk Public House, 231 Barnsley Road, Lower Denby HD8 8TX.****Surveyor - John Carlon B.Eng (Hons) C.Eng C.Env MIMM MRICS****Date of Report 18<sup>th</sup> July 2020.****Client –. Ronan Developments for the Bagden Group****Introduction**

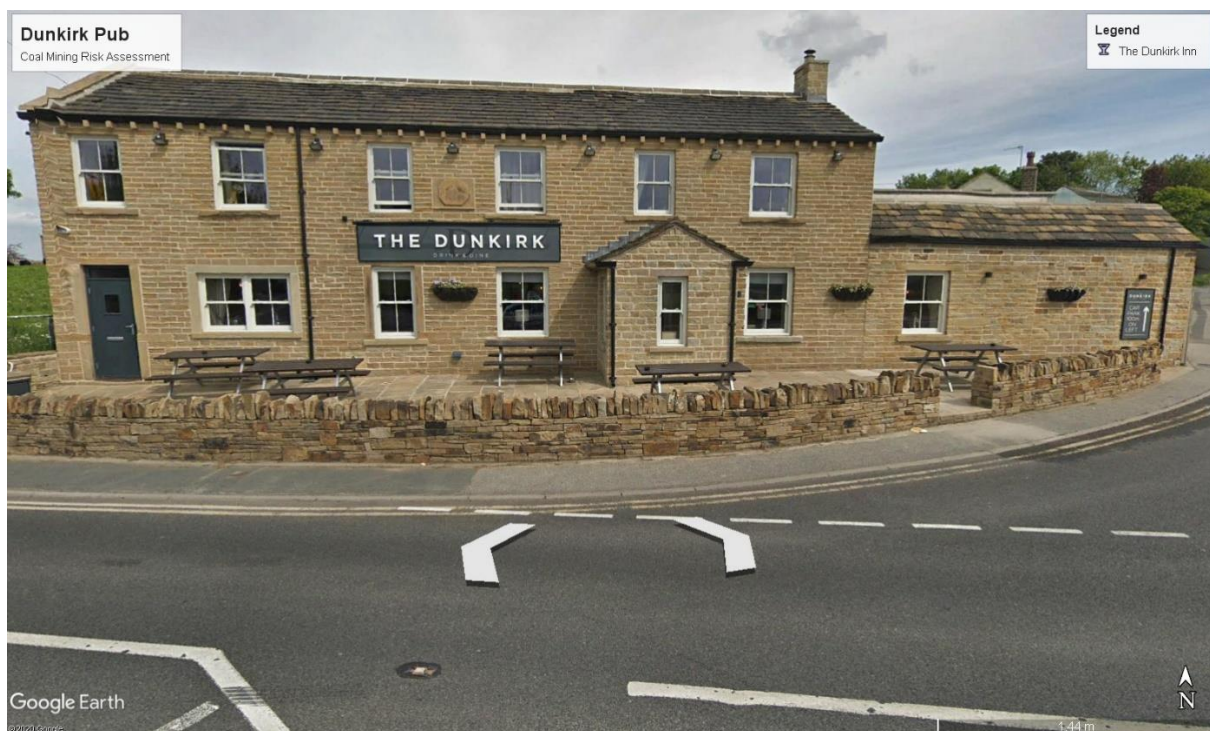
Photograph number 2 frontage of the public house.

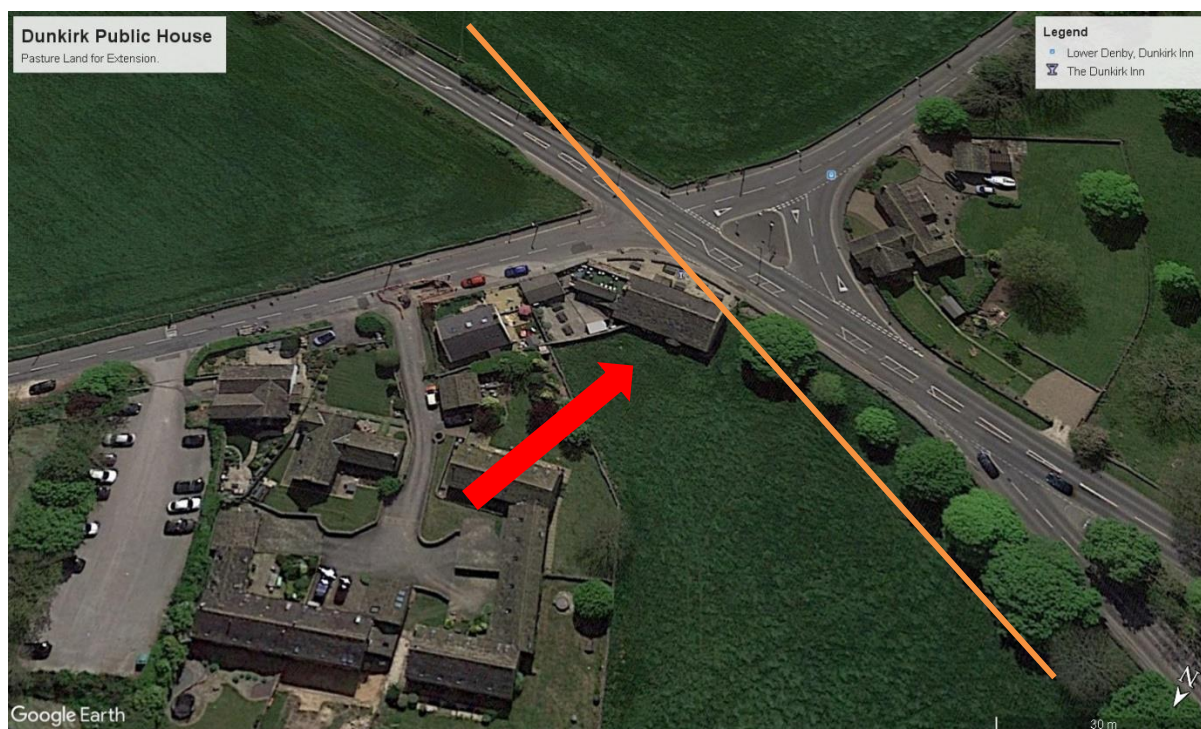
Photograph number 3 showing the rear view of the property looking south. The fault is shown brown.

The application site is crossed by a downthrow fault that runs diagonally across the site so the foundation trenches for the extension should be inspected once they are open by a mining engineer or geologist to advise the client and the structural engineer if there ought to be some reinforcement in the foundations due to the fault line. It is rare for there to be ground movement but it can happen on fault lines.
