PHASE 2 GEO-ENVIRONMENTAL  
**REPORT**

| job number<br><b>J4491/18/E/GE</b> | date<br><b>29/05/2020</b> |
| site address<br><b>79 Hall Ing Lane,<br/>Honley,<br/>HD9 6QW.</b> | |

# Report on a Phase 2 Geo-environmental Investigation

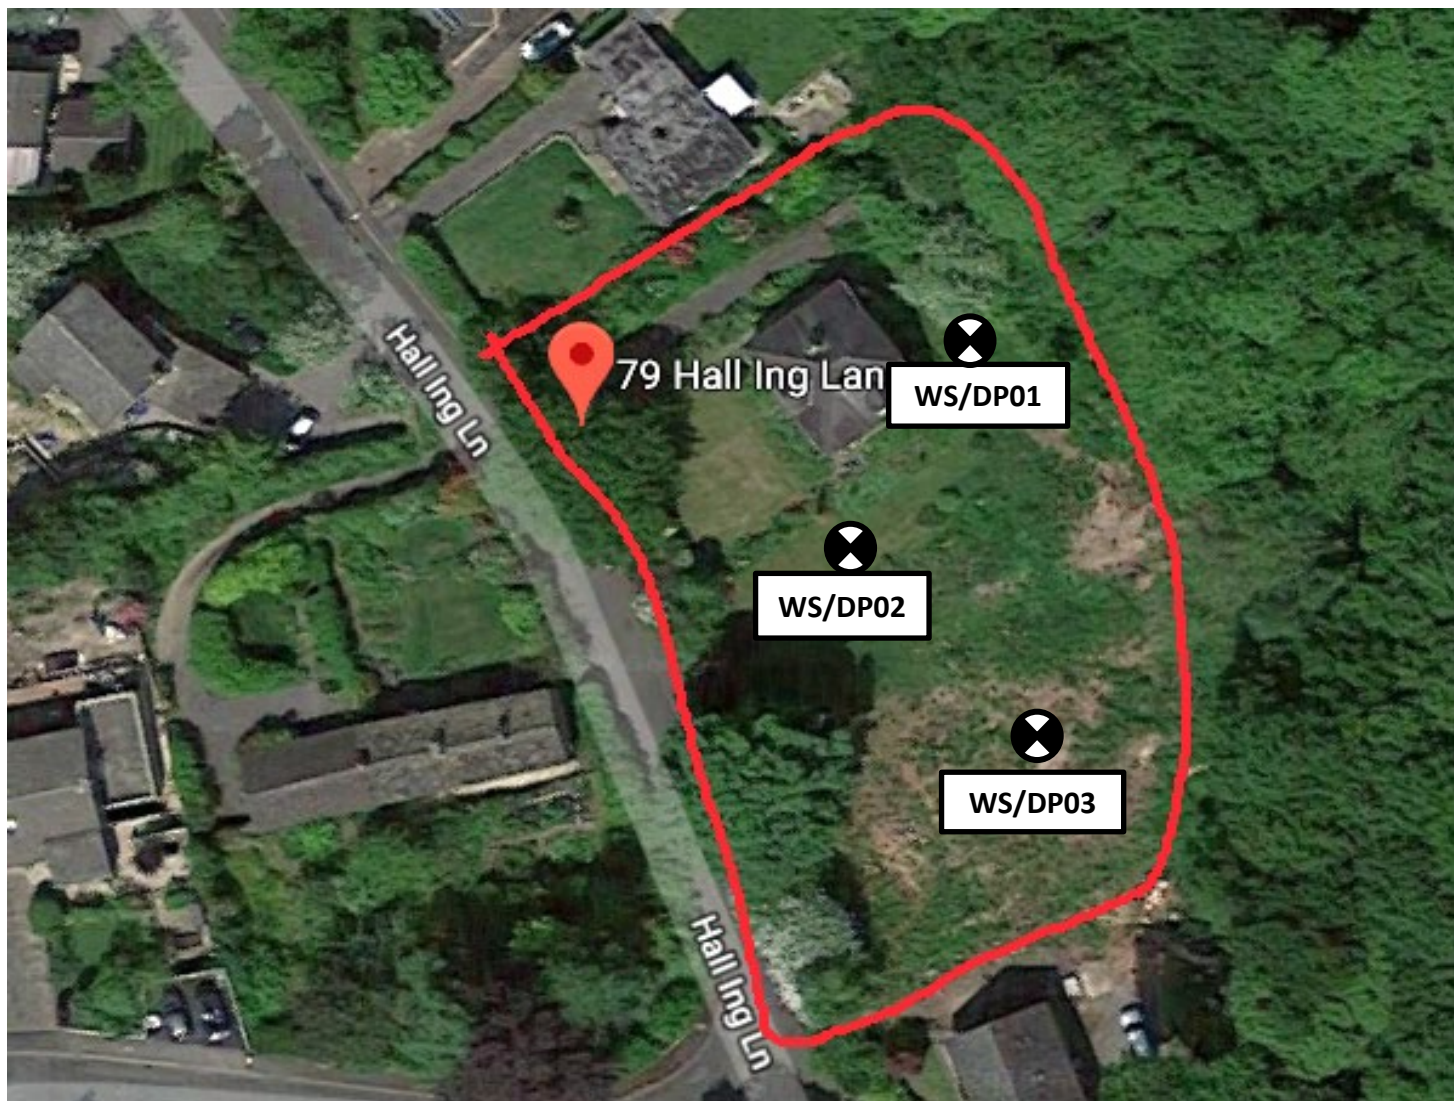
Title: **Proposed Borehole Plans (Proposed Access Route In Purple)**

Plan not to scale and investigation positions approximated from site operative's notes.

The investigatory locations are shown on the site plan which is presented in Appendix 1 to this report.
