PHASE 2 GEO-ENVIRONMENTAL REPORT

Report on a Phase 2 Geo-environmental Investigation

Location: Pentlands,
New Mill Road, Holmfirth, HD9 7LN

Report No. C406/19/E/610

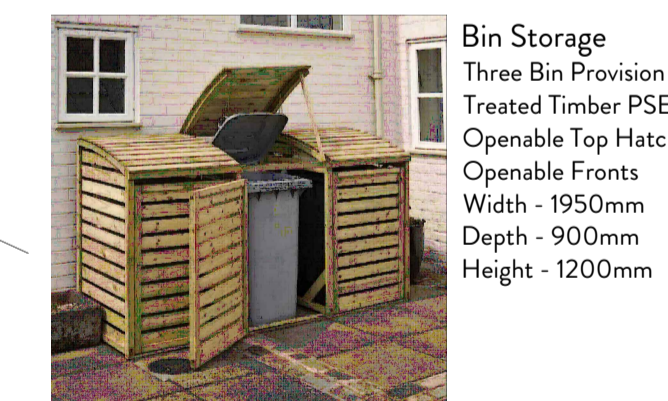
Bin Storage
Three Bin Provision
Treated Timber PSE
Openable Top Hatch
Openable Fronts
Width - 1950mm
Depth - 900mm
Height - 1200mm

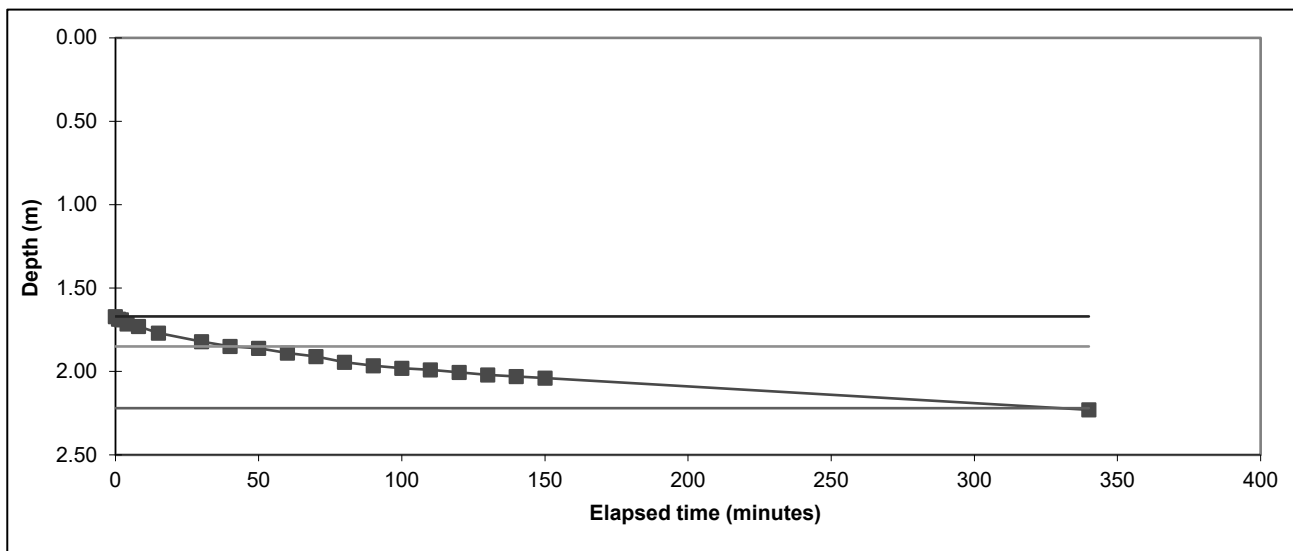
| Start water depth for analysis (mbgl): | 1.67 | Elapsed time (mins): | |
| 75% effective depth (mbgl): | 1.85 | Elapsed time (mins): | 40.0 |

| Soil infiltration rate (m/s): | 6.6E-6 |

During the soakaway tests the water level did not achieve a fall from 75% to 25% of the effective depth of the storage volume in both trialpits. In three of the four tests, the water level movement ceased at before 50% effective depth. It is considered that the initial movement was observed as water filled any gaps and fissures within the made ground at the side of the pit. On this basis, the tests could not be completed within the scope of the method provided in BRE Digest 365 due to the poor soakage rate of the exposed soils. Due to the negligible water movement it was not possible to extrapolate the results obtained within TP2, TP3 and TP4, however for TP1B, the soakage rate has been extrapolated in order to obtain an estimated soil infiltration rate.

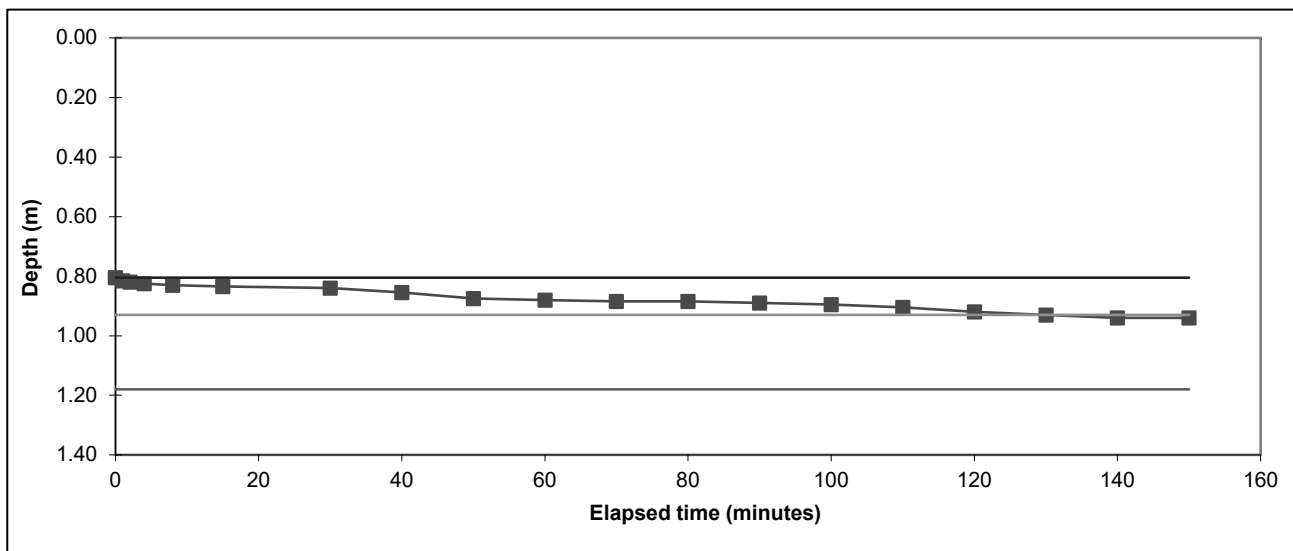
| Start water depth for analysis (mbgl): | 0.81 | | |
| 75% effective depth (mbgl): | 0.93 | Elapsed time (mins): | 130.0 |

| Soil infiltration rate (m/s): | Test incomplete as 25% effective depth not achieved. Unable to reliably determine soil infiltration rate. |

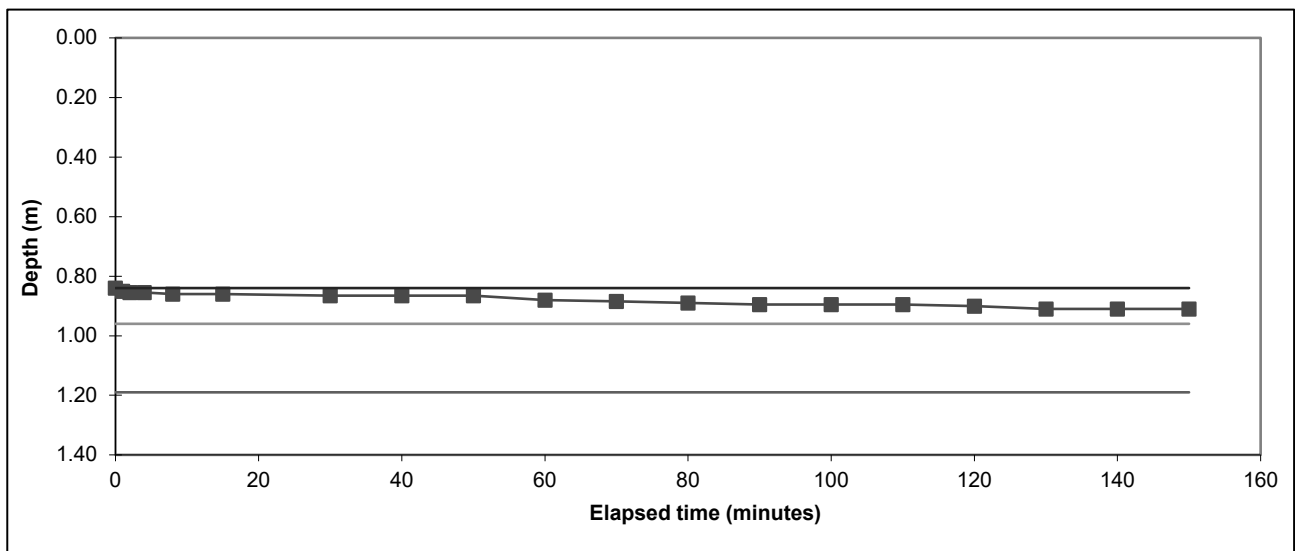
| Start water depth for analysis (mbgl): | 0.84 | Elapsed time (mins): | #N/A |
| 75% effective depth (mbgl): | 0.96 | Elapsed time (mins): | #N/A |

| Soil infiltration rate (m/s): | Test incomplete as 25% effective depth not achieved. Unable to reliably determine soil infiltration rate. |

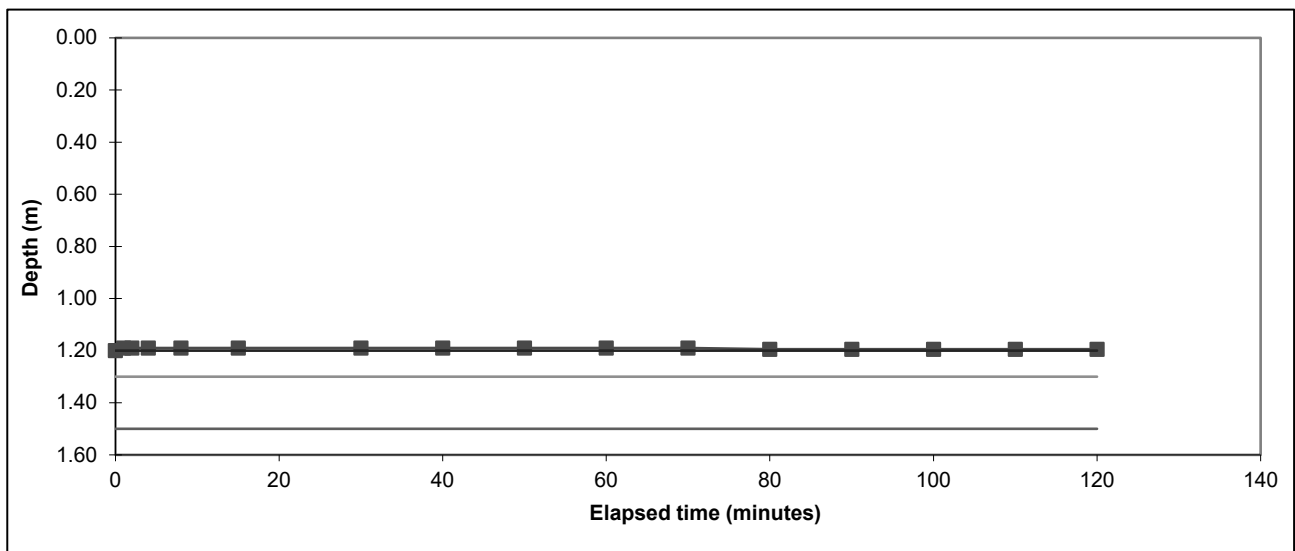
| Start water depth for analysis (mbgl): | 1.20 | Elapsed time (mins): | #N/A |
| 75% effective depth (mbgl): | 1.30 | Elapsed time (mins): | #N/A |

| Soil infiltration rate (m/s): | Test incomplete as 25% effective depth not achieved. Unable to reliably determine soil infiltration rate. |

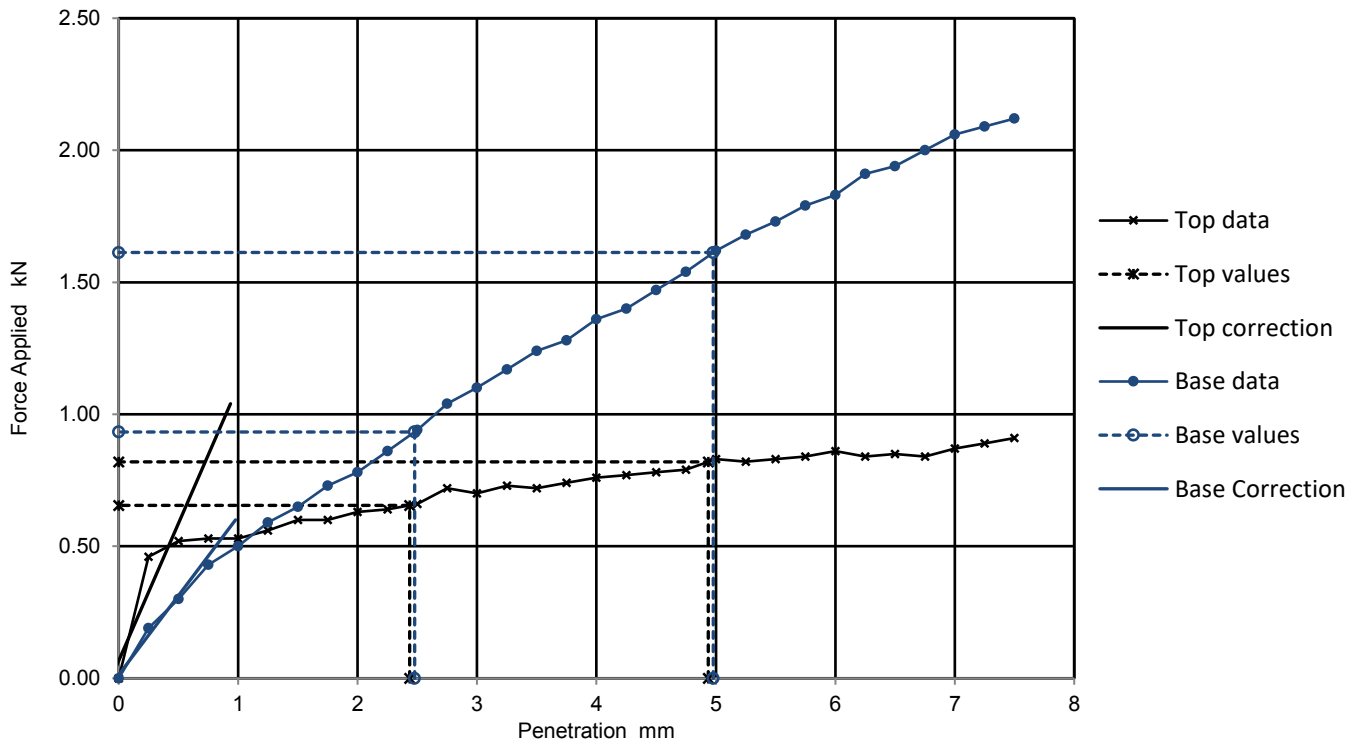
Force v Penetration Plots

| California Bearing Ratio (CBR) | | Job Ref | C406/19/E/610 | | |
| | | Borehole/Pit No. | CBR1 | | |

| Condition | REMOULDED | Soaking details | Not soaked | |
| | Moisture content | 12.2 % | | |

It is considered that any hard-standing at the site could be constructed employing traditional pavement design. A design California Bearing Ratio (CBR) of 3% could be employed in the pavement design⁵. However, it is recommended that proof rolling of the sub-grade be undertaken to establish the suitability of the soils, to expose any soft or weak ground and to ensure the sub-grade is well compacted prior to construction. Any areas of soft or weak ground should be remediated by increasing the sub-base thickness. Alternatively, weak material could be locally removed and replaced with a compacted granular capping layer. If construction were to be undertaken during the winter or after periods of prolonged rainfall, it may be prudent to employ a geotextile and/or a geogrid between the sub-base and sub-grade.

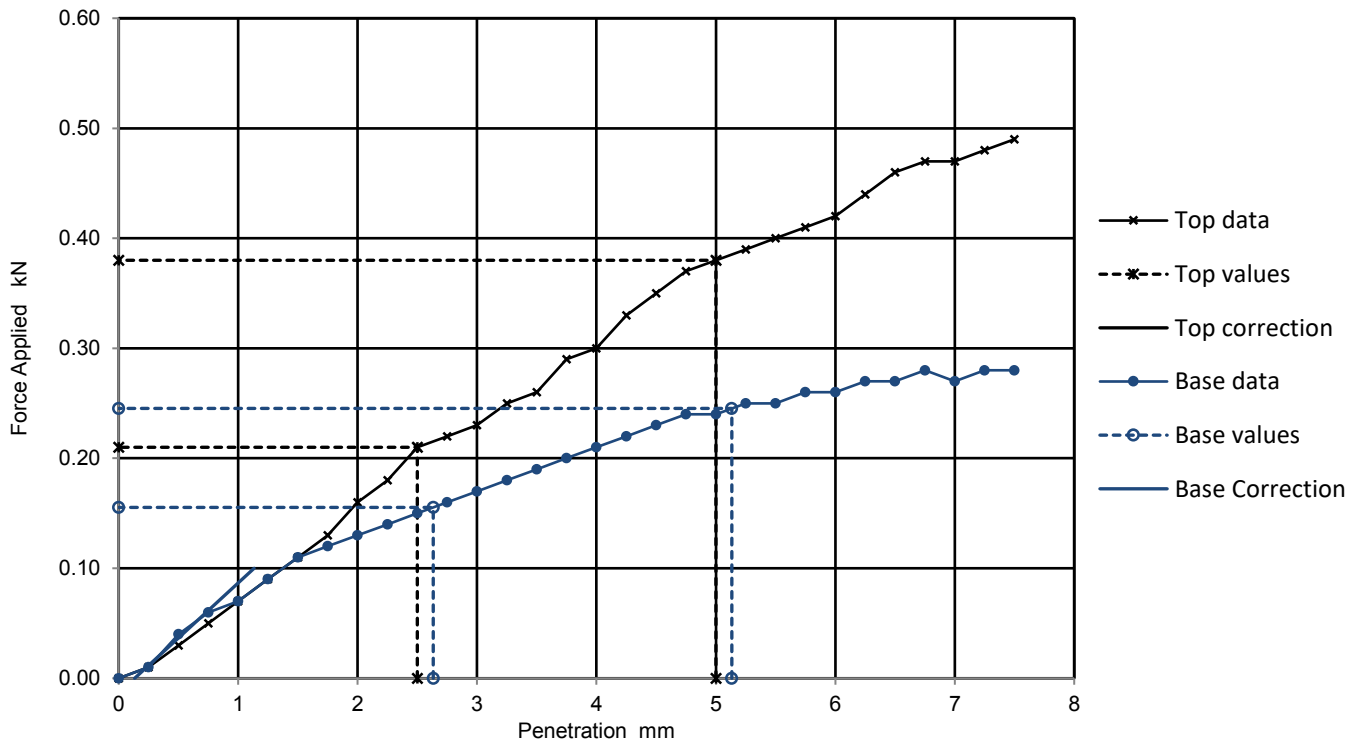
Force v Penetration Plots

| Condition | REMOULDED | Soaking details | Not soaked |
| | Moisture content | 45.0 % | 1 kPa |

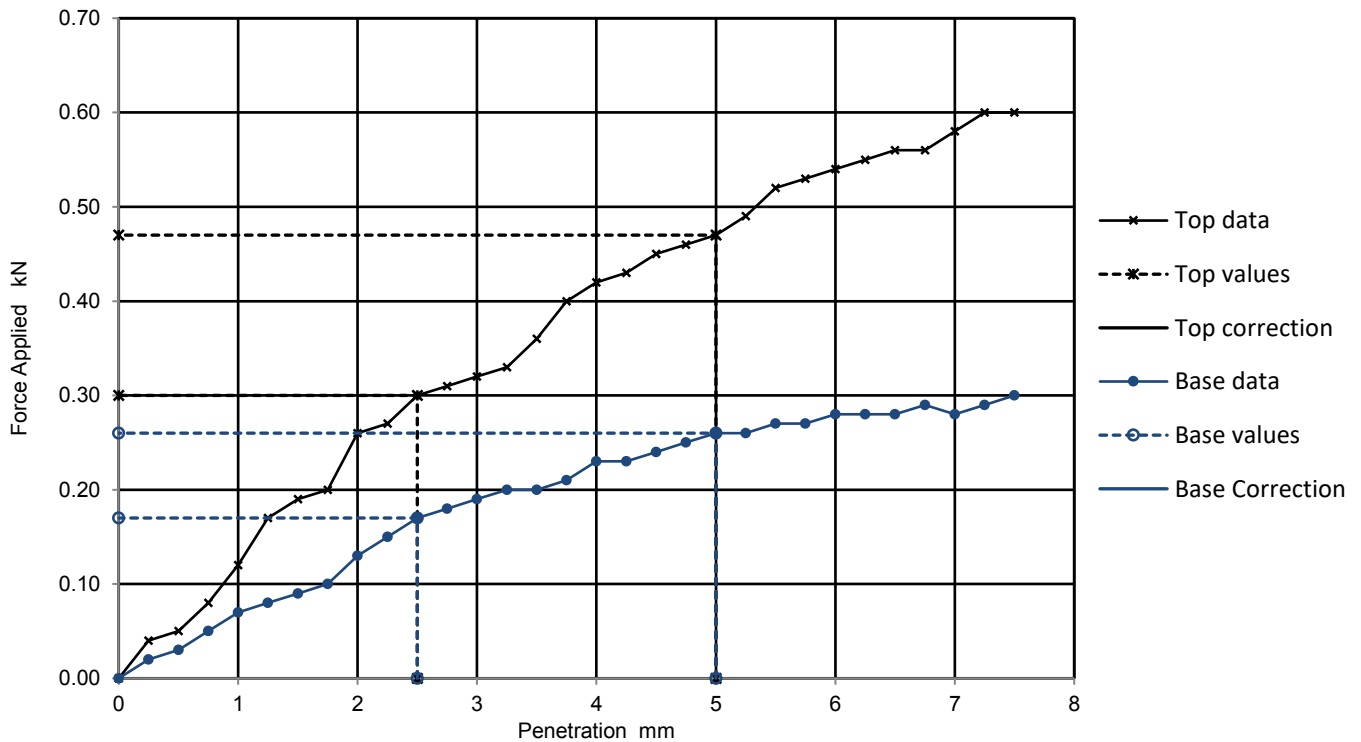
Force v Penetration Plots

| Condition | REMOULDED | Soaking details | Not soaked | |
| | Moisture content | 19.0 % | | |
