# Arboricultural Impact Assessment & Method Statement

**BE-1220-01E**

**Pentlands, New Mill Road, Holmfirth, West Yorkshire  
HD9 7LN**

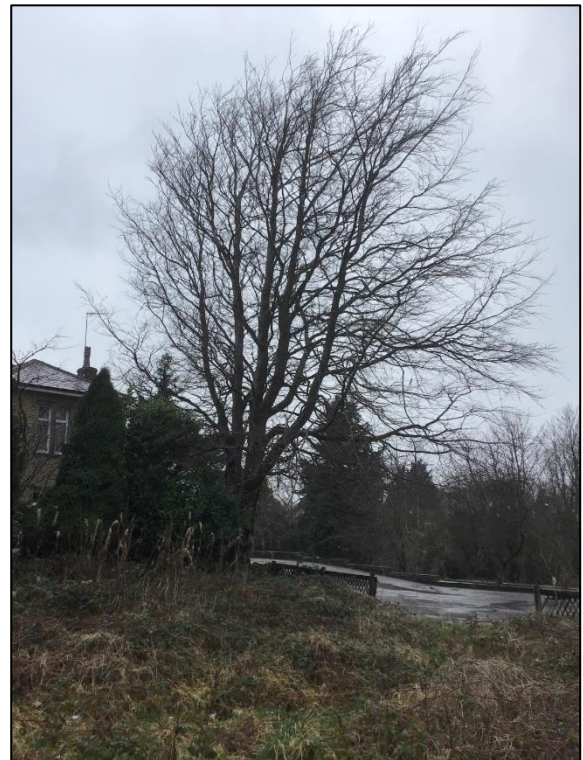
*Plate 8: T19*

T19 is a Category A tree on adjacent land. The proposed development is approximately 11.5 m from the stem of this tree. As the tree is to the north of the proposals, it will not overshadow the properties, and therefore post development impacts upon this tree are considered to be minimal.

The hardstanding surfaces within the RPAs of T17 and T19 must be constructed upon a cellular confinement system (recommended products include Cellweb and Terram Geocell).
