# Arboricultural Impact Assessment & Method Statement

**BE-1220-01G**

**Pentlands, New Mill Road, Holmfirth, West Yorkshire  
HD9 7LN**

| <b>Date</b> | 19 <sup>th</sup> October 2021 |

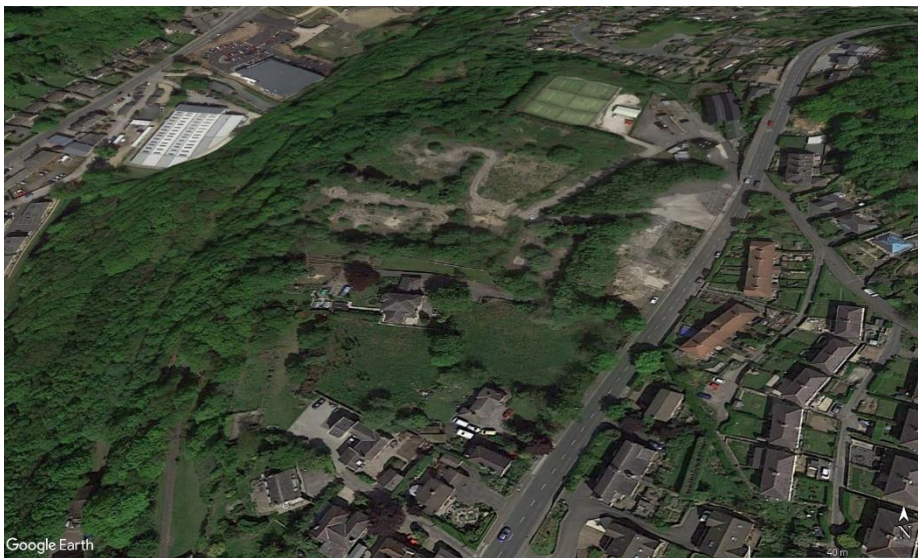
Figure 1.1 Aerial Imagery of Site and Surrounding Area (Google Earth Pro, 2020)

The site is located at grid reference SE 14809 09173 and is accessed off the west of New Mill Road (A635) in Holmfirth. The site is bordered by a residential property and its access drive to the north, by New Mill Road to the east, residential properties to the south and a garden to the west, approximately 30 m beyond which is a woodland. Figure 1.1, below, shows aerial imagery of the site and the surrounding area.

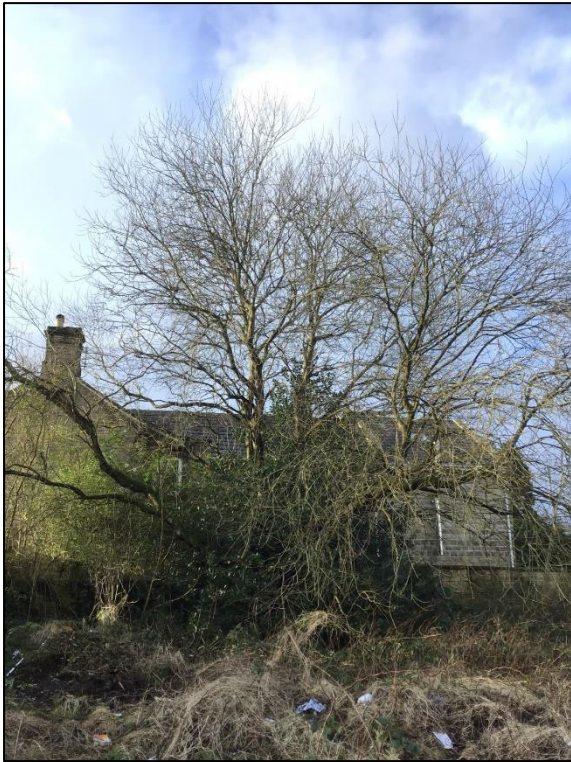
*Plate 1: T1*

| Tree No. | Species | Height | CC | Stems | DBH | Crown Spread | | | | Age | Comments | SULE | Category |
|---|---|---|---|---|---|---|---|---|---|---|---|---|---|
| T1 | Crack willow | 11 | 3 | 3 | 50 | 6 | 6 | 5.5 | 4 | EM | Dense vegetation around stems, unable to fully inspect. | 11-20 | C1 |

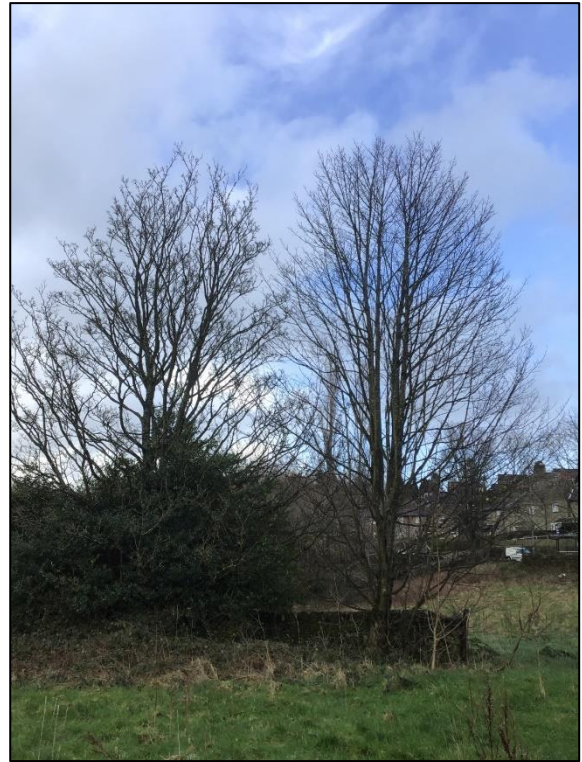
*Plate 2: T4 & T5*

| Tree No. | Species | Height | CC | Stems | DBH | Crown Spread | | | | Age | Comments | SULE | Category |
|---|---|---|---|---|---|---|---|---|---|---|---|---|---|
| T4 | Sycamore | 14.5 | 2 | 2 | 35 | 4 | 4.5 | 4 | 4.5 | EM | Dense vegetation around stem, unable to access to fully inspect. | 21-40 | B2 |
| T5 | Sycamore | 14 | 0 | 1 | 39 | 3 | 3 | 3.5 | 3 | EM | Lapsed epicormic growth. Stem bifurcates at 3 m with included bark at primary branch unions. | 21-40 | B2 |

Six Category B trees, including T4, T5, T10, T11, T14 and T15 will necessitate removal due to the development proposals.

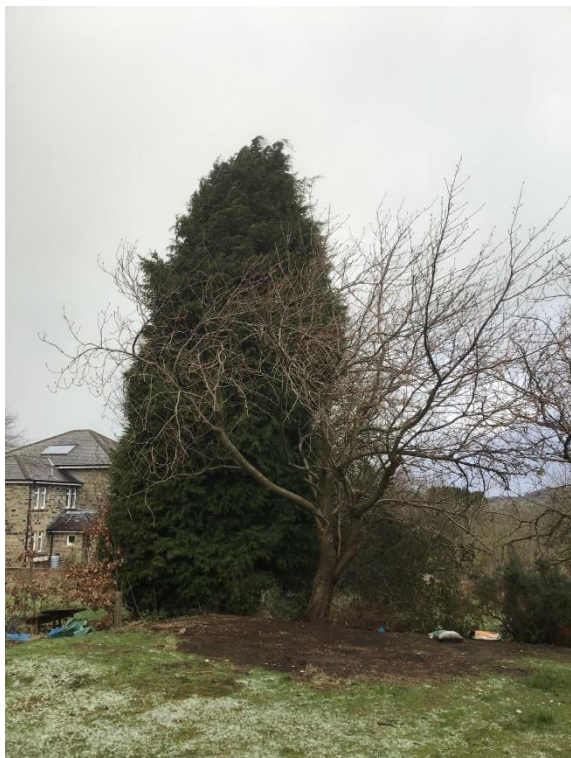
*Plate 3: T6 & T7*

| Tree No. | Species | Height | CC | Stems | DBH | Crown Spread | | | | Age | Comments | SULE | Category |
|---|---|---|---|---|---|---|---|---|---|---|---|---|---|
| T6 | Lawson cypress | 10.5 | 0 | 2 | 44 | 2 | 2 | 2.5 | 2 | M | Included bark at stem unions with good occlusion. Lacks qualities for higher categorisation. | 21-40 | C2 |

Four Category C trees and five groups of trees, including T6, T7, T8, T16, G9, G12, G13, G18, G20 will necessitate removal due to the development proposals. A small proportion of G2 will necessitate removal due to the development proposals.

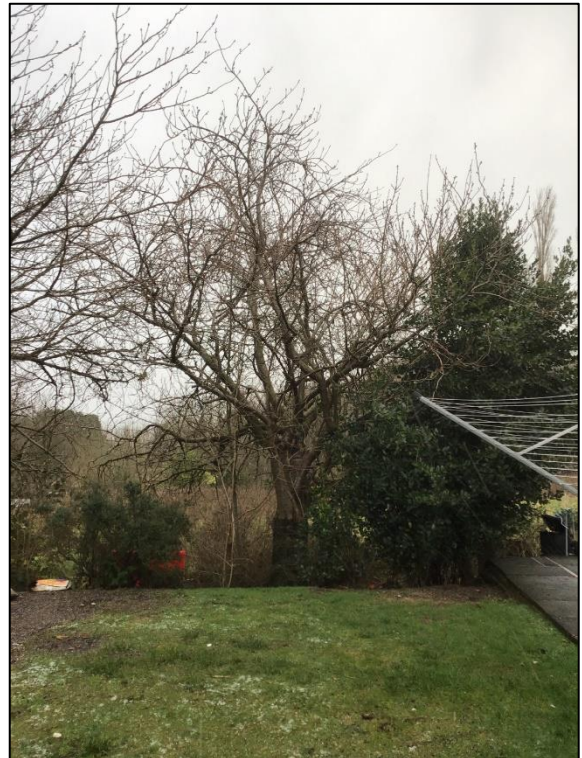
*Plate 4: T8*

| Tree No. | Species | Height | CC | Stems | DBH | Crown Spread | | | | Age | Comments | SULE | Category |
|---|---|---|---|---|---|---|---|---|---|---|---|---|---|
| T8 | Japanese cherry | 4.5 | 2 | 1 | 47 | 3.5 | 3 | 2.5 | 3 | M | Included bark at primary branch unions with poor occlusion. Decay on primary branch. | 11-20 | C1 |

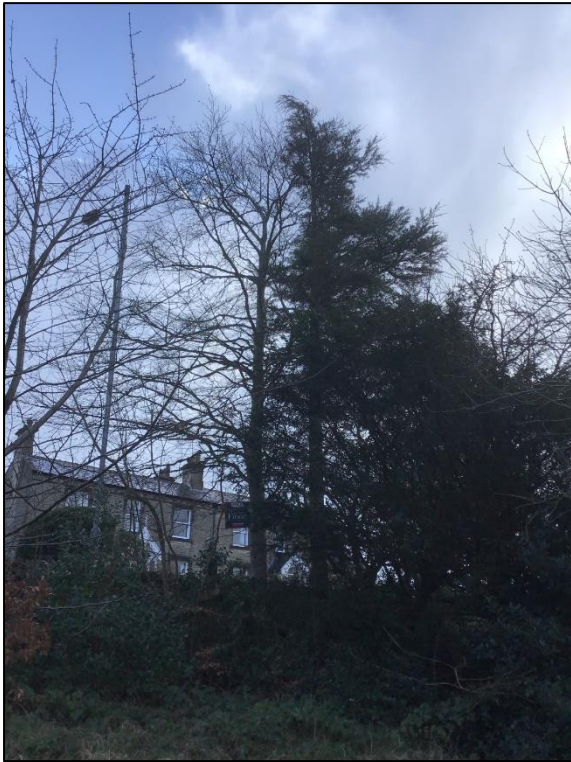
*Plate 5: T10 & T11*

| Tree No. | Species | Height | CC | Stems | DBH | Crown Spread | | | | Age | Comments | SULE | Category |
|---|---|---|---|---|---|---|---|---|---|---|---|---|---|
| T11 | Deodar cedar | 12 | 4 | 1 | 36 | 2 | 2.5 | 1.5 | 1.5 | SM | No major visible defects. Lacks qualities for higher categorisation. | 21-40 | B2 |

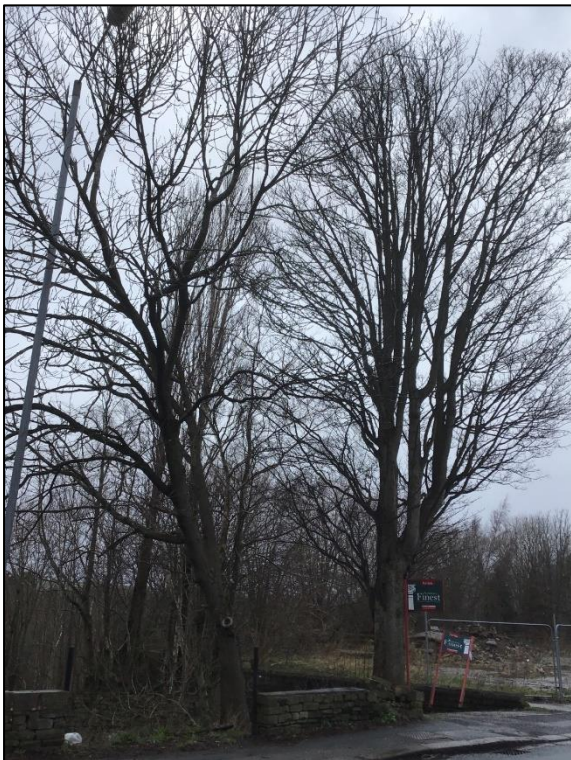
*Plate 7: T16 & T17*

The construction of hardstanding surfaces is proposed within the RPA of T17. T17 has an RPA of 132 m<sup>2</sup>. Approximately 2 m<sup>2</sup>, 2% of the total RPA will be affected. The area affected is under the 20% unsurfaced area which can be covered in hardstanding, as recommended in BS5837: 2012. This surfaces will need to be constructed using no excavation, and upon a cellular confinement system. Further details are provided in Section 4.

The hardstanding surfaces within the RPA of T17 must be constructed upon a cellular confinement system (recommended products include Cellweb and Terram Geocell).

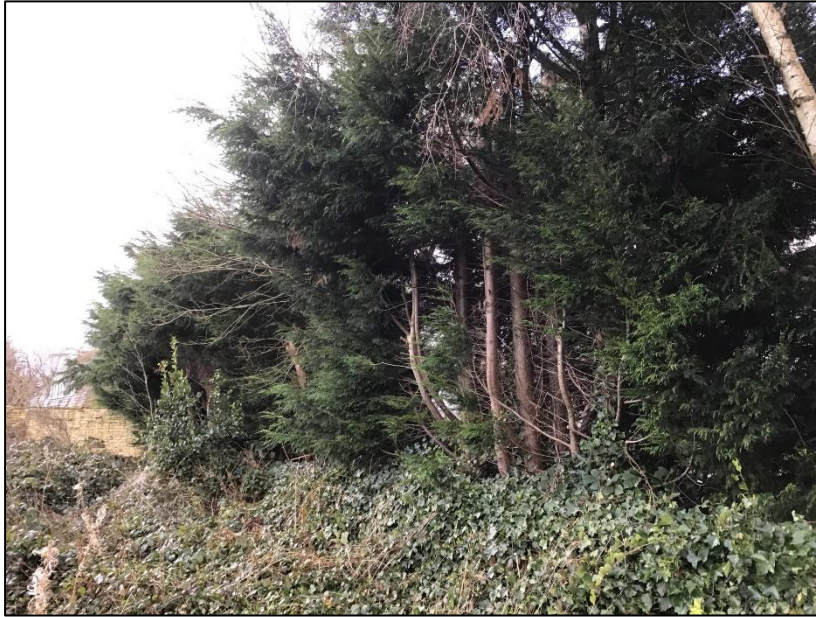
*Plate 9: G2*

G2 and G3 are Leyland cypress hedges at the site boundary. These hedges will require further cyclical pruning to ensure that they do not overshadow the proposed properties.

| Tree No. | Species | Height | CC | Stems | DBH | Crown Spread | | | | Age | Comments | SULE | Category |
|---|---|---|---|---|---|---|---|---|---|---|---|---|---|
| G2 | Leyland Cypress, silver birch, Norway spruce | 5 | 2.5 | 26 | 20 | 2 | 2 | 2 | 2 | EM | Linear group of trees on adjacent land, behind 1 m high wall. Cypress trees previously topped. | 11-20 | C1 |

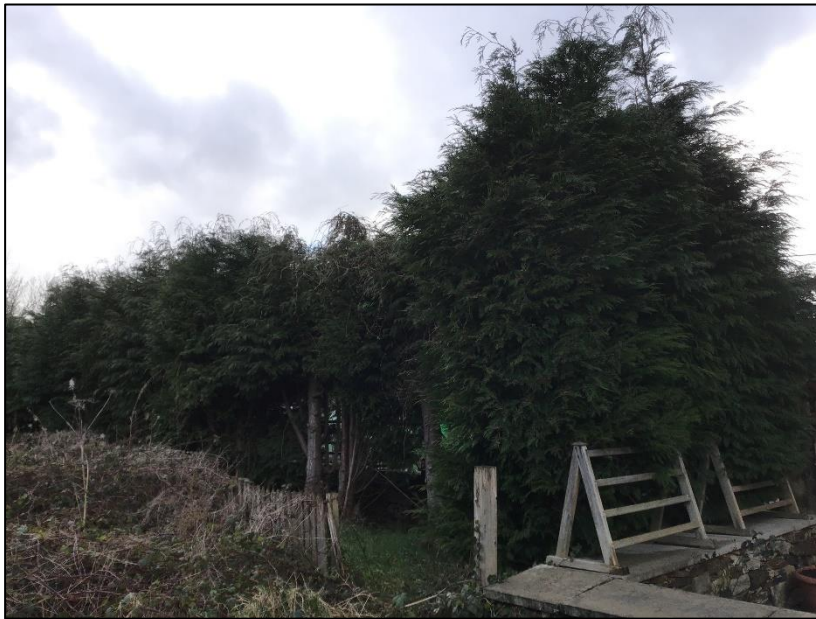
*Plate 10: G3*

| Tree No. | Species | Height | CC | Stems | DBH | Crown Spread | | | | Age | Comments | SULE | Category |
|---|---|---|---|---|---|---|---|---|---|---|---|---|---|
| G3 | Leyland cypress | 4 | 1 | 8 | 15 | 1 | 1 | 1 | 1 | SM | Linear group of trees at site boundary. Low quality trees, although screening provided between site and adjacent property. | 11-20 | C2 |

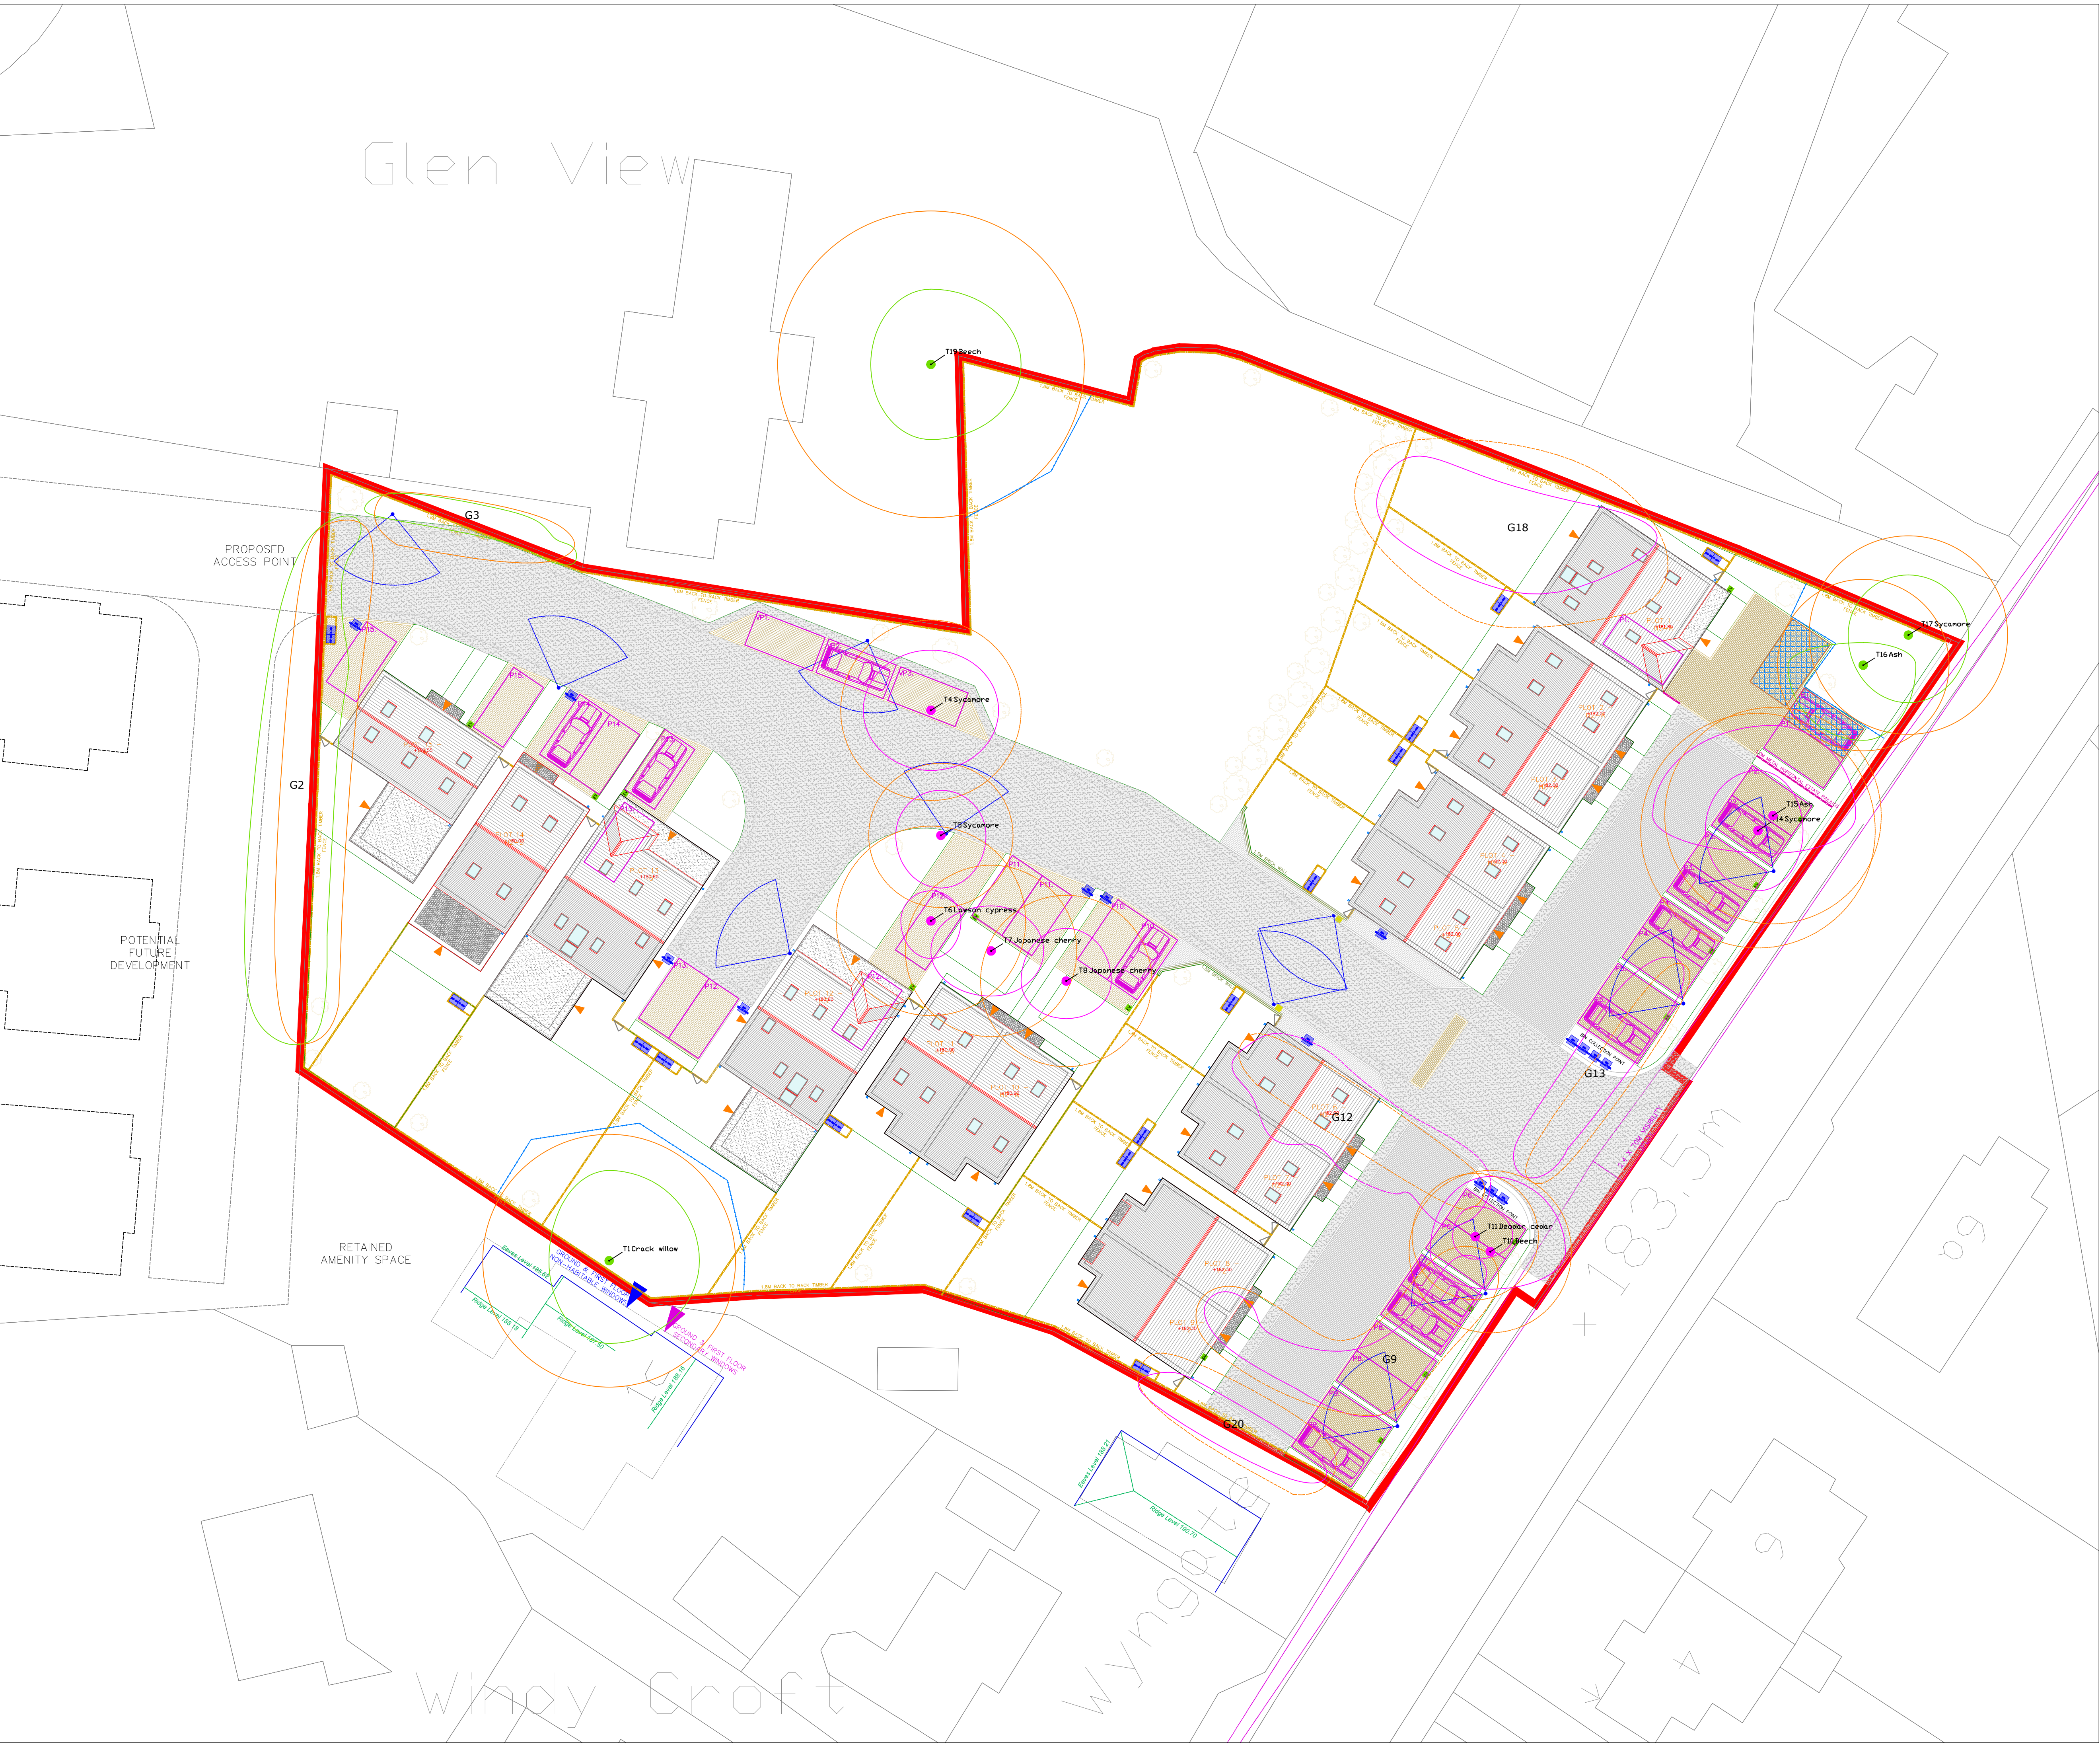
## **Appendix 4: Tree Retention & Tree Protection Plan**

Prior to machinery entering the site, it will be necessary to ensure that all trees are adequately protected by the installation of temporary tree protection fencing. This must remain in place during development works. The location of tree protection fencing can be viewed in [Appendix 4: Tree Protection Plan](#).

**(showing trees to be removed and retained and tree protection measures)**
