# **Geo-environmental Ground Investigation Report**

**PROPOSED RESIDENTIAL DEVELOPMENT**

**Bradford Road,  
Cleckheaton  
West Yorkshire**

**E18/5765/R001**

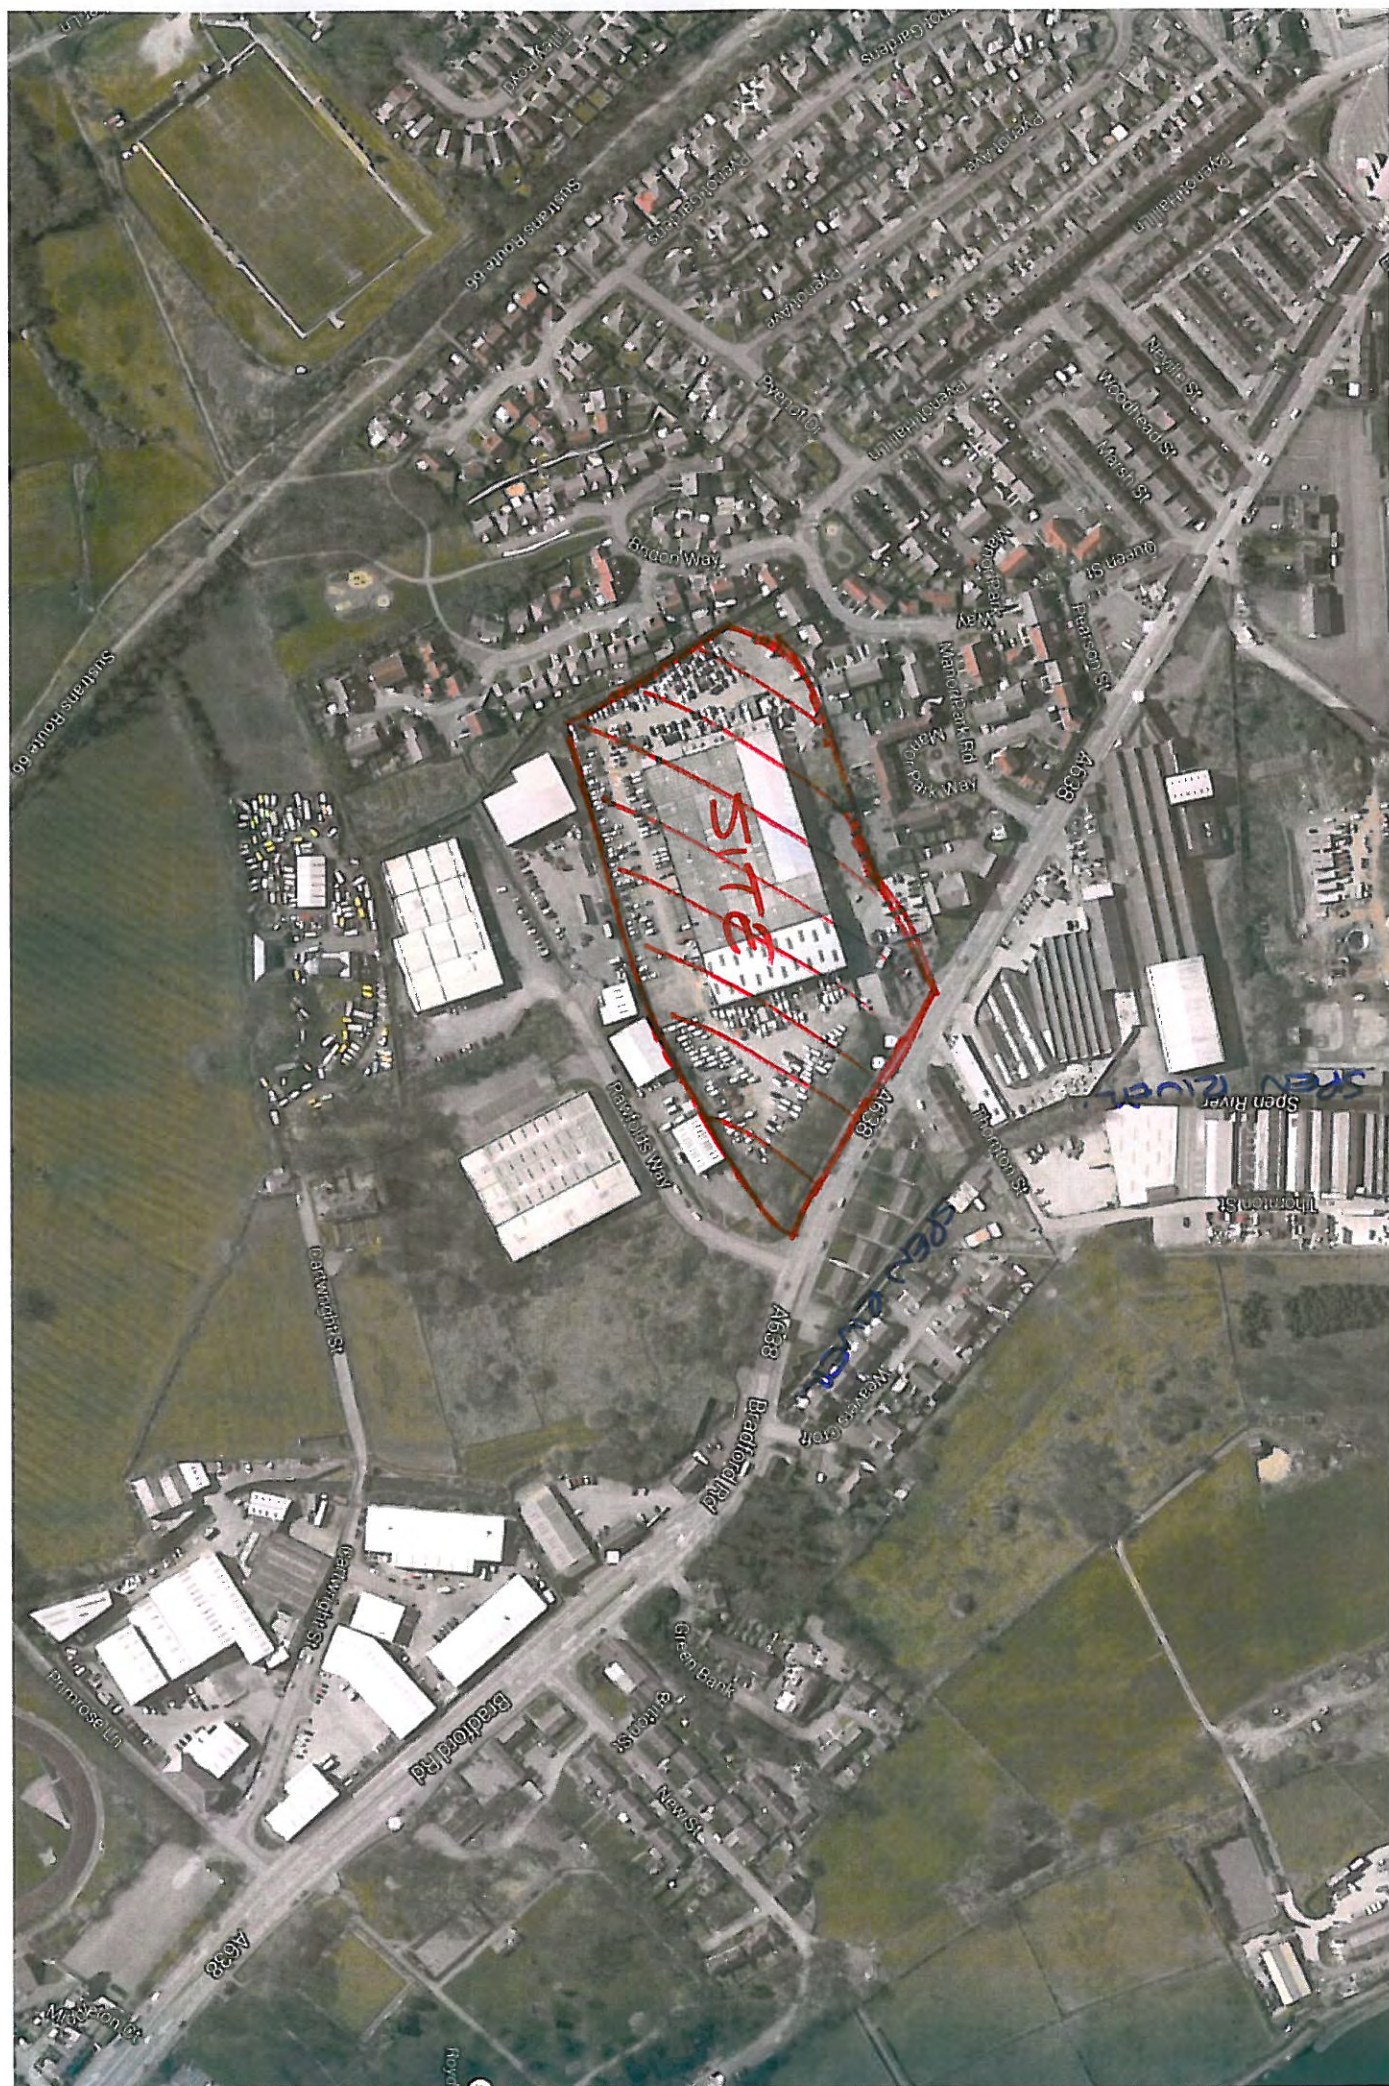
**Trial Pit Location Plan**

**Preliminary Plot Levels Drawing**
