**A PHASE 1 PRELIMINARY RISK  
ASSESSMENT OF LAND BETWEEN  
PENNINE VIEW AND PHEASANT  
DRIVE, BIRSTALL**

**REPORT REFERENCE: C20315P**

Client: Mileway Real Estate Ltd

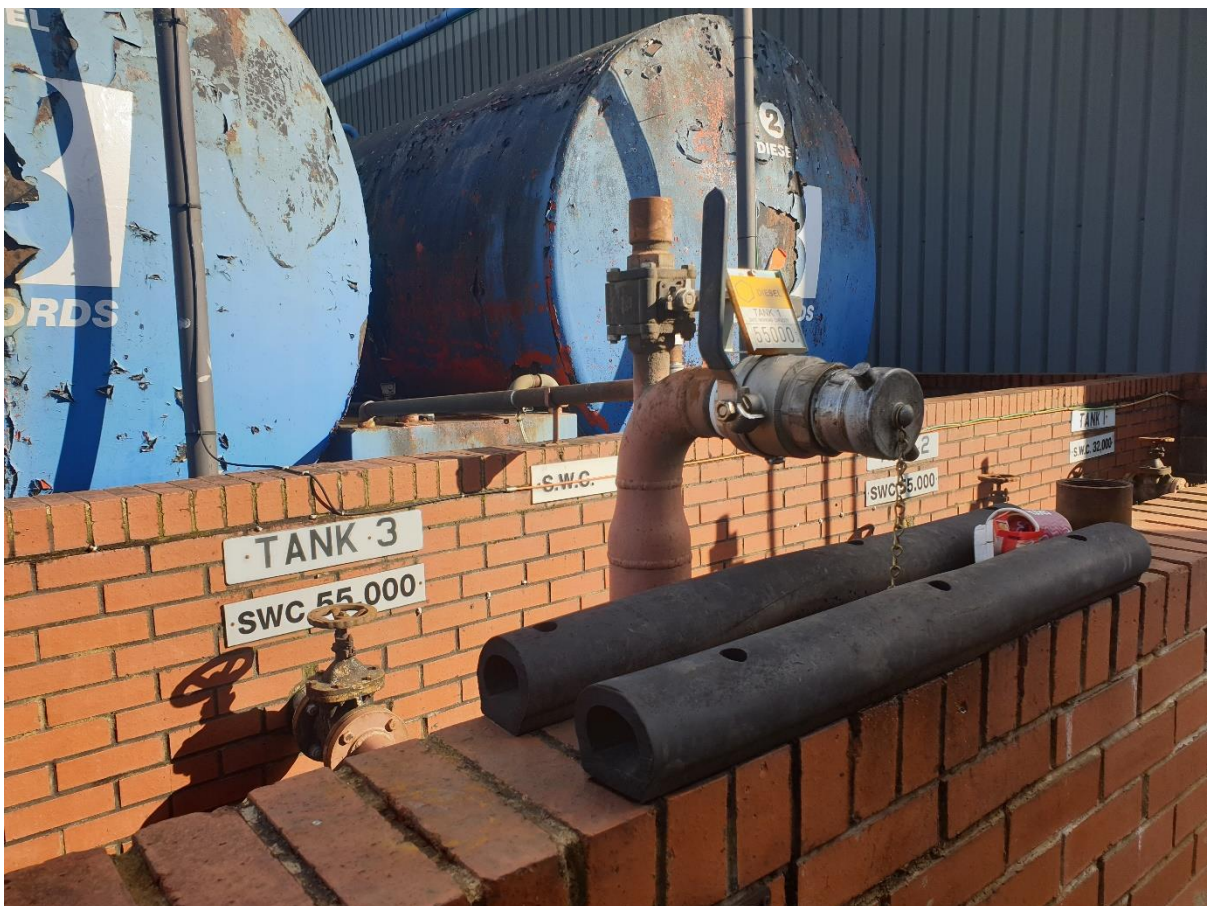
- Three large (55,000l) brick banded diesel tanks (coloured blue and rusting slightly) used for lorry refuelling. The tanks are monitored with a gauge and an alarm; staining was observed at the fill points and dispensing points, as shown in photographs.

- The bunds around the above tanks are of brick construction in a poor state of repair, with cracks in some areas.
  - One large grey fuel tank of unknown capacity.

Photograph 2: Tanks in Area A.
