**Phase 1 Geo-Environmental Desktop Study
Report**

Proposed New Lidl Store

Off New Hey Road
Huddersfield
West Yorkshire
HD3 4GP

Ref: 09-122-DOC-002

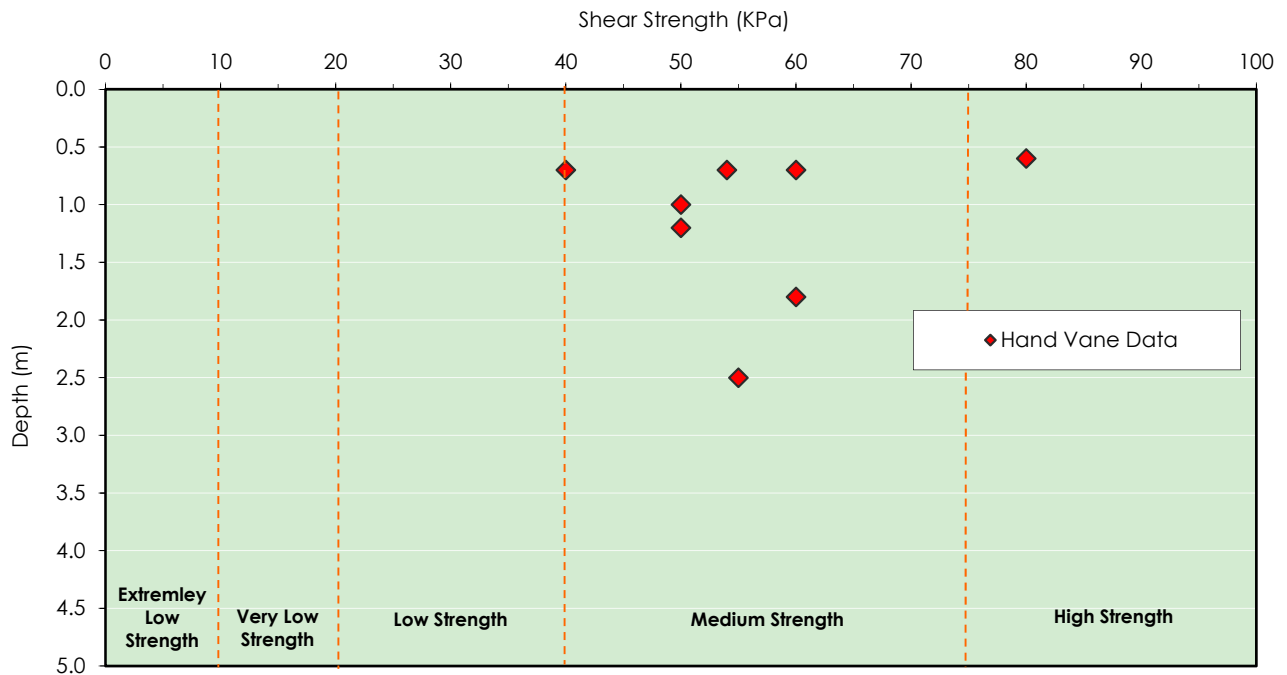
12.4.3 The results are summarised within the plot on page 22 and illustrate a typical undrained shear strength (S_u) of at least 50KPa within the cohesive strata.

12.4.2 The deposits were often gravelly and very quickly graded into bedrock from 0.5m in places therefore the opportunity for hand shear vane tests was limited.

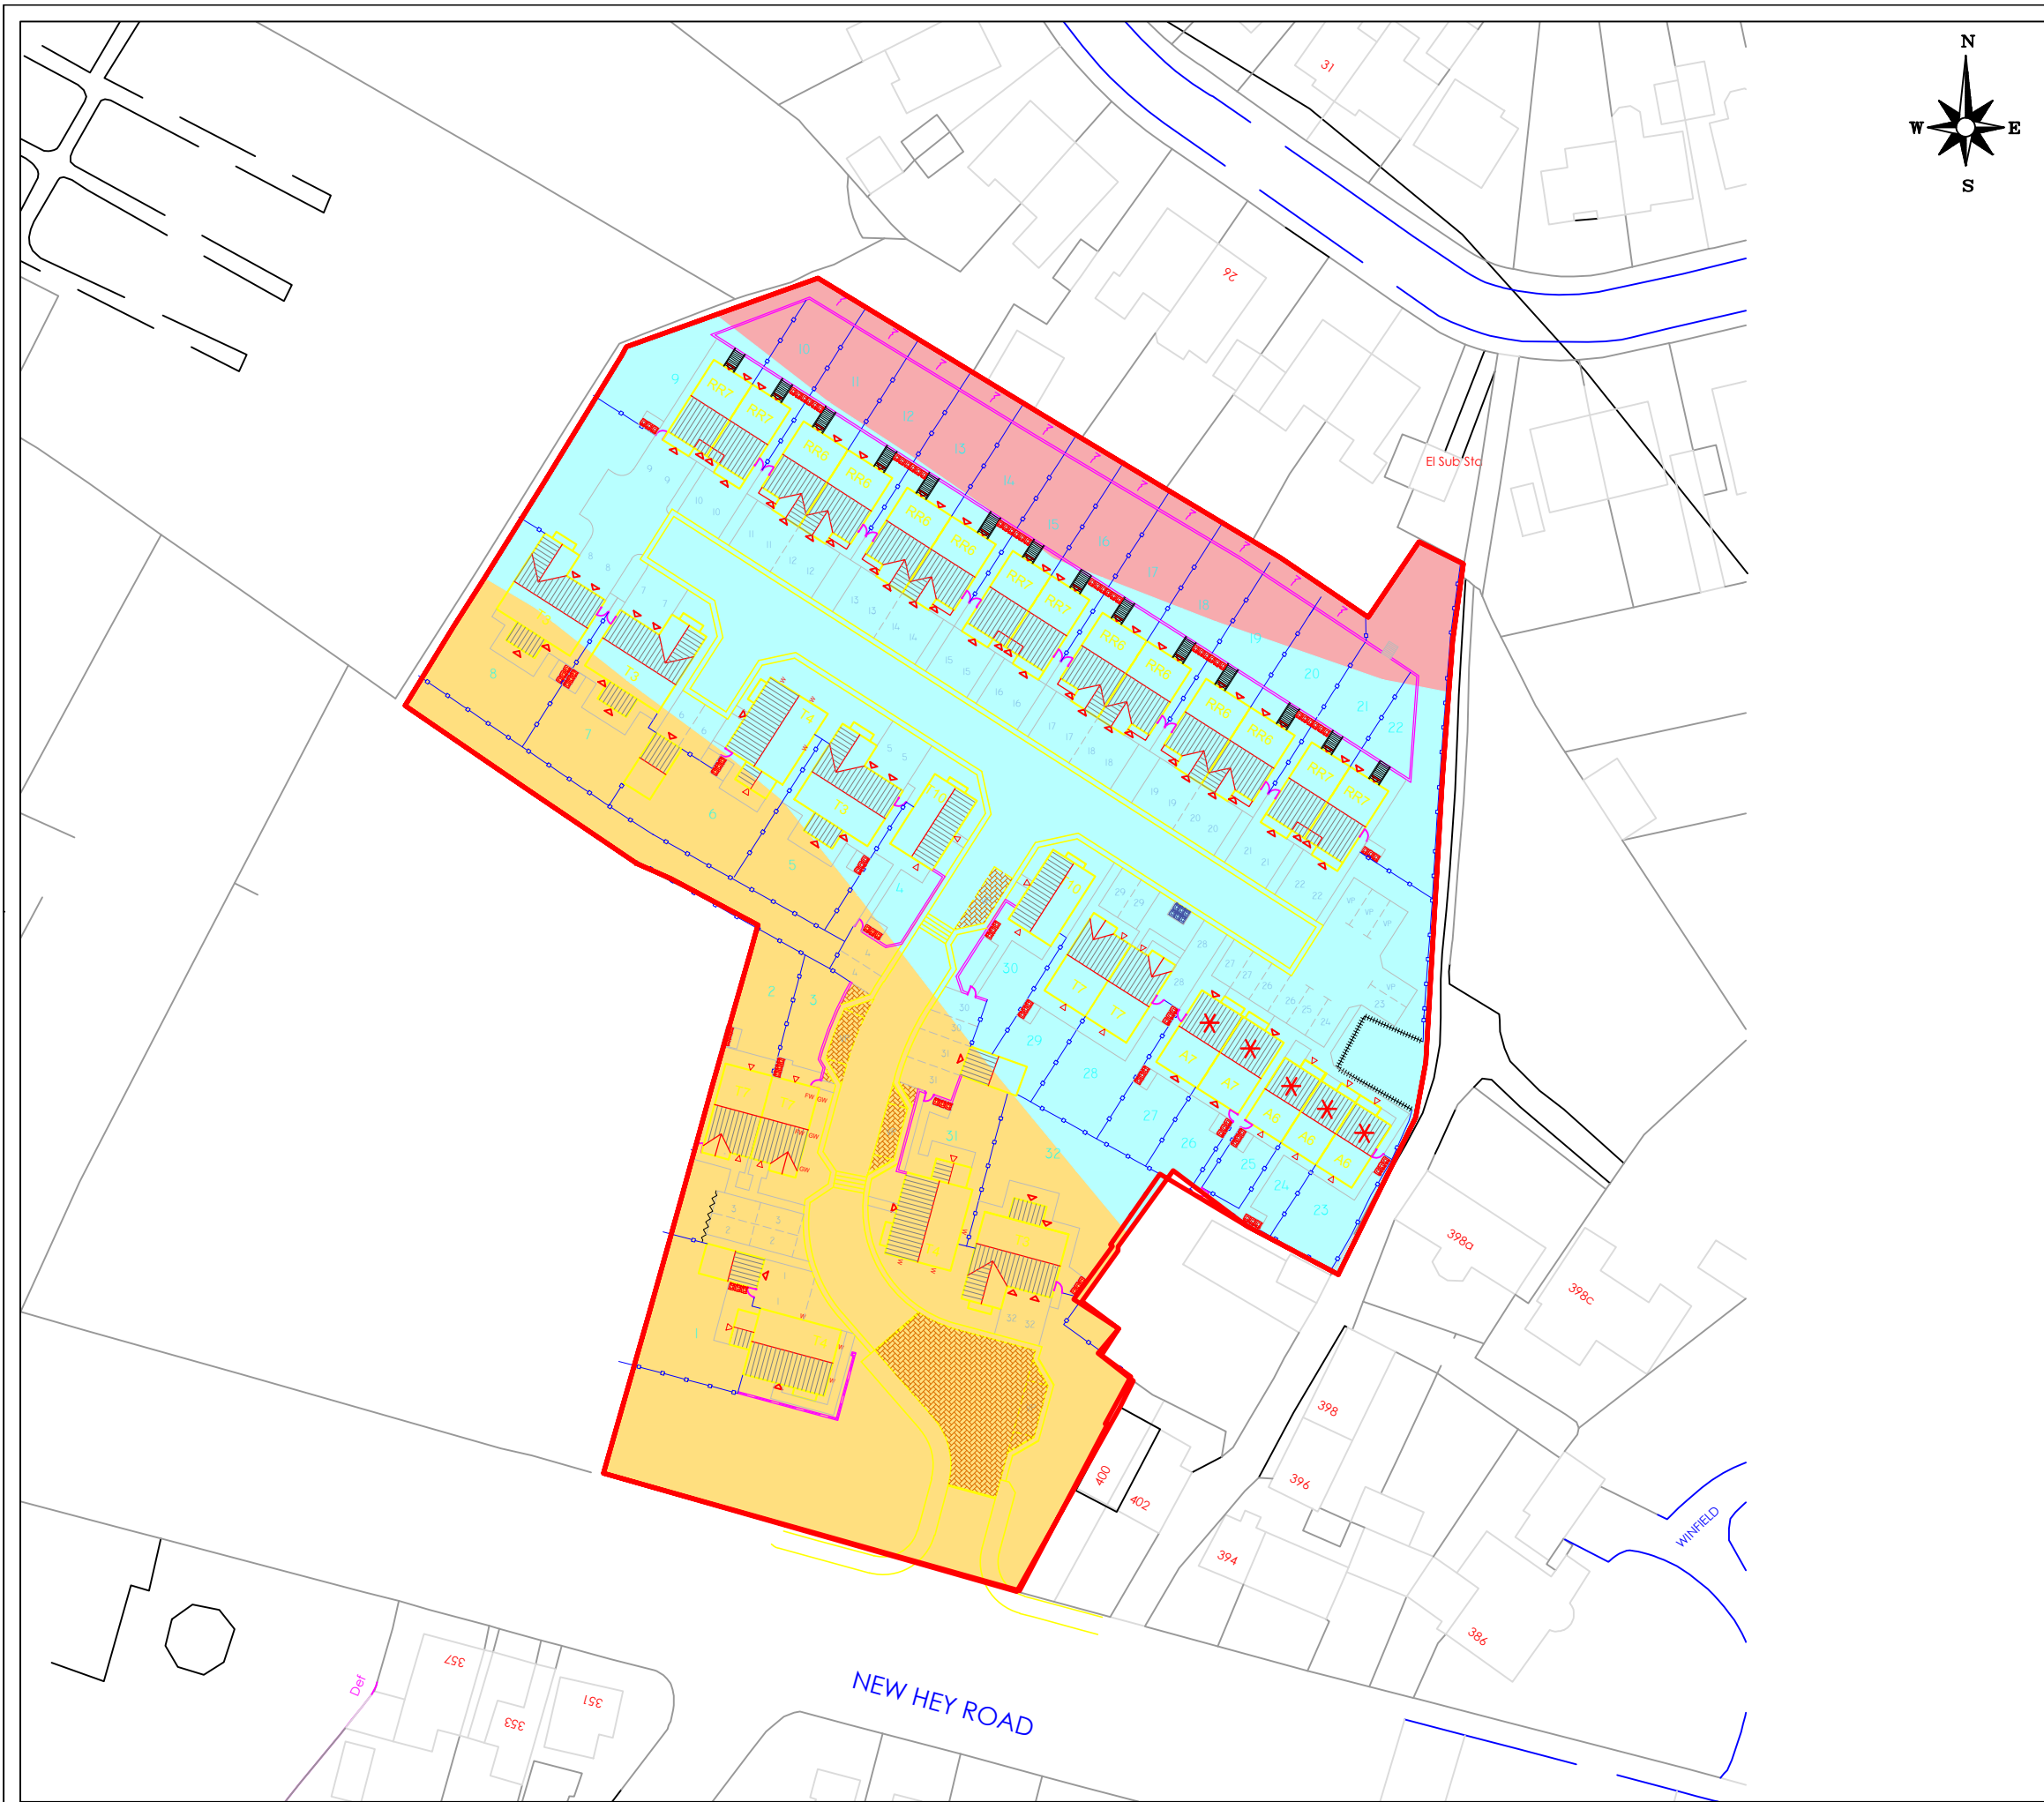
PROPOSED SITE LAYOUT

- ROUGH ROCK SANDSTONE (STRONG SANDSTONE)
- LOWER COAL MEASURES (WEAK MUDSTONE)
- SOFT BED FLAGS (WEAK SILTSTONE & SANDSTONE)
- APPROXIMATE SITE BOUNDARY

8.5.4 Anticipated geology is also overlain on the proposed layout, Drawing 2895/2, to aid foundation design and cut/fill operations.

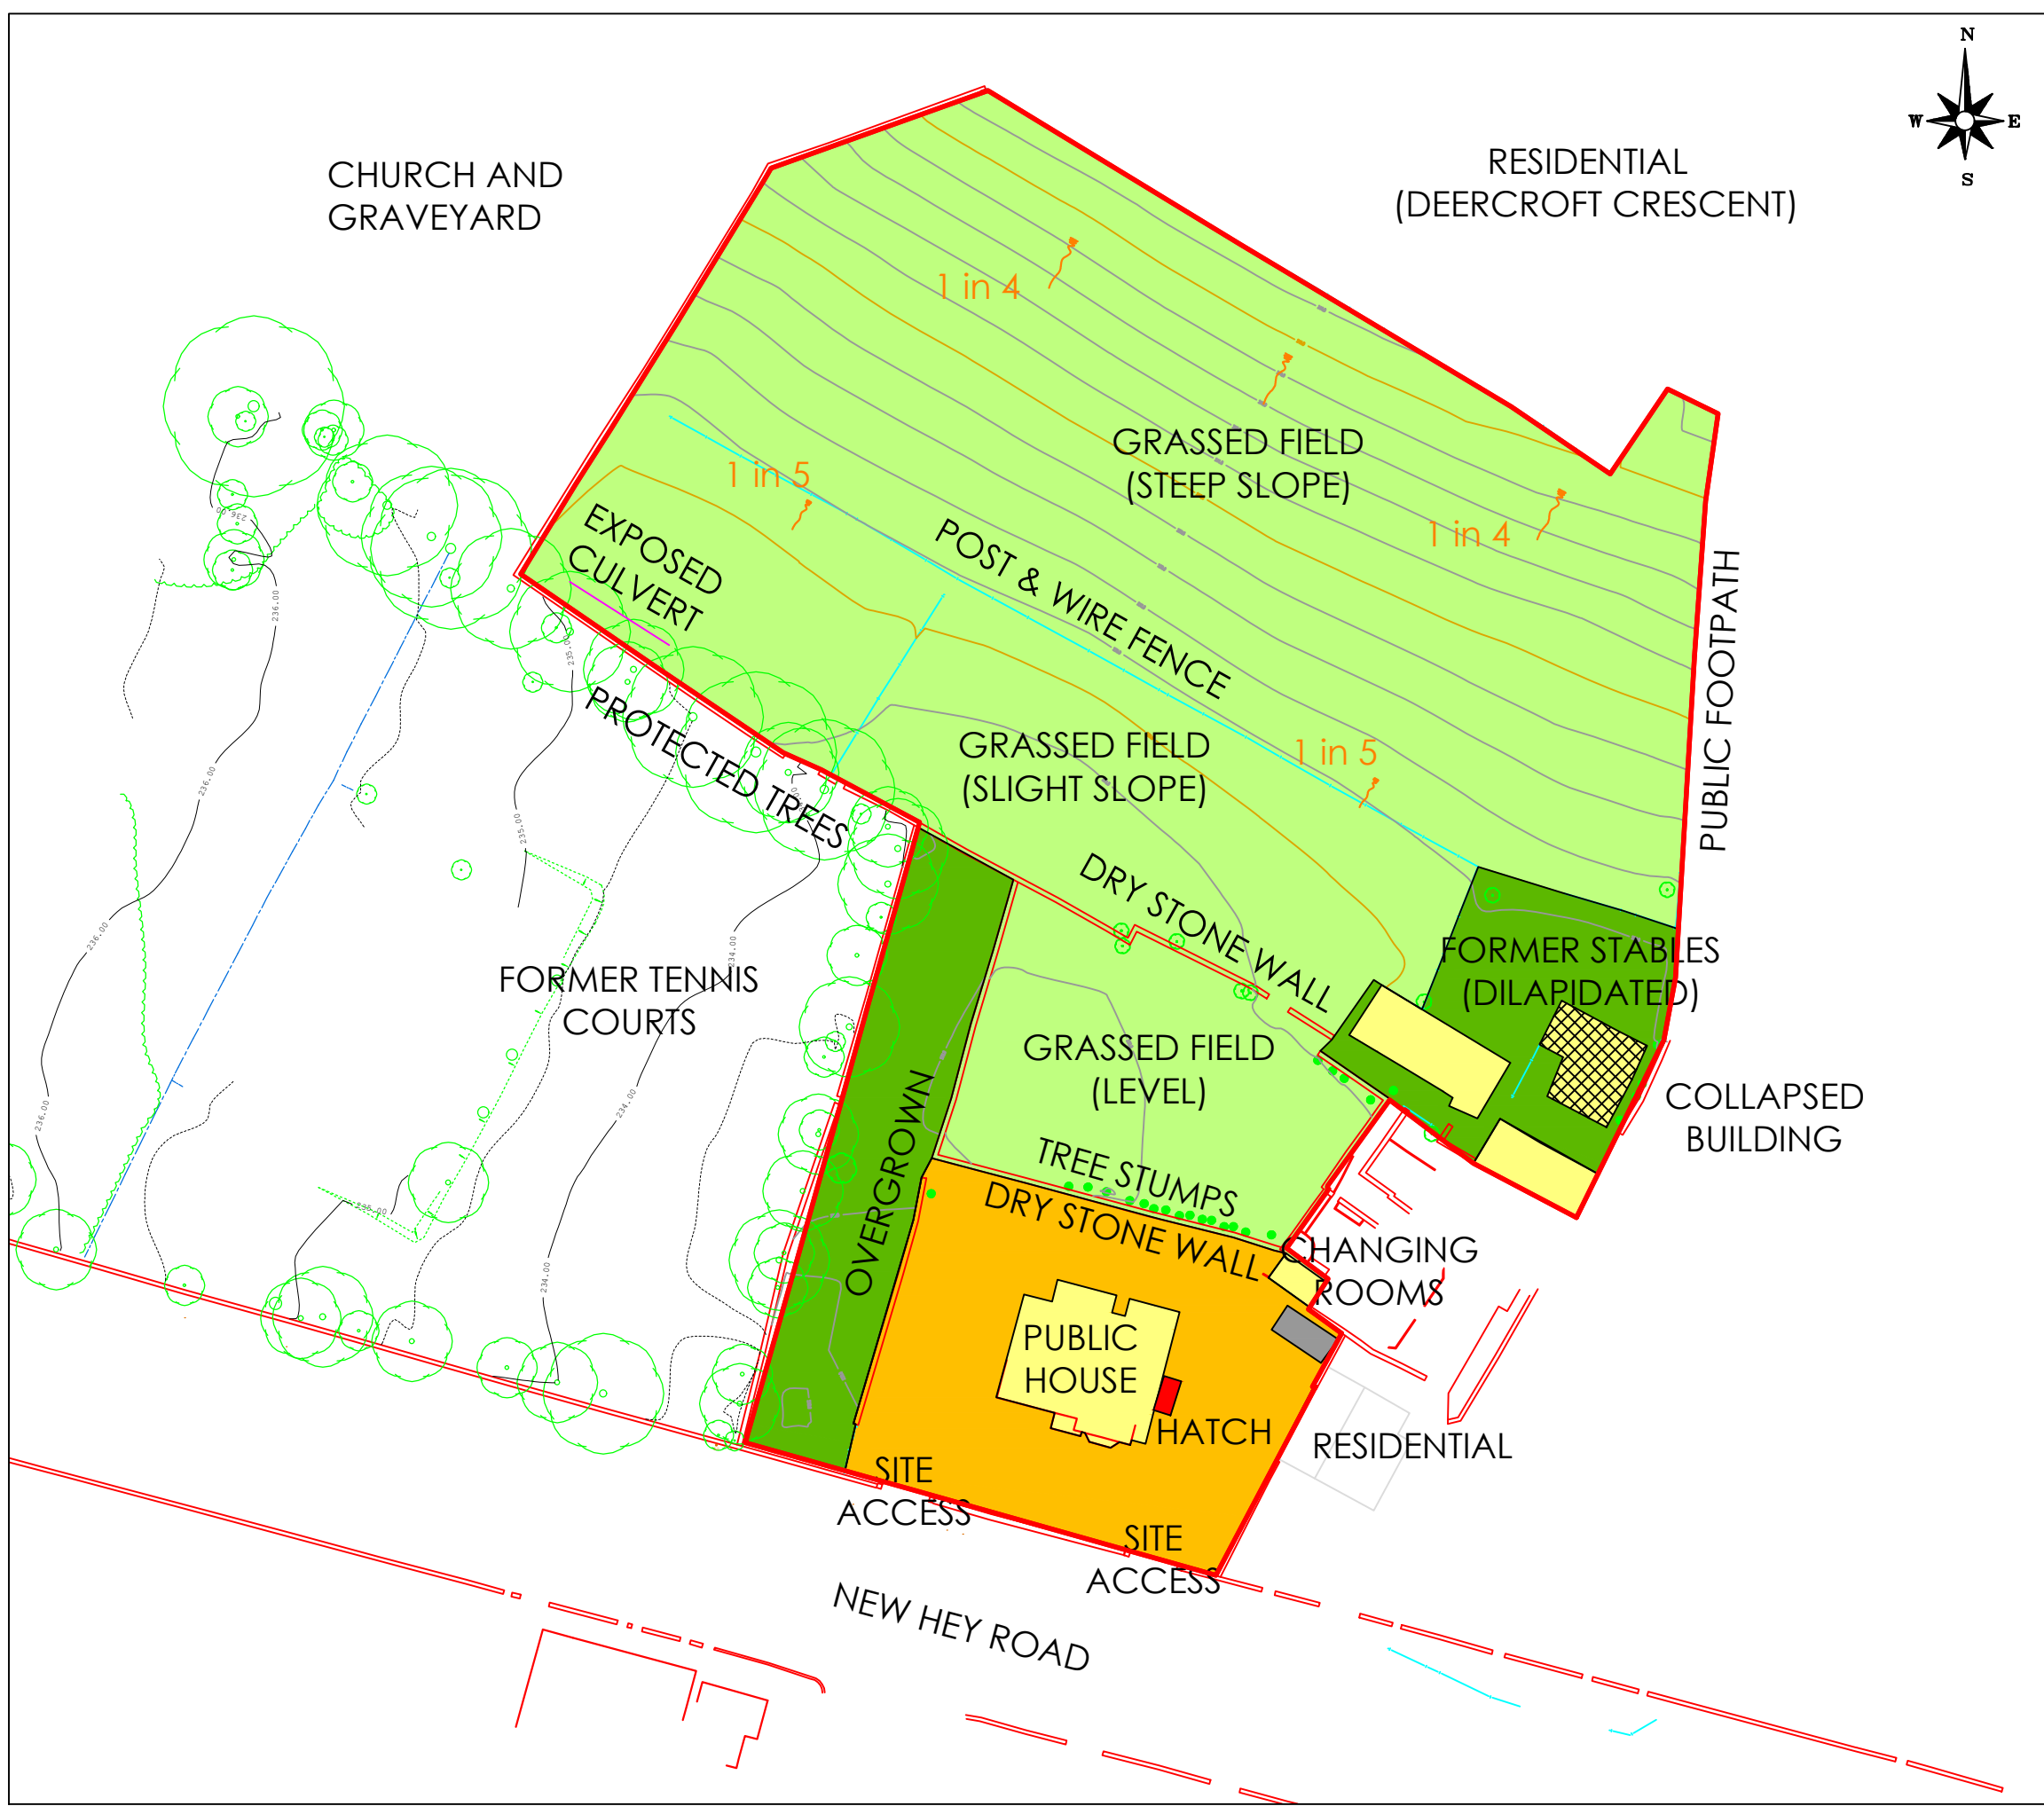
SITE FEATURES

- GRASSED FIELD
- BUILDING
- COLLAPSED BUILDING
- OVERGROWN AREAS
- TARMAC HARDSTAND
- CONCRETE
- POSSIBLE CELLAR HATCH
- APPROXIMATE SITE BOUNDARY

- 2.2.11 Dilapidated stable and garage buildings within an area of overgrown ground, associated with the property to the east, lie on the eastern site boundary in the south-east corner of the northern field. This area could not be accessed at the time of the investigation. A collapsed building was noted within the overgrown area.
- 2.2.12 A shallow stone culvert enters the site from the west and runs within the south-west boundary. Geophysical surveys suggest the culvert turns south to run along the western boundary of the car park towards New Hey Road.
- 2.2.13 Existing salient features, at the time of the walkover are presented on Drawing 2895/3 in Appendix B to this report, and summarised in the table below.

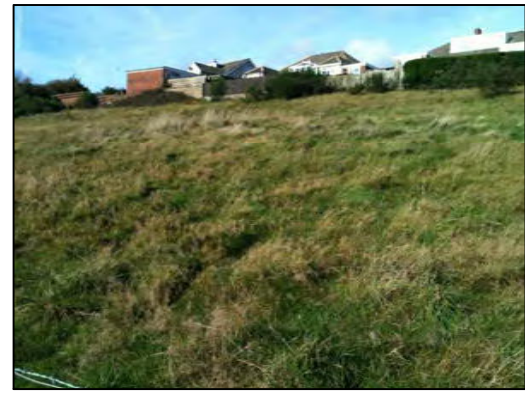
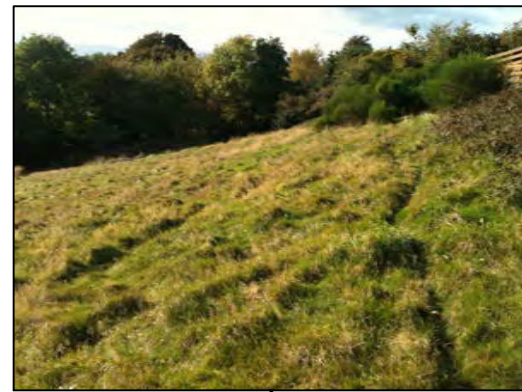
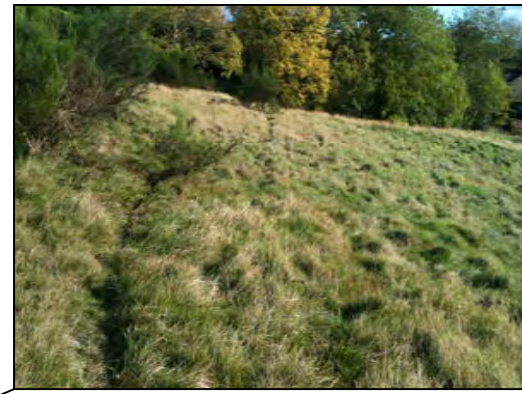
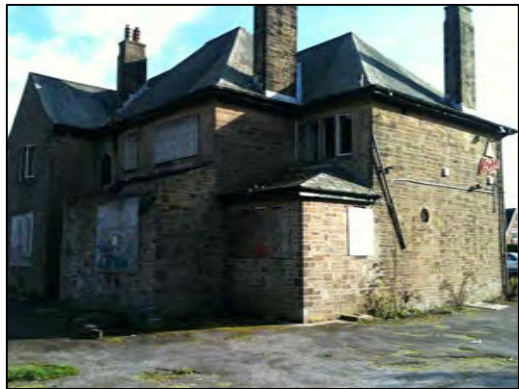
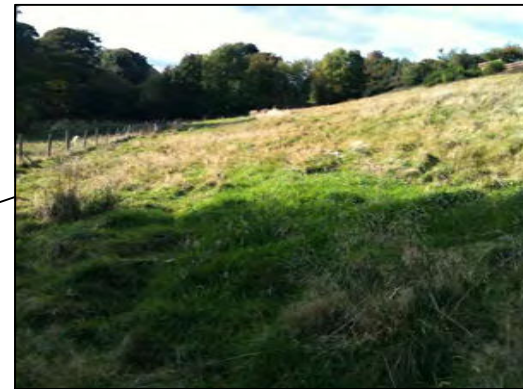
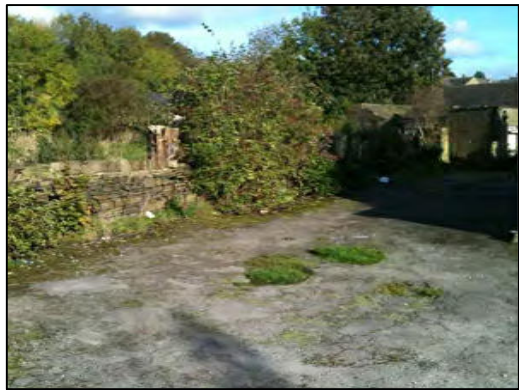
- 1.2 The site is an existing public house on the south of the site and a steep grassed field to the north. Some small buildings are present on the field. All buildings are to be demolished during site preparation works.

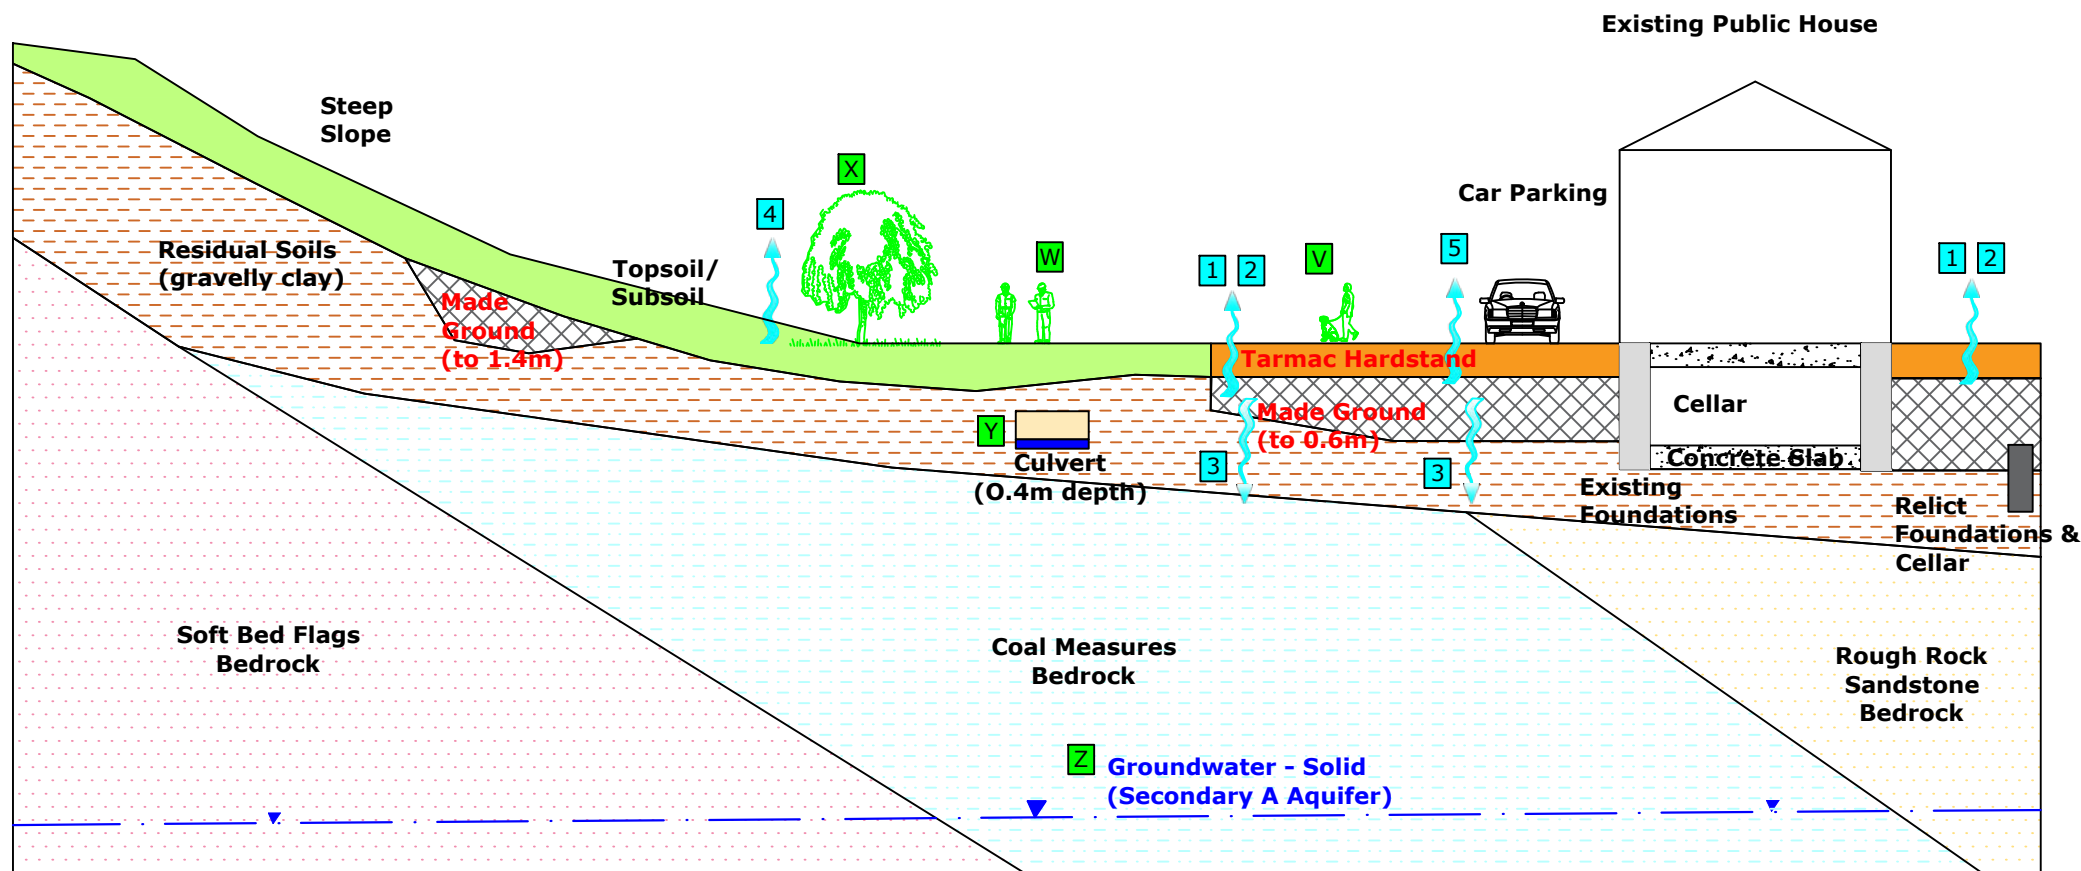
SOURCES
NO CONTAMINANTS IDENTIFIED

PATHWAYS
1 DERMAL CONTACT
2 INGESTION/INHALATION
3 LEACHING OF CONTAMINANTS
4 UPTAKE BY PLANTS
