| 01 | 09.02.21 | Photo of existing window added |
|---|---|---|
| 13 Clough Lea,<br>Marsden, HD7 6DN | | |
| Existing Elevations | | |
| P1065 | 10 | 01 |

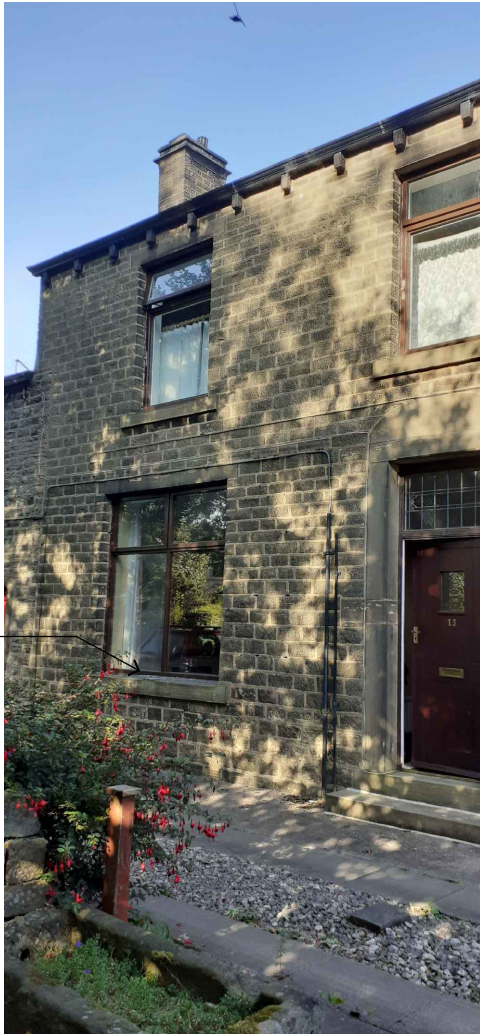
EXISTING WINDOW

STONE SILL IS CUT TO RECIEVE A STONE MULLION TO THE MIDDLE OF THE WINDOW WHICH HAS SINCE BEEN REMOVED. WE PLAN TO RE-INSTATE THIS MULLION AS PART OF THE WORK, AND AS SHOWN ON THE PROPOSED ELEVATIONS
