| Report type | Phase 1 Preliminary Risk Assessment |
| Company | Quantum Intelligent Trading Ltd t/a Oakshire Environmental |
| Site address | 41 Snelsins Road, Cleckheaton, BD19 3UE |

## **Phase 1 Preliminary Risk Assessment**

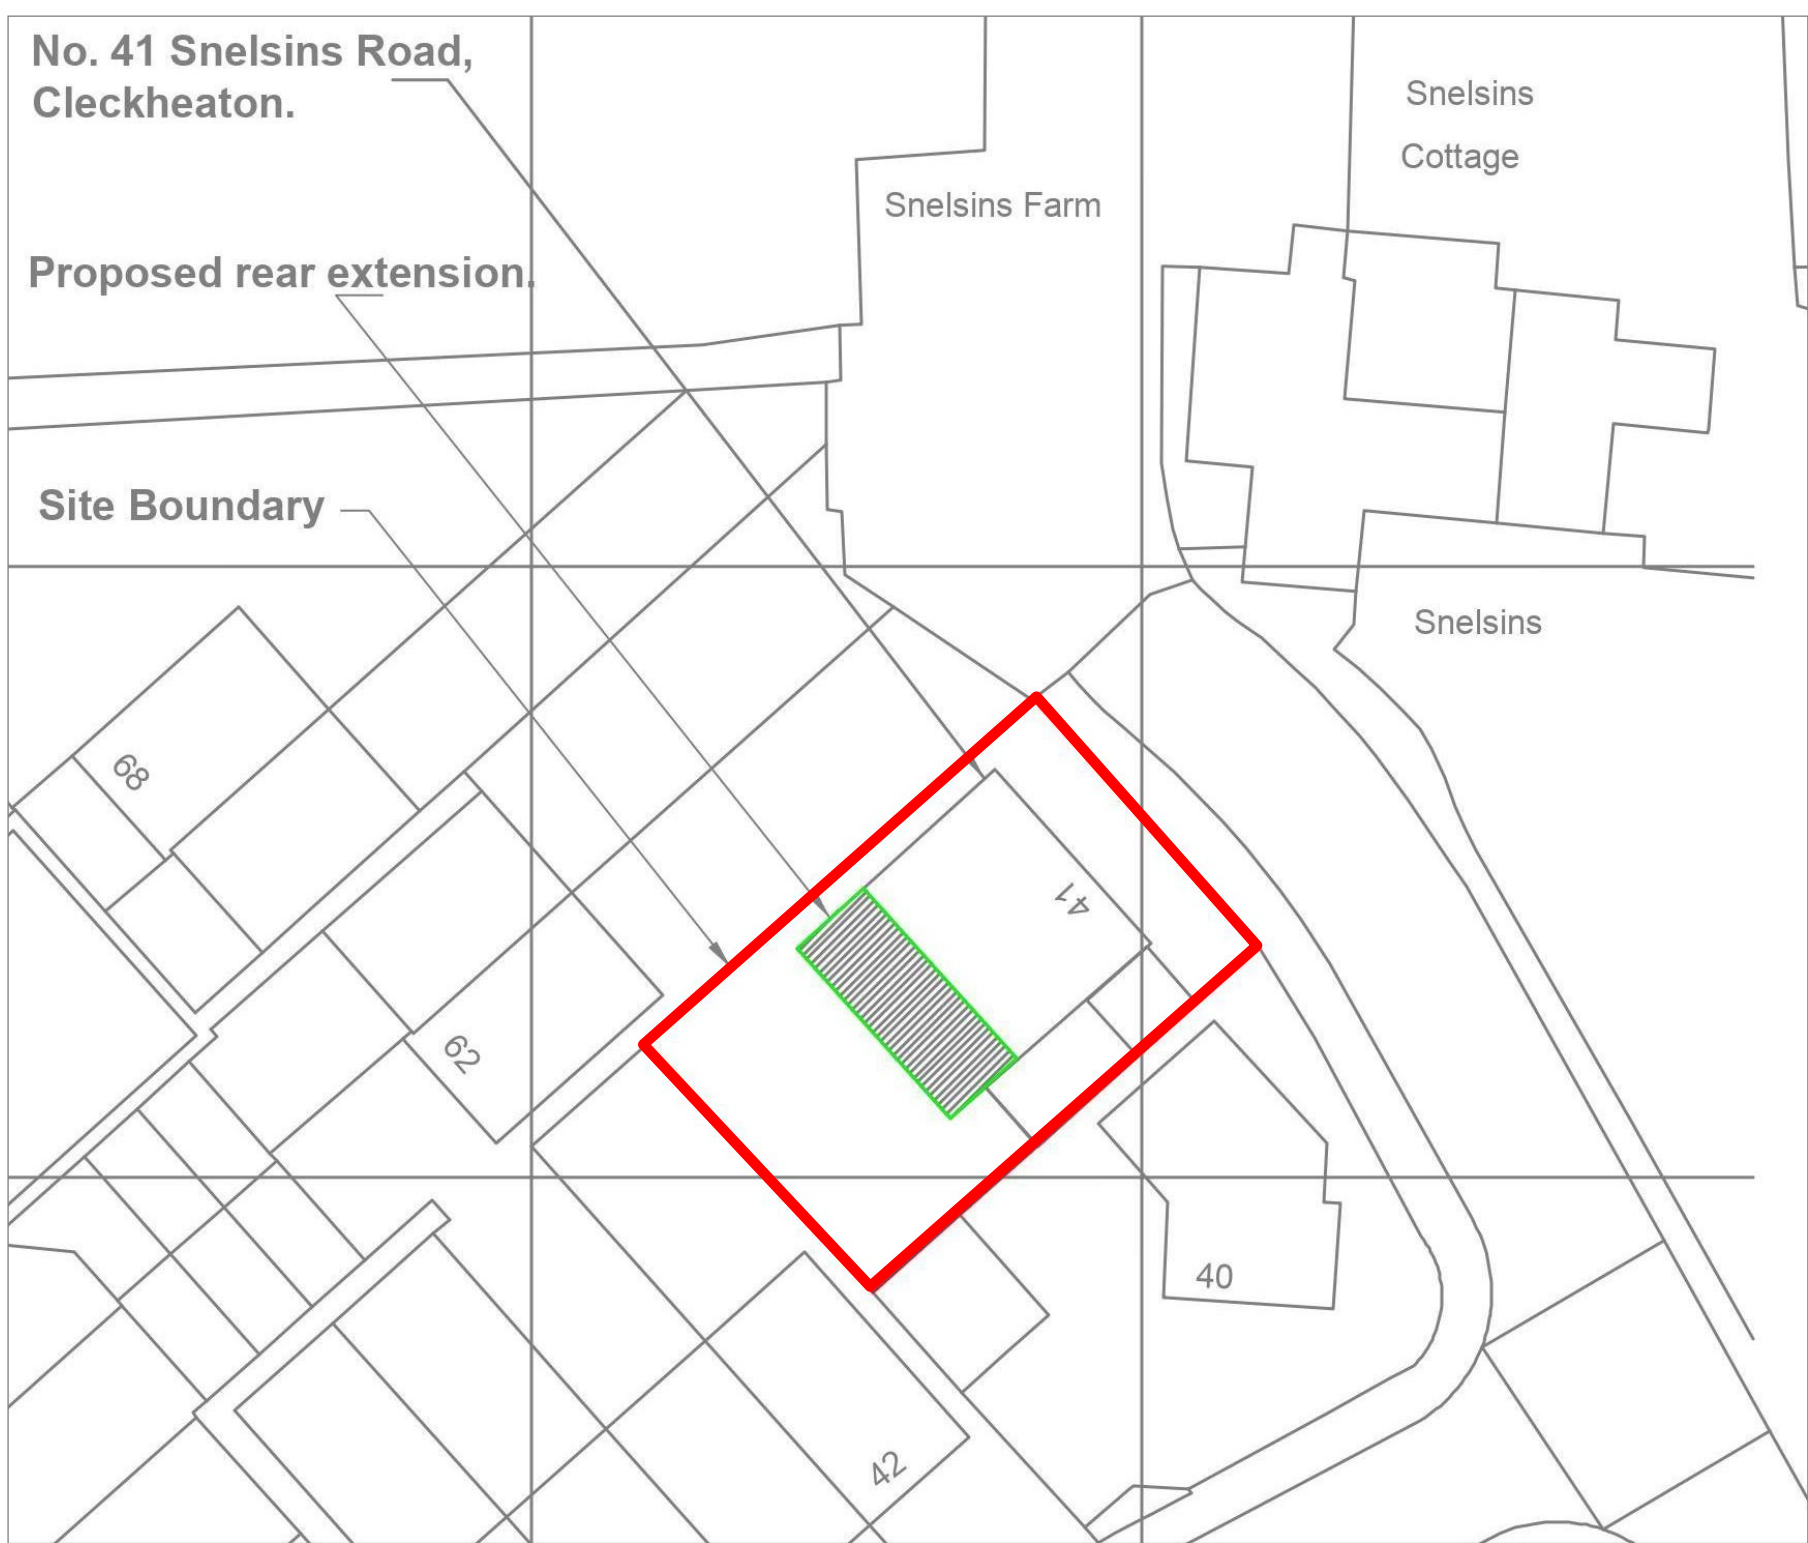
Figure 2

Proposed site plans

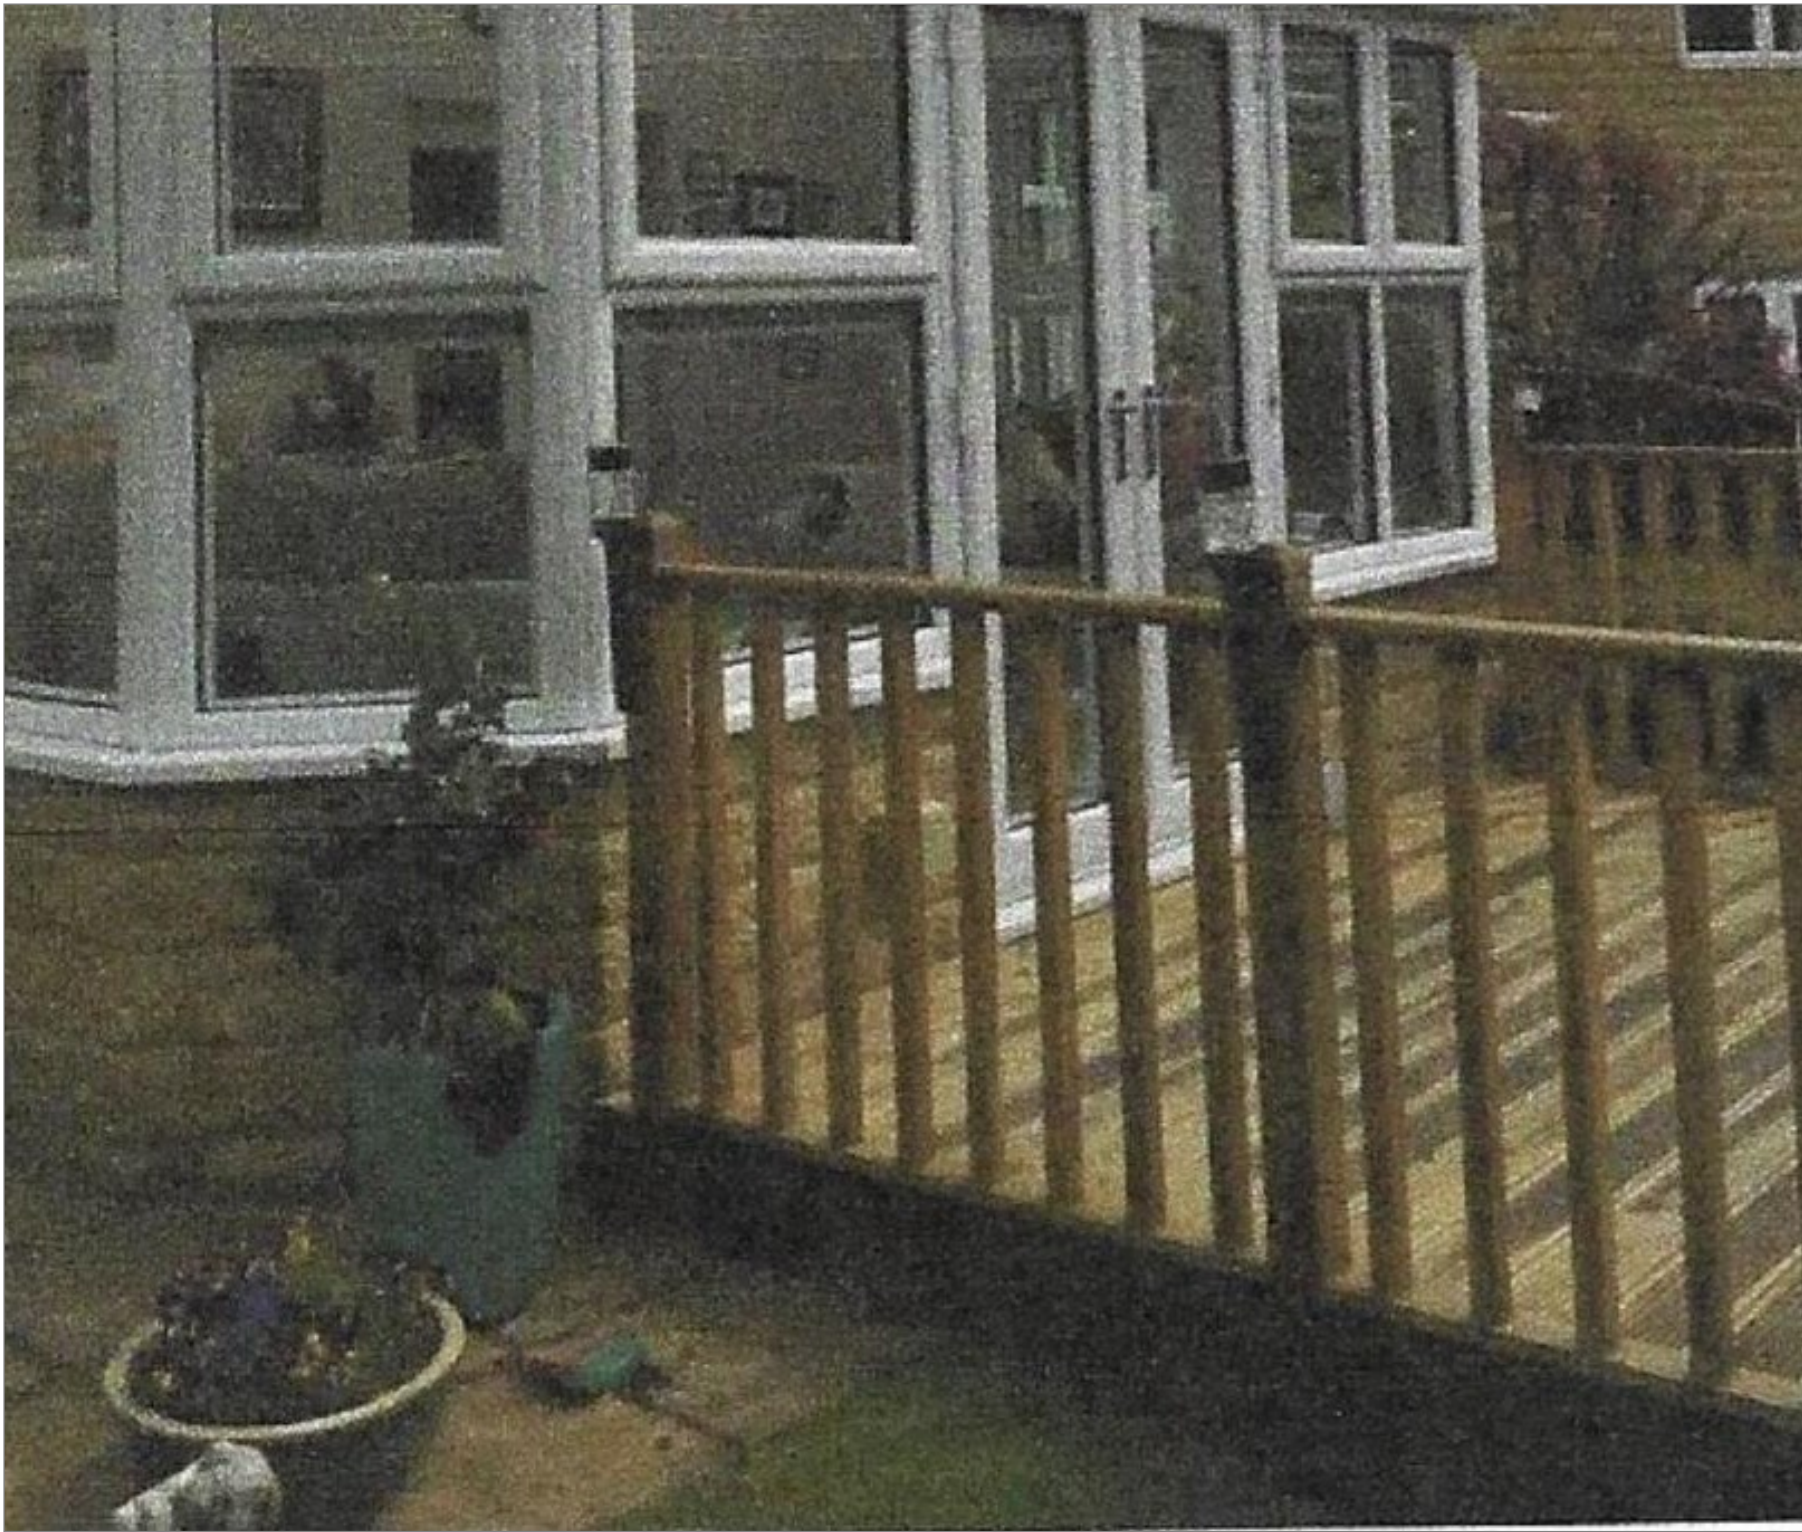
| Name | Figure 4 |

Photo of rear of dwelling showing conservatory and decking

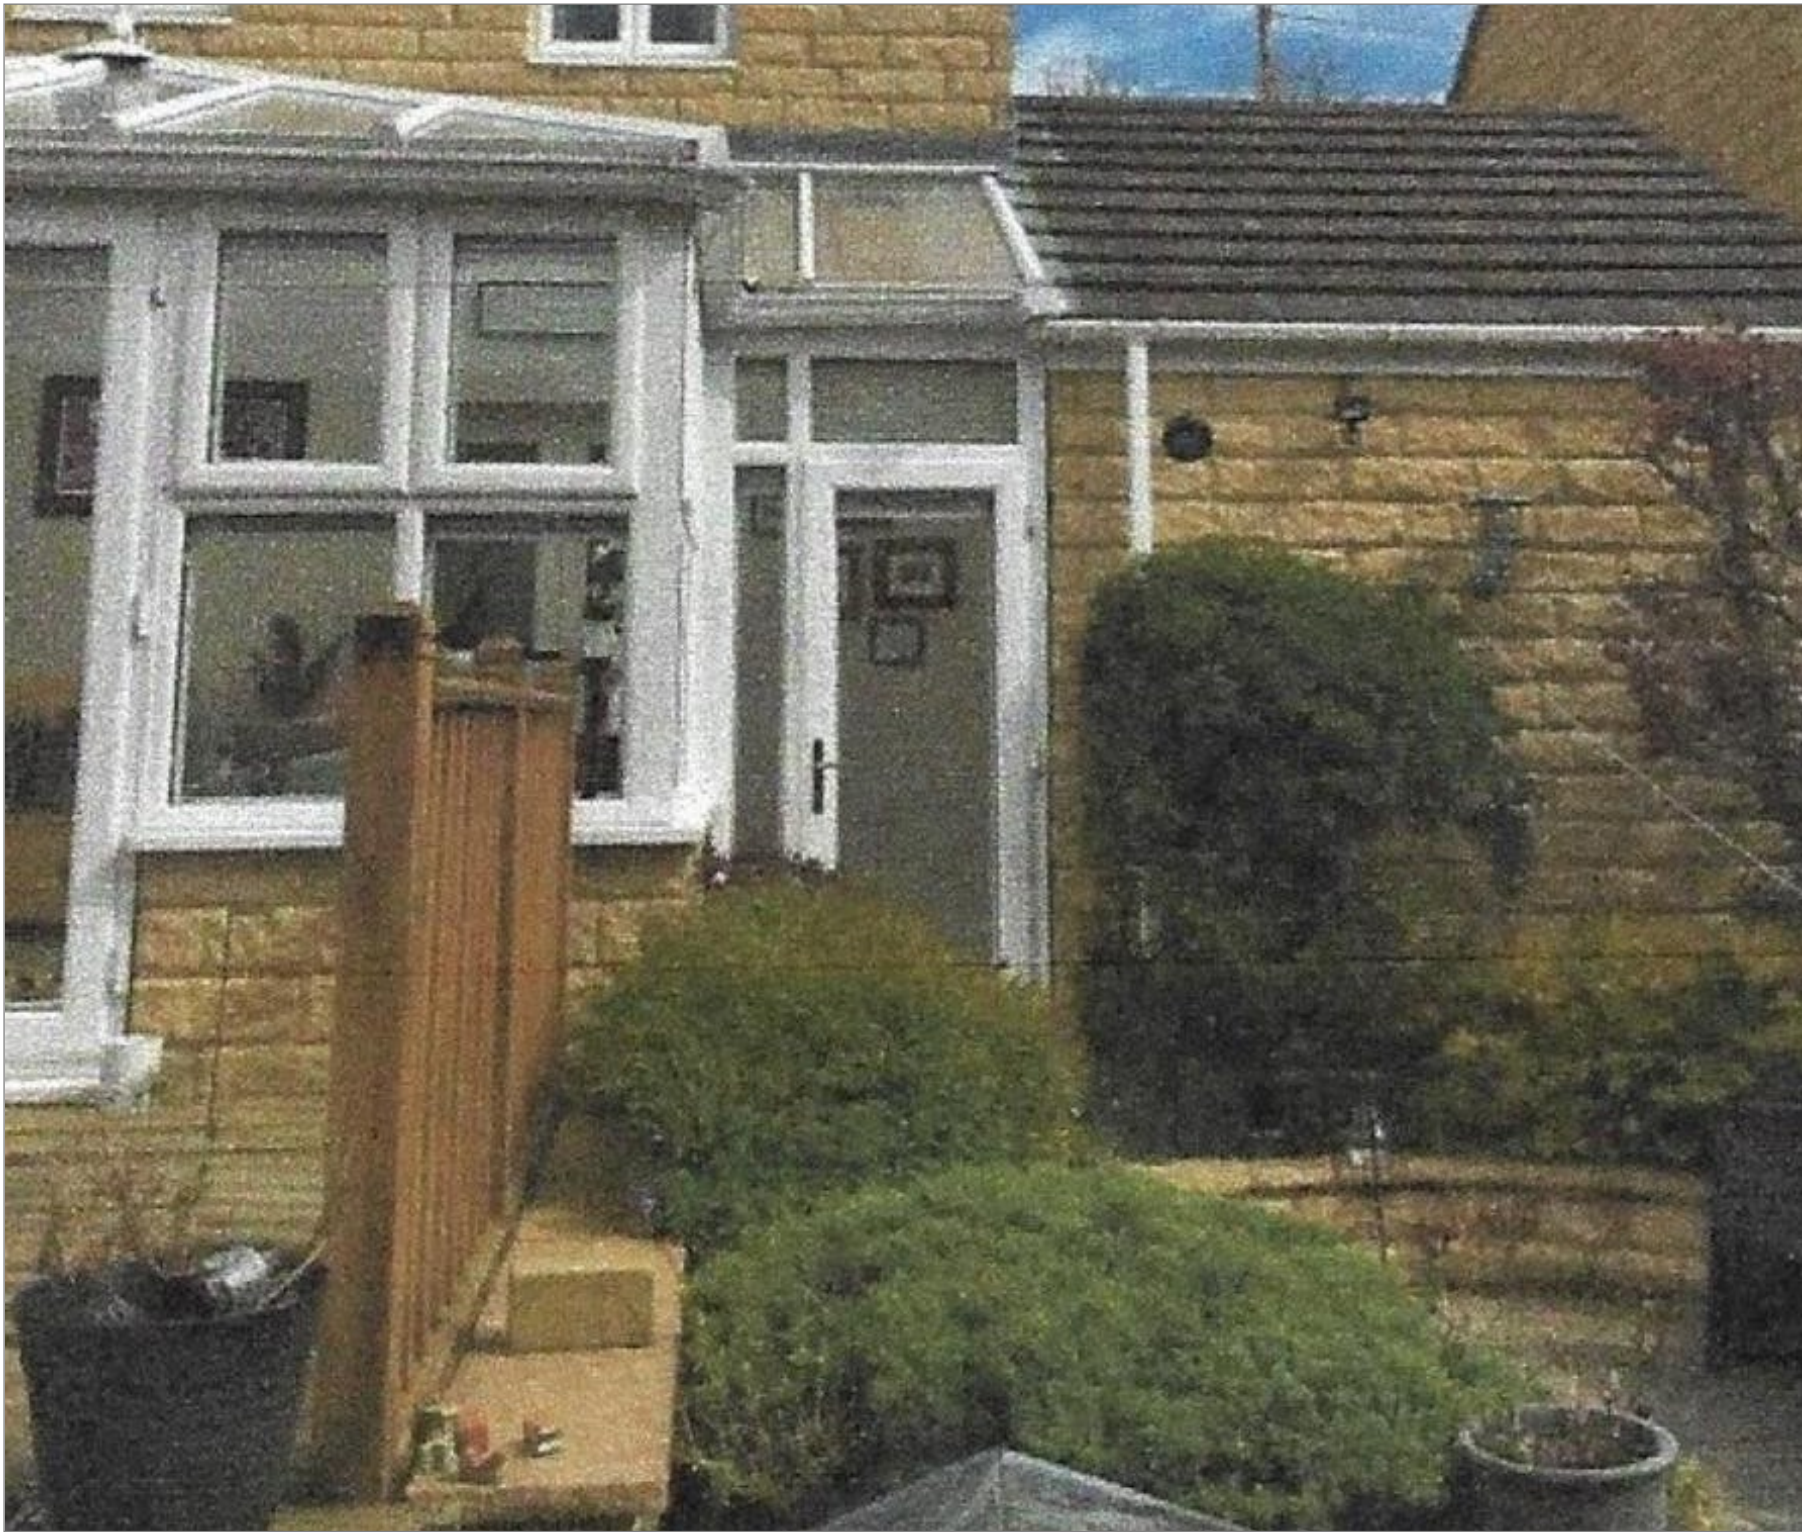
| Name | Figure 5 |

Photo of rear of dwelling showing attached garage building

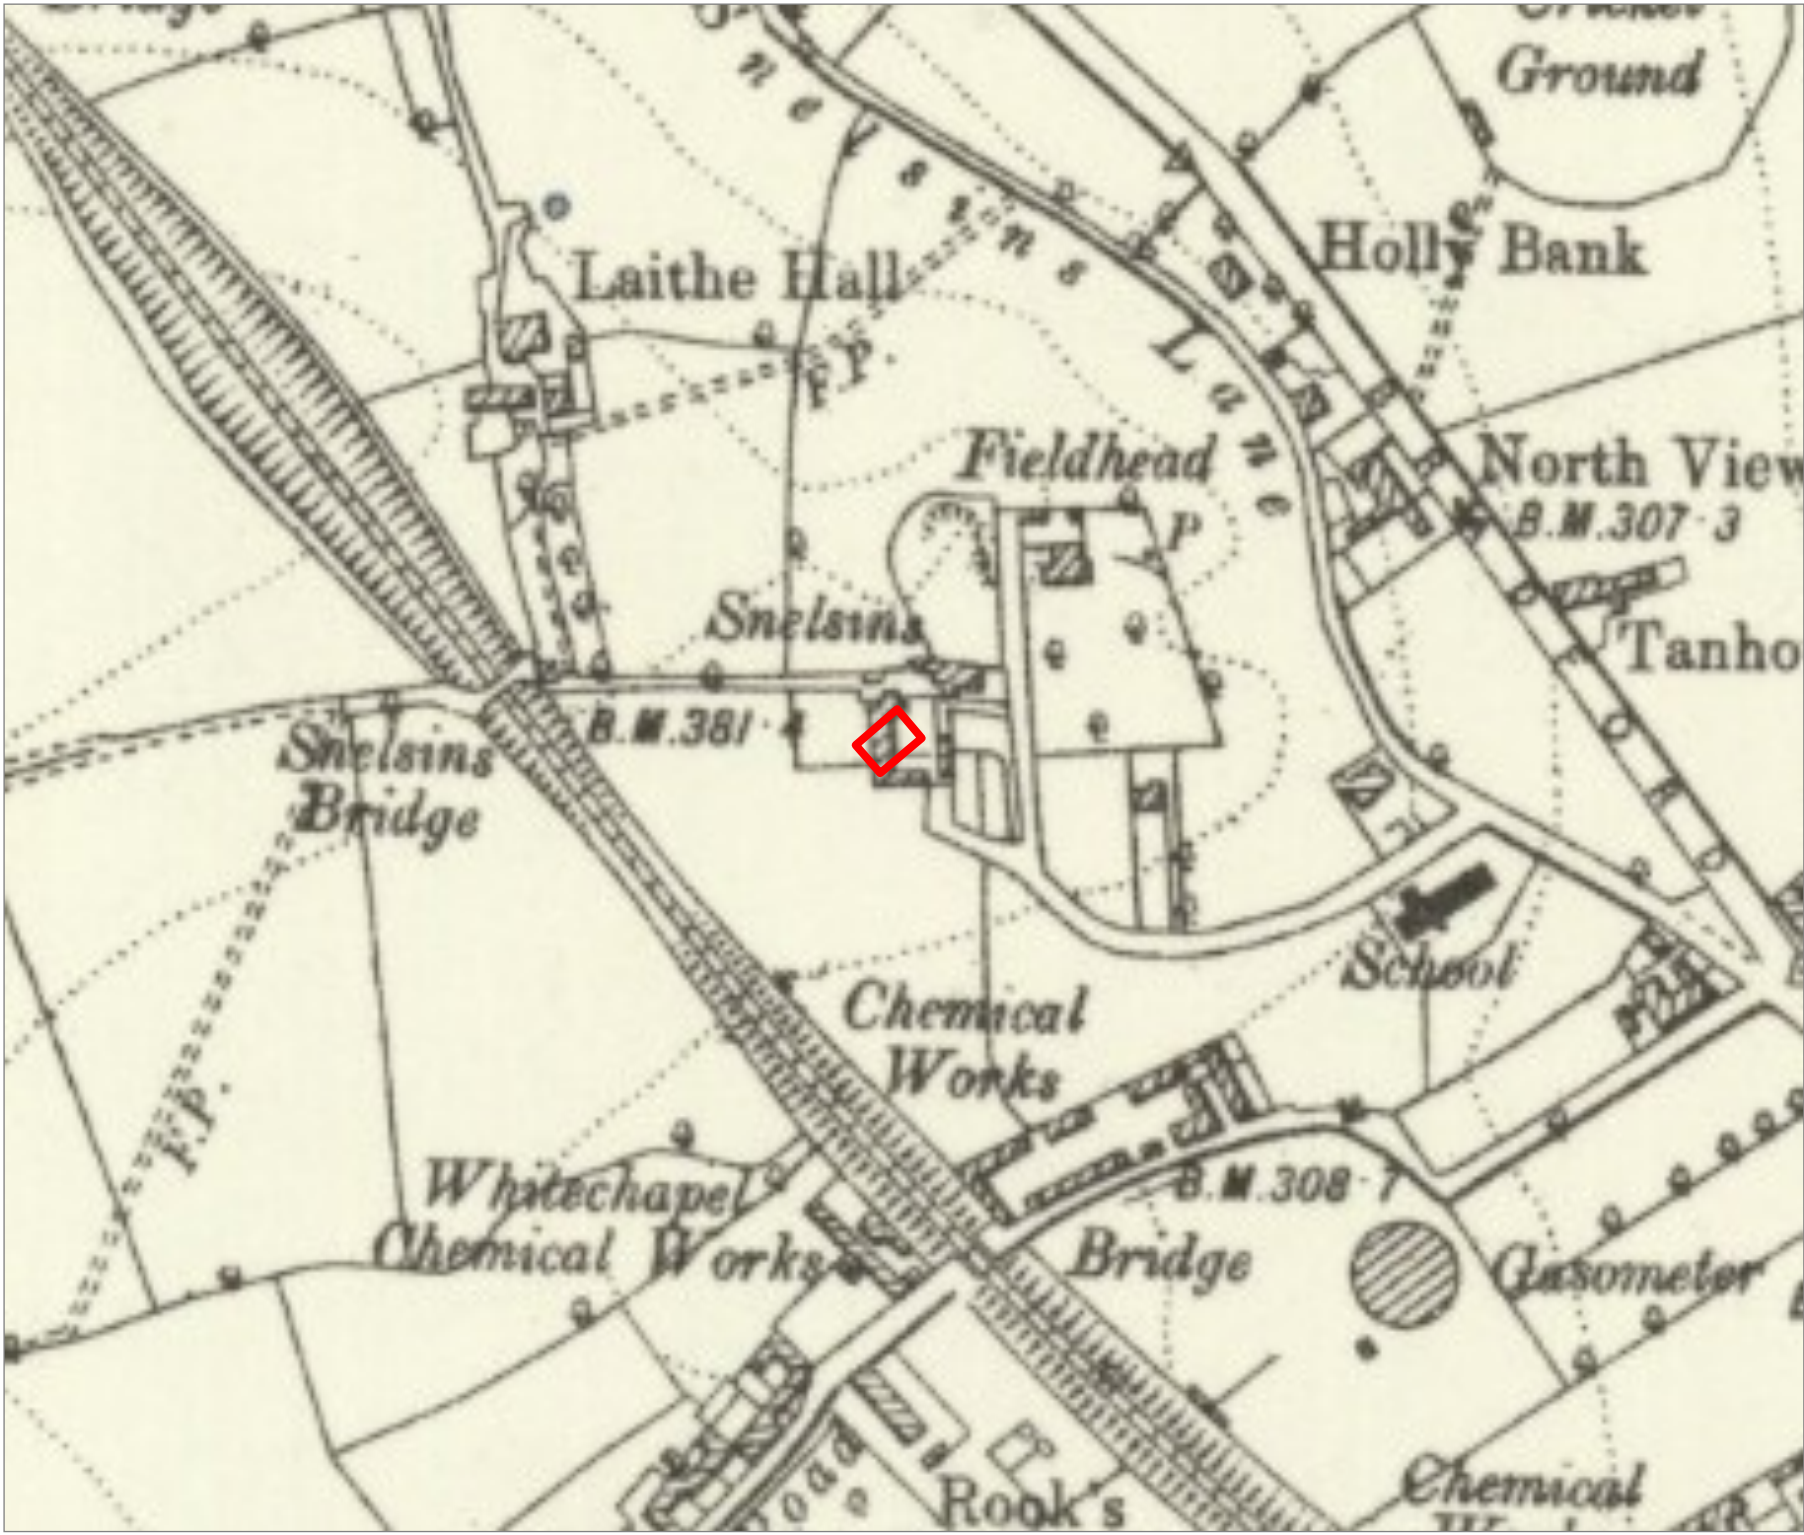
Figure 7

Historic map published in 1894

| Year | Site Description | Surrounding Area |
|---|---|---|
| 1894 | | 'Fieldhead' most likely a farm<br>Chemical works 200m south and 400m south east<br>Gasometer 250m south east<br>School 250m east |

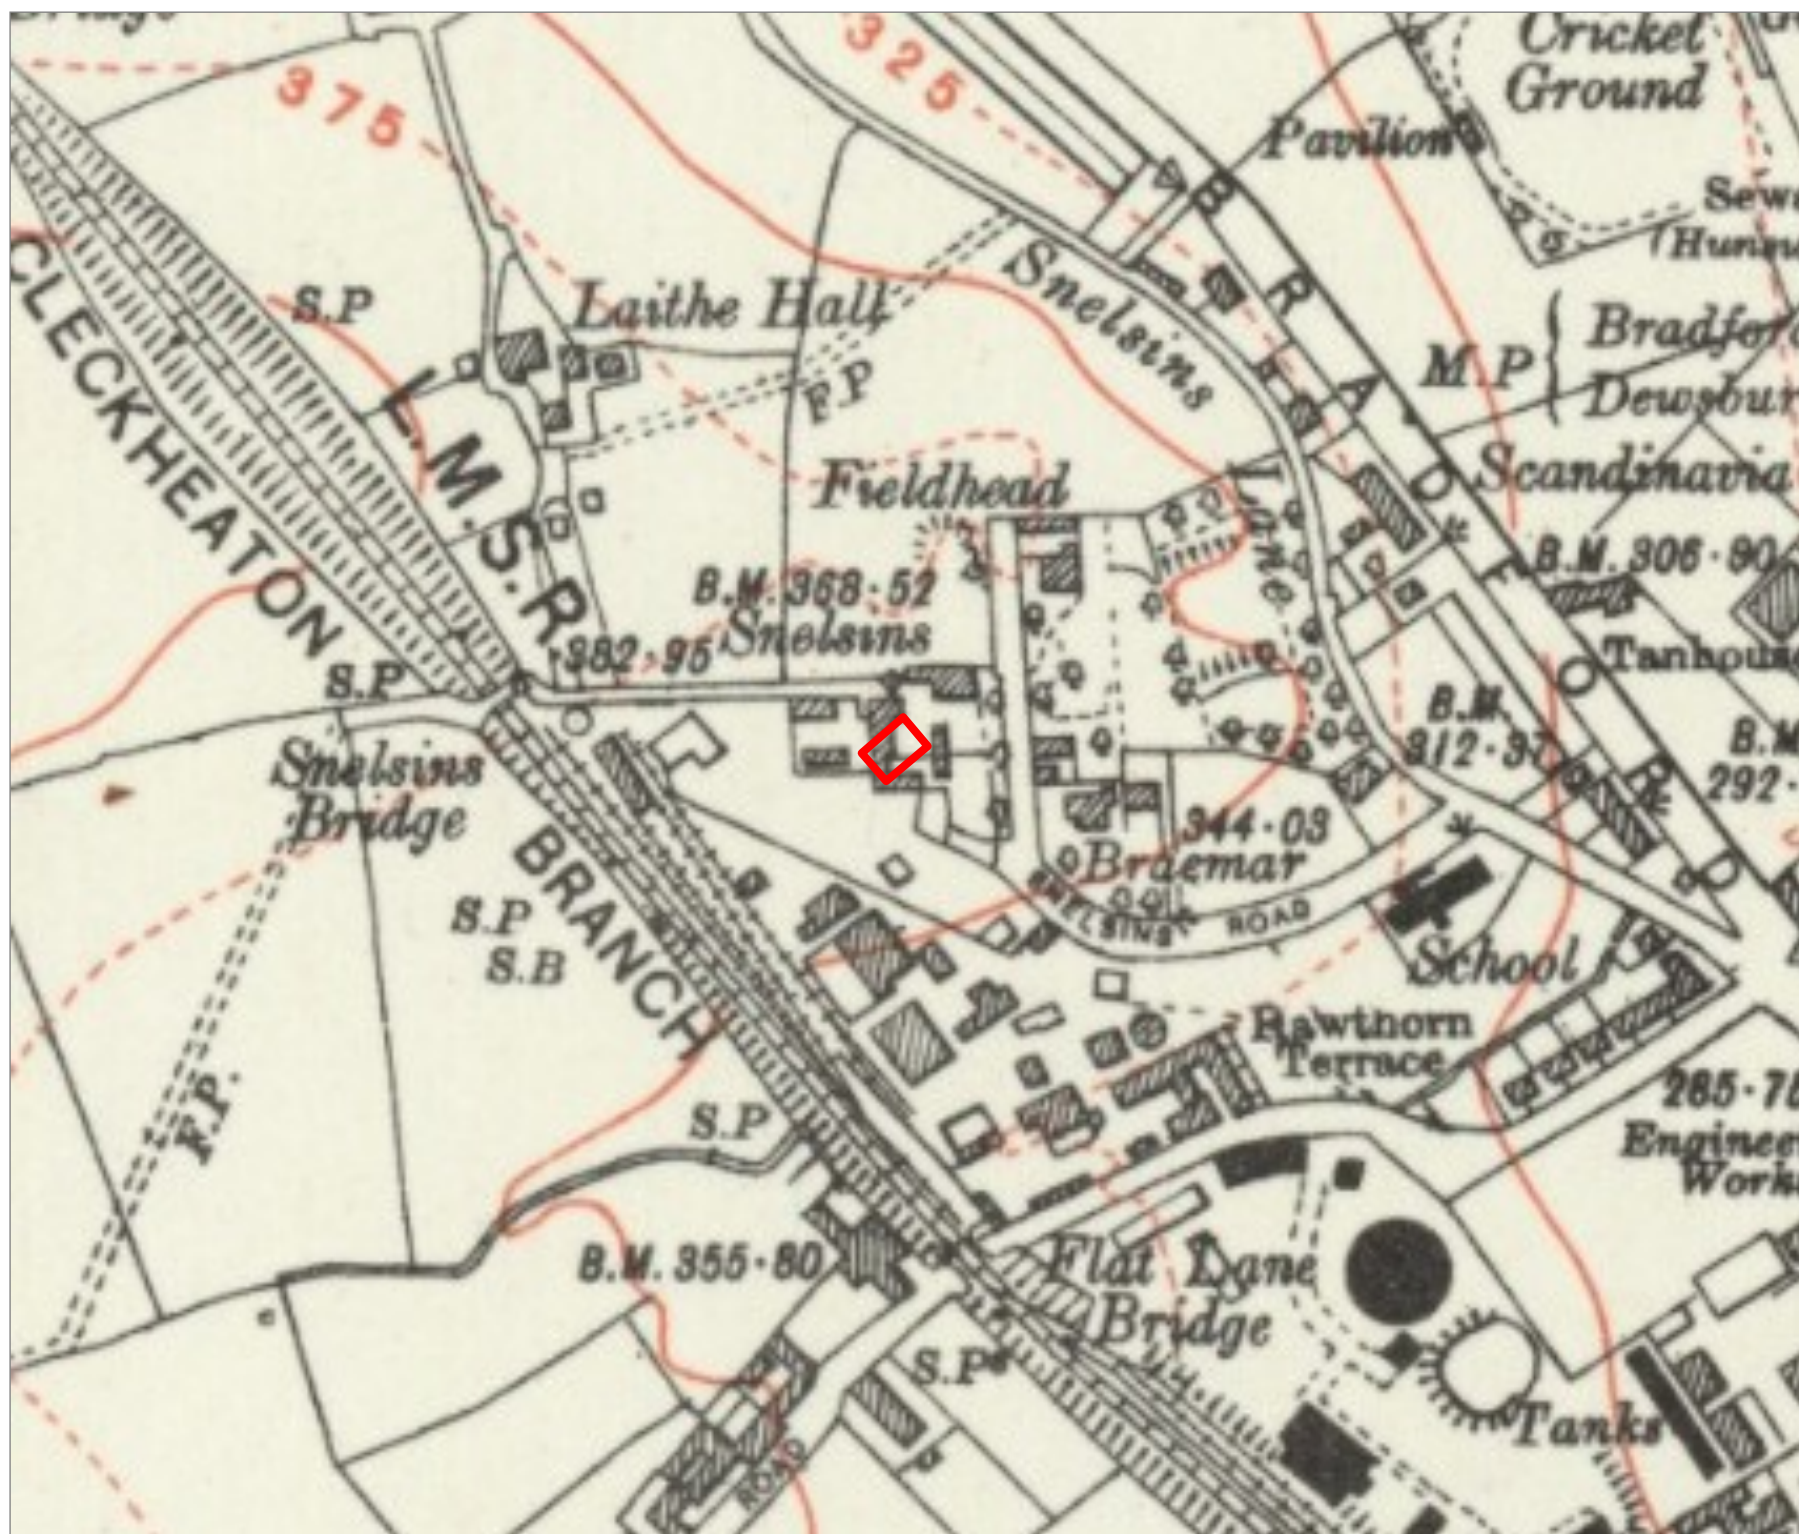
Figure 9

Historic map published in 1957

| Year | Site Description | Surrounding Area |
|---|---|---|
| 1957 | Appears to be part of chemical works | Residential development along Bradford Road to the east |

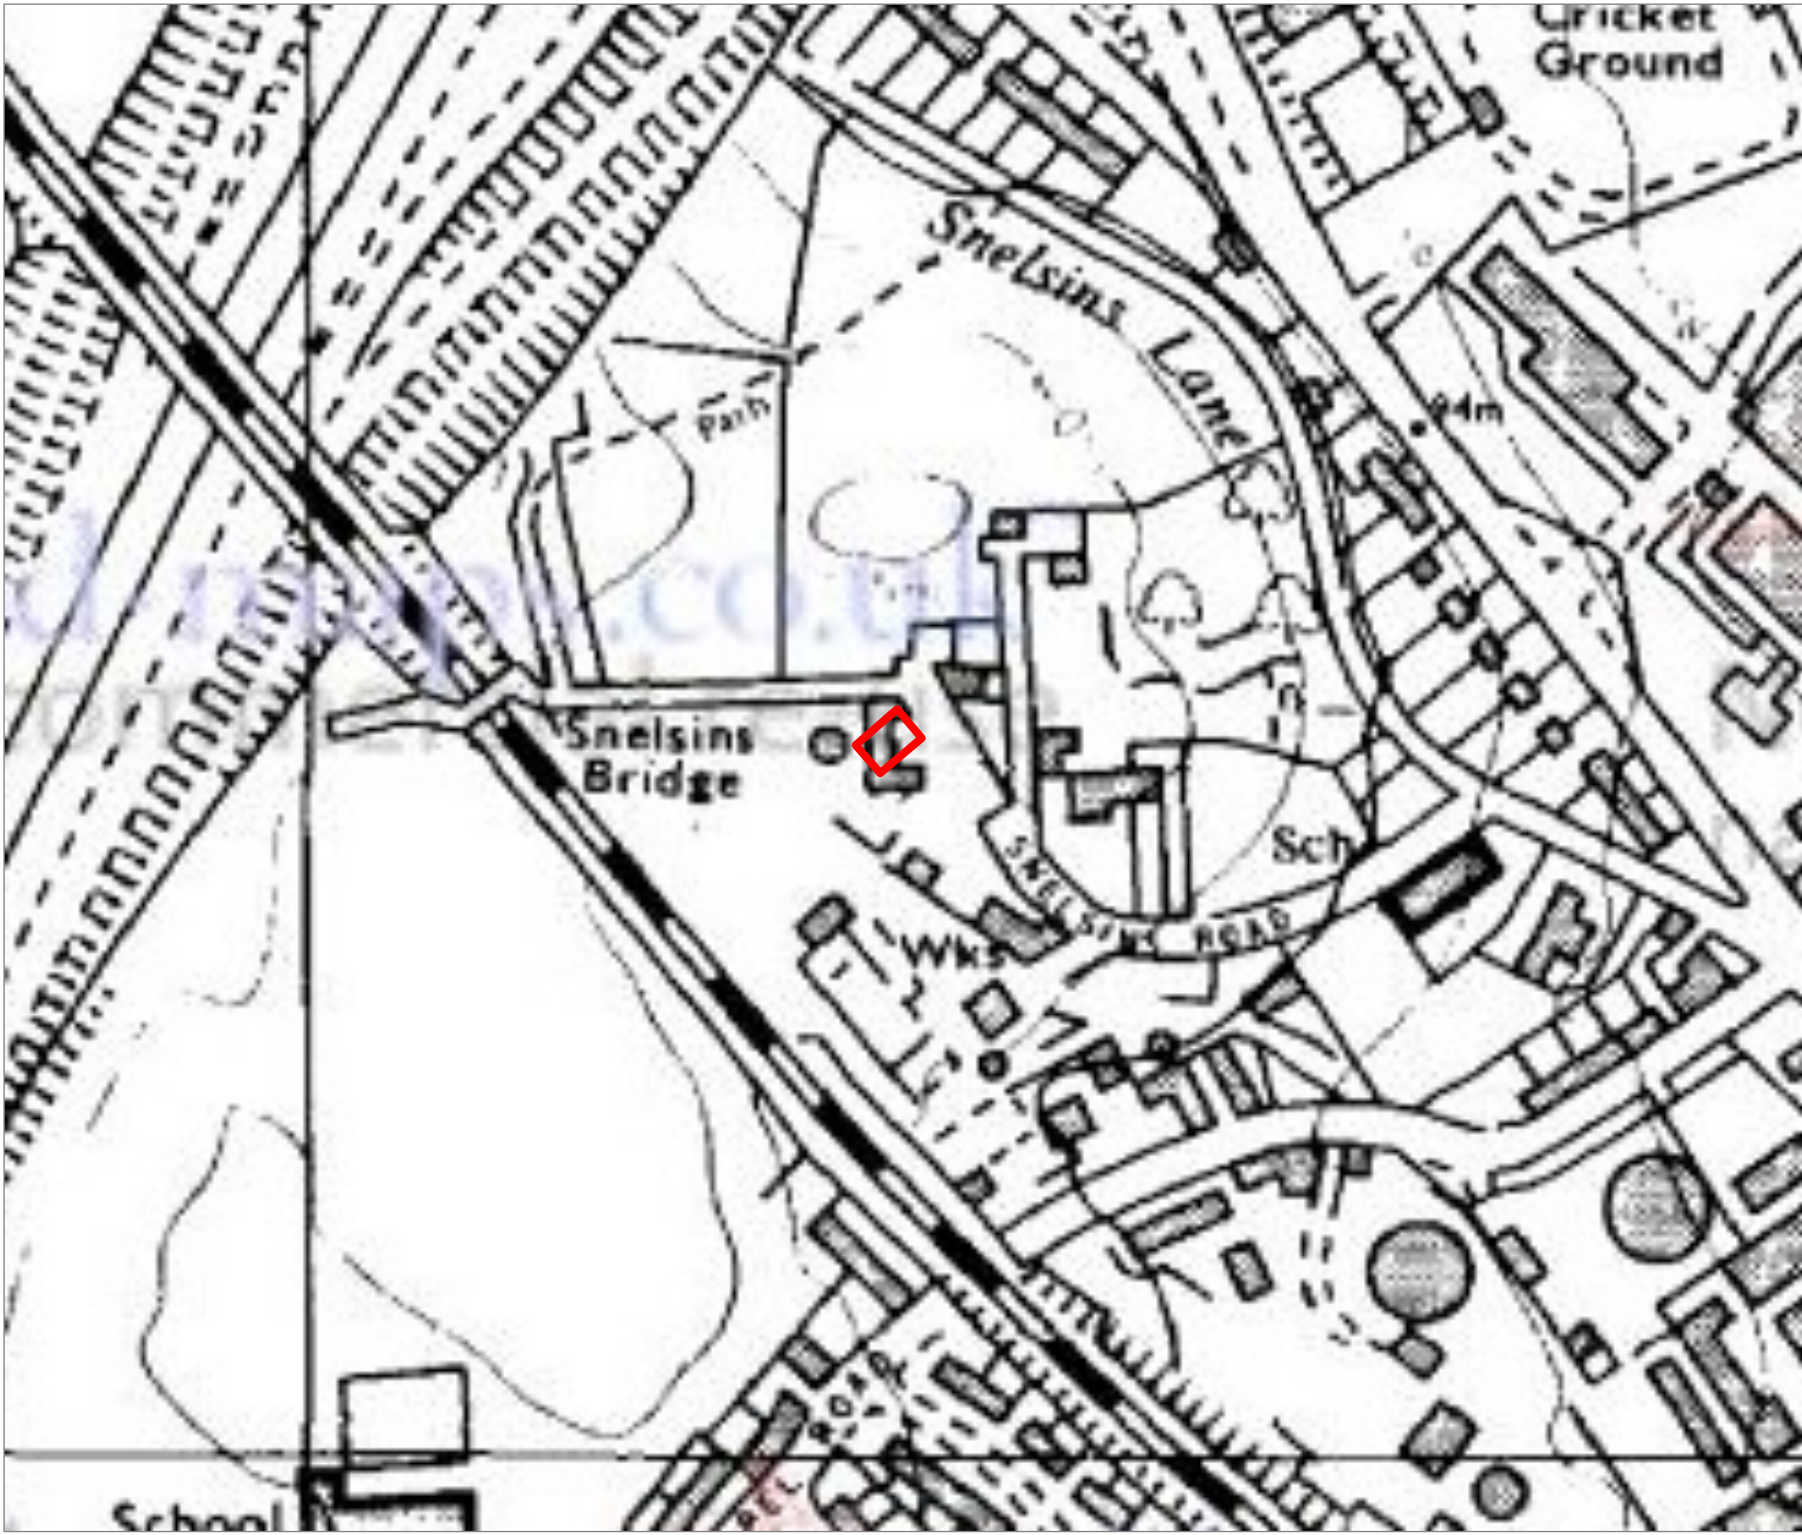
Figure 10

Historic map published in 1983

| Year | Site Description | Surrounding Area |
|---|---|---|
| 1983 | | M62 motorway 200m north west |

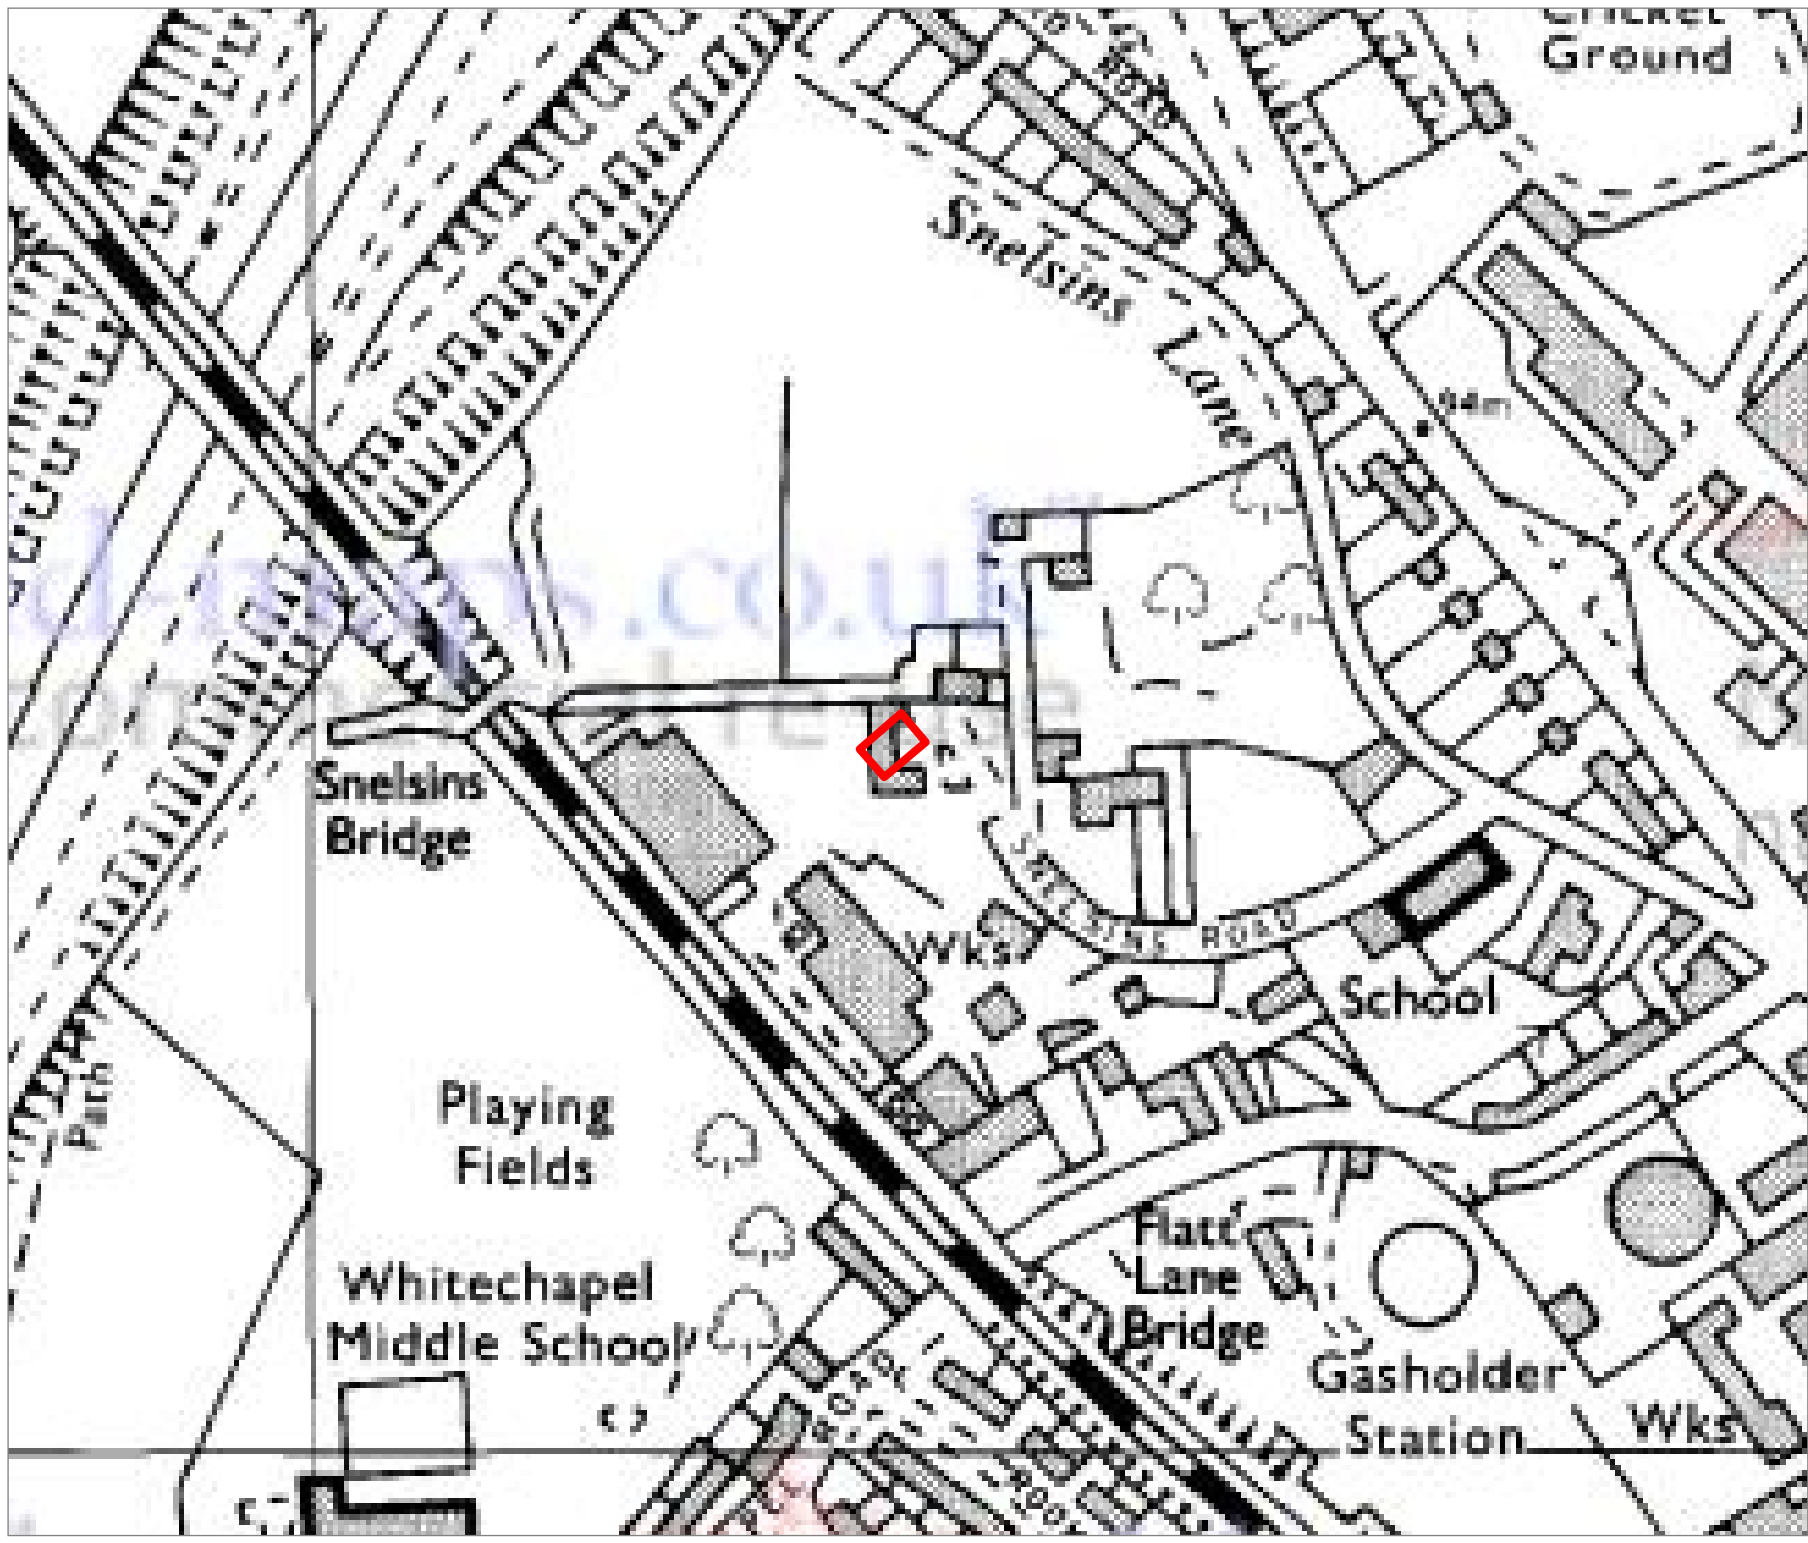
Figure 11

Historic map published in 1993

| Year | Site Description | Surrounding Area |
|---|---|---|
| 1993 | | Railway redeveloped into footpath |
