COAL MINING RISK ASSESSMENT,  
BATTYE STREET, DEWSBURY

*Kirklees Council*

# **Coal Mining Risk Assessment, Battye Street, Dewsbury**

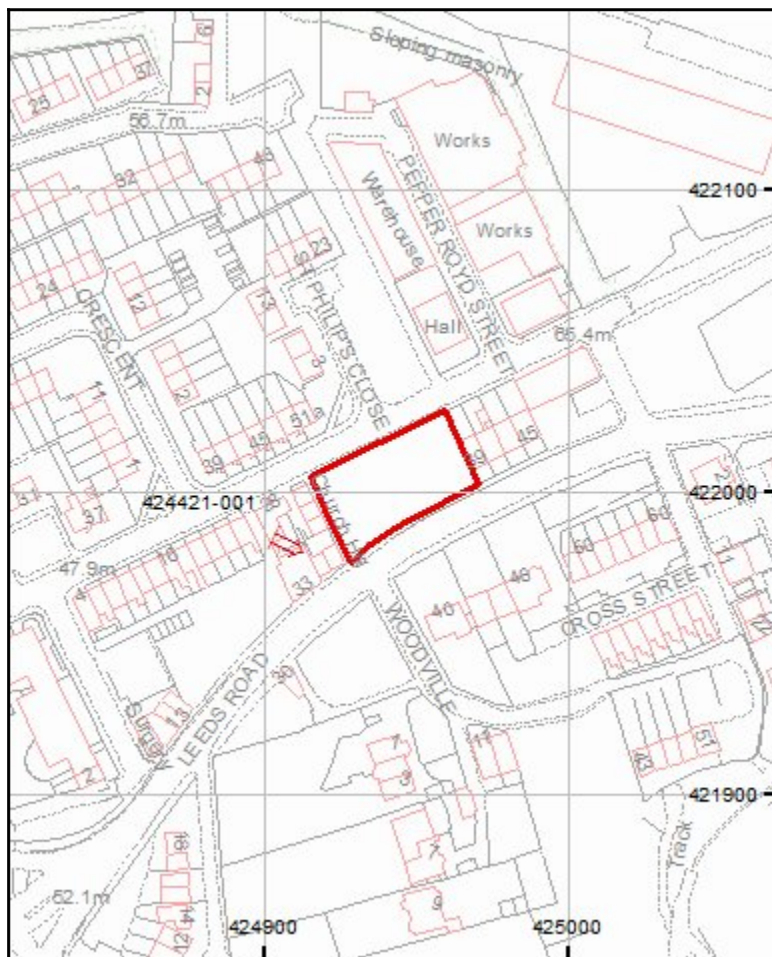
## Enquiry boundary

Within, or within 20 metres of, the boundary of the property there is 1 mine entry, the approximate position of which is shown on the attached plan.

Disused Adit or Mineshaft

| Site Characteristic | | Details |
|---|---|---|
| Mine entries | | Within, or within 20 metres of, the boundary of the property there is one mine entry designated as an adit. |
