Our Ref: E17/7092/MD/001

**Re: Proposed development at former fire station, Marsden Lane, Marsden**

Further to the initial site investigation, further works were recommended below the base of gas holder 2 and within gas holder 3 which wasn't accessible during the initial investigation works. Please find attached our findings in relation to these additional investigation works.

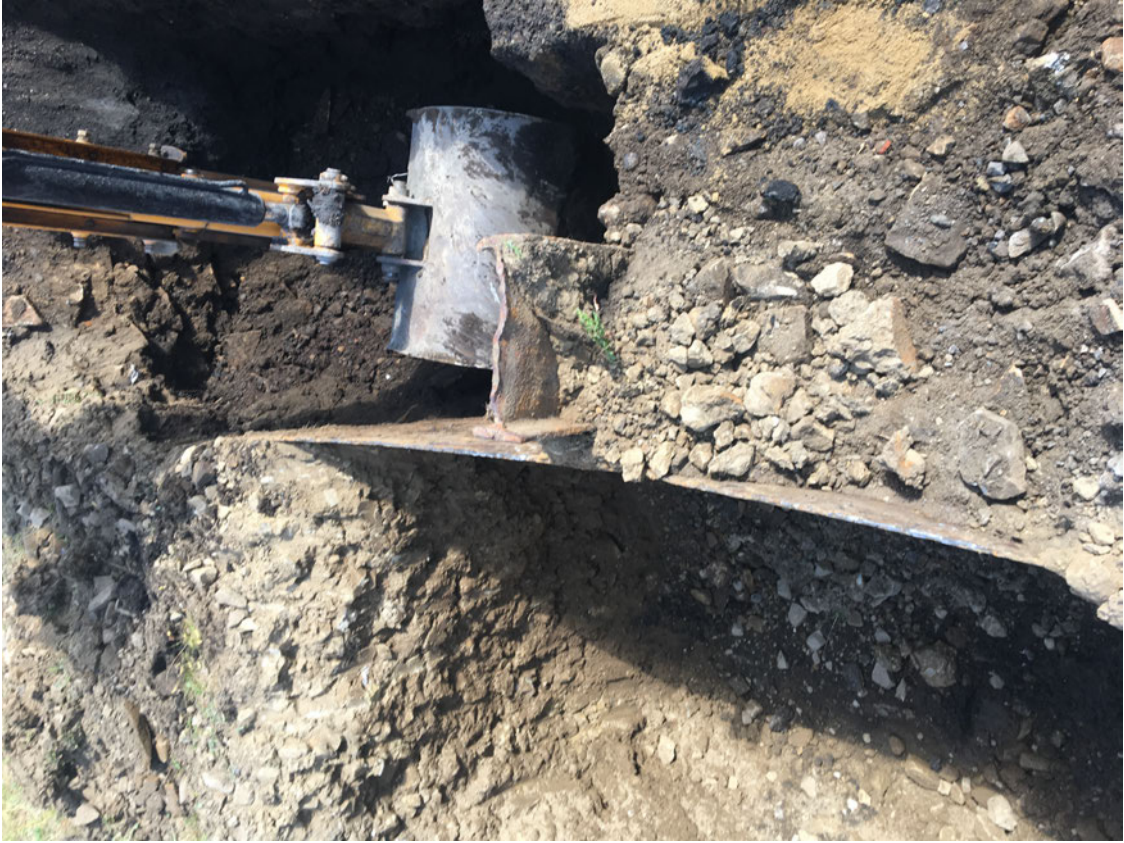
- 2.1.1 During the initial site investigation works, the structure to Gas holder 2 was identified by its circular metal frame with four stanchions (See photo 1). This was infilled with clean type 1 stone and had a concrete/stone flag base. Following the breaking out of the base, the underlying clean hardcore was excavated to prove the underlying natural strata. Trial pits have been undertaken and a sample taken from each.
- 2.1.2 Below the base construction, a soft to firm dark grey sandy clay was encountered. This material is the same as encountered outside the gas holders throughout the site and the trial pit was only excavated to a depth of 0.5m below the hardcore sub-base to allow a sample to be taken.

Photo 1 – Gas Holder 2 metal frame and stanchion

- 5.3 The entirety of gas holder 1 has been removed, and gas holder 2 will be entirely removed so they do not interfere with the proposed foundations. Gas holder 3 is beneath an area of proposed hard standing, and it will not be able to remove the entirety of the construction as it extends into third party land. We would therefore suggest that 1.0-1.5m of made ground and the buried gas holder wall should be removed from above gas holder 3 to engineer out any soft or hard spots that would affect the hard standing construction. Levels will then be brought back up to proposed final ground levels through the hard paving construction depth.

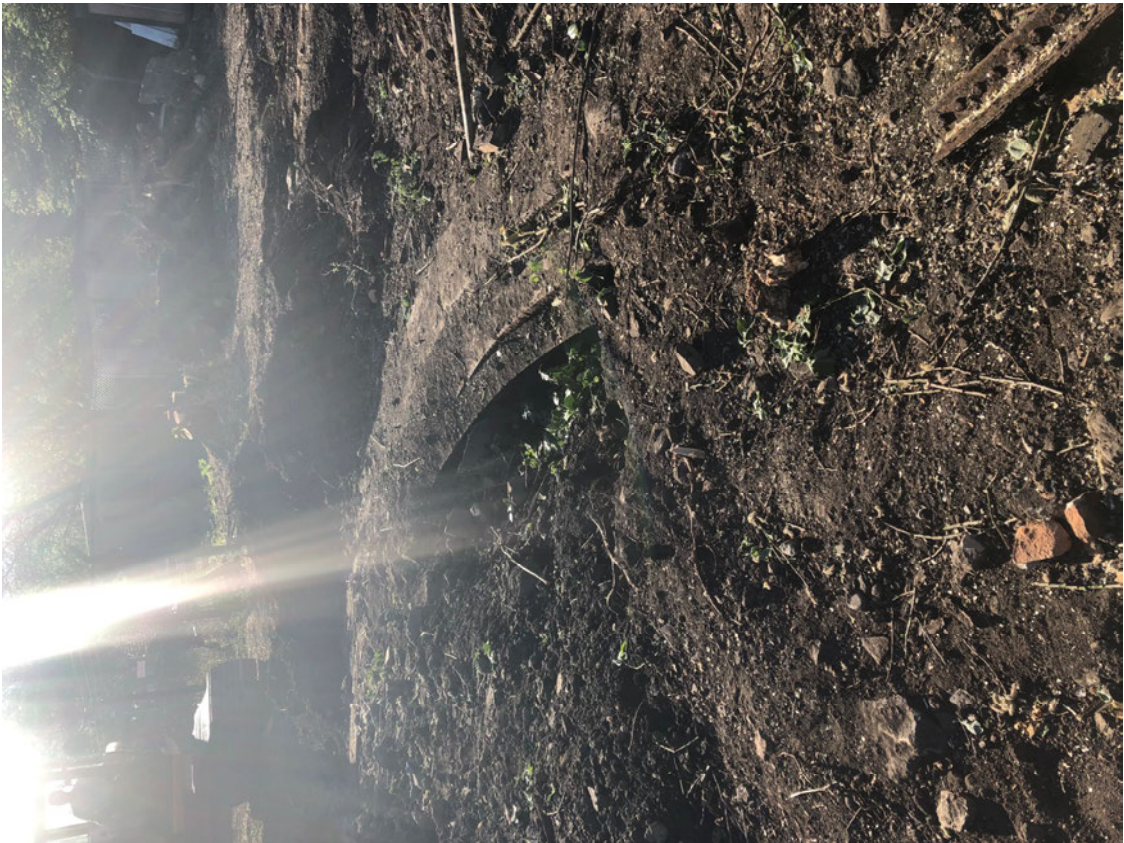
- 2.2.1 Gas Holder 3 was not accessible during the initial site investigation works, therefore a trial pit was undertaken central to the gas holder to determine the nature and depth of the fill material present. (See photo 2)
- 2.2.2 The trial pit in Gas Holder 3 proved 2m fill material consisting of dark brown clayey sands and gravels. A hydrocarbon odour was noted within this fill material as it was excavated. The base of the gas holder was not reached.
- 2.2.3 Please note this gas holder is only partly within the site, with the majority lying beneath the adjacent third party land. This restricts the investigation and treatment works that can be undertaken.

- 4.4 In addition to the above, the sample from 0.9m in gas holder 3 proved positive for amosite asbestos.

Photo 2 – Gas Holder 3 stone frame
