**72 Wood Lane, Newsome**

**Bat Survey Report**

**15<sup>th</sup> April 2021**

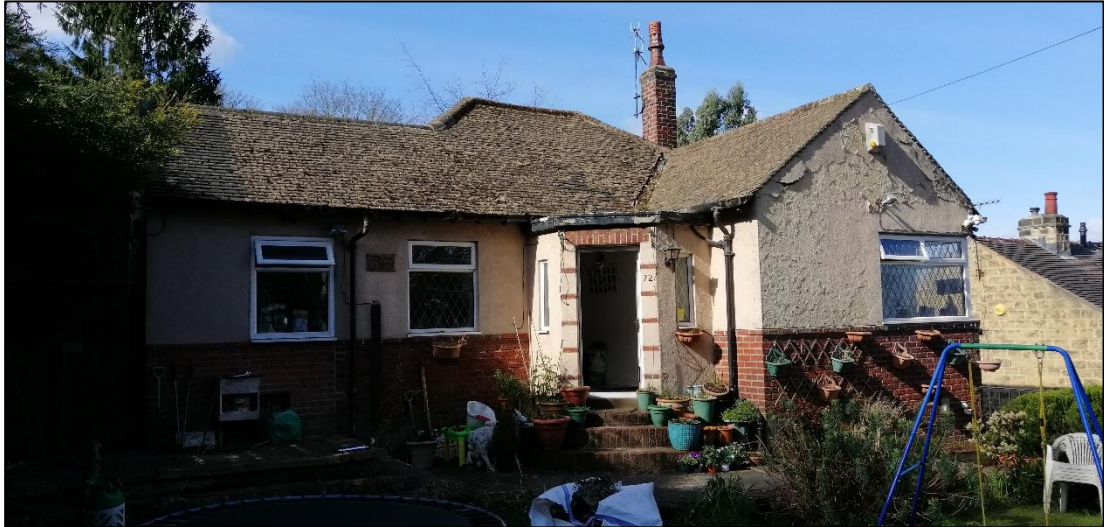
**Plate 1. Northeast elevation (front)**

- 5.2.2 The surveyed building is a detached brick-built bungalow beneath a pitched concrete tile roof with ridges, valleys, hips and gables. The external walls are largely cement rendered, with the exception of 1m of exposed brickwork at the bottom. At the rear there is a uPVC conservatory, and the building has uPVC double glazed windows throughout. There is a single brick-built chimney on the northern slope of the roof and the building has wood fascia and soffit boards (see Plate 1 & 2).

there is no access to the wall top (see Plate 3). The roof verges above two of the gables (Plates 1 & 2) are fully mortared and also the mortar bed beneath the ridge tile is intact and there is no lifted lead flashing at the base of the chimney. The only feature identified which has potential to accommodate roosting bats is the gaps between the tiles at the verge above the southeast gable (see Plate 4). This feature is largely cluttered by the foliage of a Leyland cypress *Cupressus × leylandii* but nevertheless this kind of feature is often used by single or low numbers of roosting bats. Consequently, this feature was directly inspected with the aid of a ladder and torch. Each overlapping end tile was slightly lifted to reveal any signs of historical use (droppings) by roosting bats, but none were found.

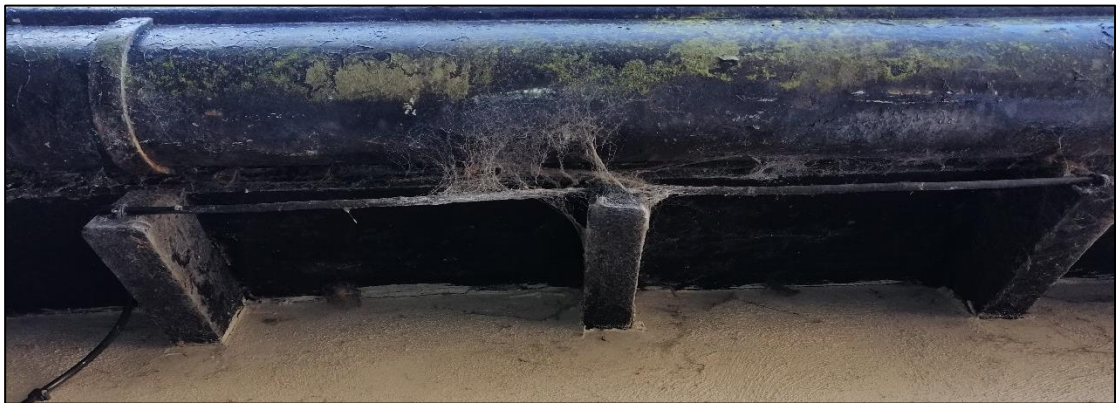
**Plate 3. No gaps under eaves**

- 5.2.3 The render on some of the gables is in a bad state of repair and as blown creating shallow crevices which offer no more than negligible bat roost potential. There are many broken tiles, but none provide access to the roof-space as they are broken across their width where the above tile overlaps, therefore the base of the broken tile is still in place. The cement render was applied after the soffit boards and therefore

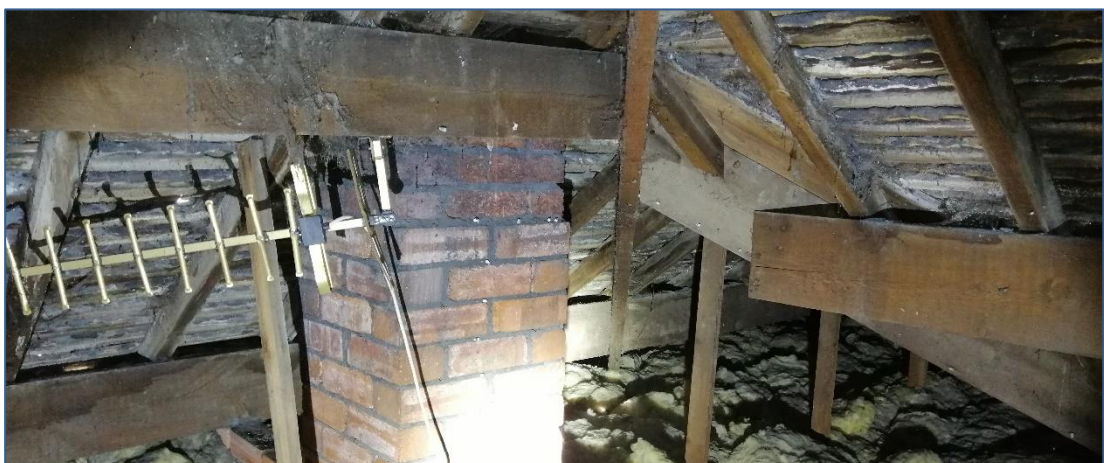
**Plate 5. Roof-space**

- 5.2.4 The roof is supported by purlins, beams, rafters and laths. The space has a height to the ridge of approximately 2.1m and there is no membrane beneath the tiles, however, there is 200mm of glass fibre insulation on the ceiling (Plate5). The roof-space was found to be very dusty and 'cobwebby' but no signs of bats were found.
