# COAL INVESTIGATION

# Report on a Shaft Investigation

Location: **Land off Ravensthorpe Road,**  
Dewsbury Riverside, Thornhill Lees, Dewsbury, WF12 9EG.

Report No. C1035/20/E/1902

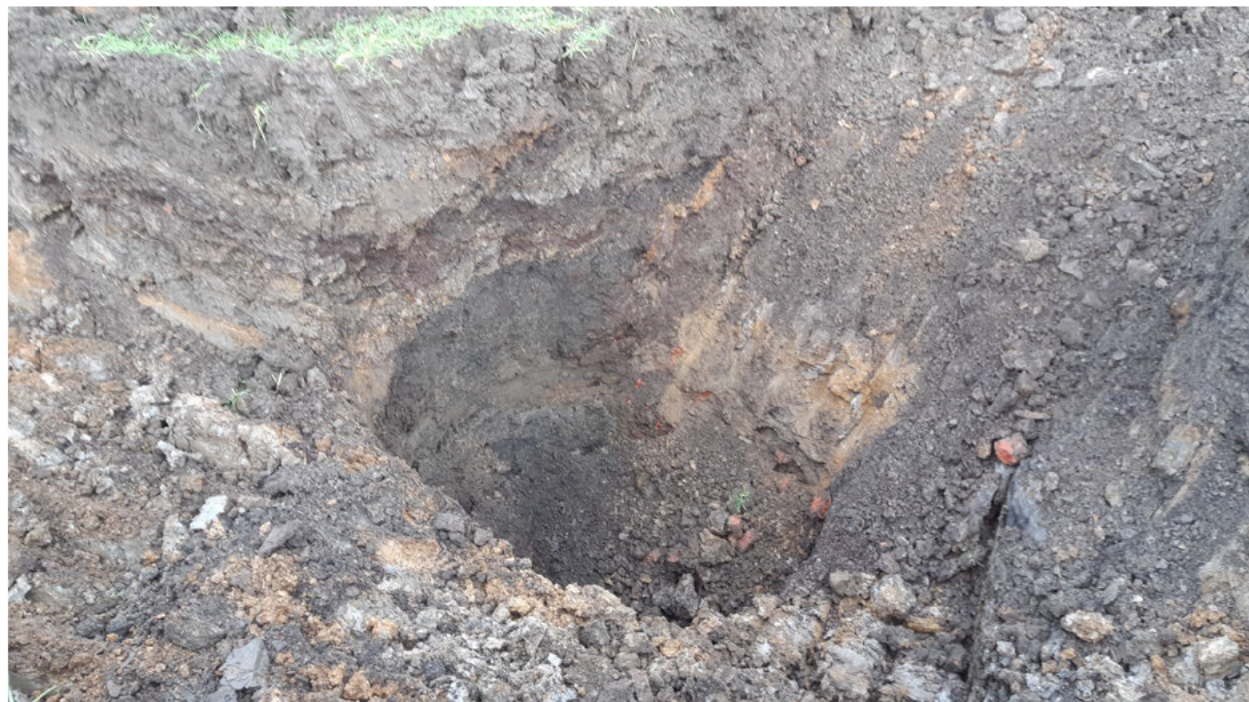
The trenching in close proximity to the grid reference for shaft 423419-006, revealed generally 0.35m of topsoil, over made ground described as soft greyish brown very gravelly clay. The gravel included mudstone, siltstone, coal and brick fragments. Shaft 413419-006 was revealed 1.45m below ground level and located at 423188.2 E, 419671.65 N. The mine entry was observed to be a 2.2m diameter brick lined feature, which had been infilled with cohesive soils. Furthermore, it could be seen that the shaft had not been treated or capped and is in poor condition as some bricks were missing around the lining. It should be appreciated that sandstone rockhead was encountered within a nearby trial pit at 4m below ground level. Photographs of the feature are presented in Appendix 4.

Photo 1: Mine shaft 423419-006. Shaft level approximately 1.45m bgl.

Mine shaft 423419-006 whilst infilled with soil is considered to be present in an unstable condition, thus some remediation will be required. This could comprise a two-way spanning reinforced concrete capping located at or below rockhead, anticipated to be present at around 4m depth. The width of the capping should be at least twice the diameter of the shaft (4.4m in this instance) and a minimum of 0.45m thick. The cap should be designed in accordance to BS EN 1992 -1-1:2004 with a design life of 120 years. The reinforced concrete caps should be designed to carry the weight of the overburden and any other superimposed, loads, including transient loads the engineer deems are likely to be imposed. In addition, any buildings will need to be sited outside the potential zone of collapse of the shaft.

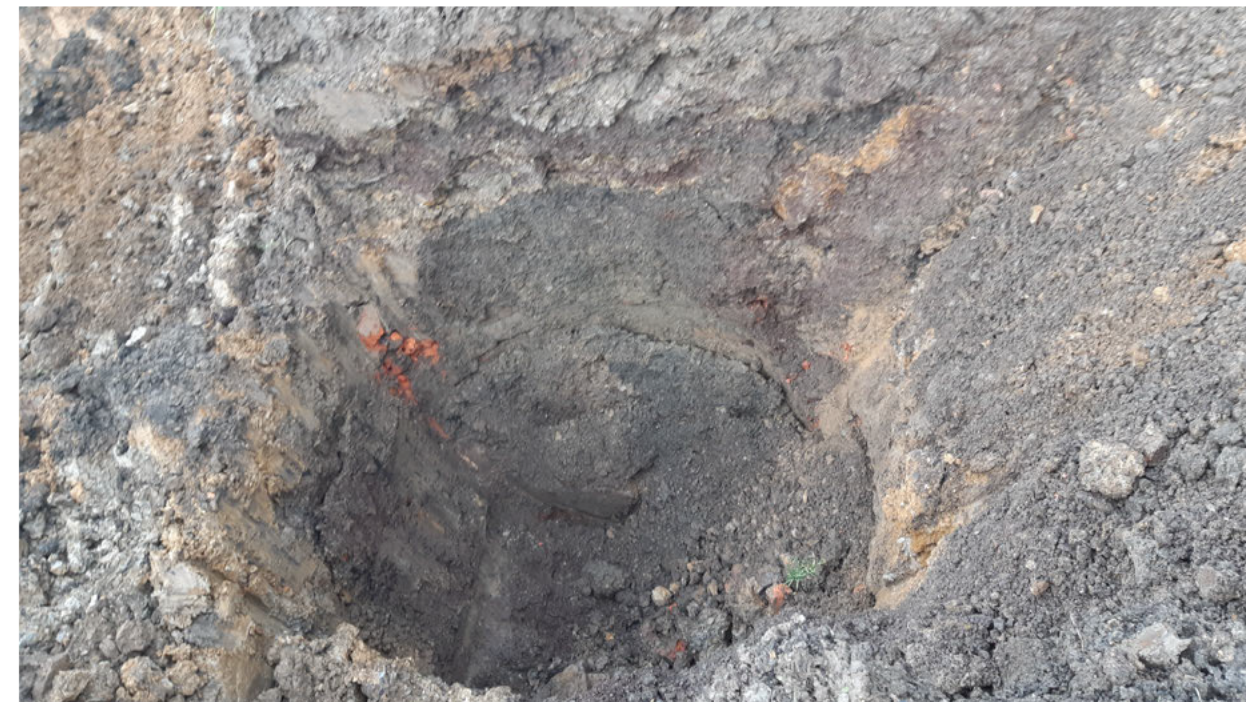
| Water<br>Strike | Samples and In Situ Testing | | | Depth<br>(m) | Level<br>(m) | Legend | Stratum Description |
|---|---|---|---|---|---|---|---|
| | | | | | | | 1.45m: Shaft level. Shaft noted to be 2.2m diameter, circular, brick lined feature. Poor condition. |

Photo 2: Mine shaft 423419-006. Circular feature, 2.2m diameter.

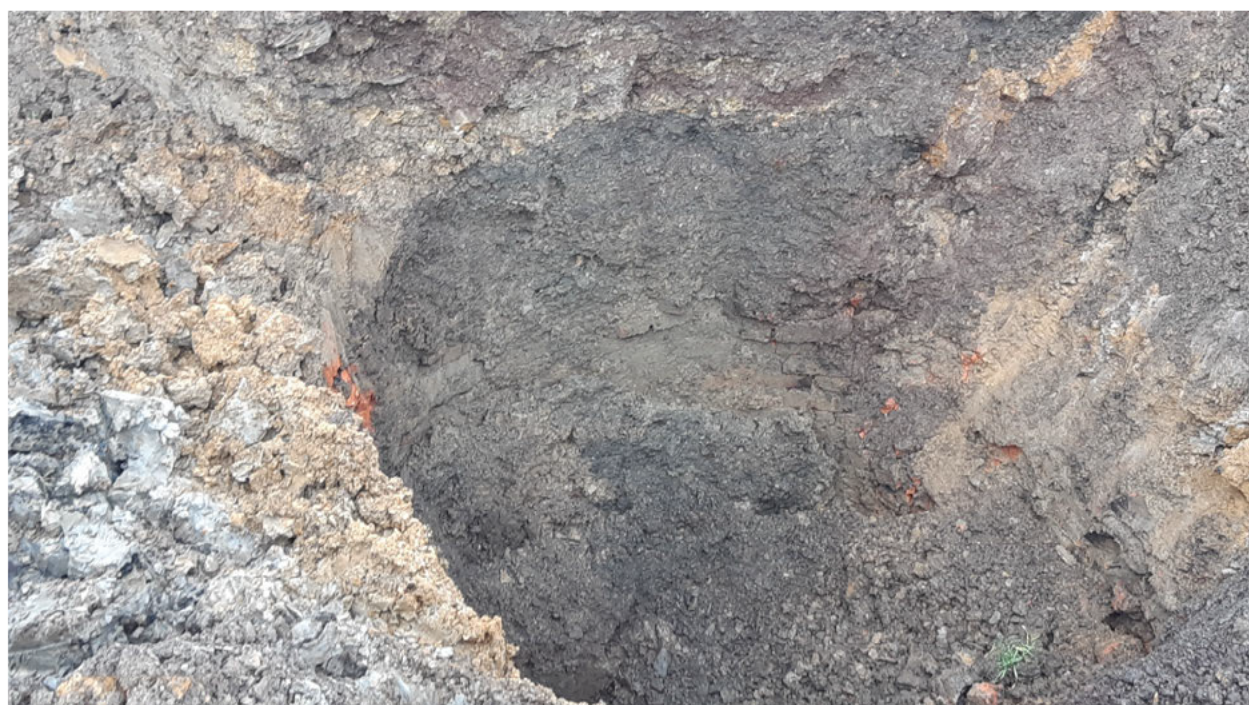
Photo 3: Mine shaft 423419-006. Remnant of brick lining can still be seen as impressions in shaft wall.

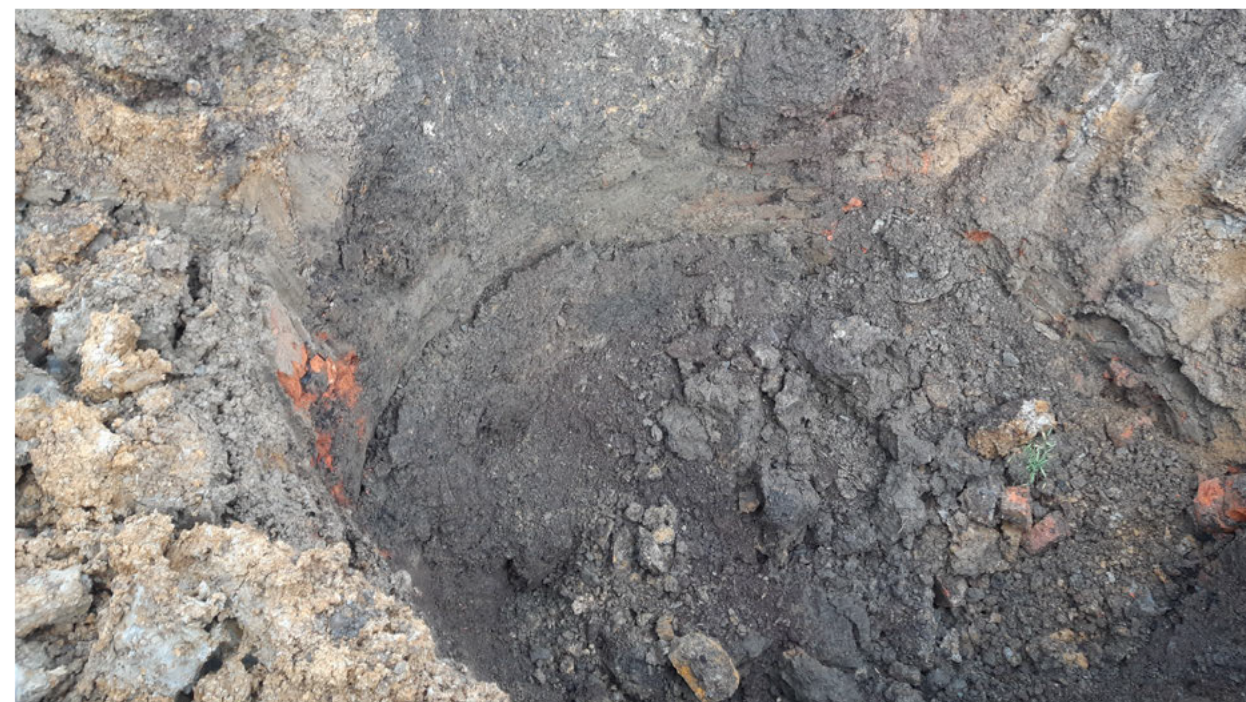
| Item | Risk of Instability | Comments | Risk Rating |
|---|---|---|---|
| 1 | Collapse of shaft (mine entry reference: 423419-006). | Located at grid reference 423188.2 E, 419671.65 N. | High |

Photo 4: Mine shaft 423419-006. Shaft infilled with soil. Poor condition. No capping or evidence of treatment.

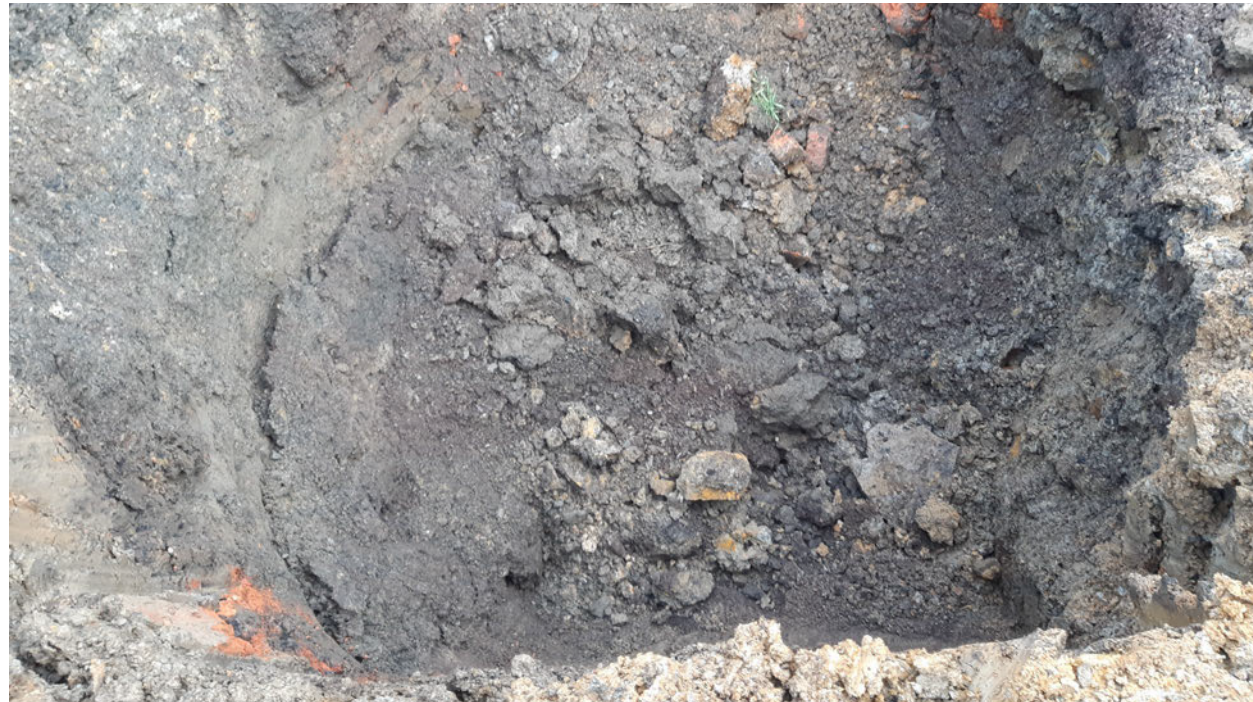
Photo 5: Mine shaft 423419-006. Much of former brick lining has degraded and is no longer present.

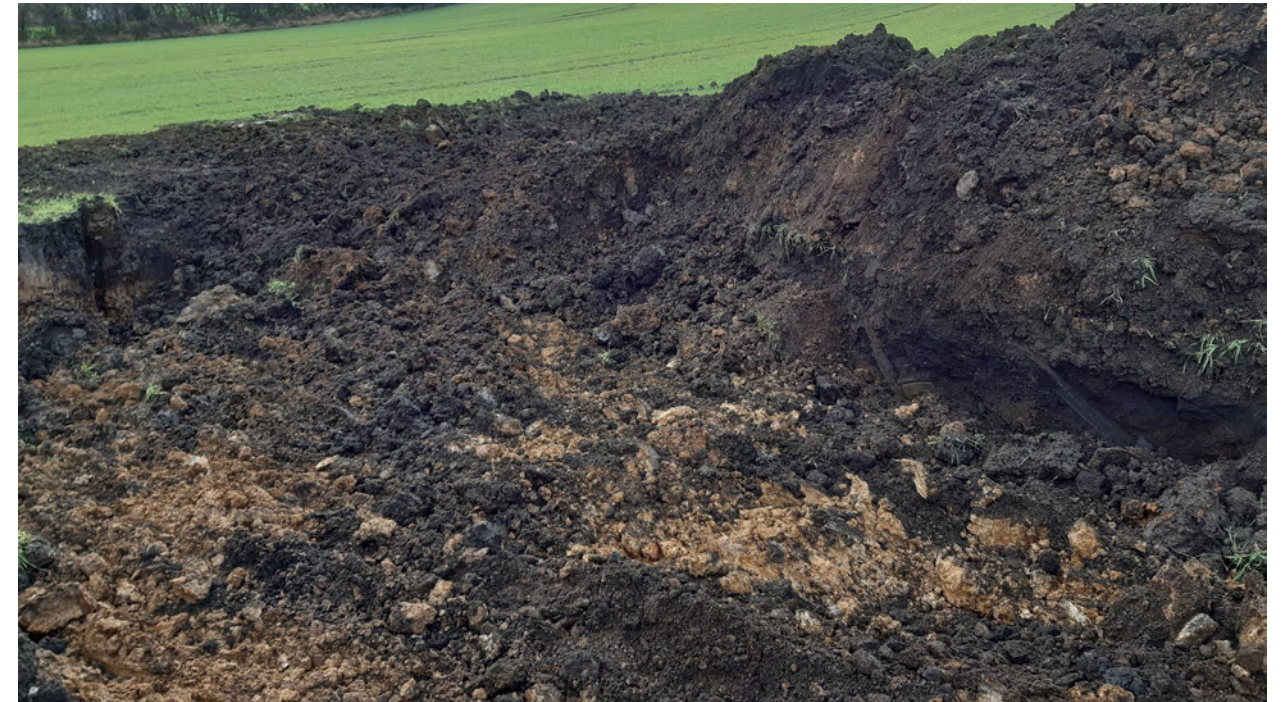
With reference to shaft 423419-005, an area of approximately 17m x 16m was excavated around the coordinates given by the Coal Authority. It should be appreciated that as the shaft has been located from abandonment plans, a departure of 8m from the given coordinates has been taken (see C1035/20/E/1615 Mine Entry Interpretive Report, November 2020). It should be appreciated that no evidence of a shaft was observed within the departure zone. Moreover, whilst it was noted that the made ground was thickest (up to 1m) close to the expected location, the fill reduced to around 0.5m depth towards the edge of the departure zone. In view of this, it is considered unlikely that shaft 423419-005 is present outside of the excavated area.

Photo 6: Area excavated as part of search for shaft 433419-005.

It should be appreciated that with regards to mine shaft 423419-005, no evidence has been observed of its presence both at the given coordinates and within the departure zone of 8m as such, whilst it can be suggested that the shaft is not present, some level of risk of the shaft being at locations outside its given departure zone remains. As such it is strongly recommended that a watching brief is undertaken during the groundworks phase of both the remediation works for shaft 423419-006 and for the final development itself. It would also be prudent to extend excavations for the shaft remedial works to cover the departure zone for shaft 423419-005. Clearly, if any evidence of this shaft is subsequently found, then all work should stop immediately and the advice of a specialist geotechnical engineer should be sought.

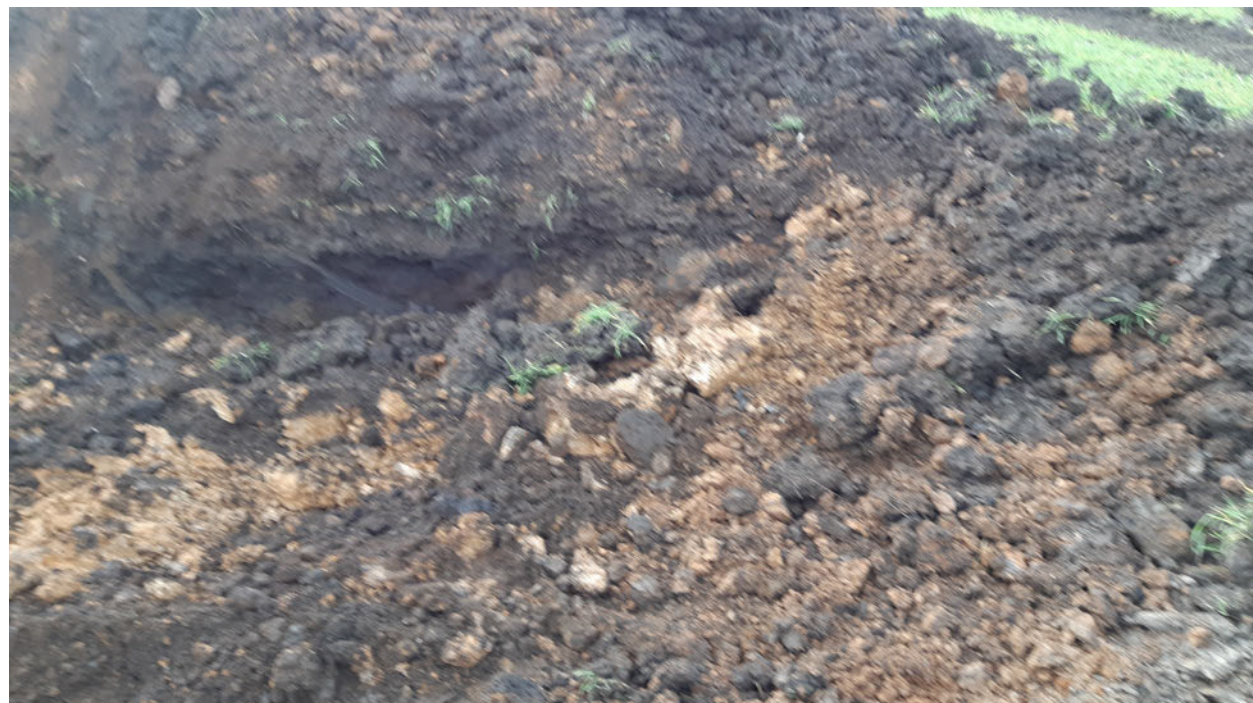
Photo 7: Area excavated as part of search for shaft 433419-005.
