# ENVIRONMENTAL REPORT

| job number<br><b>C1035/20/E/1613/R1</b> | date<br><b>28/01/2021</b> |
| site address<br><b>Land off Ravensthorpe Road,<br/>Dewsbury Riverside,<br/>Thornhill Lees,<br/>Dewsbury, WF12 9EG.</b> | |

# Report on an Environmental Investigation

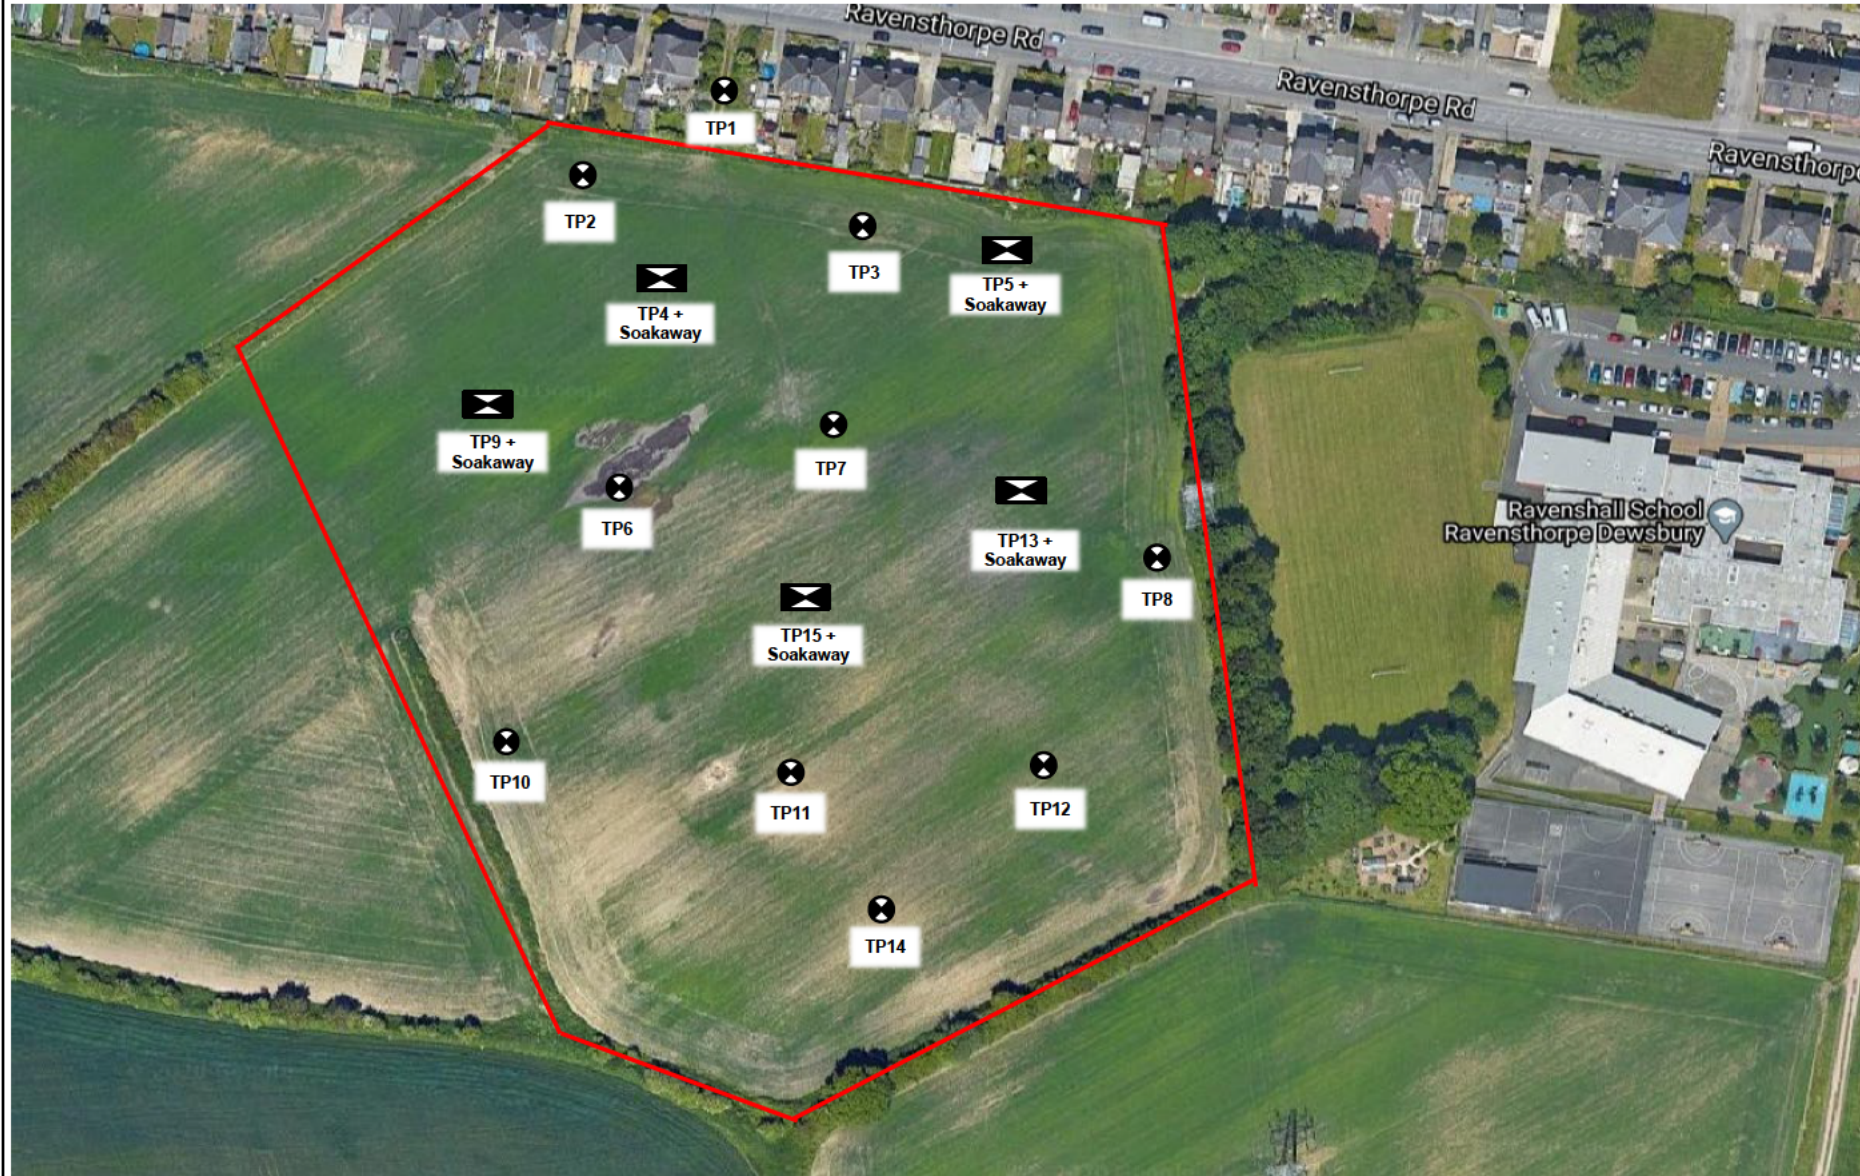
### Site Plan

The fieldworks were undertaken on the 2<sup>nd</sup> October 2020 and included ten hand-dug trialpits, to reveal the nature of the near surface soils and to obtain soil samples. Whilst initial plans also included the excavation of five machine dug trial pits for soakaway testing, due site constraints attributed to boggy ground, these locations also had to be undertaken with hand sapling equipment. The investigatory locations are shown on the site plan which is presented in Appendix 1 of this report.
