REMEDIATION STATEMENT
FOR TOPSOIL

DEWSBURY RIVERSIDE
RAVENSTHORPE ROAD, THORNHILL LEES
DEWSBURY, WF12 9EG

FOR
KIRKLEES COUNCIL

REPORT REF: KC 3464REM Rev 1

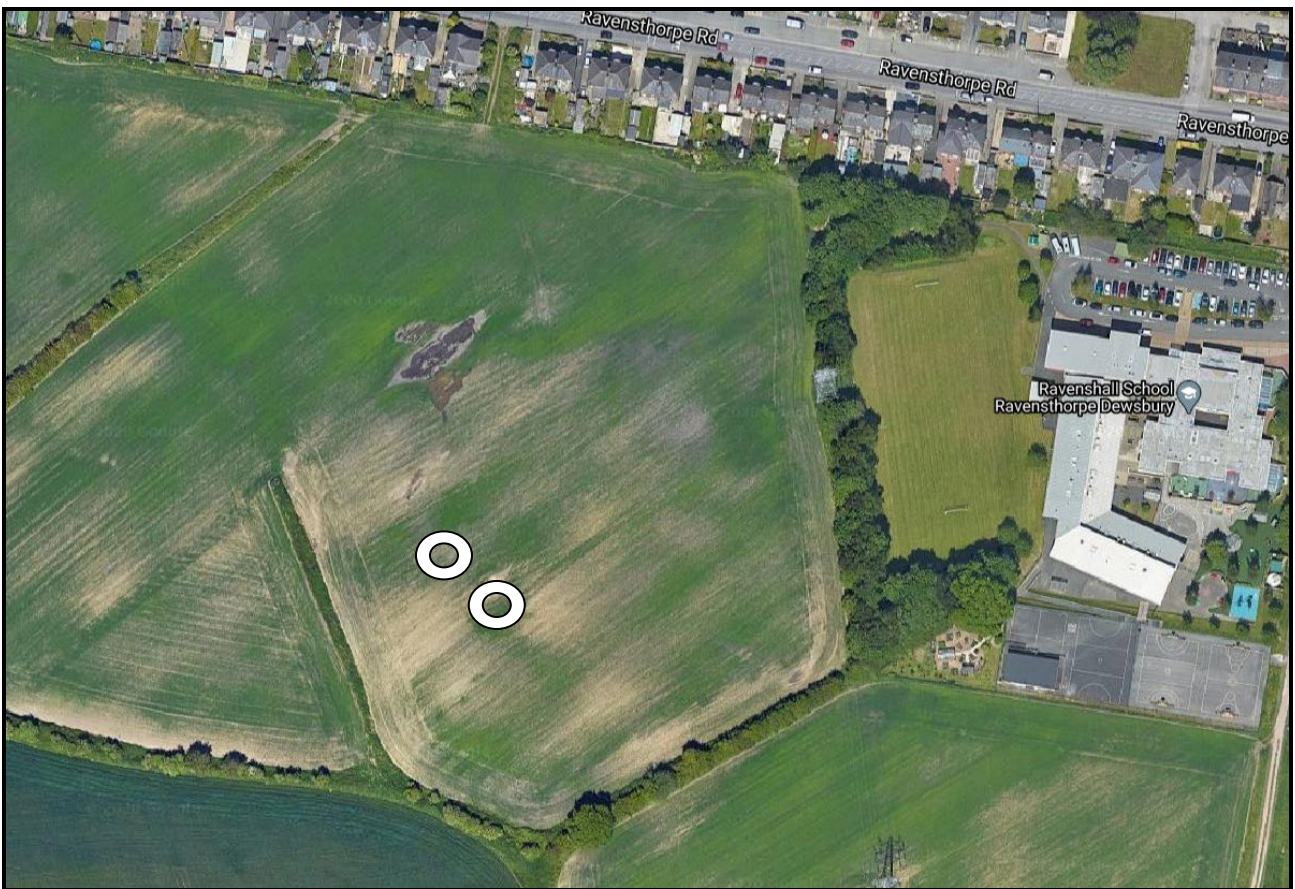
Figure 3 Presumed Location of Mine Shafts

The report identified the presence of two mine shafts on the site with the probability that more may be present. The recorded shafts lie at SE23117 19464 and SE23140 19622. Two pits with broken land drains at the base were recorded carrying water in a westward direction. One is illustrated in Figure 4.

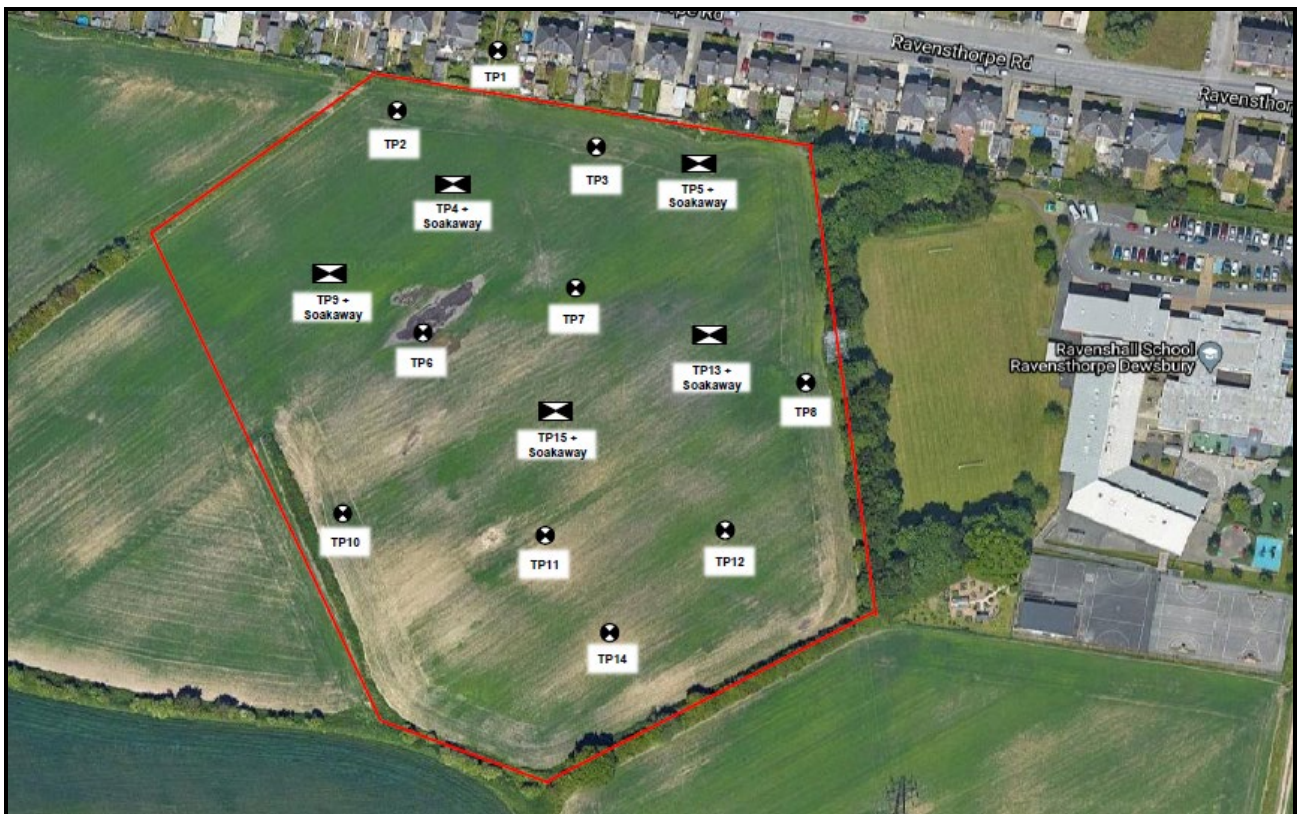
Figure 5 RGS Trial Pit Location Plan

RGS undertook a ground investigation on the site in order to assess the quality of the topsoil and the presence of any contamination in the topsoil in order to assess the sites suitability for use for allotments.

Investigative Location	Topsoil In mbgl	Made Ground in mbgl	CLAY In mbgl
TP1	GI-0.60		
TP2	GL-0.60		0.60-0.70
TP3	GL-0.30		0.30-0.60
TP4	GL-0.30		0.30-0.70
TP5	GL-0.40		0.40-0.60
TP6	GL-0.20		0.20-0.50
TP7	GL-0.25		0.25-0.60
TP8	GL-0.40	0.40-0.60	
TP9	GL-0.30		0.30-1.30
TP10	GL-0.30		0.30-0.40
TP11	GL-0.40		0.40-0.60
TP12	GL-0.25		0.25-0.30
TP13	GL-0.20		0.20-0.60
TP14	GL-0.35		0.35-0.50
TP15	GL-0.30		0.30-0.90

Topsoil thicknesses and nature of immediate underlying strata is presented in Table 1.

Groundwater was not encountered in the trial pits with the exception of TP 5 in the north east corner of the site. Soakaway tests indicated that soakaways will not work on the site. Testing of soils was undertaken for BS3882 suite of tests to assess topsoil quality plus a suite of heavy metals, PAHs, TPHs, pH, organic content, soluble sulphate and asbestos screen. In addition a suite for Waste Acceptance Criteria (WACS) tests was undertaken.

The three test results that exceed the SSV for allotments are widespread across the field. The level of 53mg/kg was detected in TP8 in made ground in the west of the site, the level of 100mg/kg was detected in TP8 on the eastern site boundary and the level of 110mg/kg was detected in TP 11 in the south of the site.
