# ENVIRONMENTAL REPORT

# Report on an Environmental Investigation

Location: Land off Ravensthorpe Road,  
Dewsbury Riverside, Thornhill Lees, Dewsbury, WF12 9EG.

Report No. C1035/20/E/1613/R2

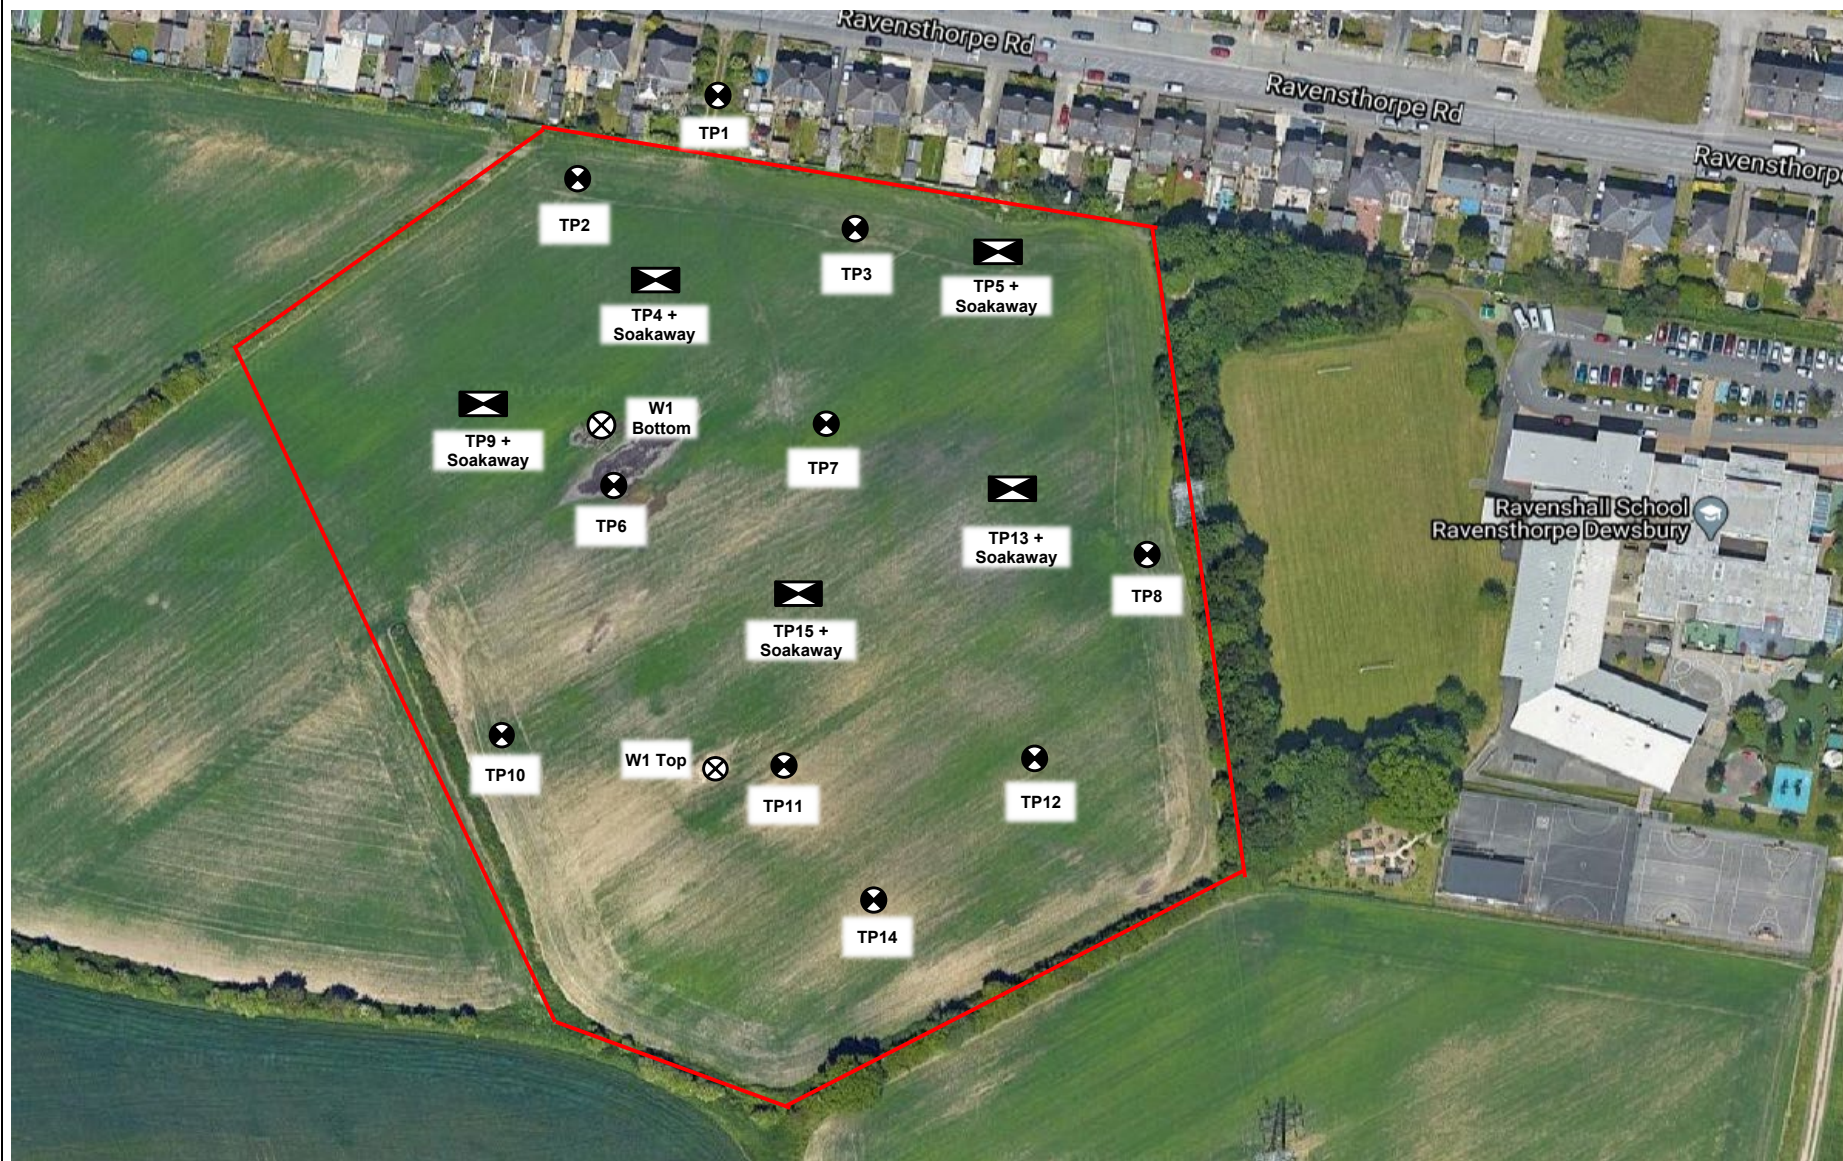
### Site Plan

The fieldworks were undertaken on the 2<sup>nd</sup> October 2020 and included ten hand-dug trialpits, to reveal the nature of the near surface soils and to obtain soil samples. Whilst initial plans also included the excavation of five machine dug trial pits for soakaway testing, due to site constraints attributed to boggy ground, these locations also had to be undertaken with hand sampling equipment. The investigatory locations are shown on the site plan which is presented in Appendix 1 of this report.

In addition, an exposed water bearing pipe was located across the central section of the site, which was sampled at two locations, the positions of which are shown on the site plan in Appendix 1.
