# **Bat Survey Report and Method Statement European Protected Species (Bats)**

## **Reasonable Avoidance and Mitigation Measures**

**Outbuildings at Gledhill Farm,  
Kaye Lane,  
Almondbury,  
HD5 8XU**

**15.03.2021**

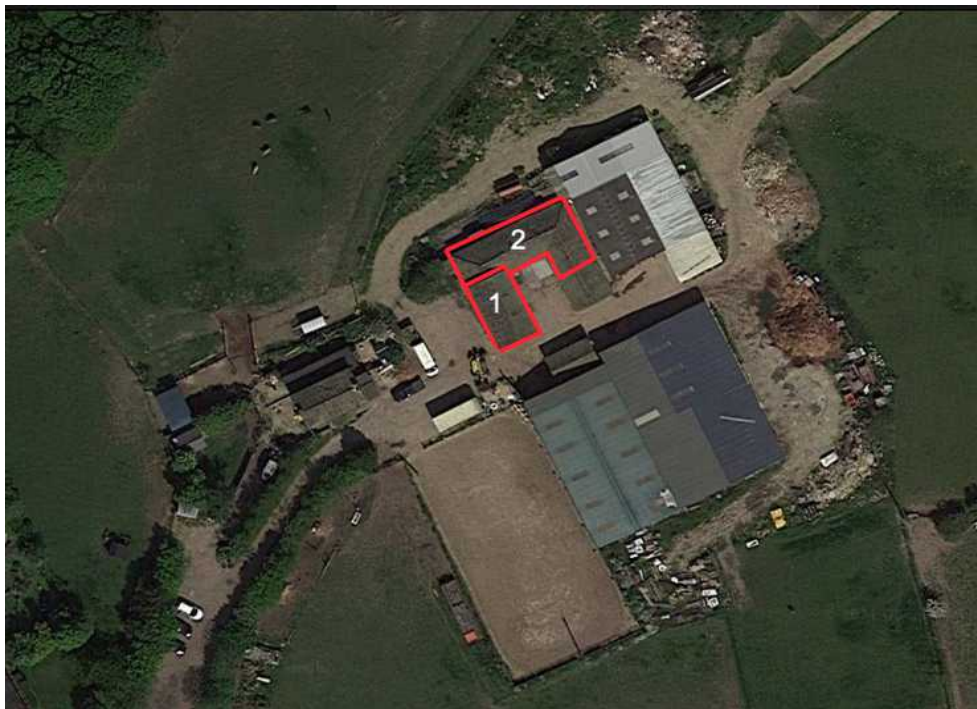
### Site Layout

The site consists of three buildings that were assessed as offering negligible/low bat roost potential:

- 1) A two storey stone outbuilding, with proposed ground floor development.
- 2) A single storey outbuilding used for livestock.

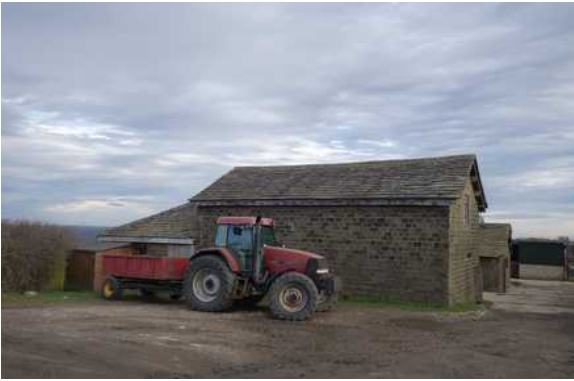
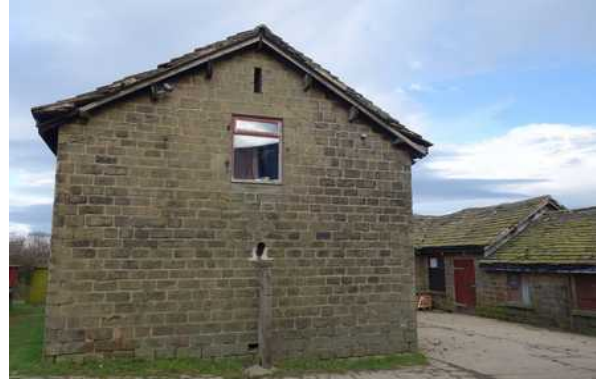
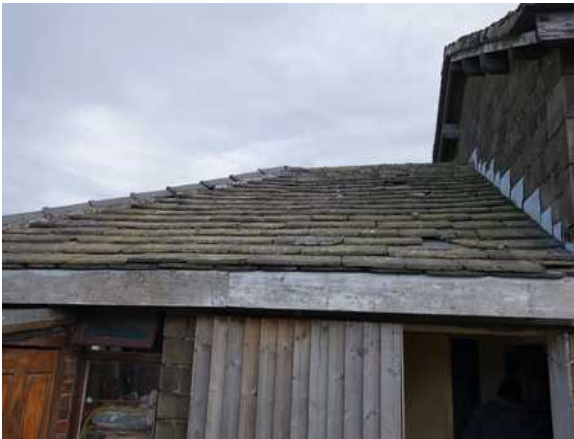
### Building 1

A two storey stone built outbuilding with double pitched stone slate roof. The roof is lined internally as the upper floor has a vaulted roof. Some gaps and crevices recorded in external walls however resulting crevices are shallow, missing pointing on gable ends offers some roost potential however it is considered the development of the building will not affect these due to work being internal and restricted to ground floor.

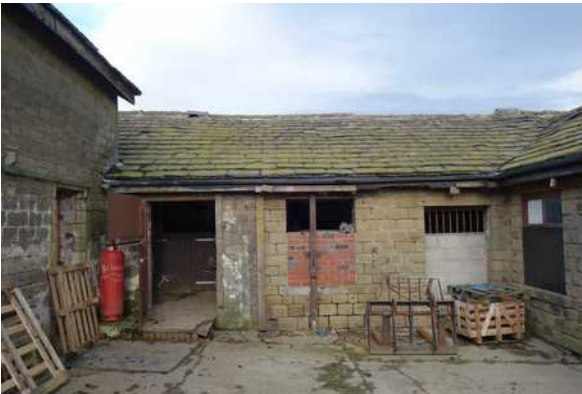
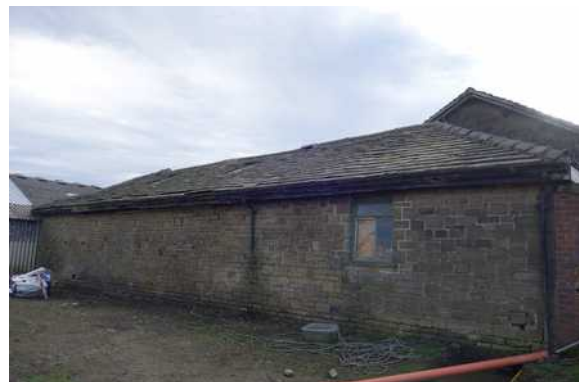
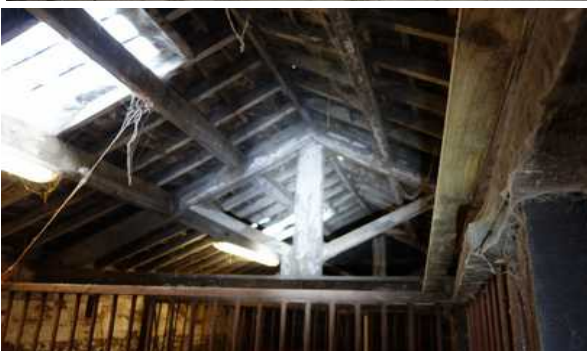
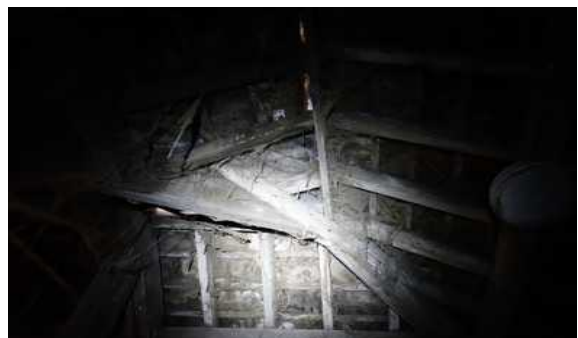
### Building 2

A single storey stone built outbuilding, adjoining building 1, with a double pitched stone slate roof. Roof is unlined to the interior and heavily cobwebbed. External walls are generally pointed with no obvious gaps or crevices, roof slates are generally close fitting, however an area of lifted slates was recorded. Ridge tiles are pointed and sealed, a ridge vent is present allowing access to the interior. The building was assessed as offering low potential for roosting bats, however heavy cobwebbing of the interior roof space suggests a lack of bat activity.

Roof stripping where necessary will be undertaken by hand and under supervision following a precautionary emergence survey carried out between May and September and installation of compensatory roost boxes.

Removal of roof slates will be carried out by hand and under supervision where necessary.
