## **REPORT ON A GEO-ENVIRONMENTAL INVESTIGATION**

**348A LEEDS ROAD, HOWDEN CLOUGH, BIRSTALL WF17 OHY**

**Report No J3546/16/E**

**August 2016**

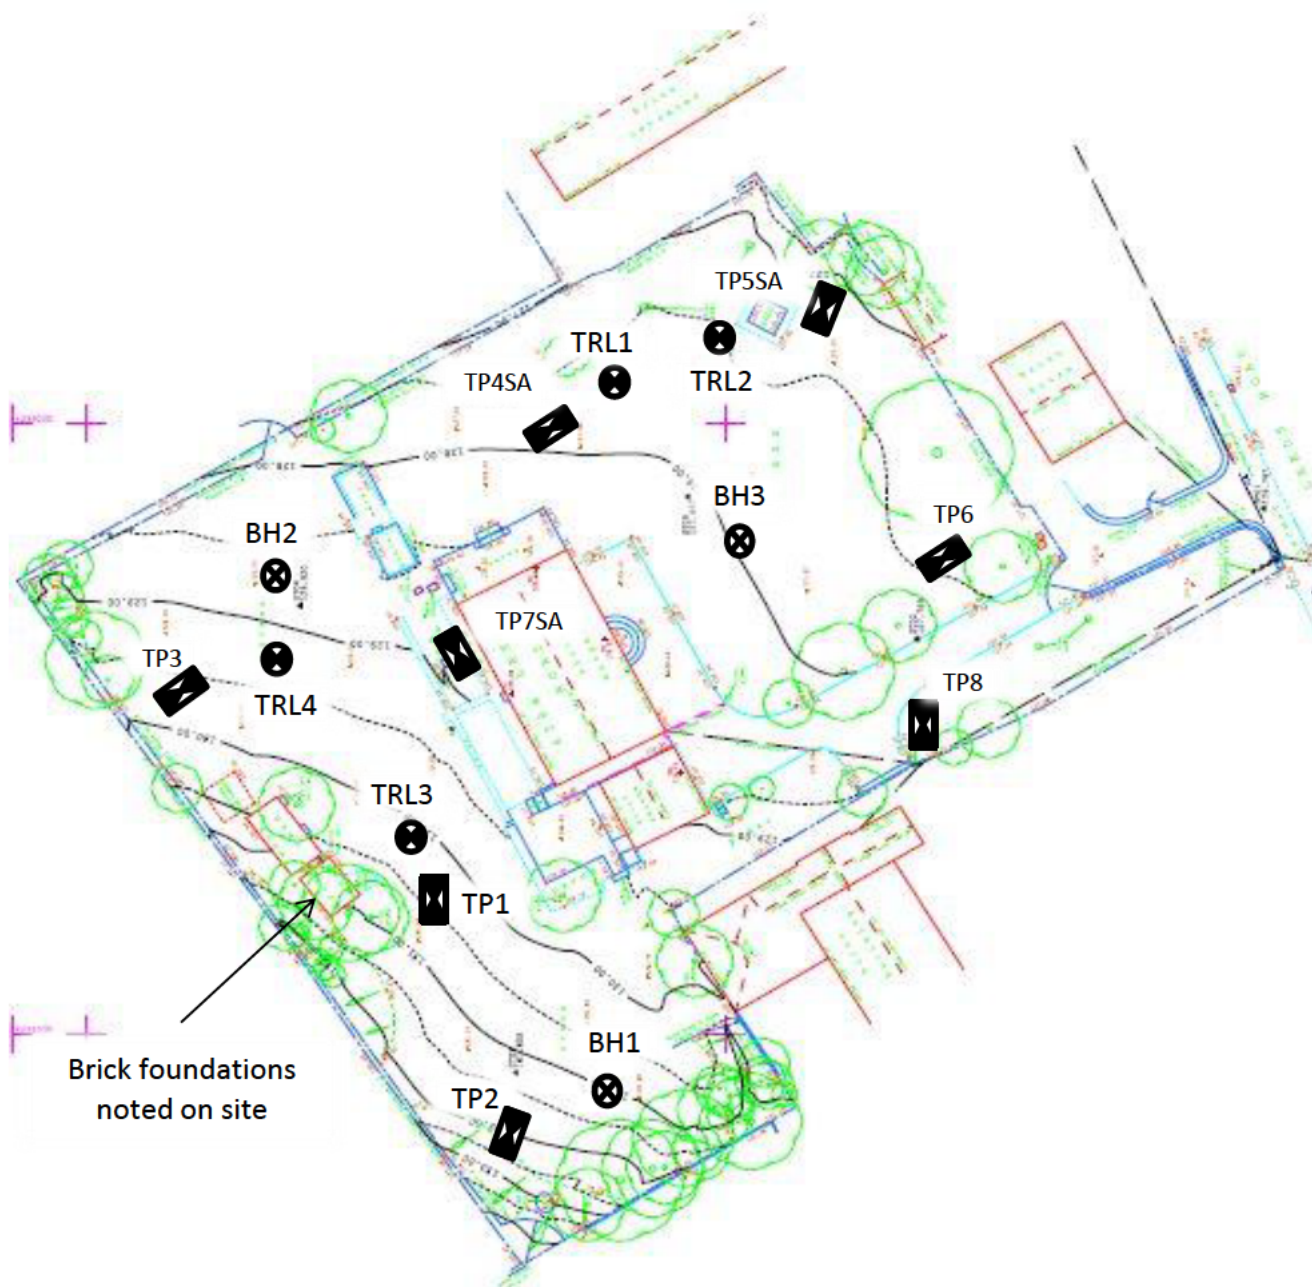
Title: **Investigation Location Plan**

Plan not to scale and investigation positions approximated from site operative's notes.

The borehole positions are shown on the site plan, which is presented in Appendix 1 and the strata conditions are presented on the borehole records in Appendix 2.
