Old White Lee Colliery  
Leeds Road  
Heckmondwike

Visual Assessment

m b Heritage & Planning Ltd  
Leeds

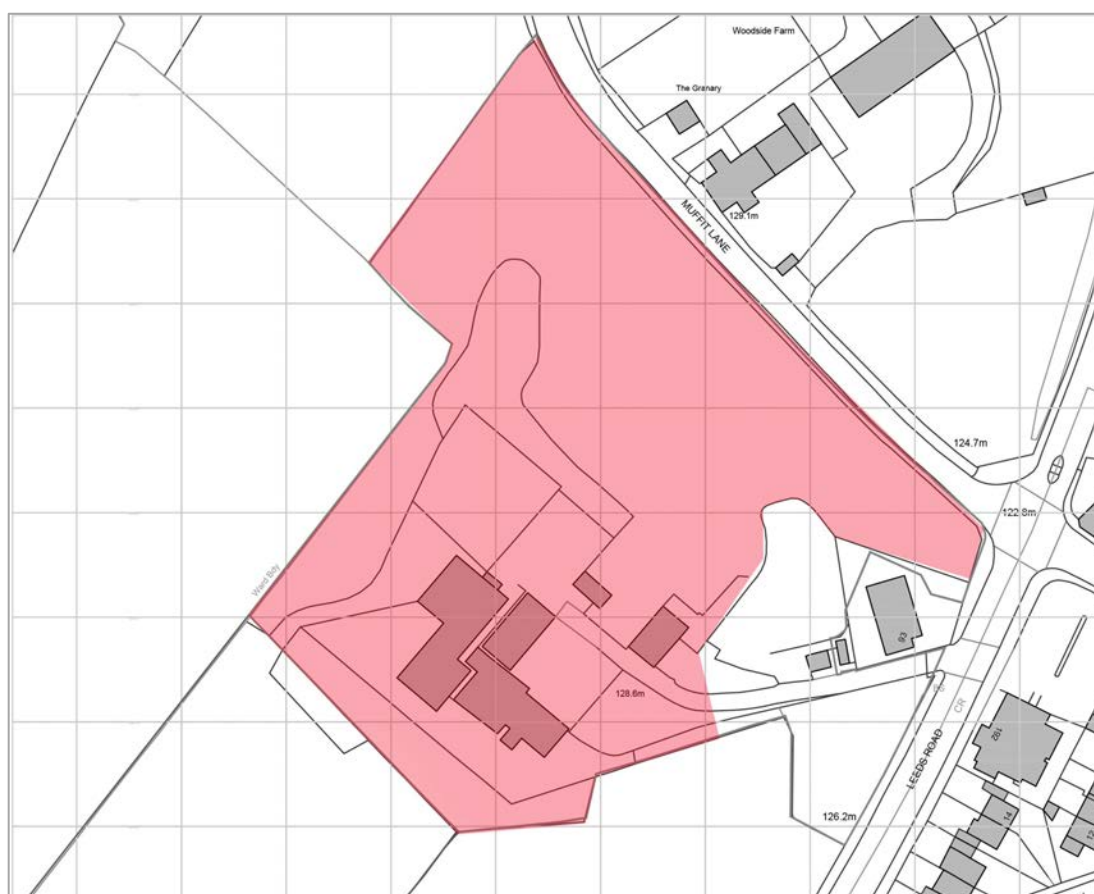
Figure 1: Site Extent

- 1.01 This Report sets out an initial desk-based and visual assessment of land and buildings comprising the site of the former White Lee Colliery to the west of the junction of Leeds Road with Muffit Lane in Heckmondwike (NGR SE21930 25194). The extent of the assessment site is shown at Figure 1.

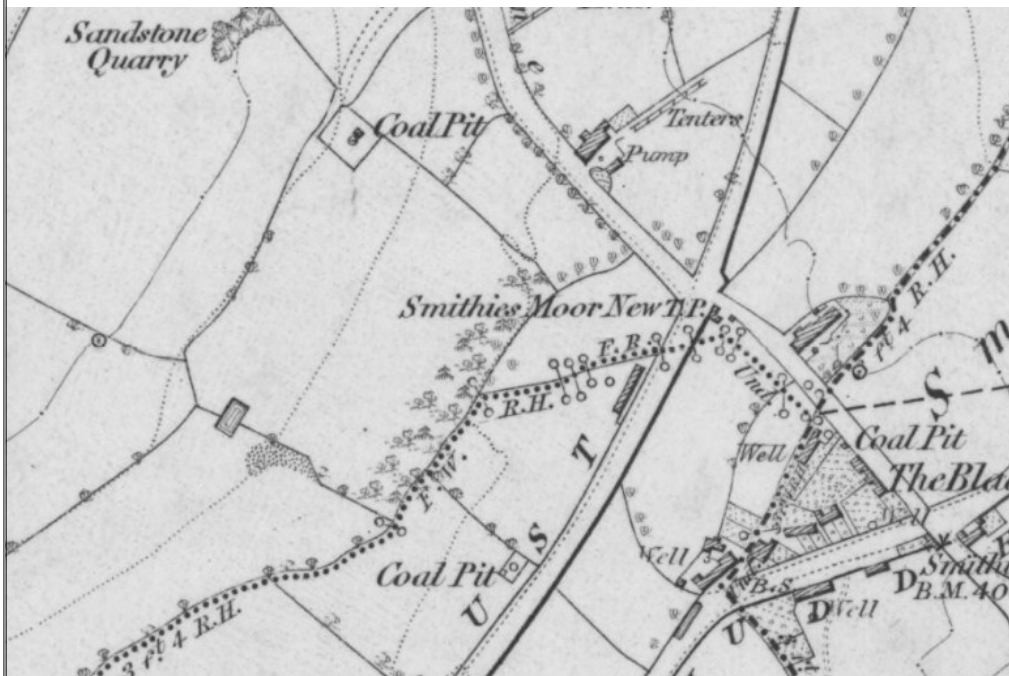
OS Plan 1854 (1:10560)

- 2.03 The earlier pit workings are not shown on the 1854 Ordnance Survey plan so its location and extent unclear although a number of shallow pits are shown in the vicinity of the site and a possible shaft marked to the south. A terrace of workers houses shown in 1854 at the Leeds Road frontage may have been associated with the earlier mine. The Northern Mining Research Society records the White Lee Colliery as operating between 1888 and 1941 when it was abandoned. The mine was abandoned due to flooding.

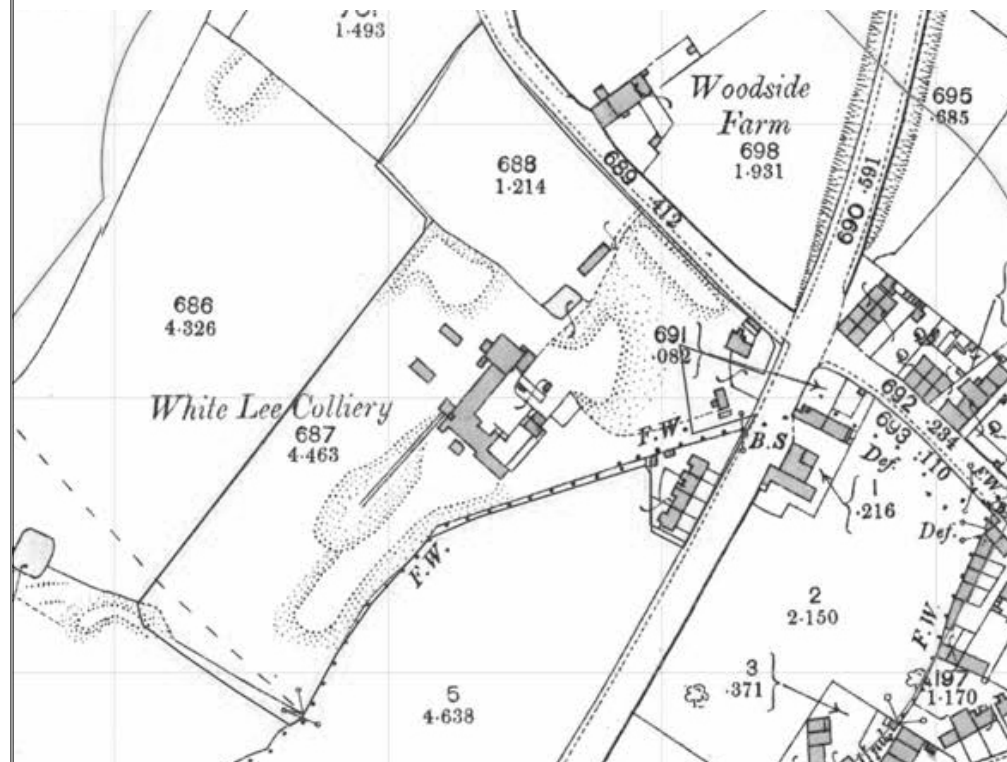
OS Plan 1894 (1:2500)

- 2.06 The 1894 OS plan marks White Lee Colliery with a range of buildings, on a broadly L-shape plan form to the north and west sides of the current yard area. A square plan building to the north-east was likely winding house or pump house and corresponds with the position of a shaft shown on later mapping. Spoil areas are shown to the south-west and east of the building group with the former linked by a tram line.

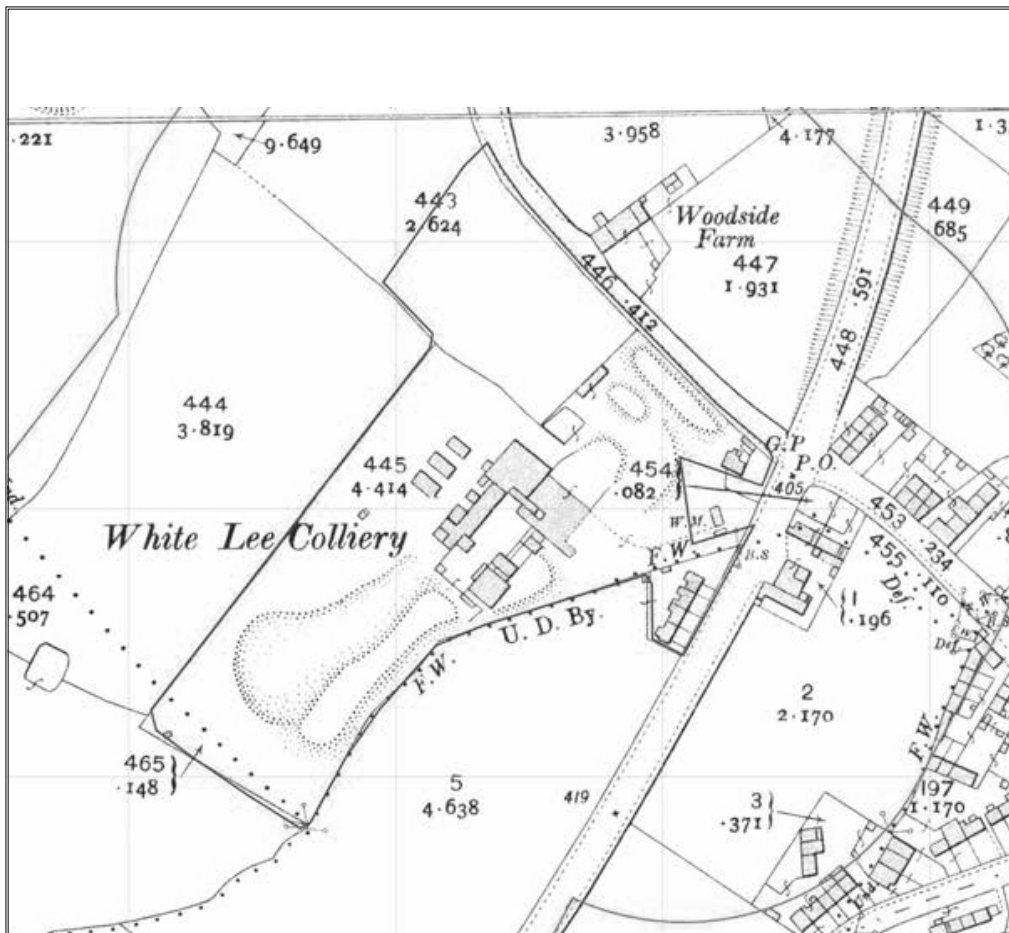
OS Plan 1907-08 (1:2500)

- 2.07 The 1907-08 OS plan shows a reworking of the building with the western range removed and northern range extended to the north-east. A new building, on square plan, is shown to the south and likely built as an engine or pump house. By 1922 the site is annotated as *White Lea Colliery* and a second shaft is shown to the south of the building group with ventilation chimneys to the north. Spoil areas have expanded and a reservoir is marked to the north of the site. Little change to the configuration of buildings is shown on the 1938 OS plan. A tramway is shown to the northern spoil areas and outbuildings and tanks shown to the south of the building group.

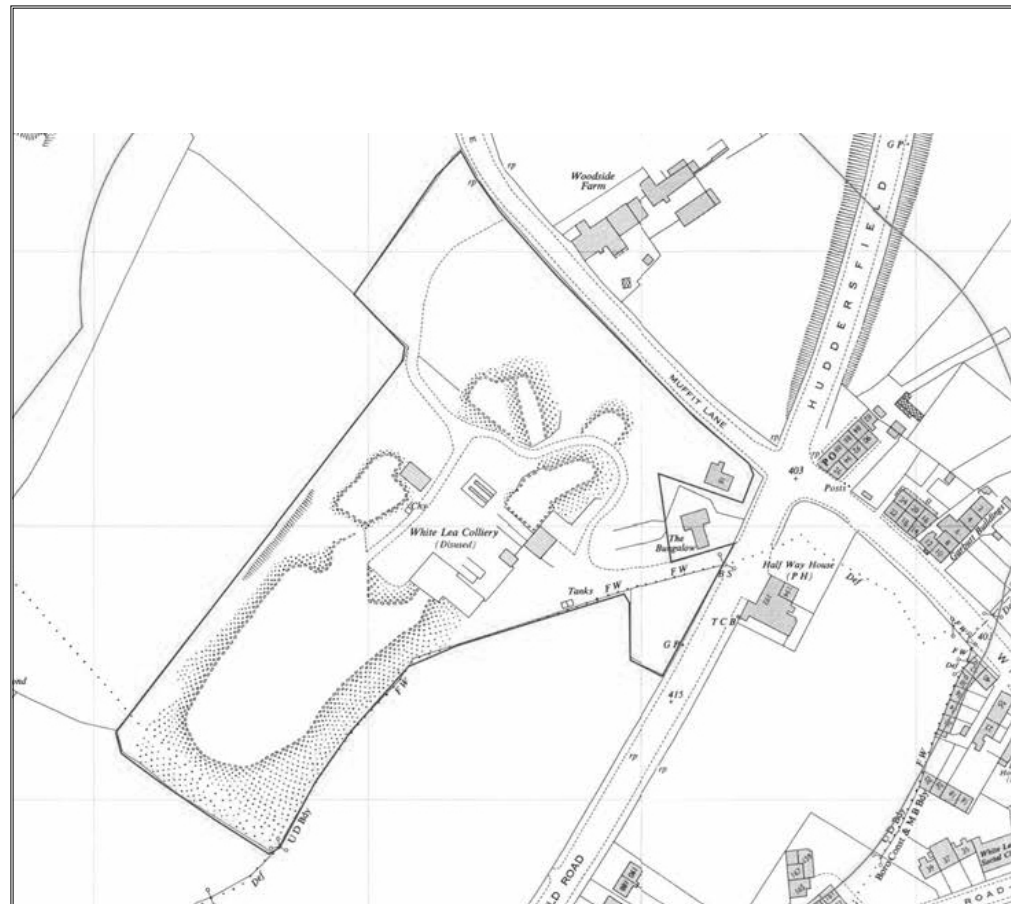
OS Plan 1955 (1:1250)

- 2.08 The 1955 OS plan marks the site as disused and the majority of buildings associated with the colliery use removed. The southernmost building within the range, originally on a square plan form, appears partially retained although by this point extended to the north-west. This building corresponds with the current western range within the site. The retained garage building has also been constructed by this point. The position of one ventilation chimney remains marked.

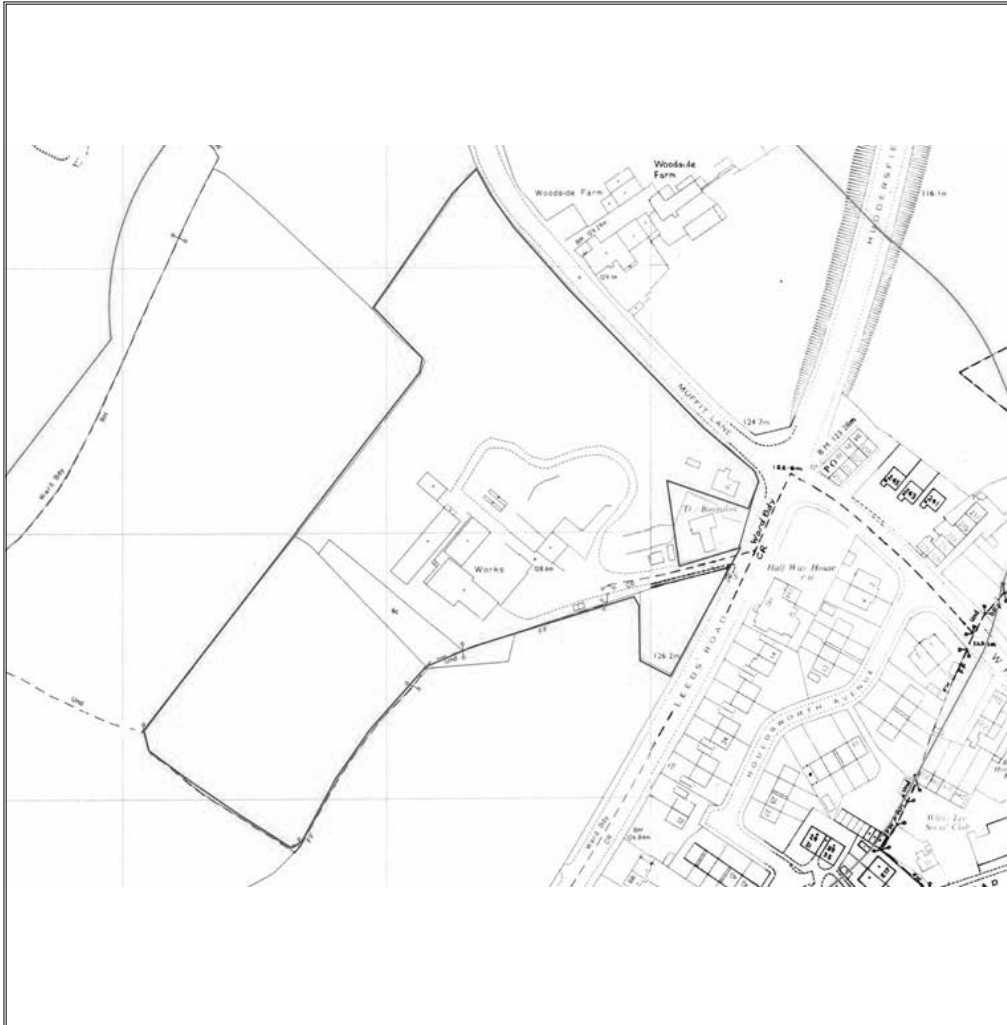
OS Plan 1988-93 (1:2500)

- 2.09 The 1988-93 OS plan shows the current building range of works buildings as constructed. A small building to the north is no longer present and subsequent to the publication of the plan a 2-storey office building was constructed. Later work also included the extension of the north range to the north-west.
- 2.10 Extracts from OS mapping are included at Appendix 1.

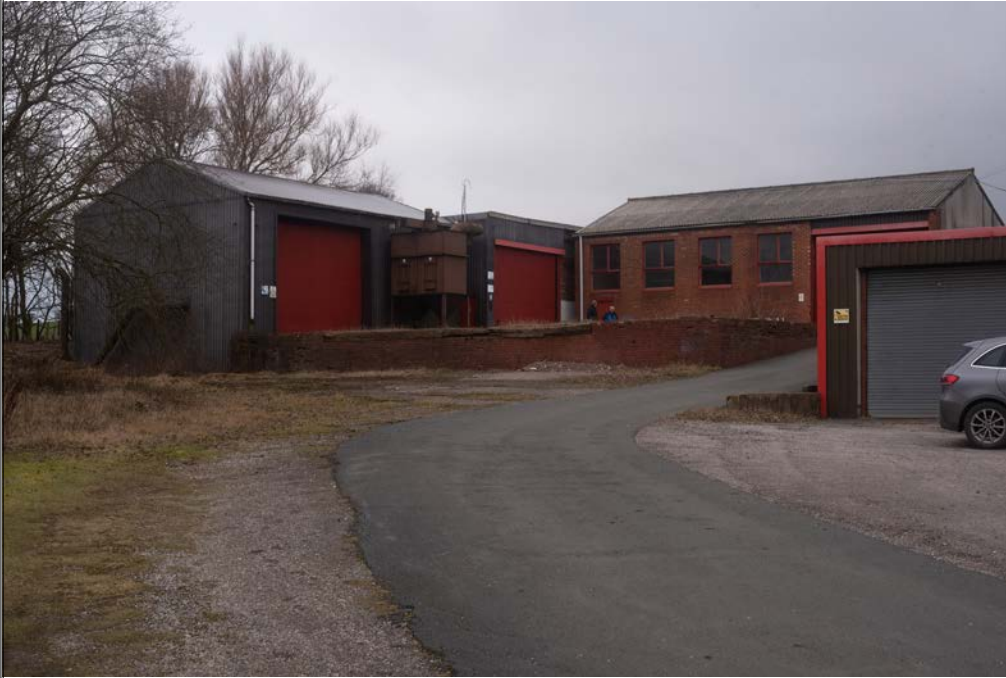
- 3.06 Retaining walling to the south of the building group retains brickwork matching that within the west range and may indicate the base/platforms of earlier buildings. The remainder of yard areas are now hard surfaced. Walkover of the wider site revealed no surface evidence of previous mining activity although areas of made ground relating to the position of the eastern spoil tip are apparent.

Plate 1  
Building group from the south showing retained building platform with later workshop buildings beyond. A later 20th century garage block is to the foreground ,right.

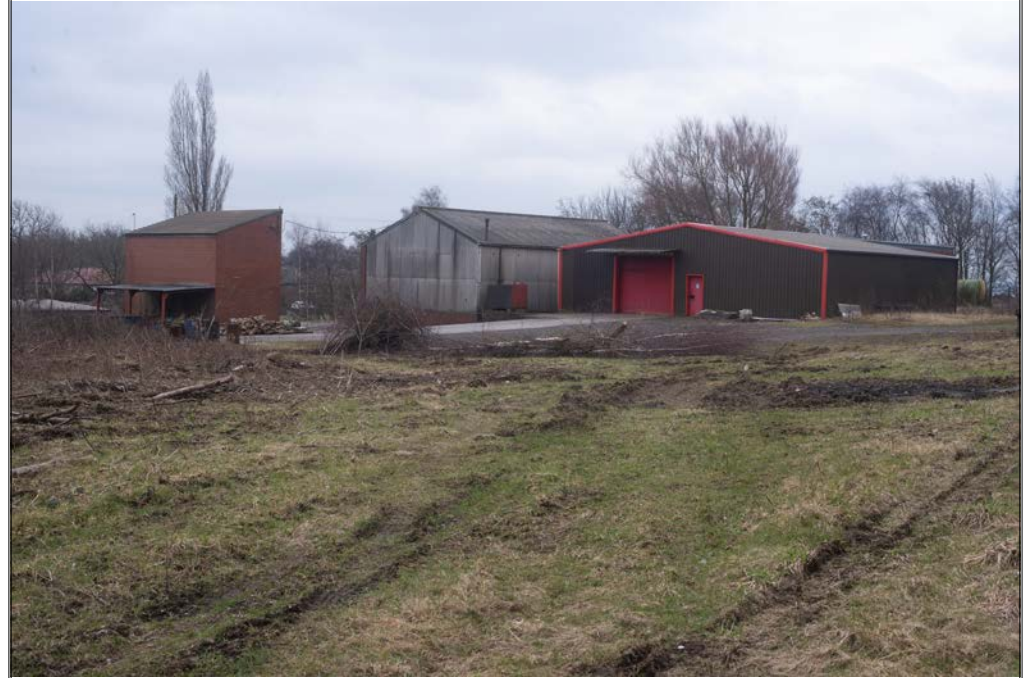
Building group from the north with former spoil areas to foreground.

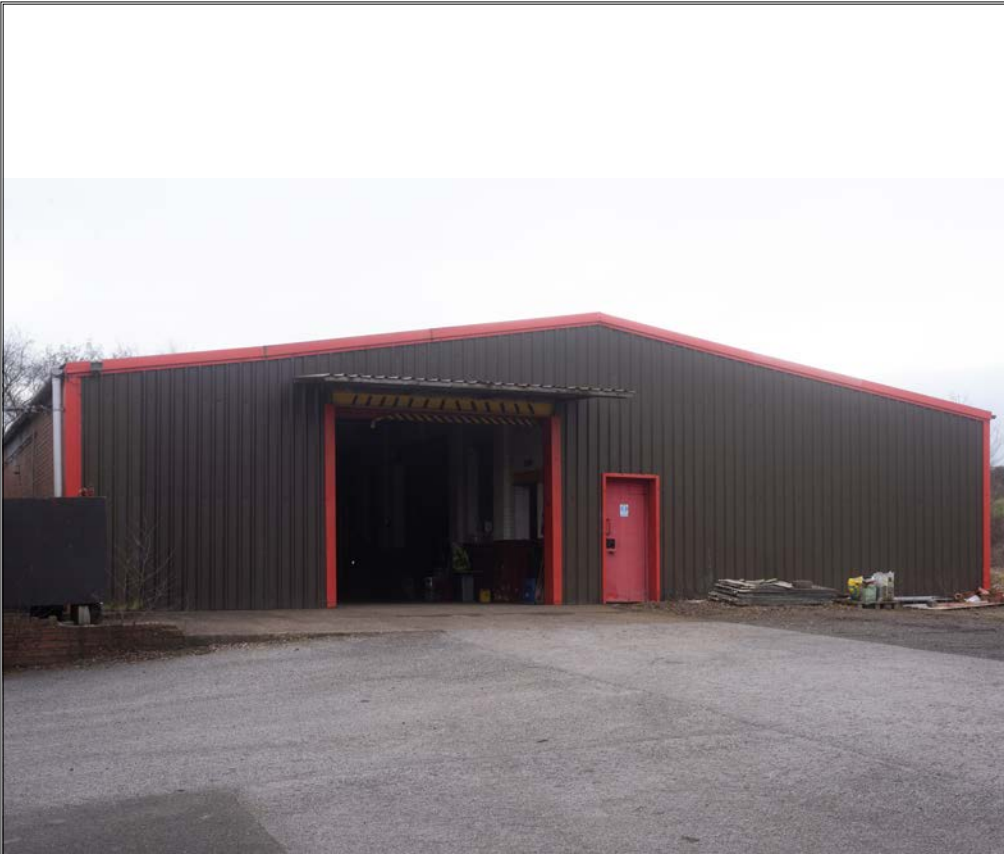
Plate 3  
North range shed from the east. Constructed in a red stock brick with later extension to north in blockwork and now over-clad.

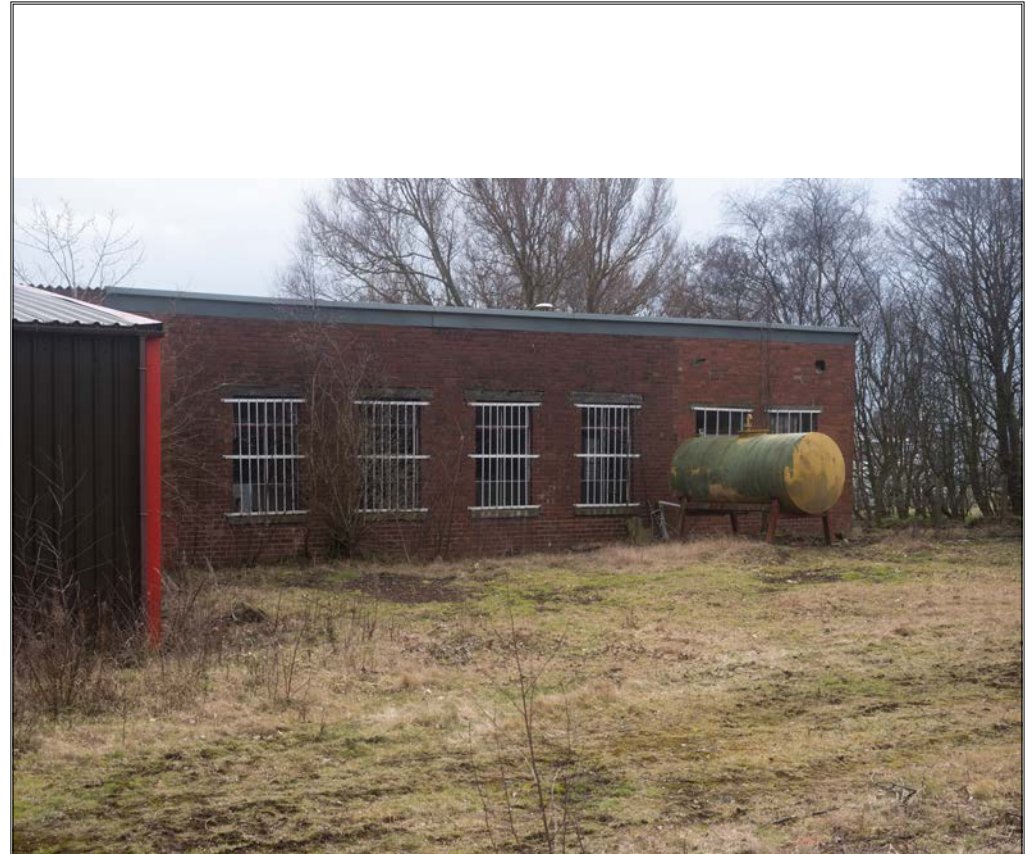
Plate 4  
North range shed from north. The western section has not been extended to the north but changes in brickwork and window treatment indicate an extension to the east.

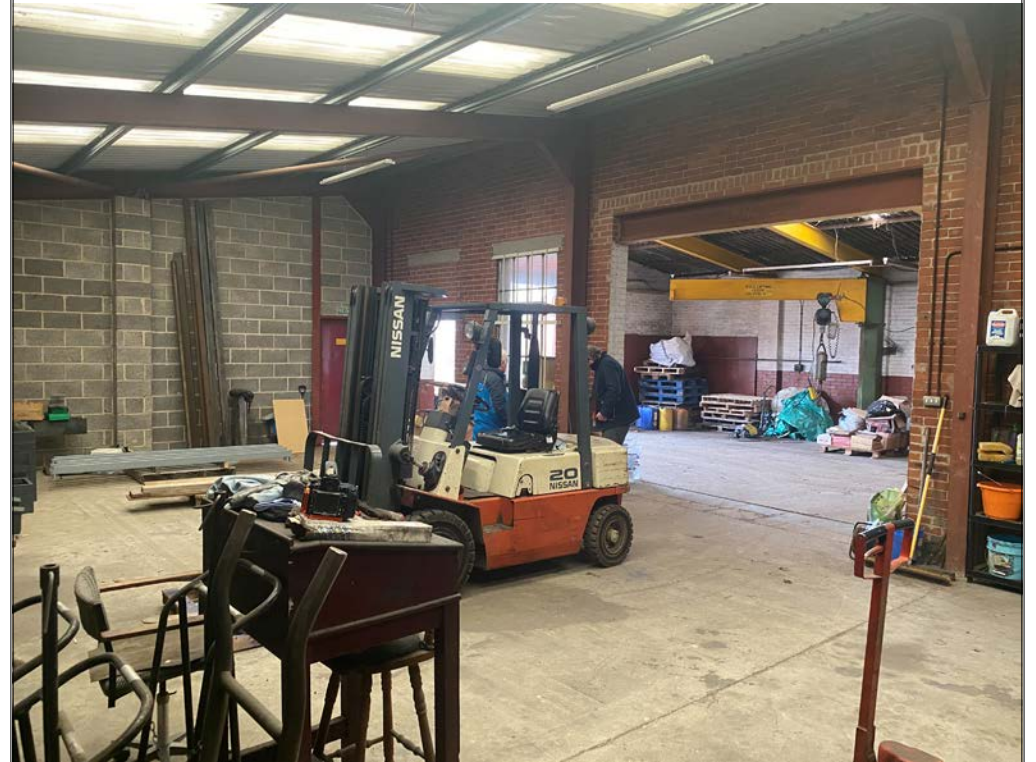
Plate 6  
North range shed interior. Original north wall now internal within later blockwork extension.

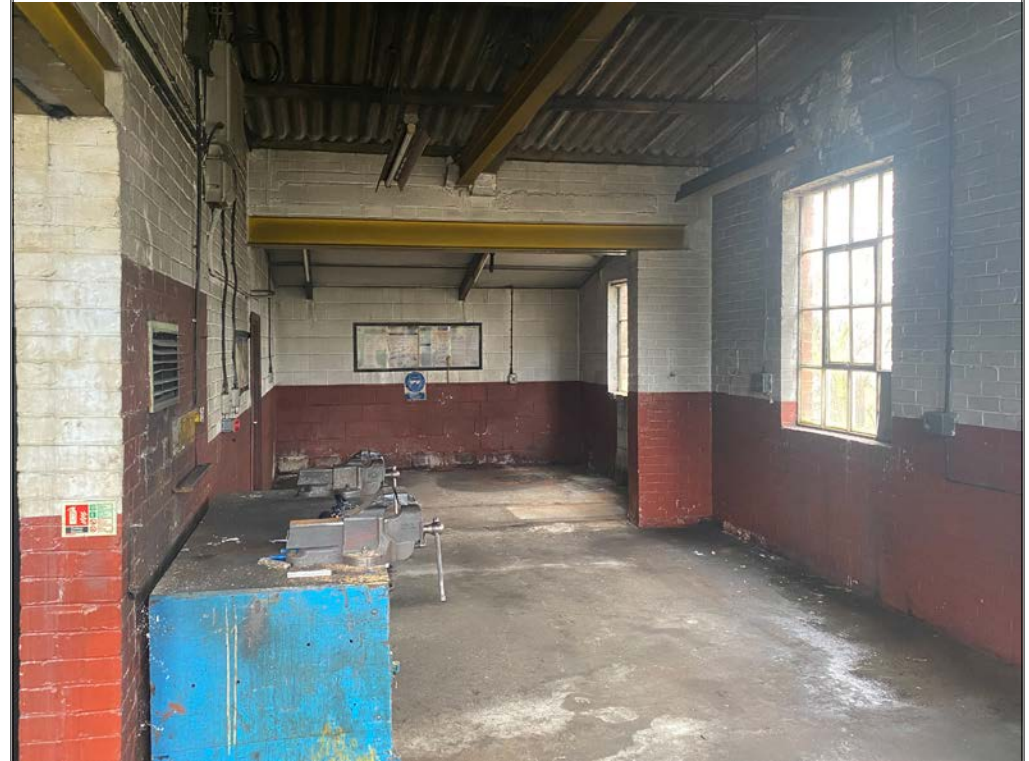
Plate 8  
North range shed, eastern section interior. Later extension.

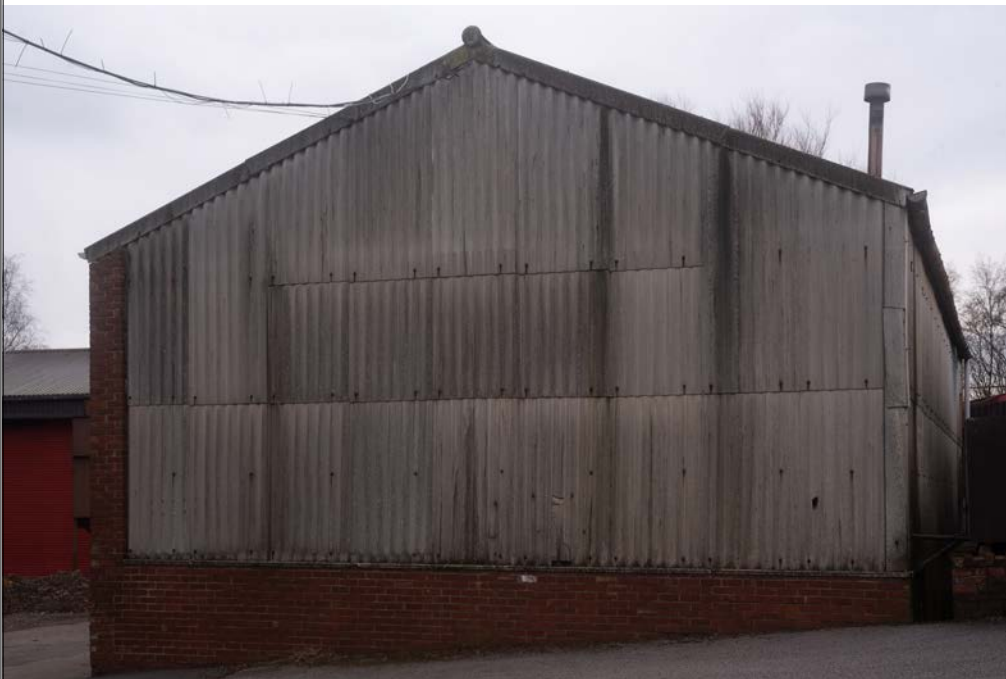
Plate 9  
Central range shed from east. Building is constructed in a red stock brick, sheet cladding and latter blockwork.

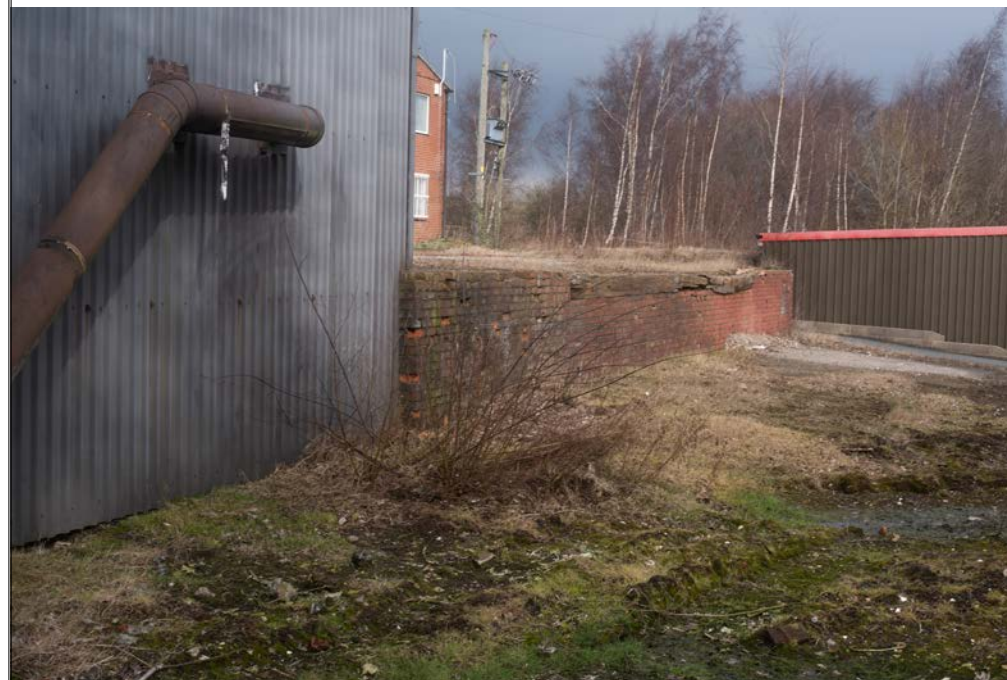
Plate 16  
West range shed, south elevation. Retaining walls indicating fabric from earlier buildings and structures.

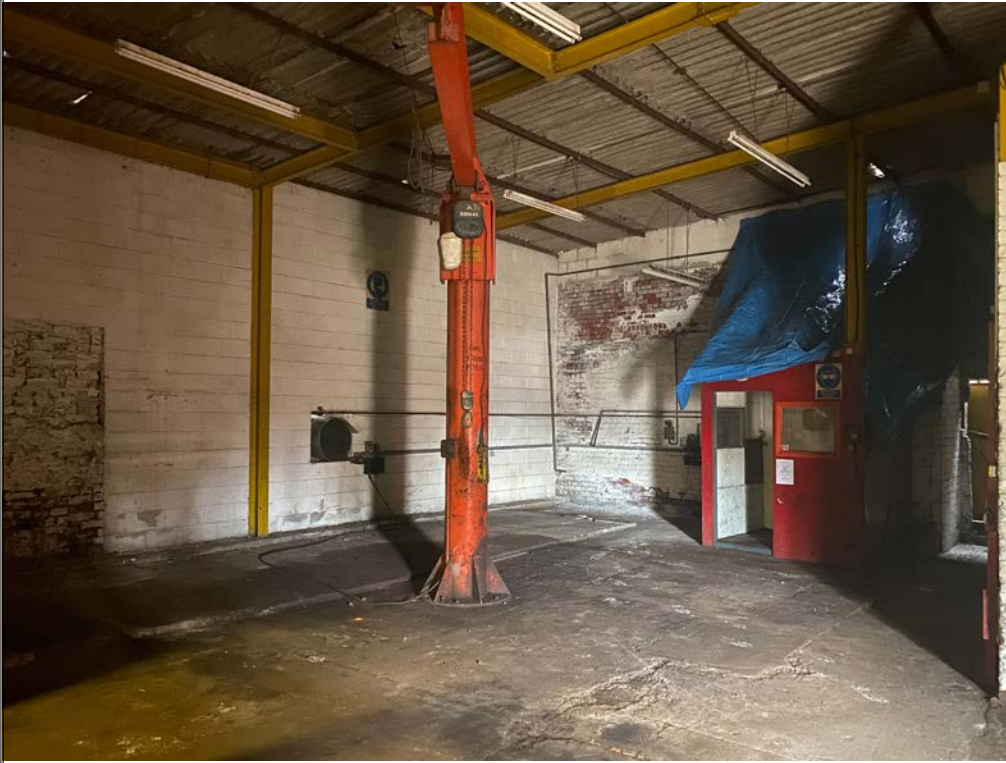
Plate 17  
West range shed interior, northern section. Some earlier fabric is retained with the majority of walling now formed in blockwork.

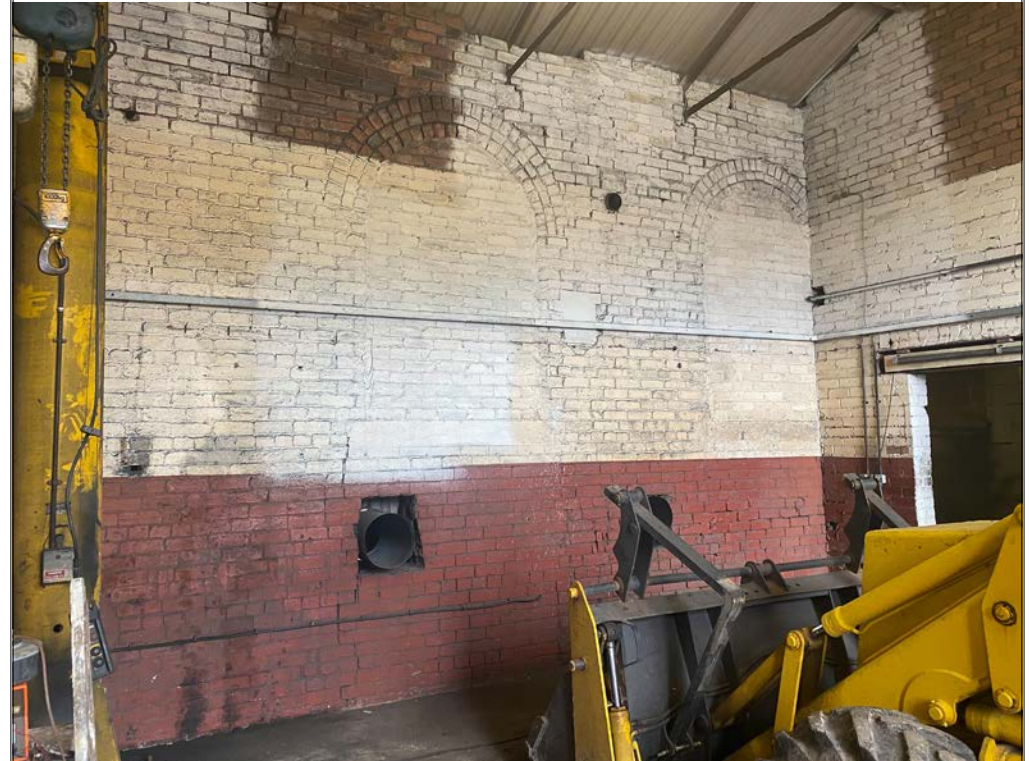
- 3.05 The west and south-east walls of the west range retain blocked off window openings with brick arched heads those to the west wall in part bisected by a later division wall. The design and depth of the openings is suggestive of an engine or pump house although legibility is poor. The positioning of openings suggests a constructed in 2 x 3 bays. Wall boxes are evident but appear to be later additions connected with the engineering works. The original height of the

Plate 20  
West range shed interior, southern section, east wall. Earlier fabric retained with arch head window openings. Division wall to right is later addition.

- 4.03 Further pre-demolition evaluation of retained fabric is unlikely to further understanding of mining operations within the site during the 19<sup>th</sup> and early 20<sup>th</sup> century. Remaining fabric is fragmentary with no fully retained buildings from this period standing. It is however recommended that further discussions are undertaken with West Yorkshire Archaeological Advisory Services in respect of any further recording or evaluation work.

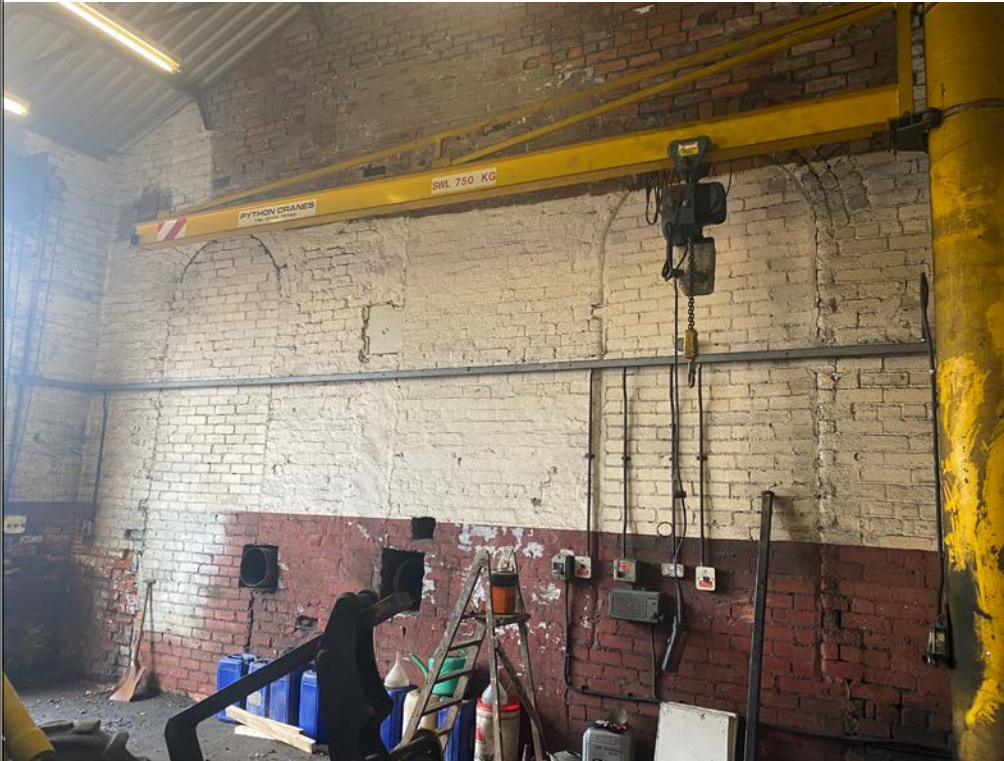
Plate 21  
West range shed interior, southern section, south wall. Earlier fabric retained with tall arch head window openings. Wall boxes appear later additions.

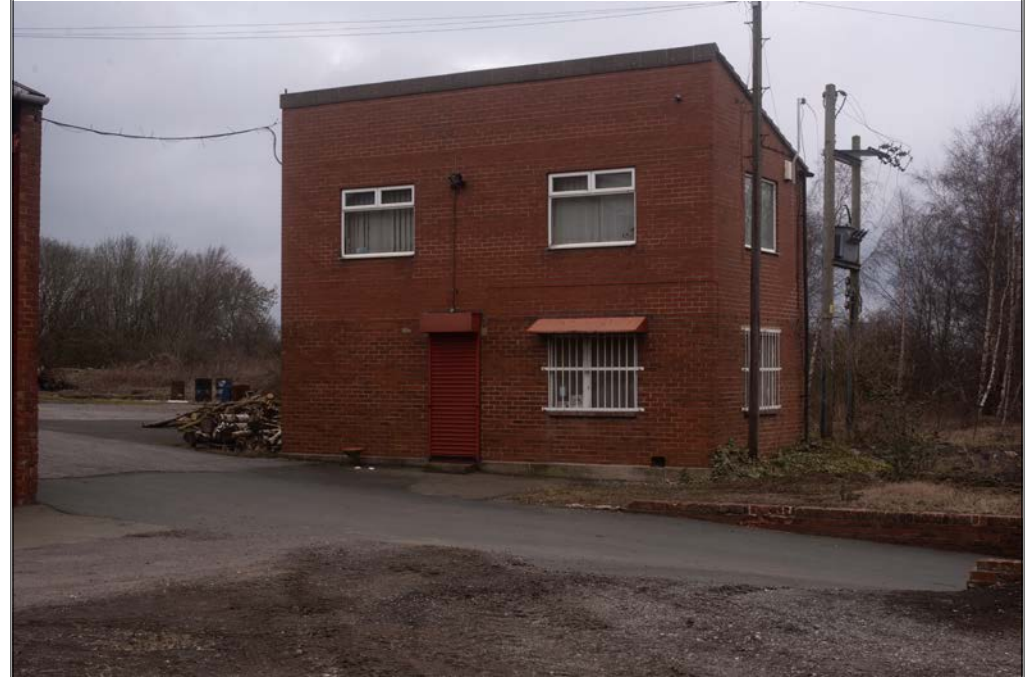
Plate 22  
Later office building in red stock brick with profile sheet roof covering.
