REPORT ON A GEO-ENVIRONMENTAL INVESTIGATION

**MANASHAY, UPPER BROW ROAD, PADDOCK
HUDDERSFIELD HD1 4UP**

Report No J3220/15/E

November 2015

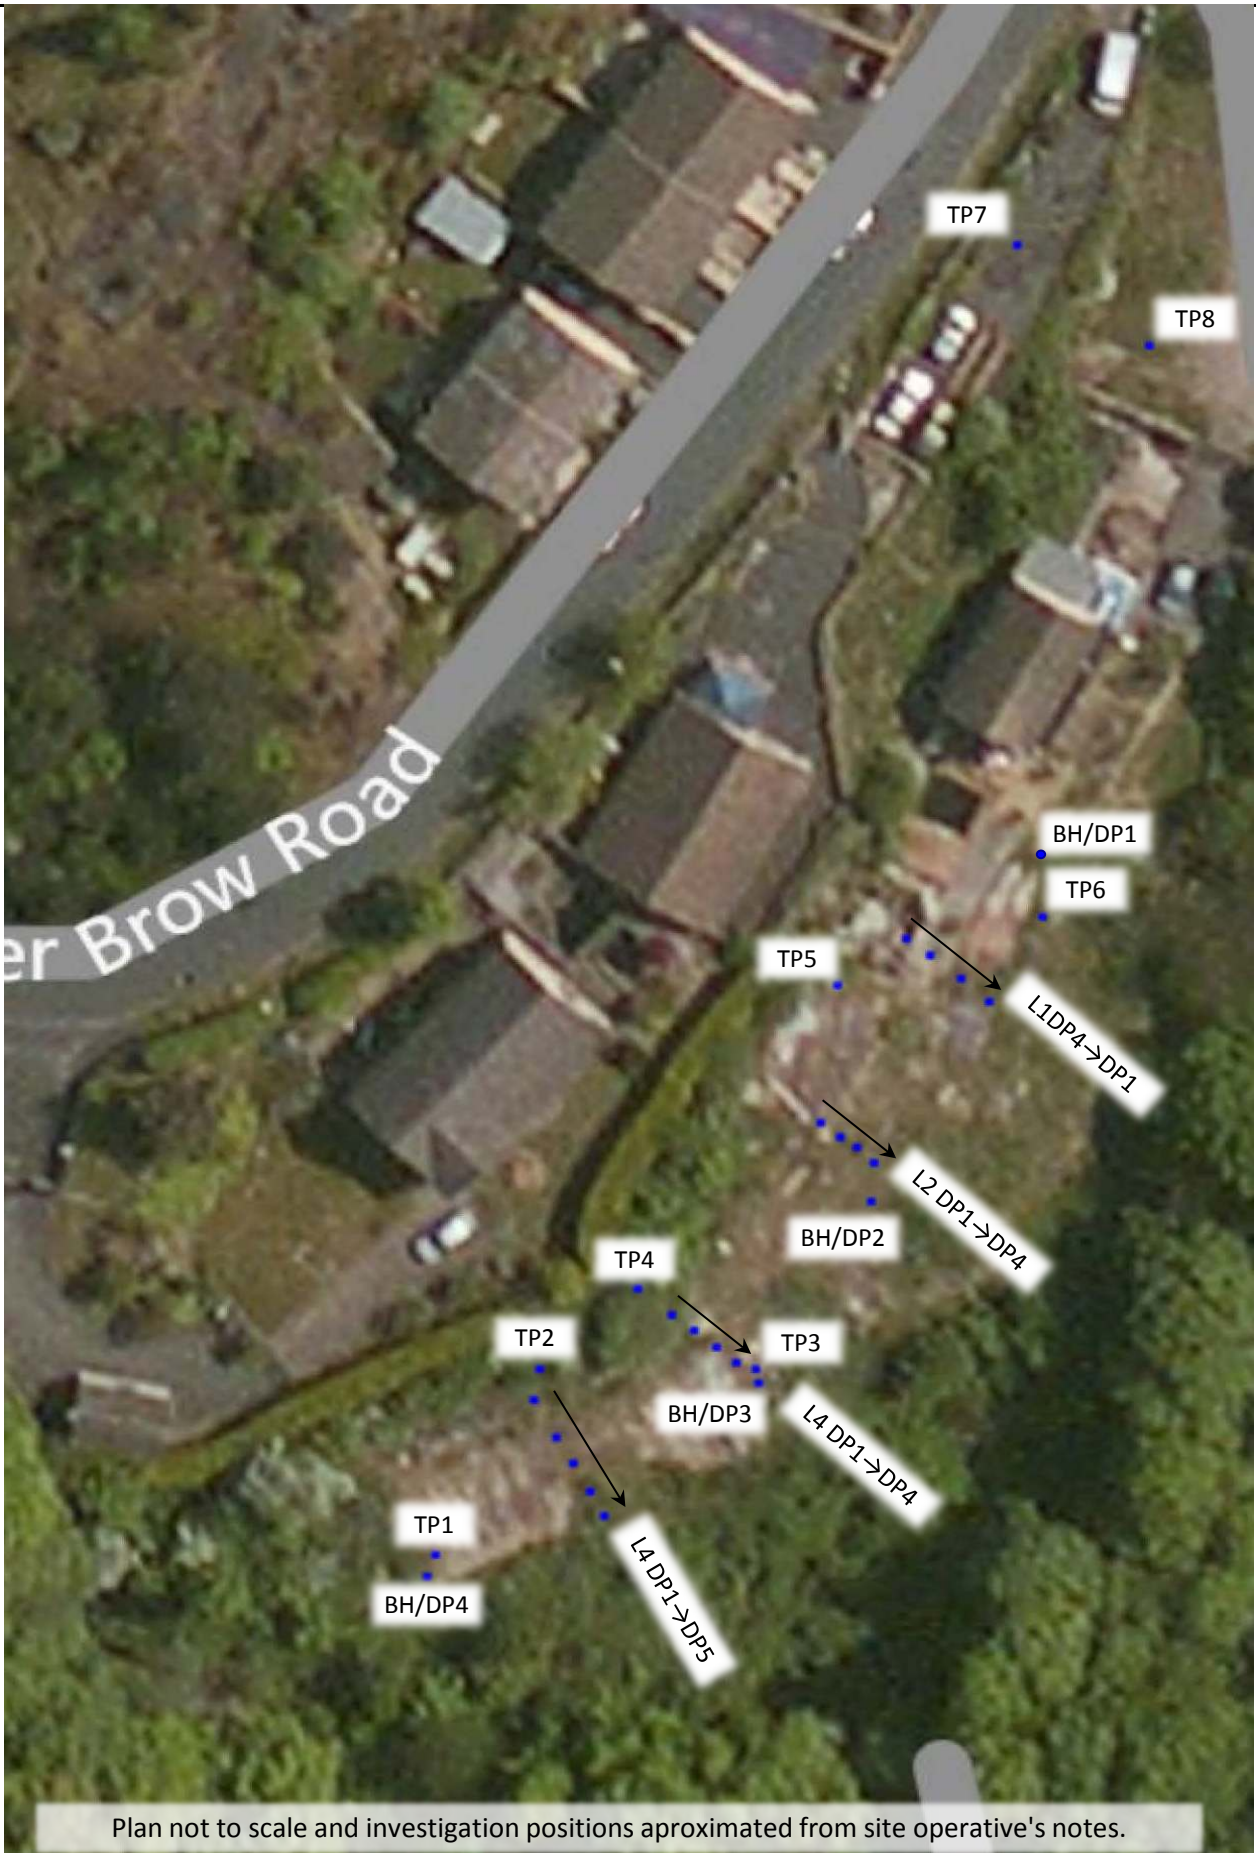
Title: **Investigation Location Plan**

Plan not to scale and investigation positions approximated from site operative's notes.

- Eight machine excavated trialpits.
- Eighteen dynamic probes to profile the sub-surface conditions.
- Four windowless sample and rotary boreholes with adjacent dynamic probes.

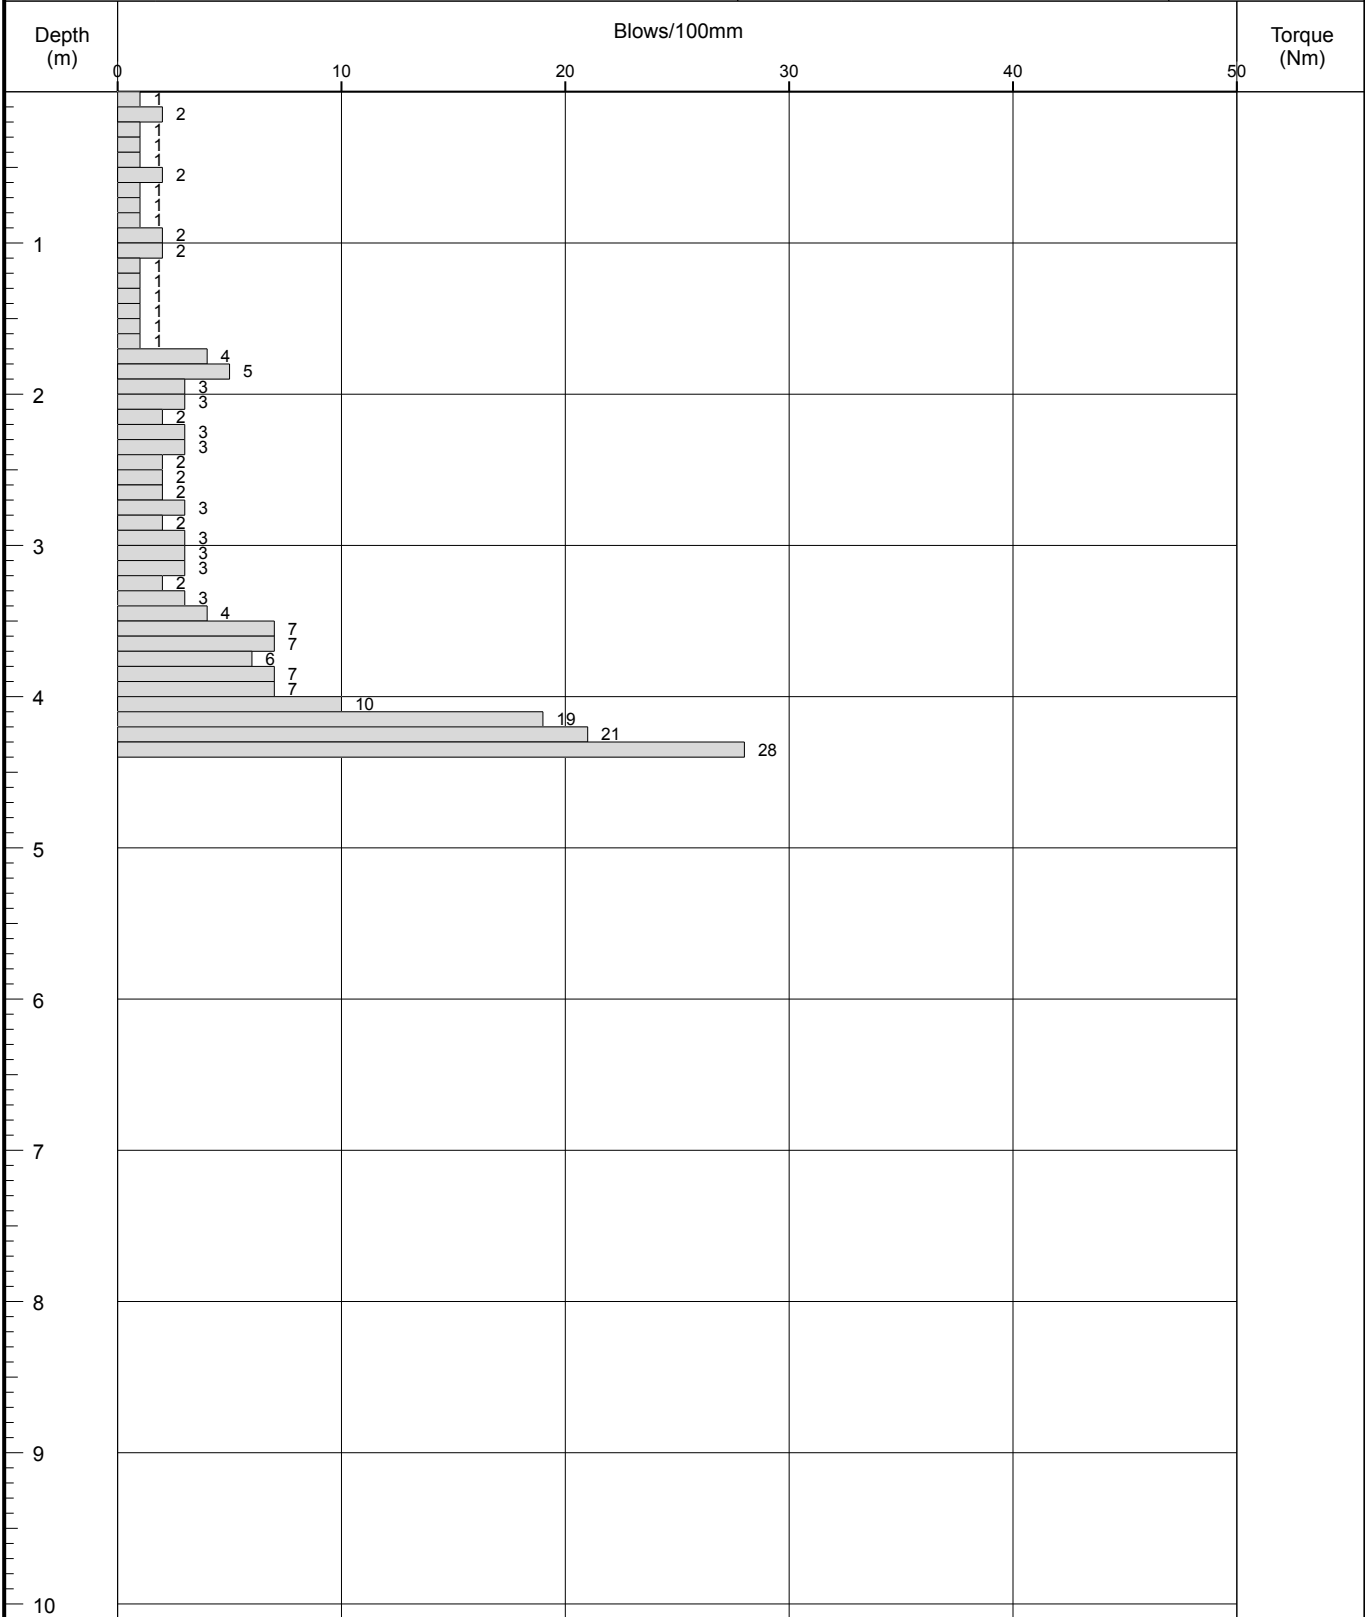
Project Name: Manashay, Upper Brow Road	Project No. J3220/15/E	Co-ords:	Hole Type DCP
Location: Paddock, Huddersfield		Level:	Scale 1:50
Client: Shaw & Jagger		Dates: 17/08/2015	Logged By

Remarks:	Fall Height	750mm	Cone Base Diameter	50.5mm
	Hammer Wt	63.5kg	Final Depth	4.3m
	Probe Type	DPSH-B

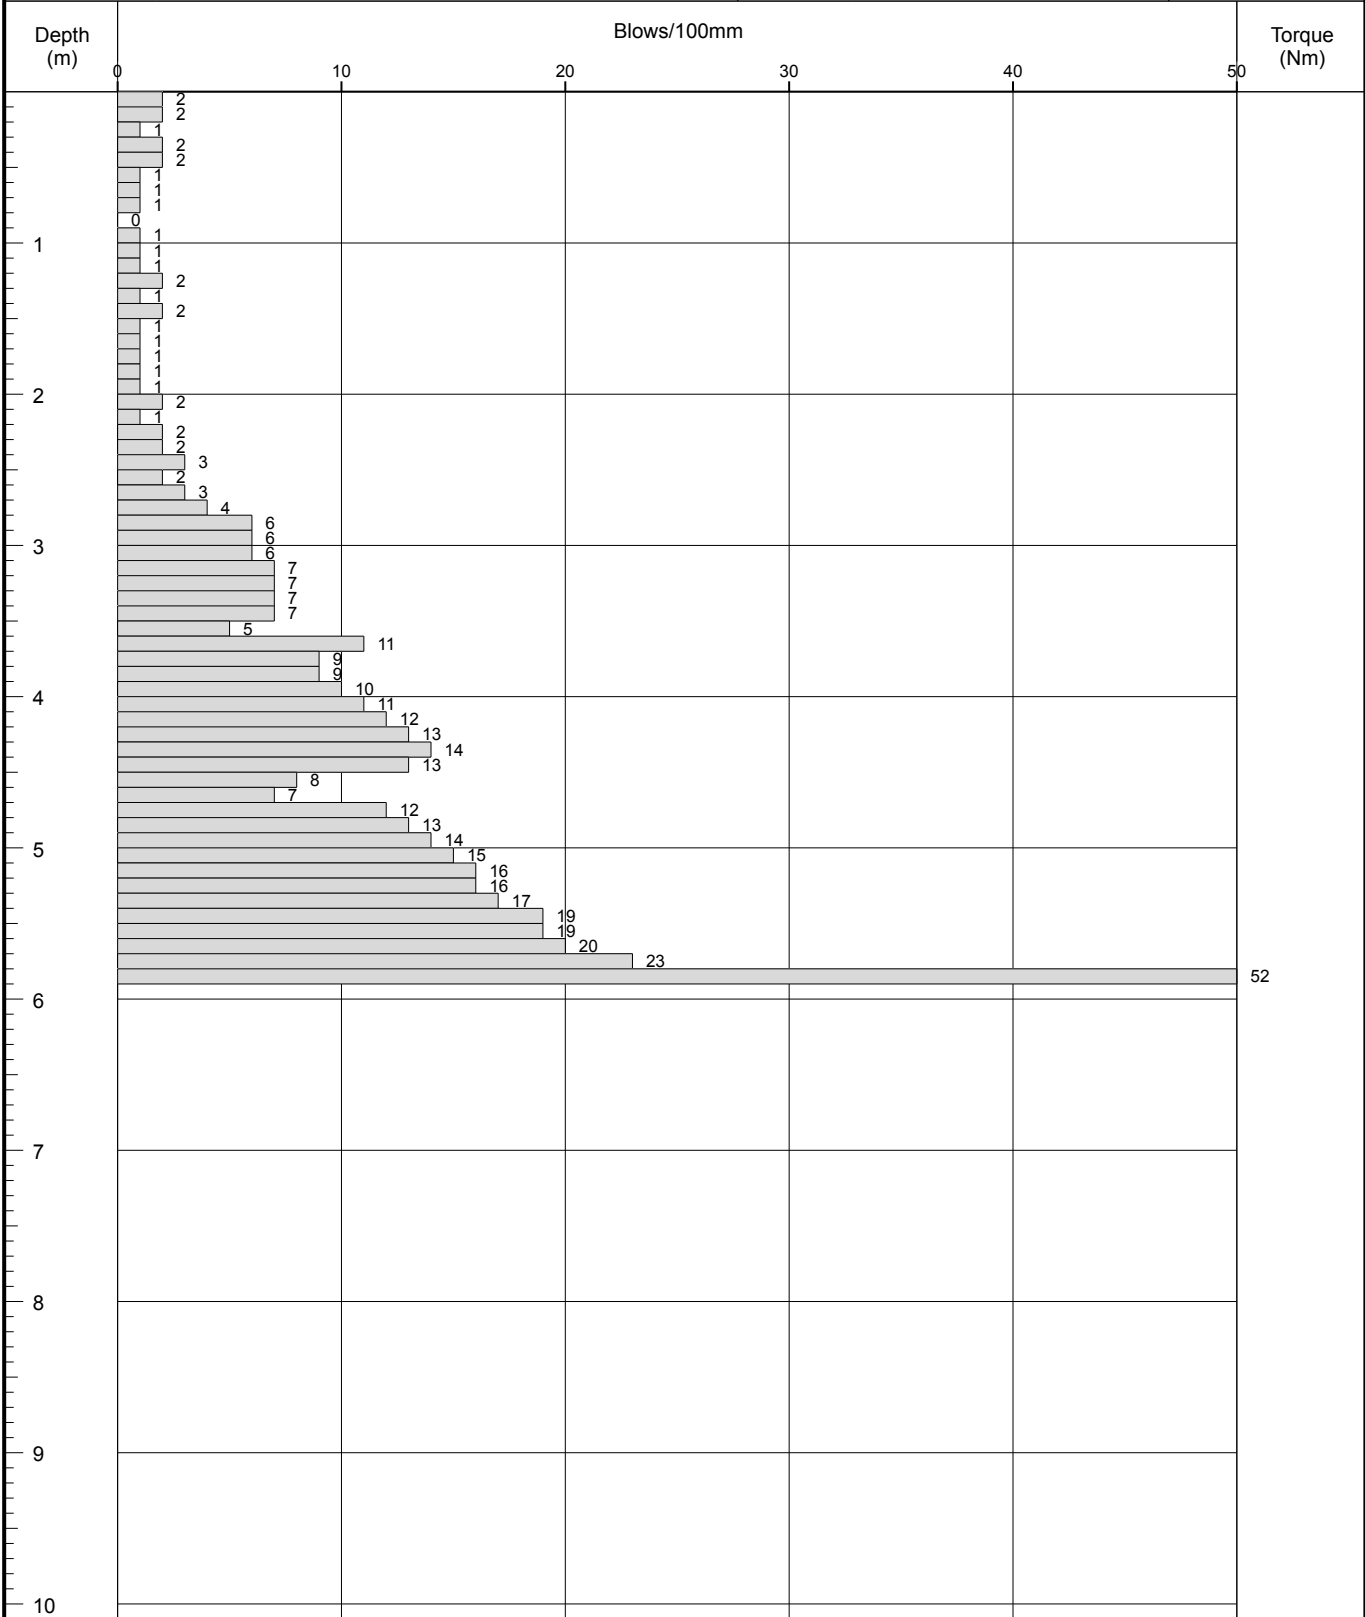
Project Name: Manashay, Upper Brow Road	Project No. J3220/15/E	Co-ords:	Hole Type DCP
Location: Paddock, Huddersfield		Level:	Scale 1:50
Client: Shaw & Jagger		Dates: 17/08/2015	Logged By

Remarks:	Fall Height	750mm	Cone Base Diameter	50.5mm
	Hammer Wt	63.5kg	Final Depth	5.8m
	Probe Type	DPSH-B

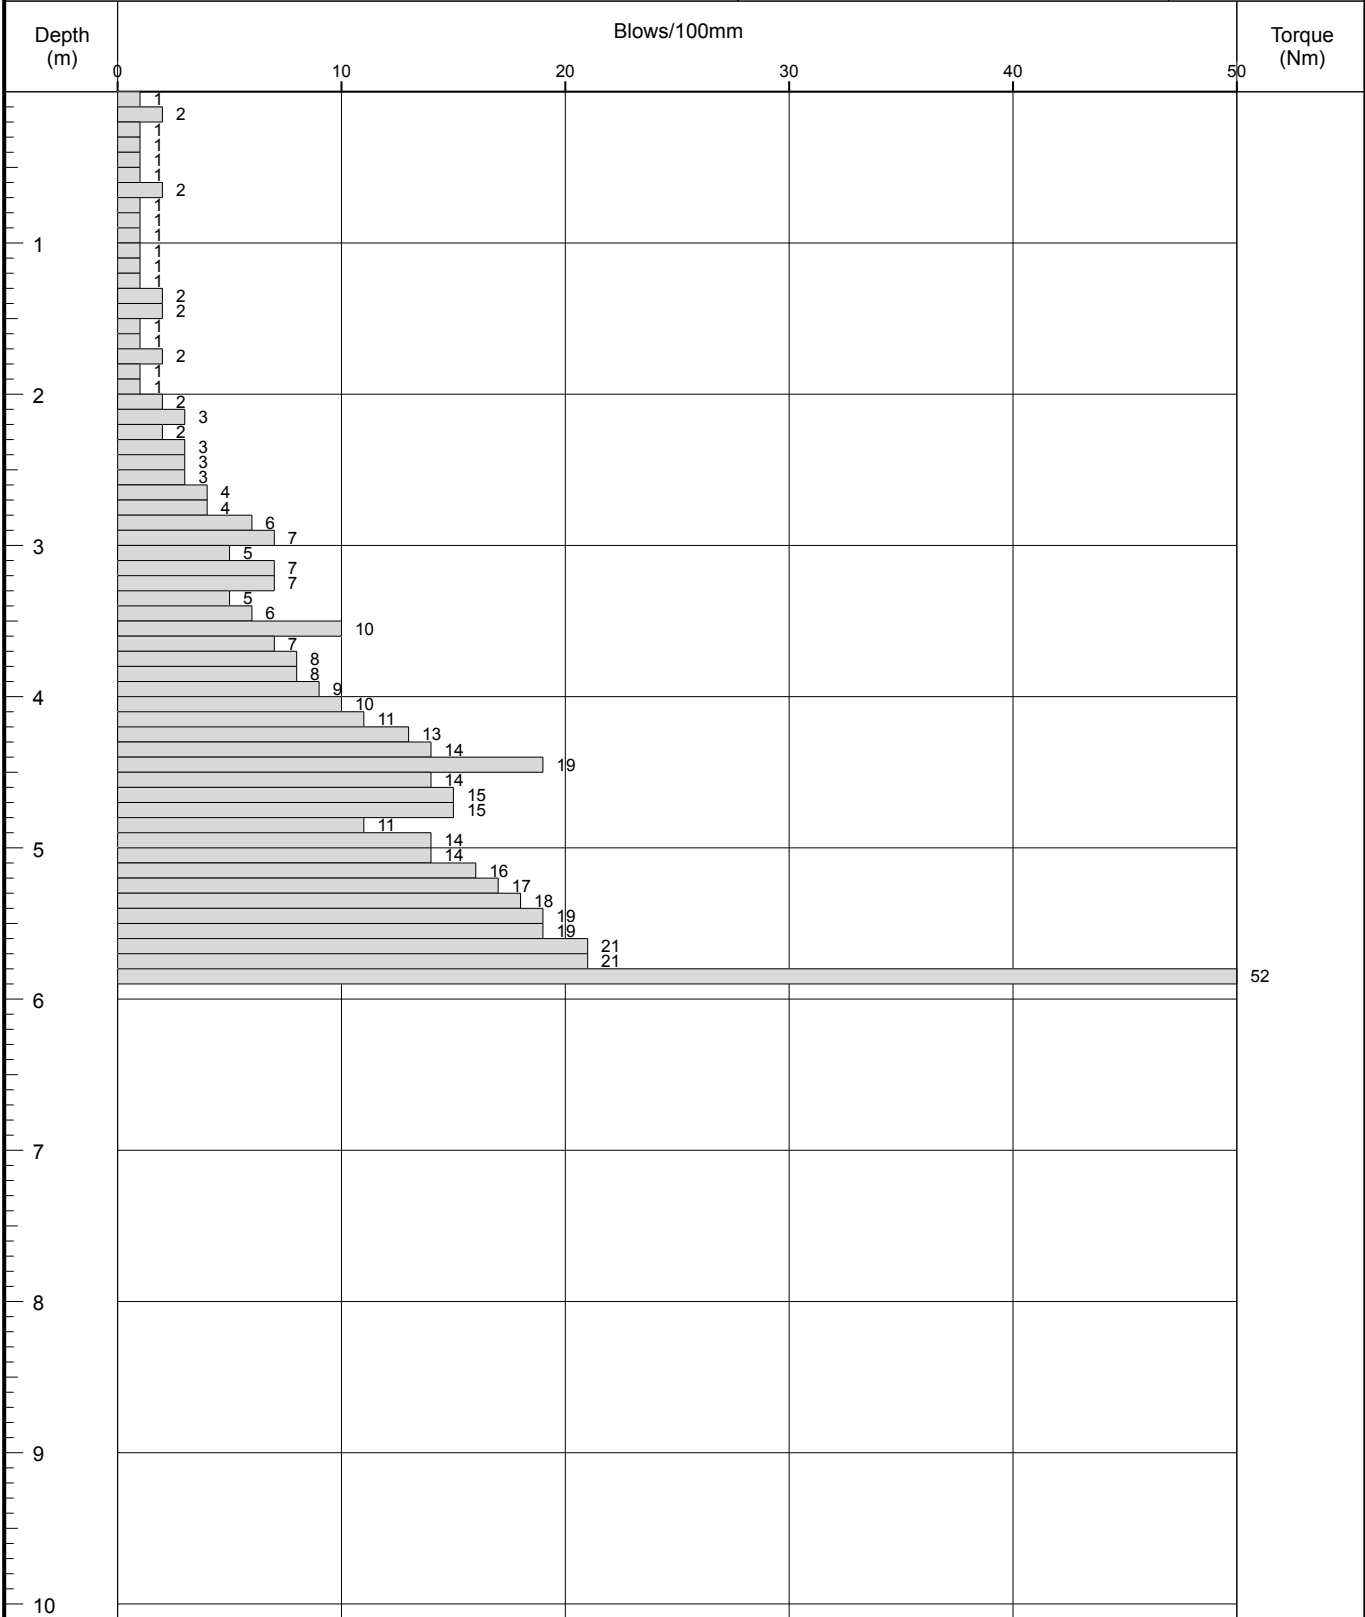
Project Name: Manashay, Upper Brow Road	Project No. J3220/15/E	Co-ords:	Hole Type DCP
Location: Paddock, Huddersfield	Level:		Scale 1:50
Client: Shaw & Jagger	Dates: 17/08/2015		Logged By

Remarks:	Fall Height	750mm	Cone Base Diameter	50.5mm
	Hammer Wt	63.5kg	Final Depth	5.8m
	Probe Type	DPSH-B

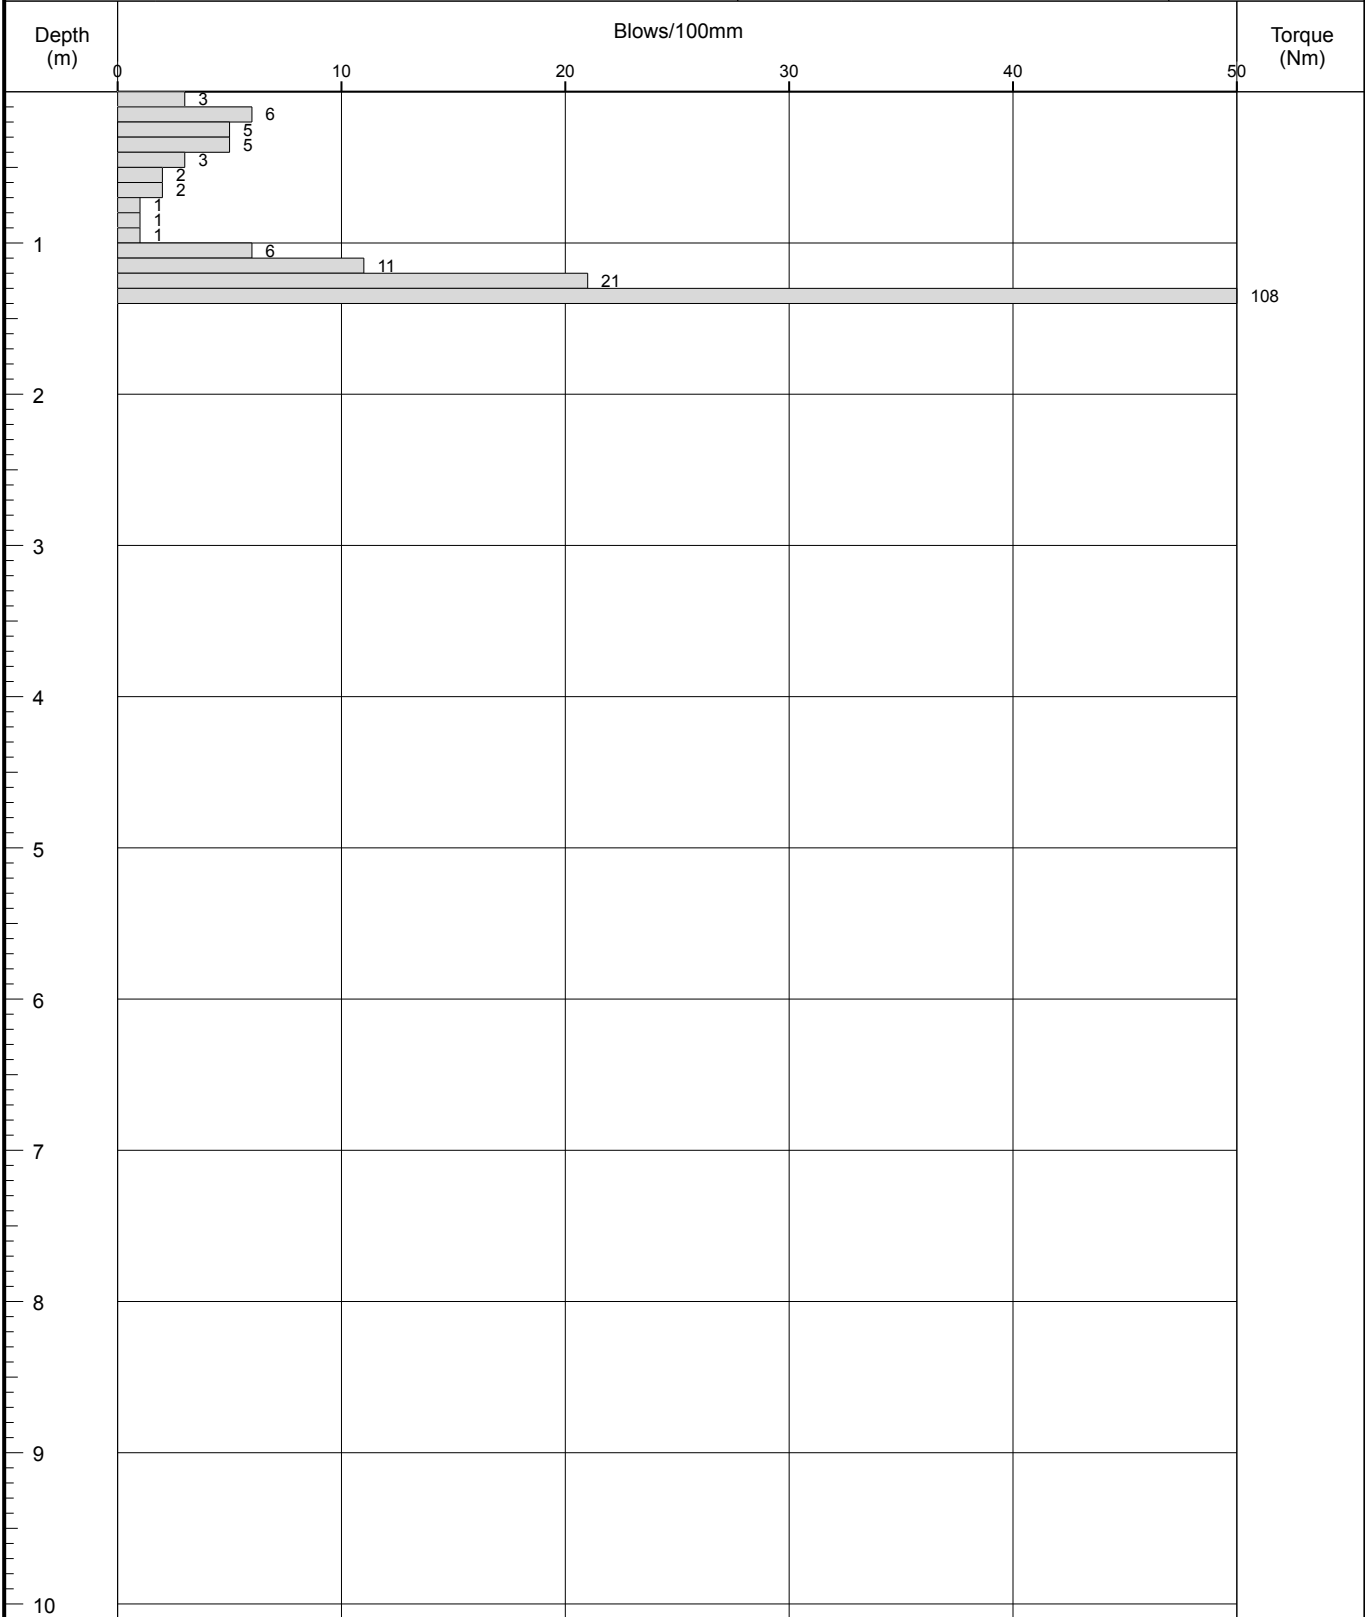
Project Name: Manashay, Upper Brow Road	Project No. J3220/15/E	Co-ords:	Hole Type DCP
Location: Paddock, Huddersfield	Level:		Scale 1:50
Client: Shaw & Jagger	Dates: 17/08/2015		Logged By

Remarks:	Fall Height	750mm	Cone Base Diameter	50.5mm
	Hammer Wt	63.5kg	Final Depth	1.3m
	Probe Type	DPSH-B

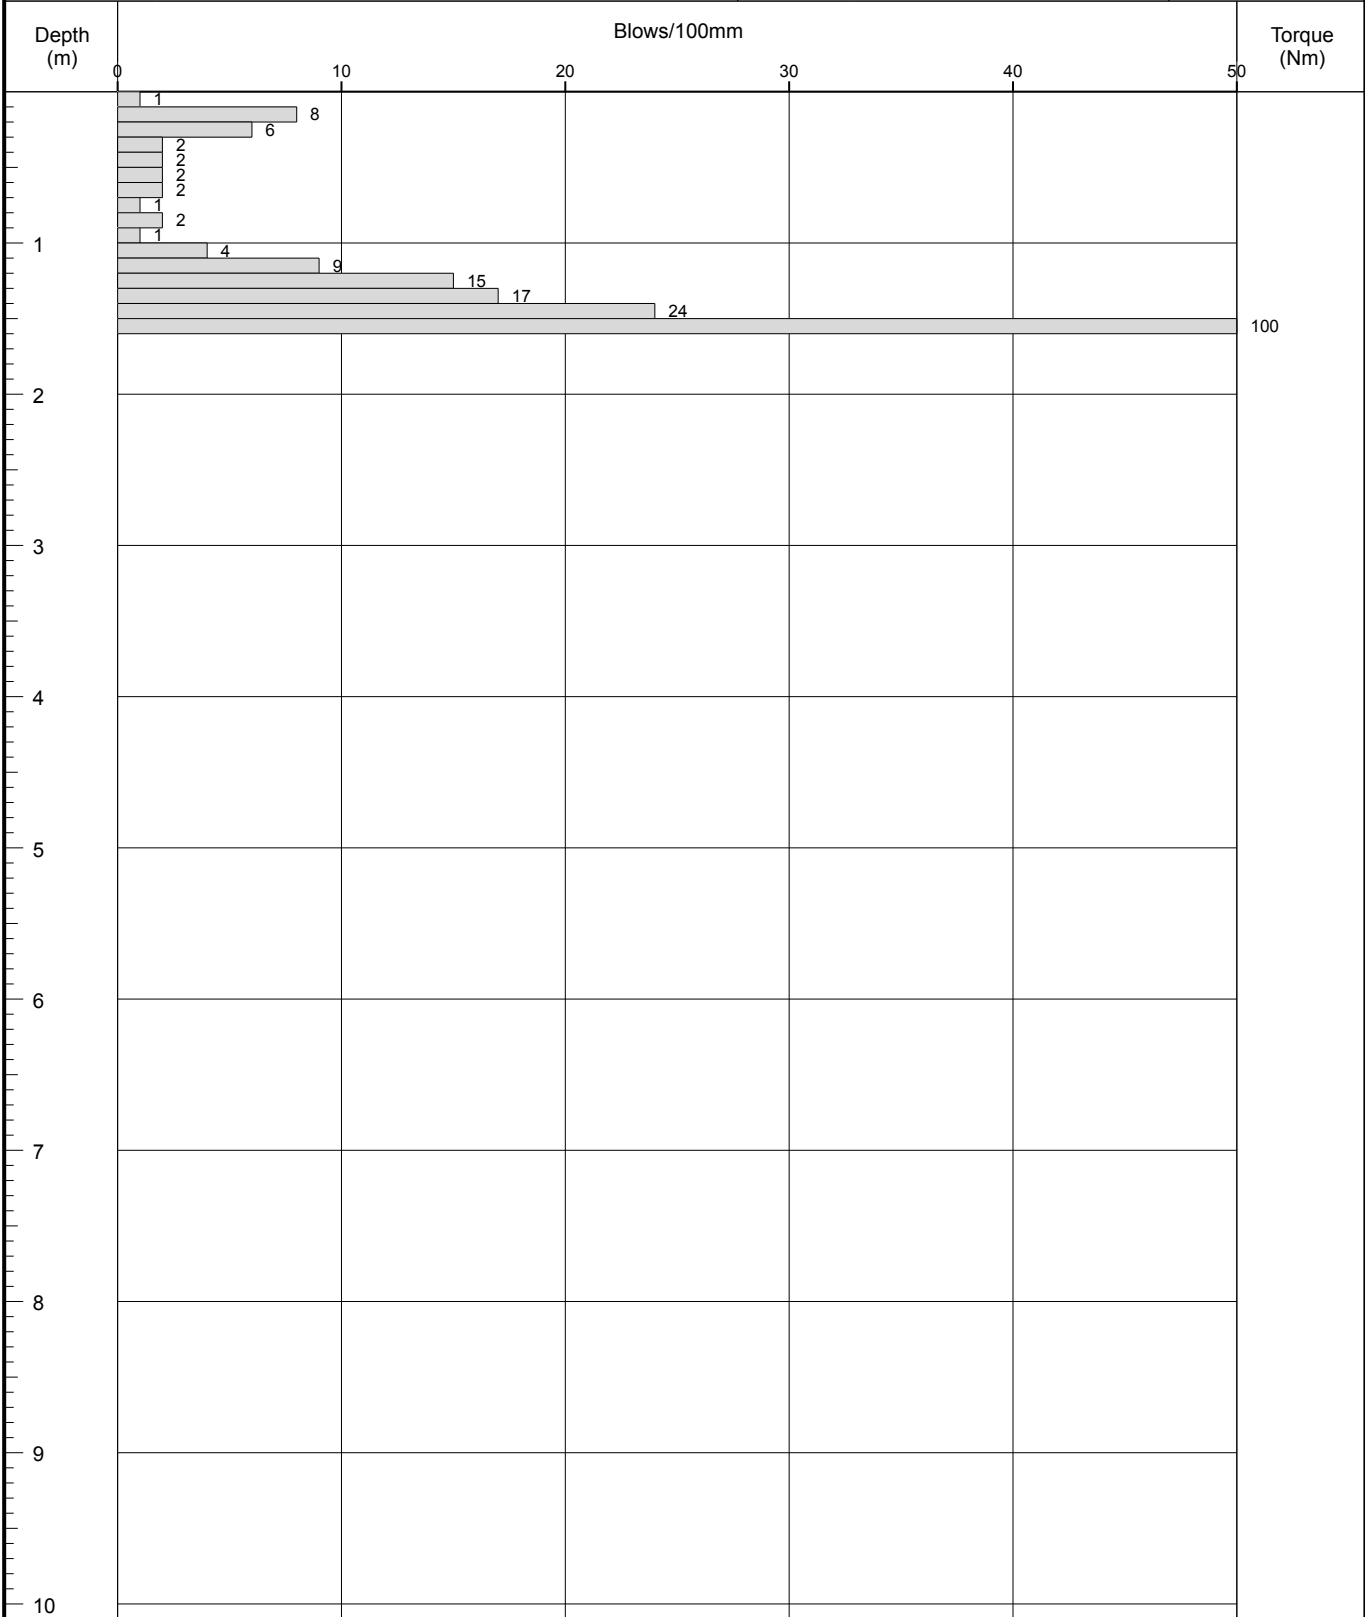
Project Name: Manashay, Upper Brow Road	Project No. J3220/15/E	Co-ords:	Hole Type DCP
Location: Paddock, Huddersfield		Level:	Scale 1:50
Client: Shaw & Jagger		Dates: 17/08/2015	Logged By

Remarks:	Fall Height	750mm	Cone Base Diameter	50.5mm
	Hammer Wt	63.5kg	Final Depth	1.5m
	Probe Type	DPSH-B

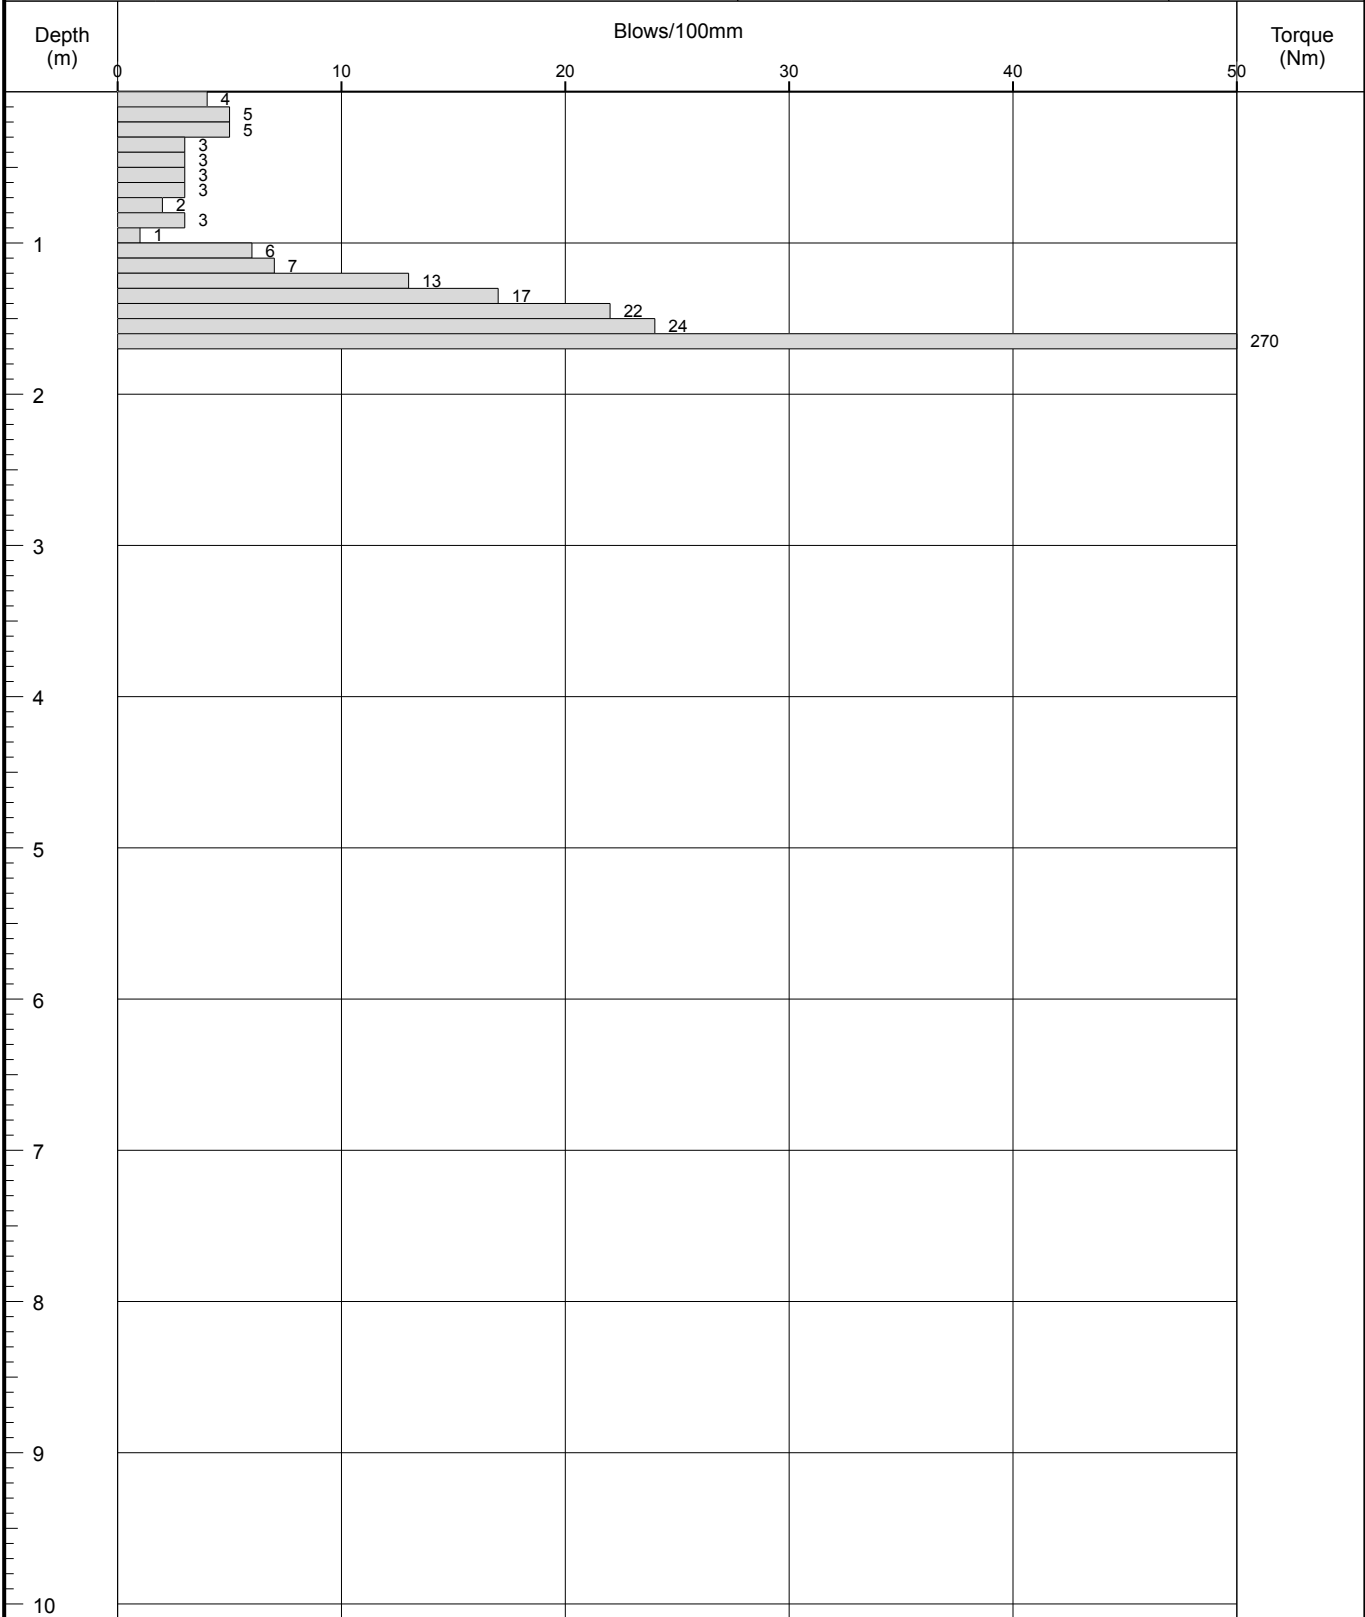
Project Name: Manashay, Upper Brow Road	Project No. J3220/15/E	Co-ords:	Hole Type DCP
Location: Paddock, Huddersfield		Level:	Scale 1:50
Client: Shaw & Jagger		Dates: 17/08/2015	Logged By

Remarks:	Fall Height	750mm	Cone Base Diameter	50.5mm
	Hammer Wt	63.5kg	Final Depth	1.6m
	Probe Type	DPSH-B

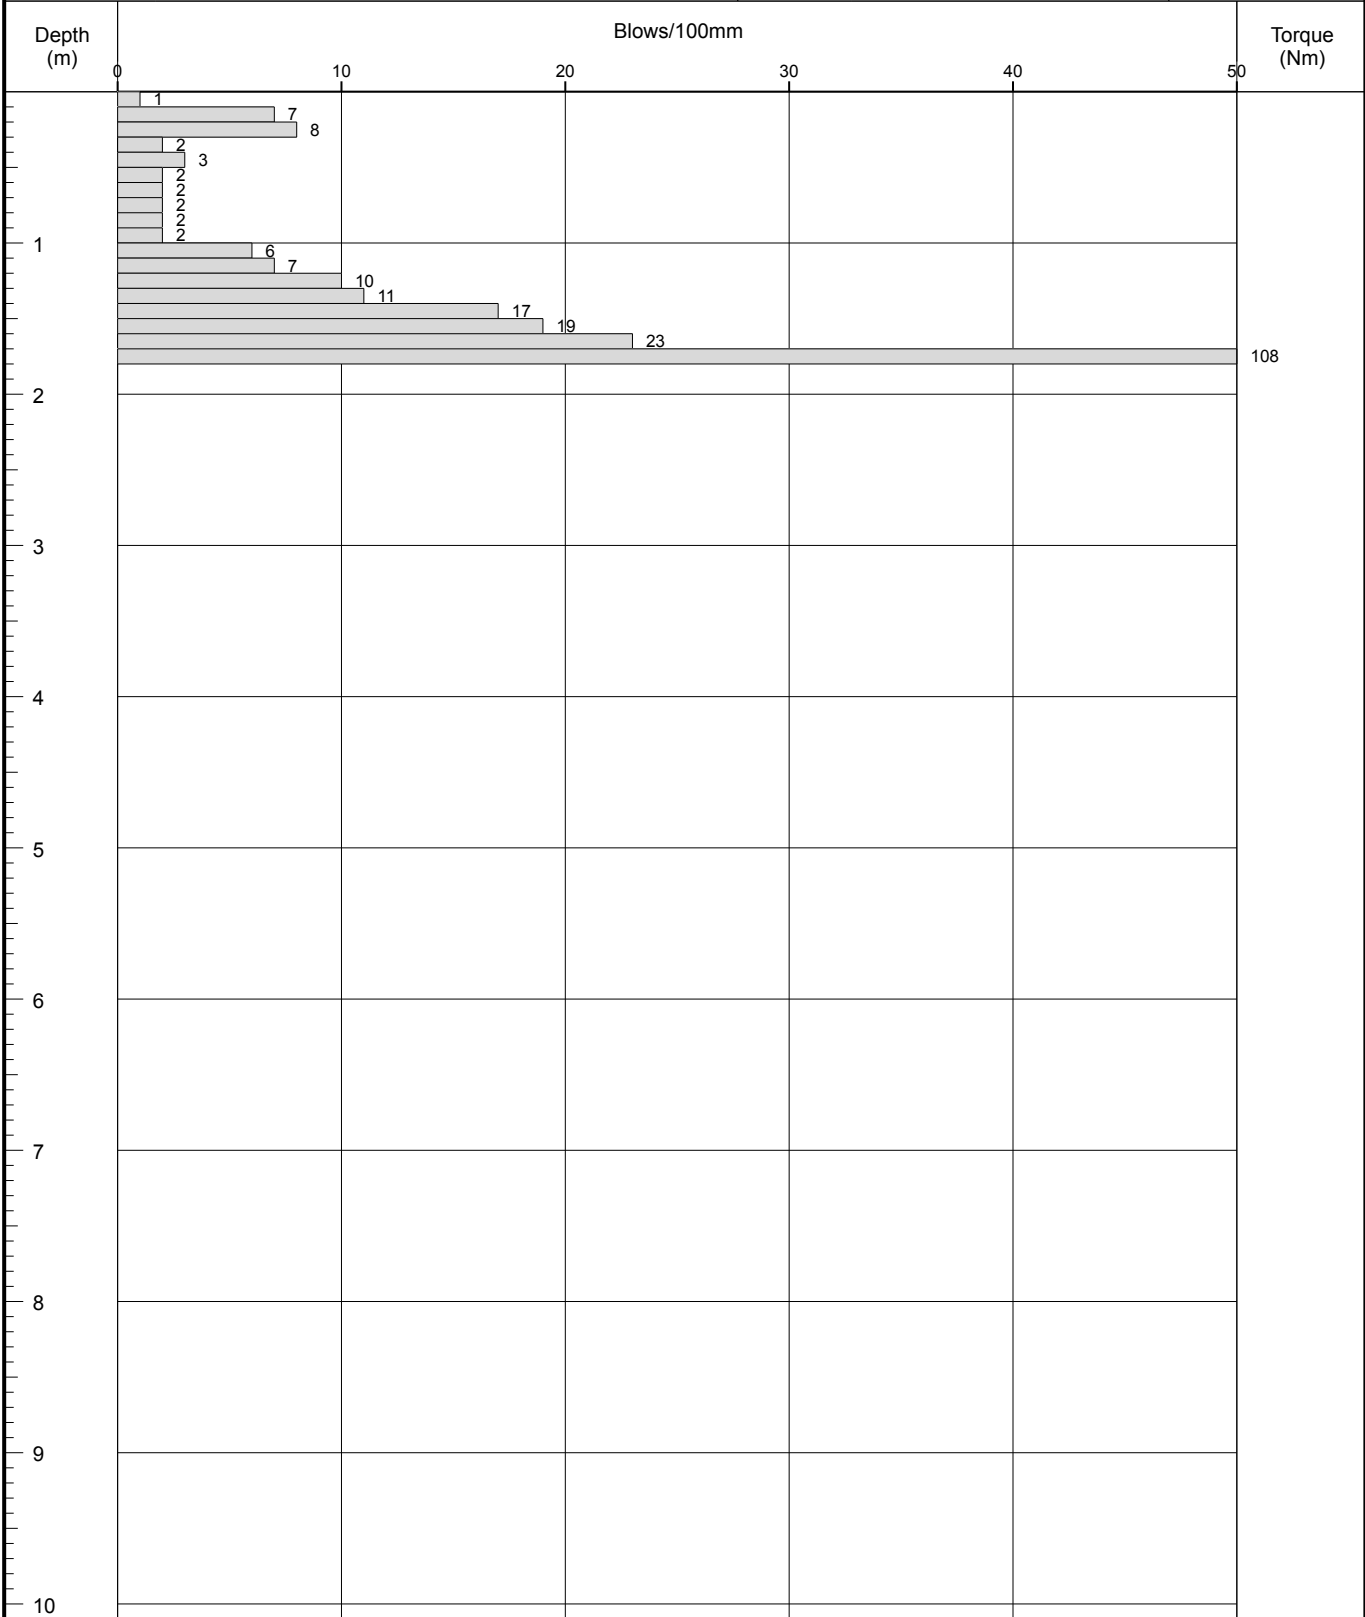
Project Name: Manashay, Upper Brow Road	Project No. J3220/15/E	Co-ords:	Hole Type DCP
Location: Paddock, Huddersfield		Level:	Scale 1:50
Client: Shaw & Jagger		Dates: 17/08/2015	Logged By

Remarks:	Fall Height	750mm	Cone Base Diameter	50.5mm
	Hammer Wt	63.5kg	Final Depth	1.7m
	Probe Type	DPSH-B

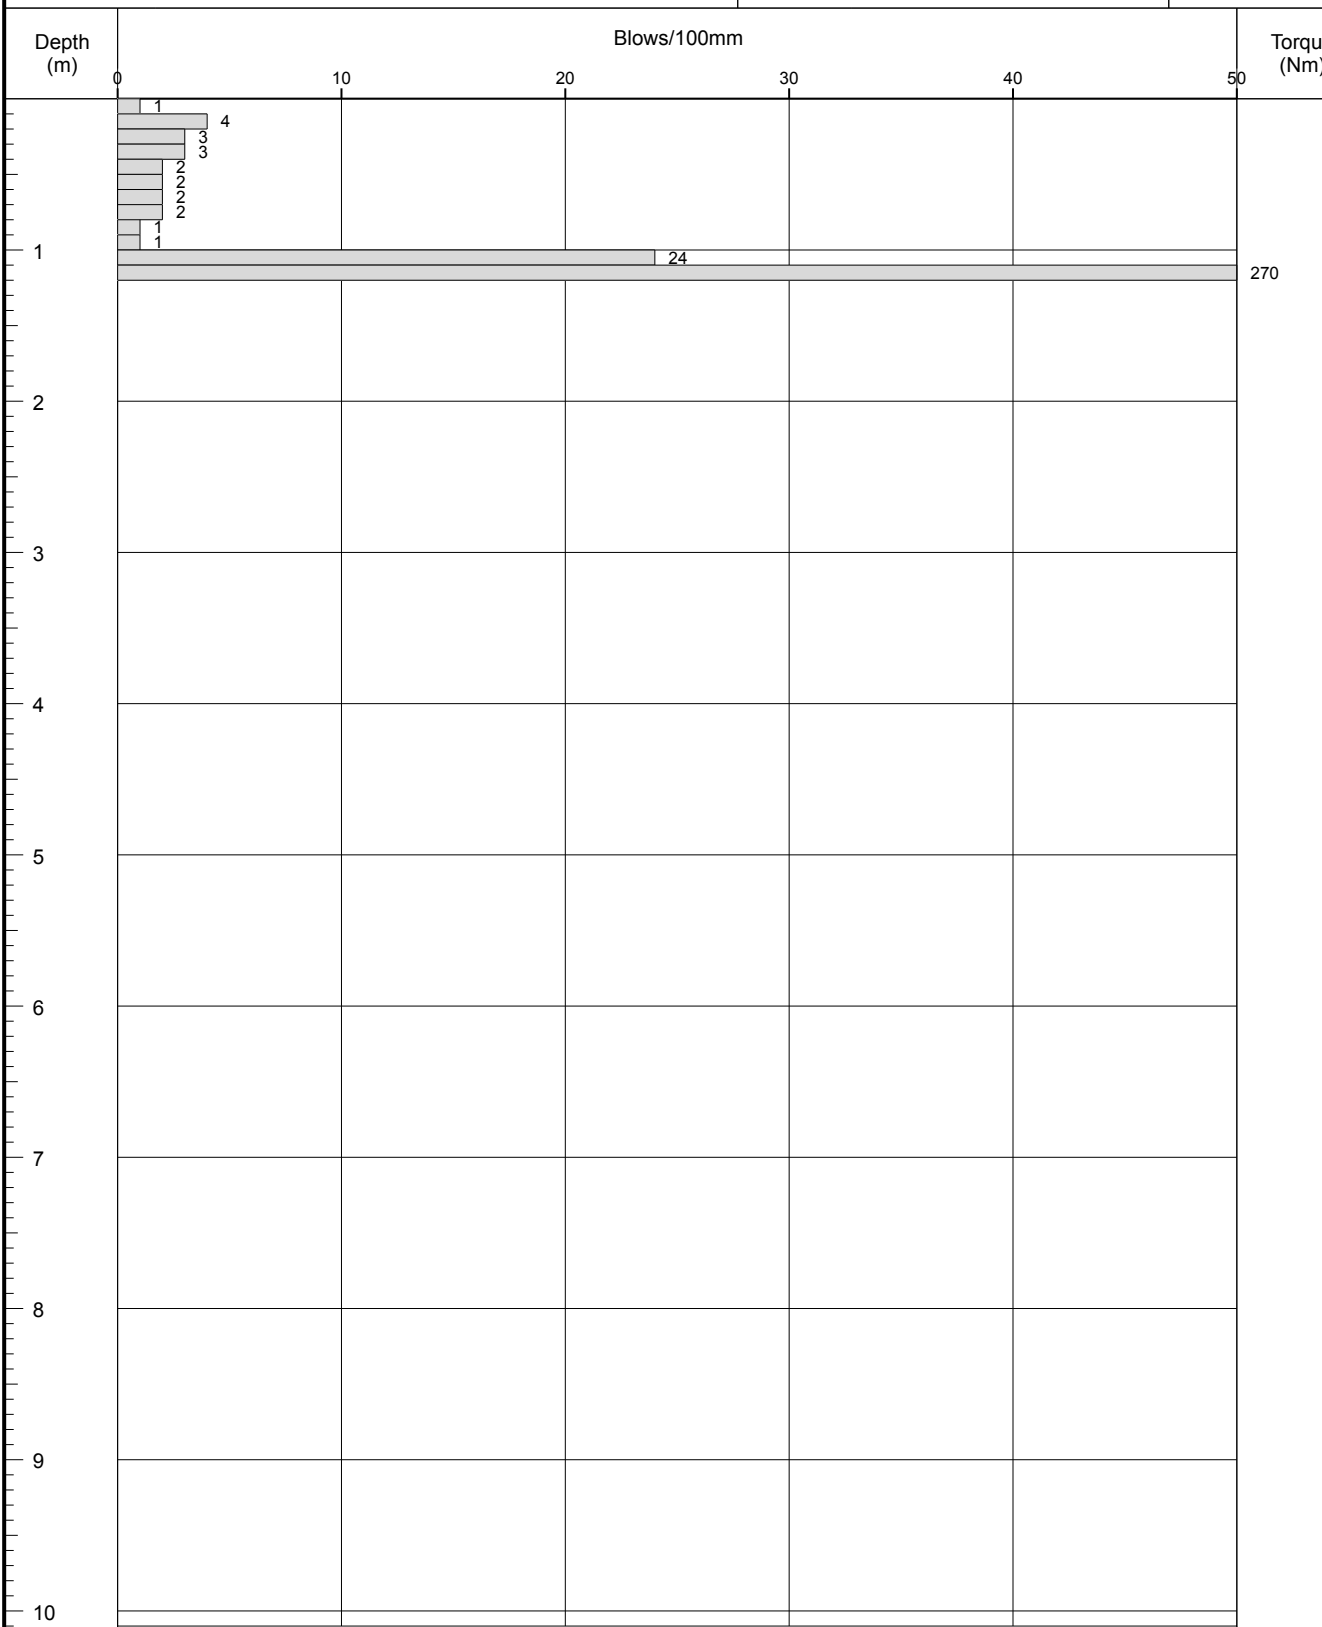
Project Name: Manashay, Upper Brow Road	Project No. J3220/15/E	Co-ords:	Hole Type DCP
Location: Paddock, Huddersfield		Level:	Scale 1:50
Client: Shaw & Jagger		Dates: 17/08/2015	Logged By

Remarks:	Fall Height	750mm	Cone Base Diameter	50.5mm
	Hammer Wt	63.5kg	Final Depth	1.1m
	Probe Type	DPSH-B

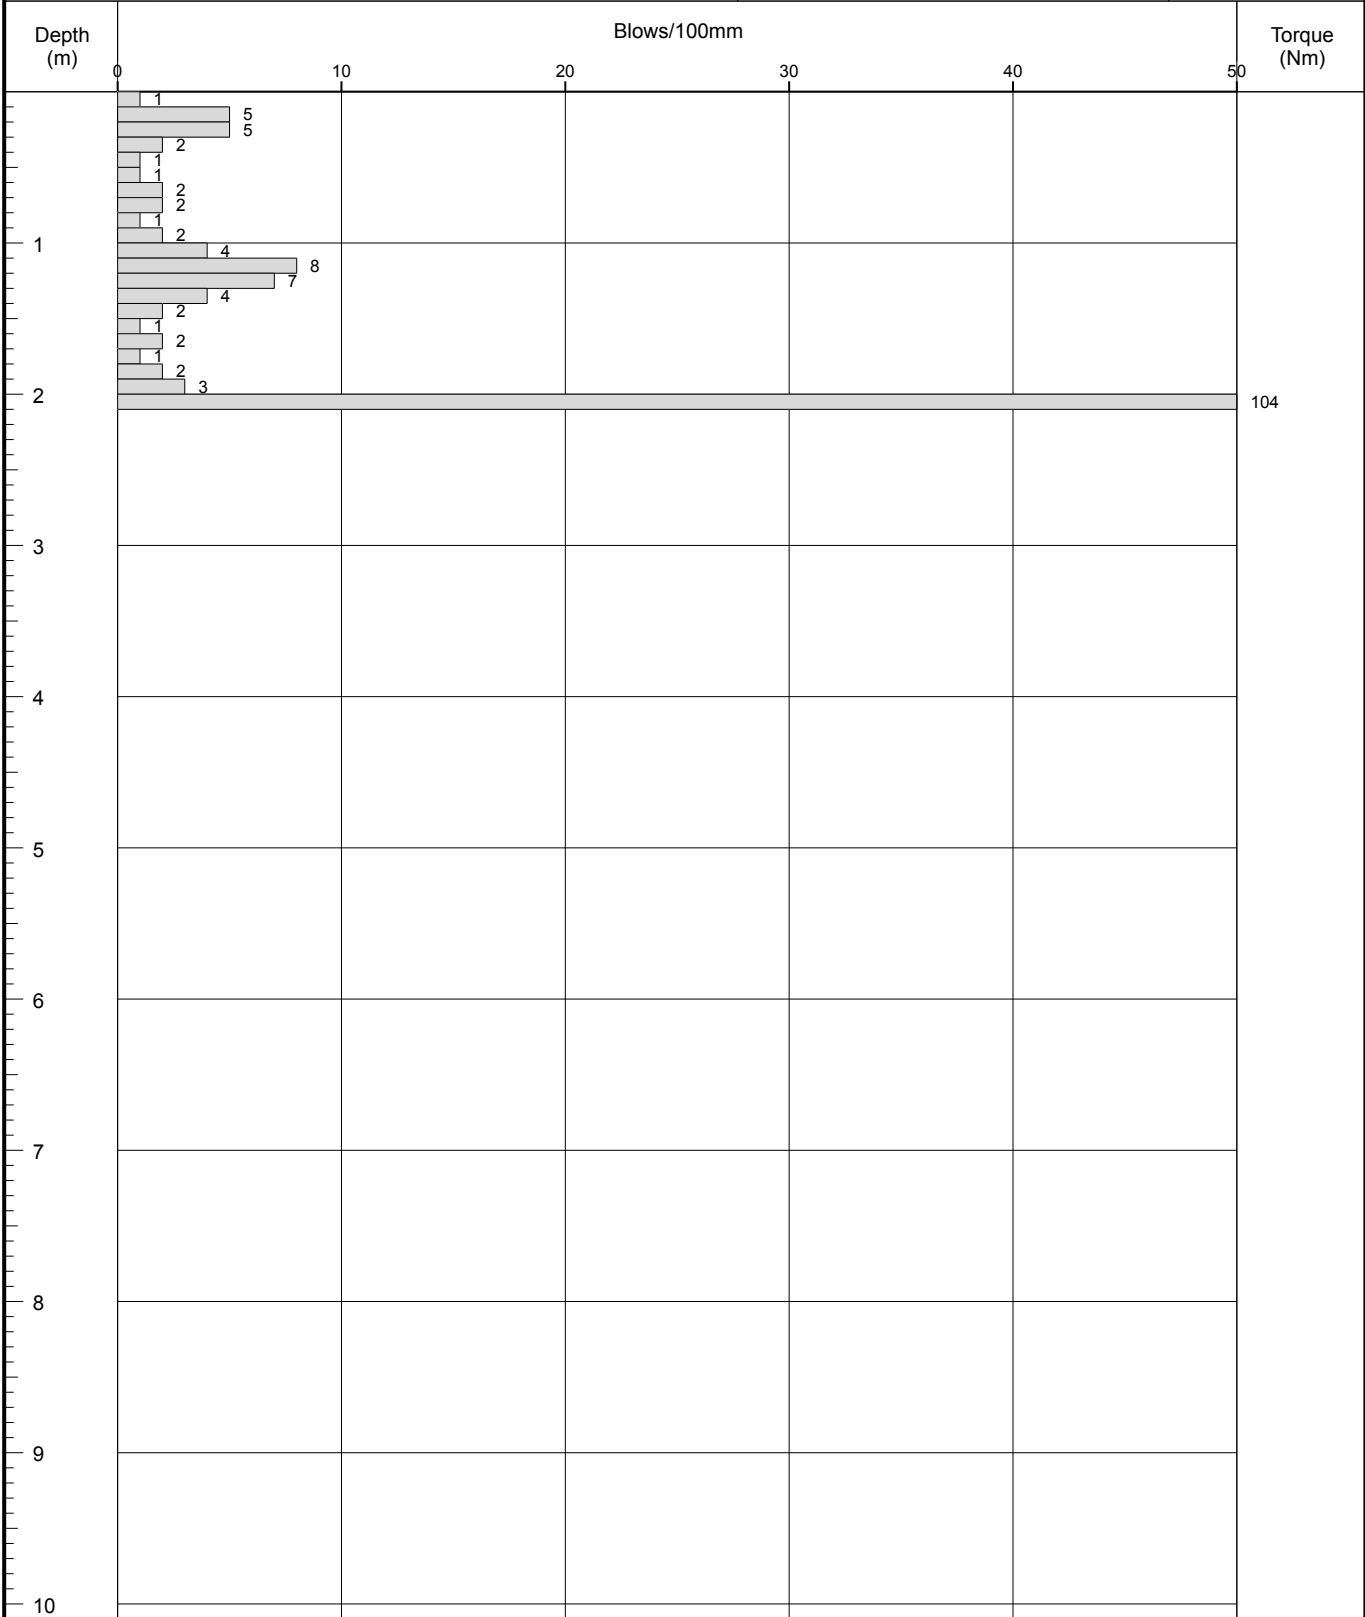
Project Name: Manashay, Upper Brow Road	Project No. J3220/15/E	Co-ords:	Hole Type DCP
Location: Paddock, Huddersfield	Level:		Scale 1:50
Client: Shaw & Jagger	Dates: 17/08/2015		Logged By

Remarks:	Fall Height	750mm	Cone Base Diameter	50.5mm
	Hammer Wt	63.5kg	Final Depth	2m
	Probe Type	DPSH-B
