REPORT ON A GEO-ENVIRONMENTAL INVESTIGATION

**MANASHAY, UPPER BROW ROAD, PADDOCK
HUDDERSFIELD HD1 4UP**

Report No J3220/15/E

November 2015

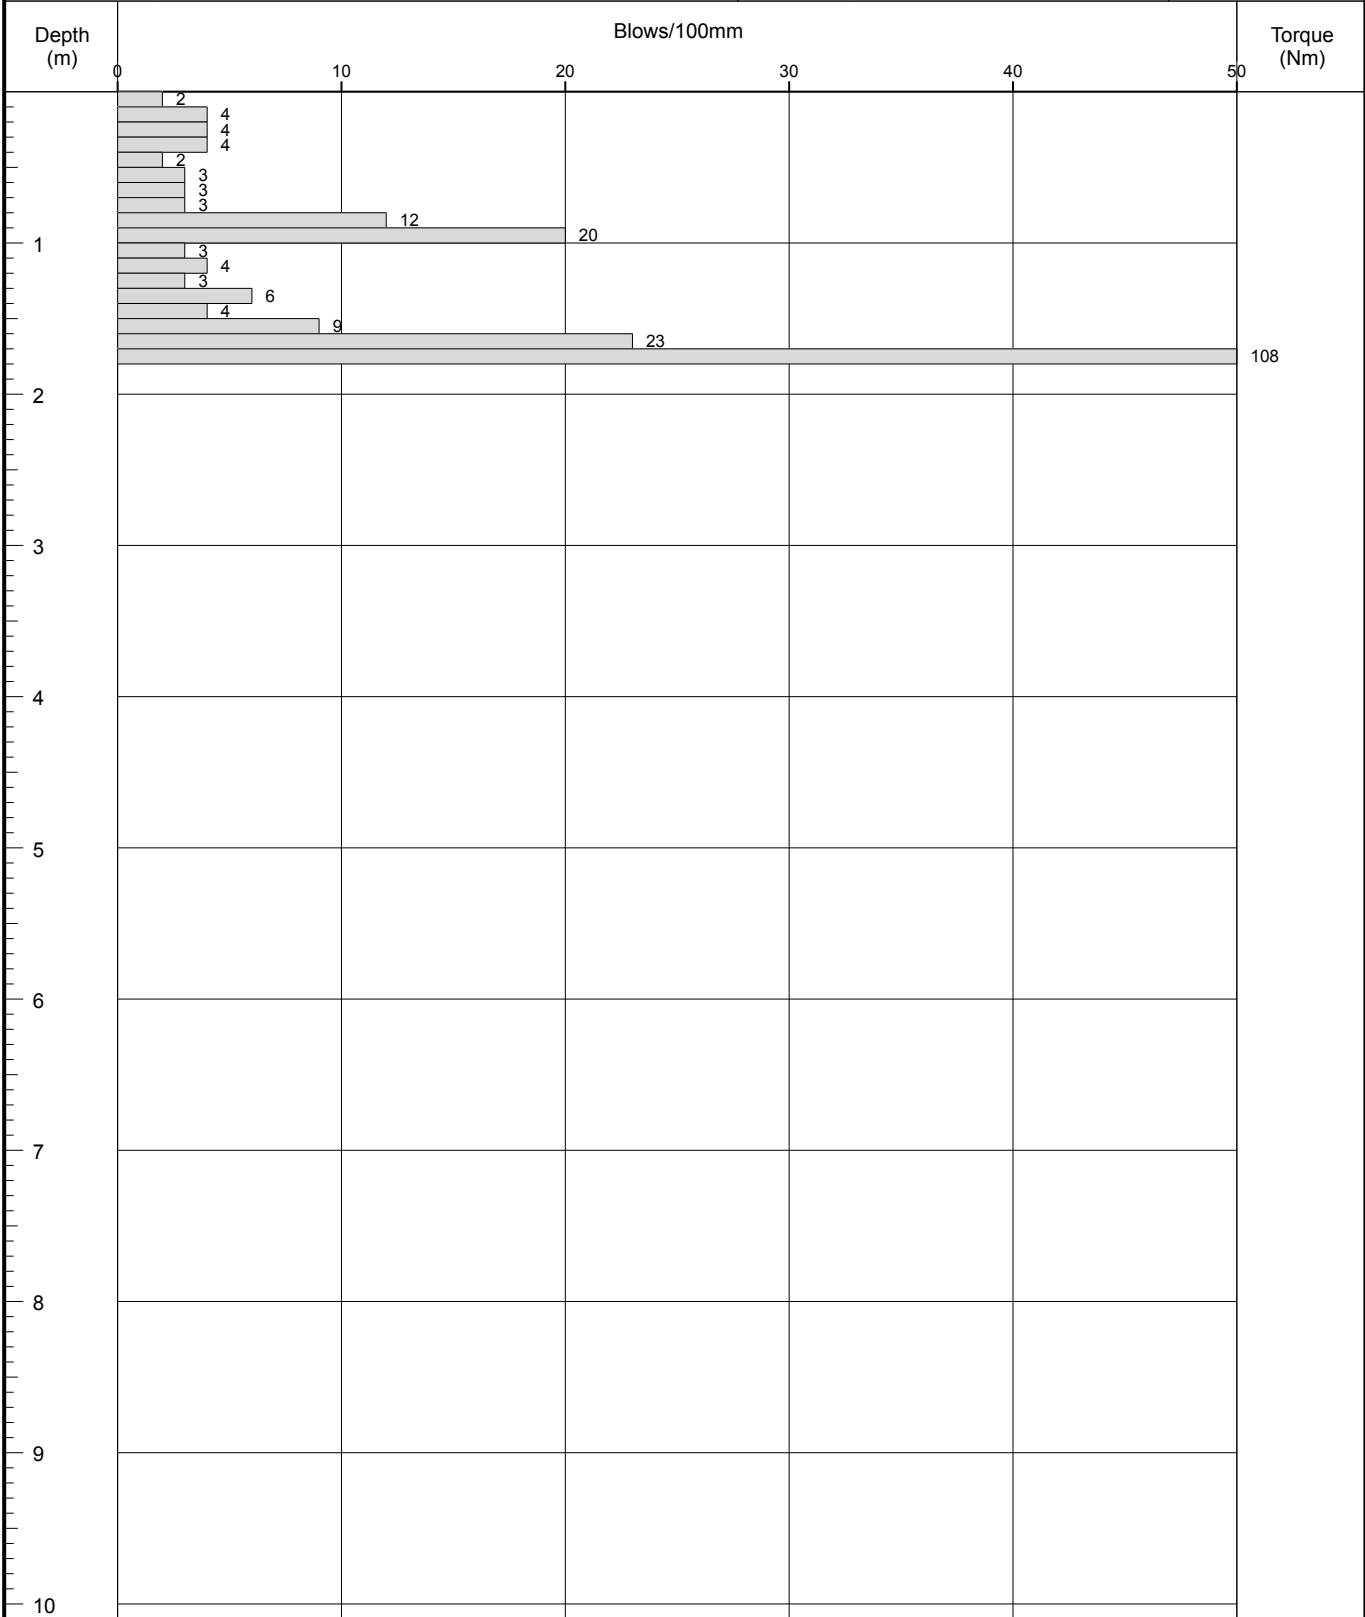
Project Name: Manashay, Upper Brow Road	Project No. J3220/15/E	Co-ords:	Hole Type DCP
Location: Paddock, Huddersfield		Level:	Scale 1:50
Client: Shaw & Jagger		Dates: 17/08/2015	Logged By

Remarks:	Fall Height	750mm	Cone Base Diameter	50.5mm
	Hammer Wt	63.5kg	Final Depth	1.7m
	Probe Type	DPSH-B

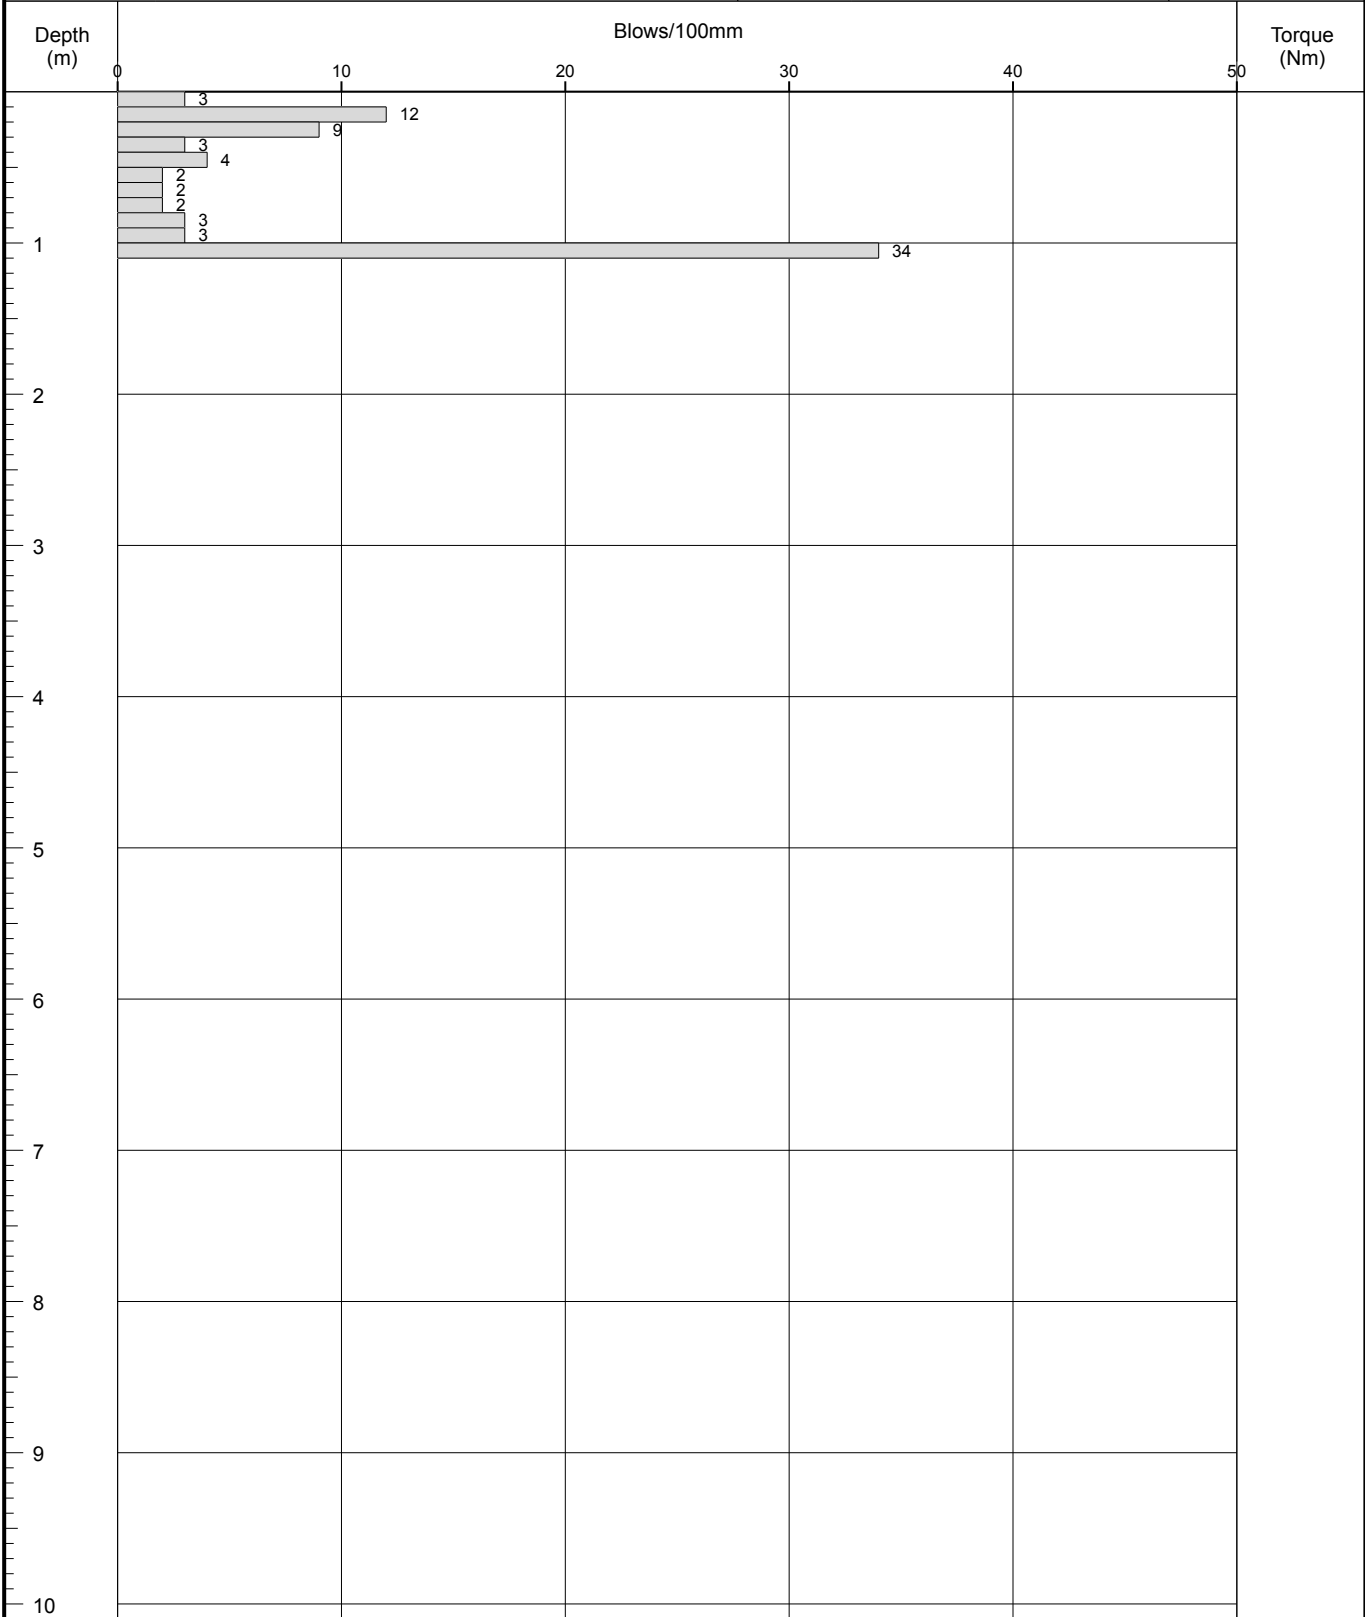
Project Name: Manashay, Upper Brow Road	Project No. J3220/15/E	Co-ords:	Hole Type DCP
Location: Paddock, Huddersfield		Level:	Scale 1:50
Client: Shaw & Jagger		Dates: 17/08/2015	Logged By

Remarks:	Fall Height	750mm	Cone Base Diameter	50.5mm
	Hammer Wt	63.5kg	Final Depth	1m
	Probe Type	DPSH-B

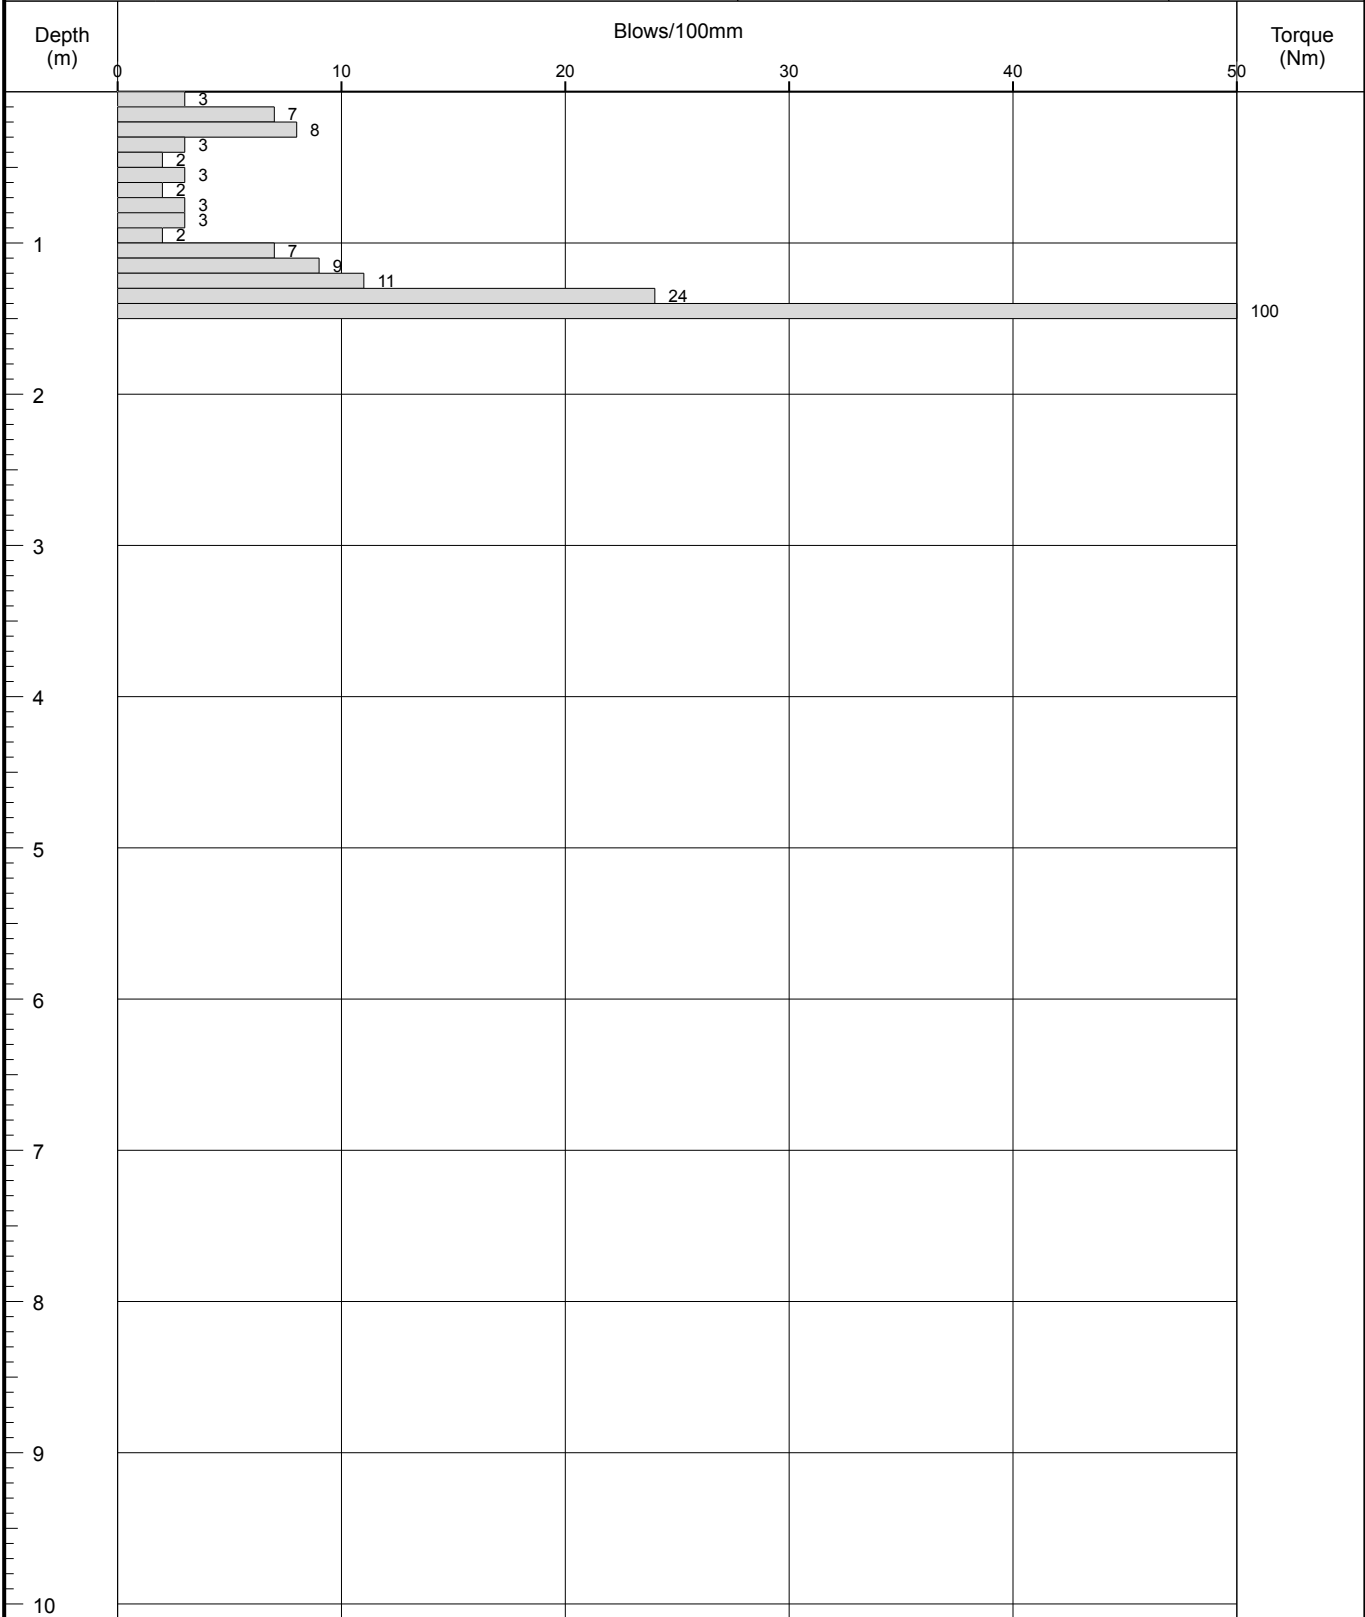
Project Name: Manashay, Upper Brow Road	Project No. J3220/15/E	Co-ords:	Hole Type DCP
Location: Paddock, Huddersfield	Level:		Scale 1:50
Client: Shaw & Jagger	Dates: 17/08/2015		Logged By

Remarks:	Fall Height	750mm	Cone Base Diameter	50.5mm
	Hammer Wt	63.5kg	Final Depth	1.4m
	Probe Type	DPSH-B

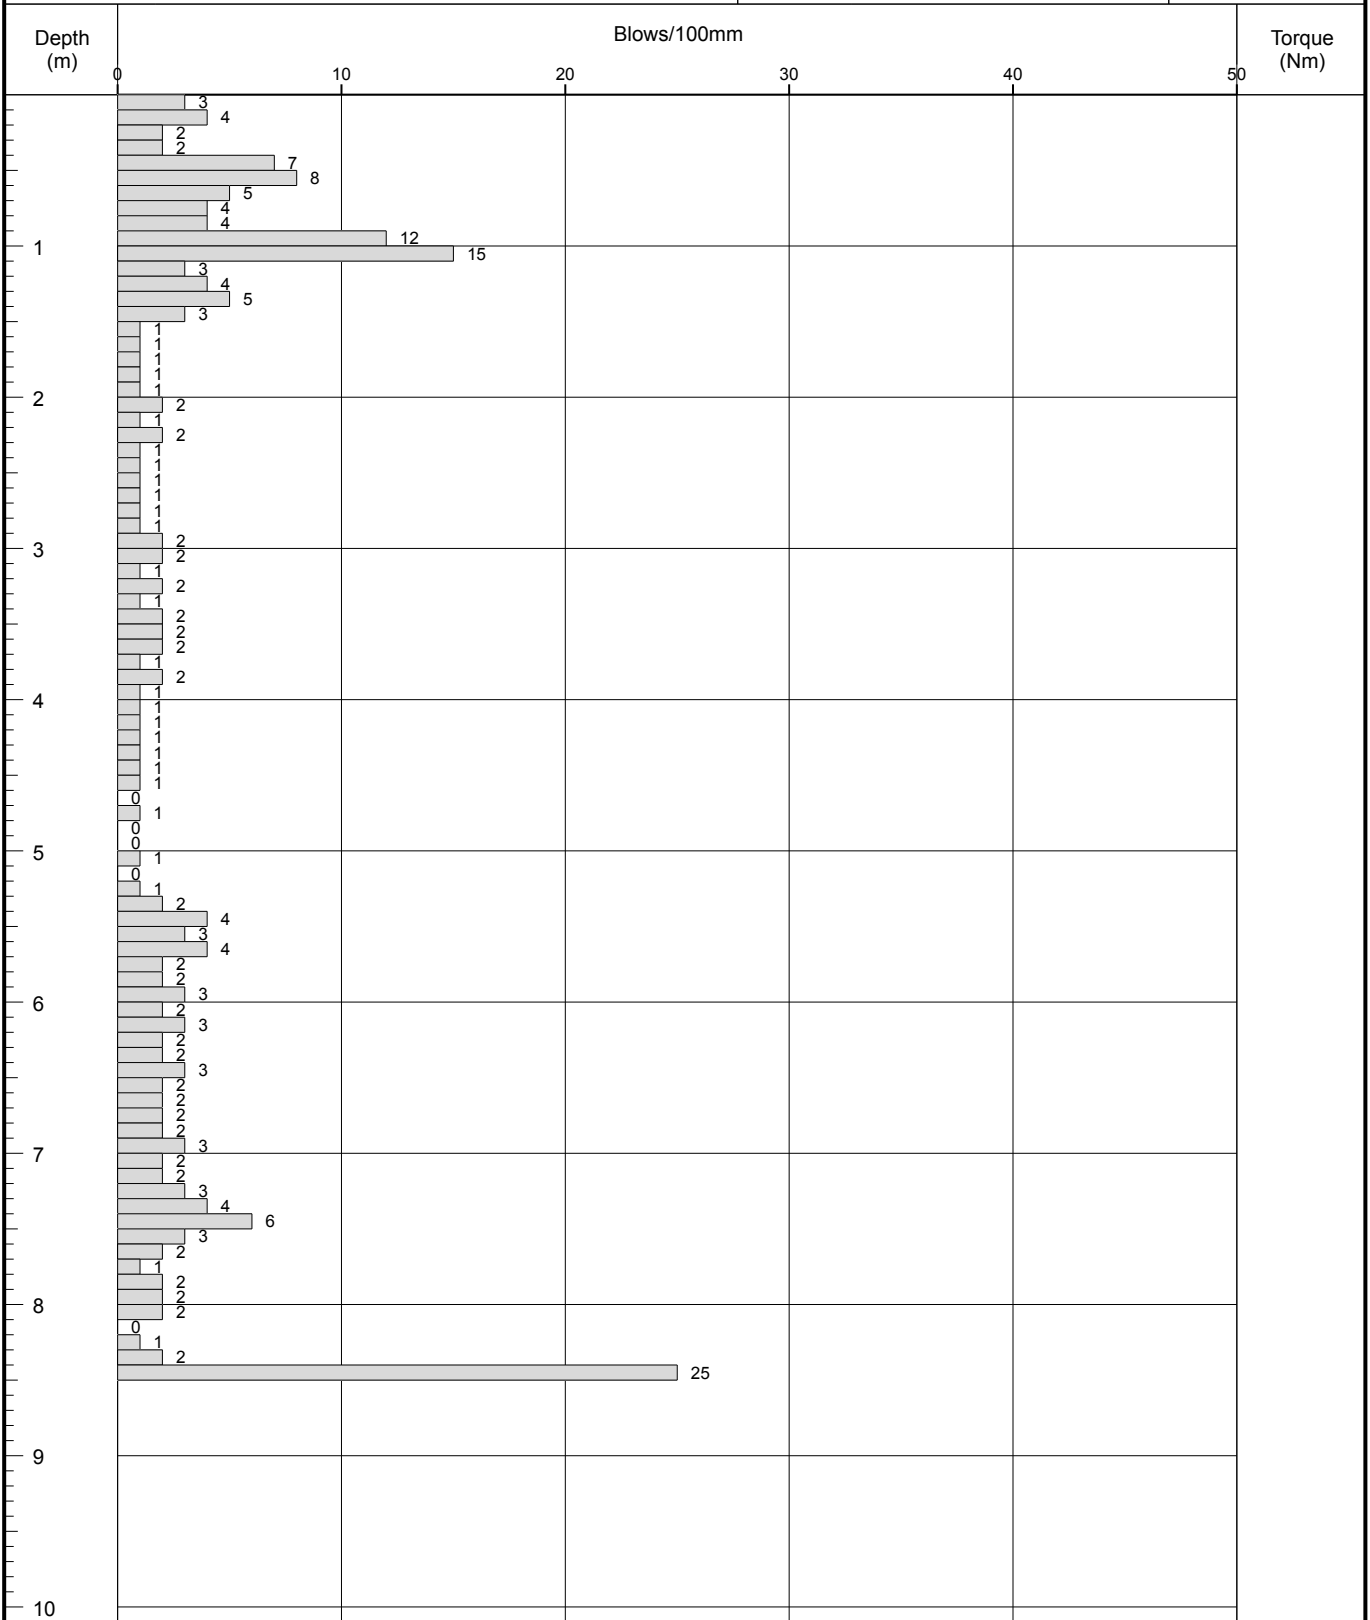
Remarks:
Abrupt Refusal at 8.50m.

Fall Height 750mm

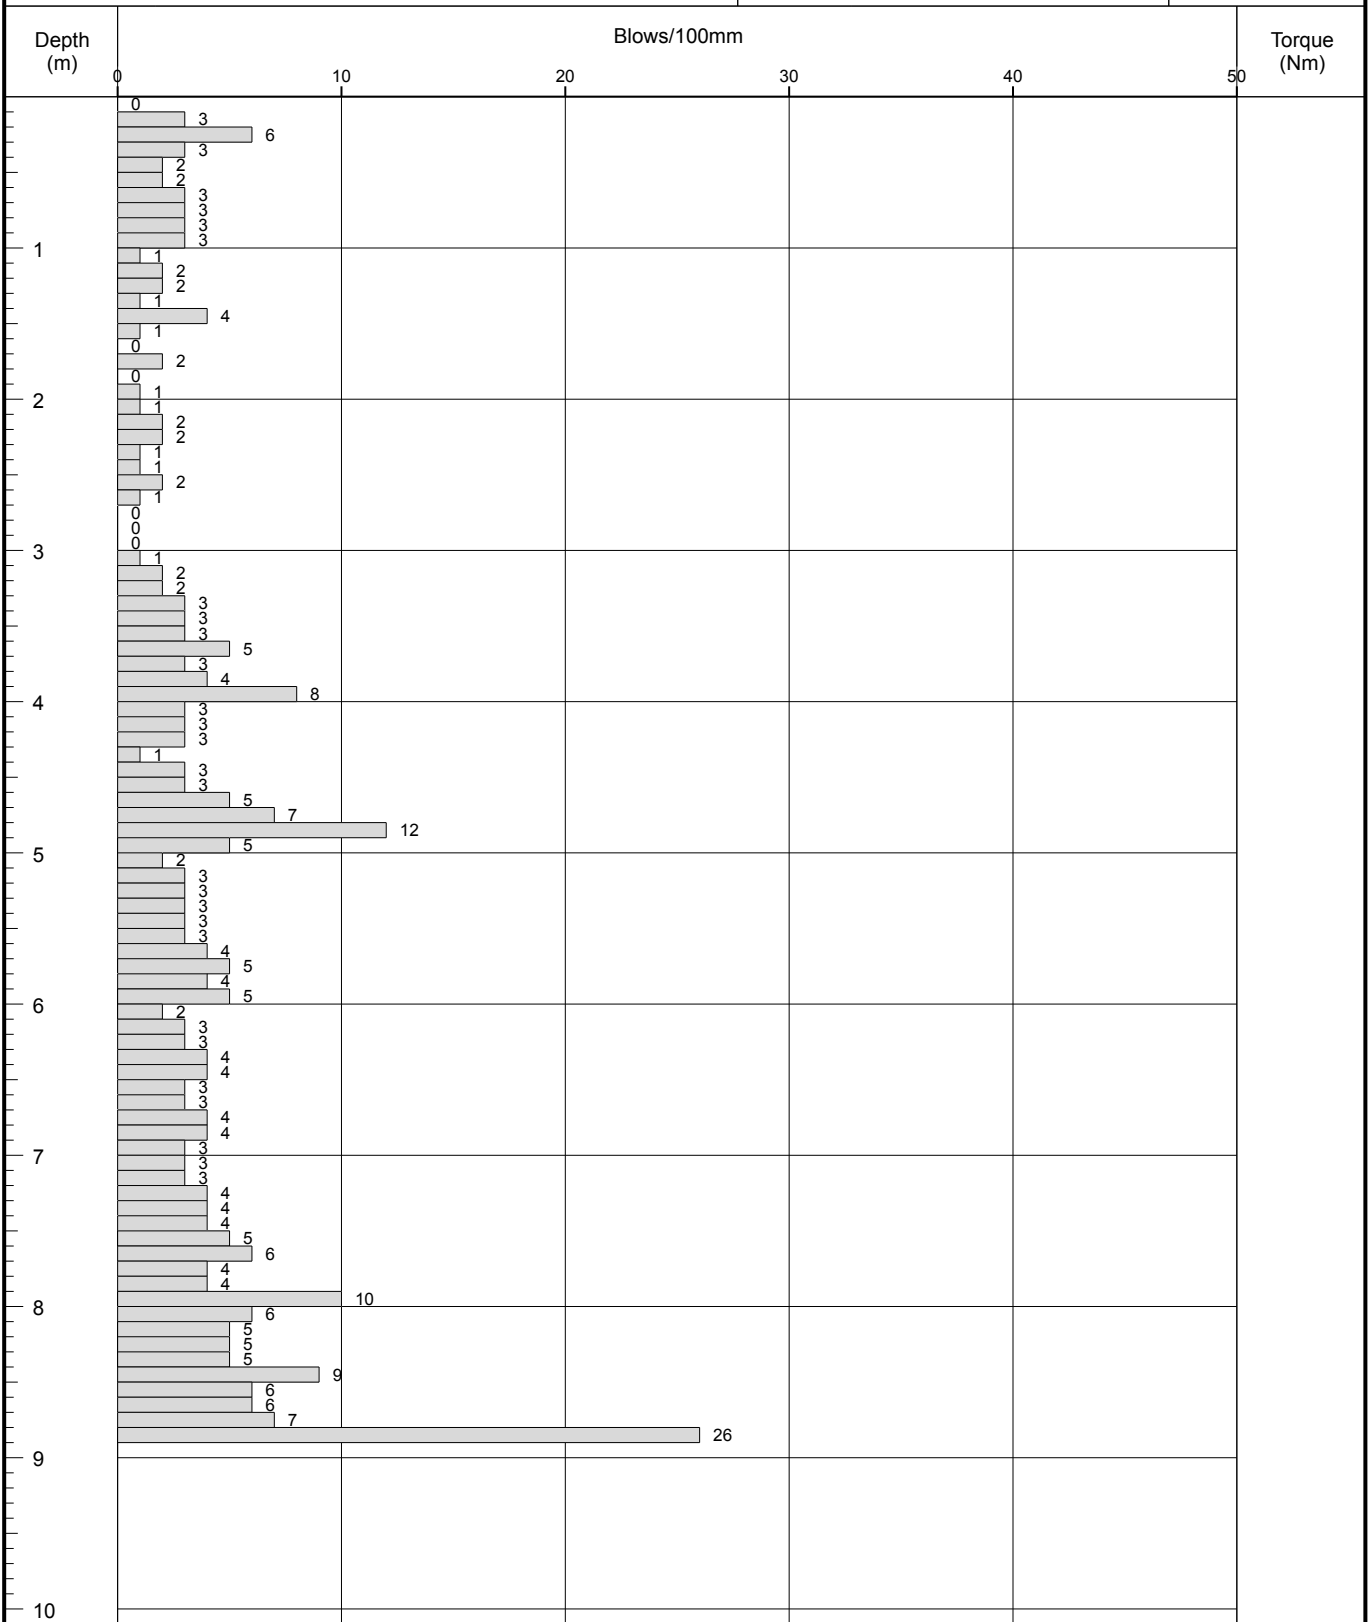
Remarks:
25 blows for 95mm shown as 26 blows for 100mm.
Abrupt refusal.

Fall Height 750mm

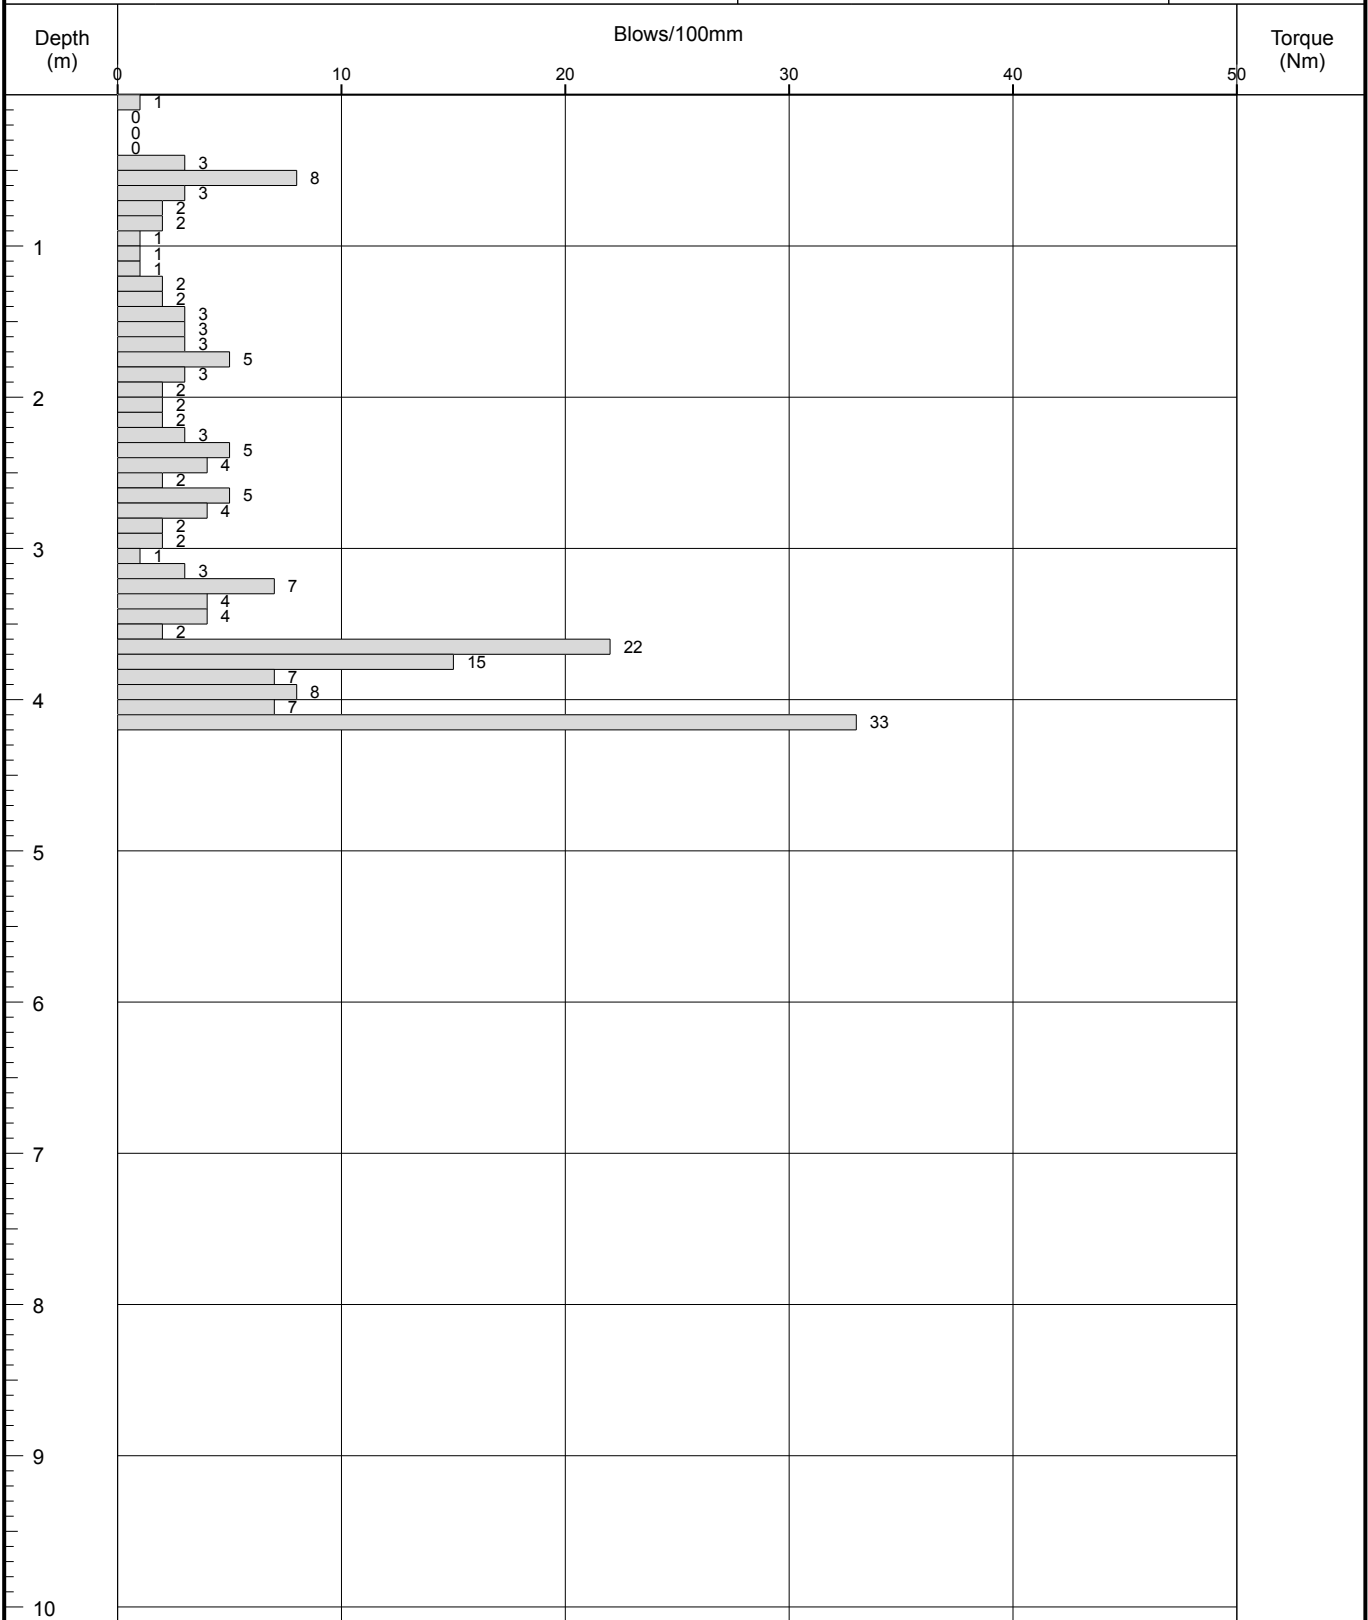
Remarks:
25 blows for 75mm shows as 33 blows for 100mm.
Abrupt refusal.

Fall Height 750mm
