Land at Northorpe Lane, Mirfield For Newett Homes

Report no: 3433/2C

Date: March 2022

SUMMARY OF GEOENVIRONMENTAL ISSUES

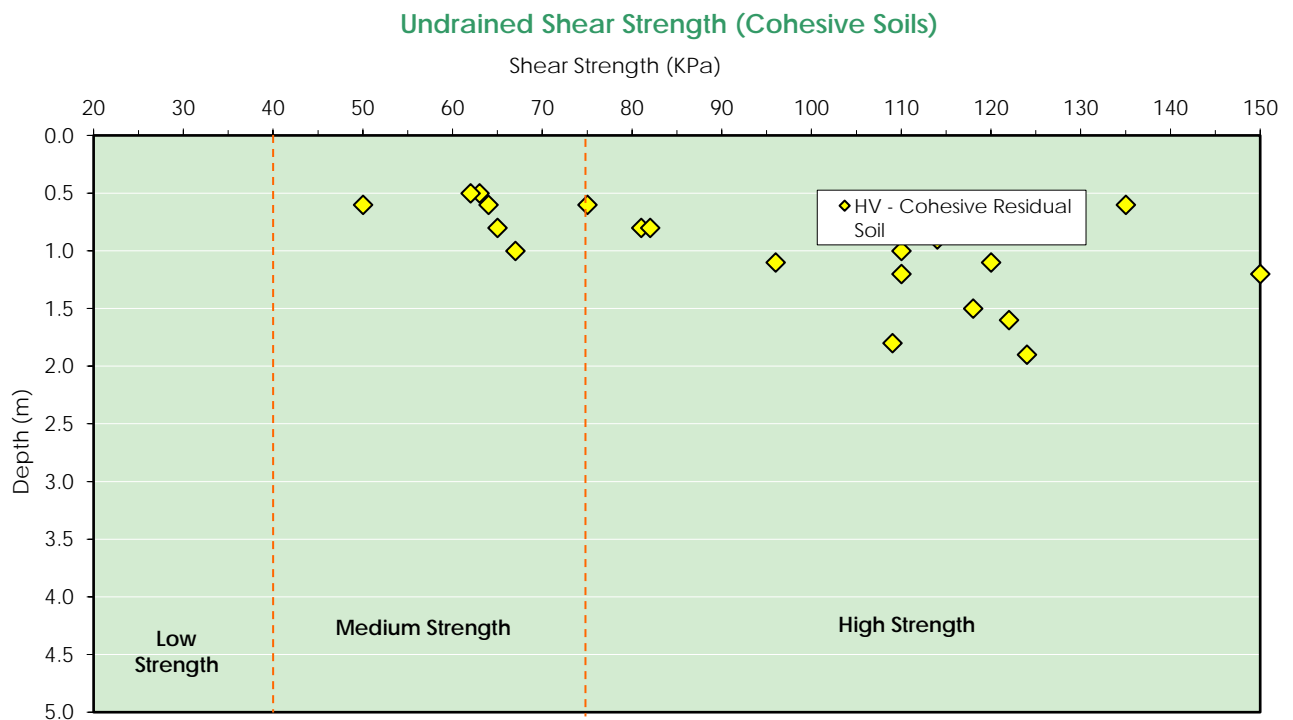
- 12.6.1 Hand shear vane testing was undertaken within trial pits in-situ to around 1.2m depth and from larger blocks of excavated clay below that depth.
- 12.6.2 The results are summarised within the plot below and illustrate a linear increase in undrained shear strength (S_u) with depth within the Cohesive Residual Soil. Below approximately 1m depth S_u is typically greater than 65kPa.
- 12.6.3 The plot below provides a summary of undrained shear strengths.

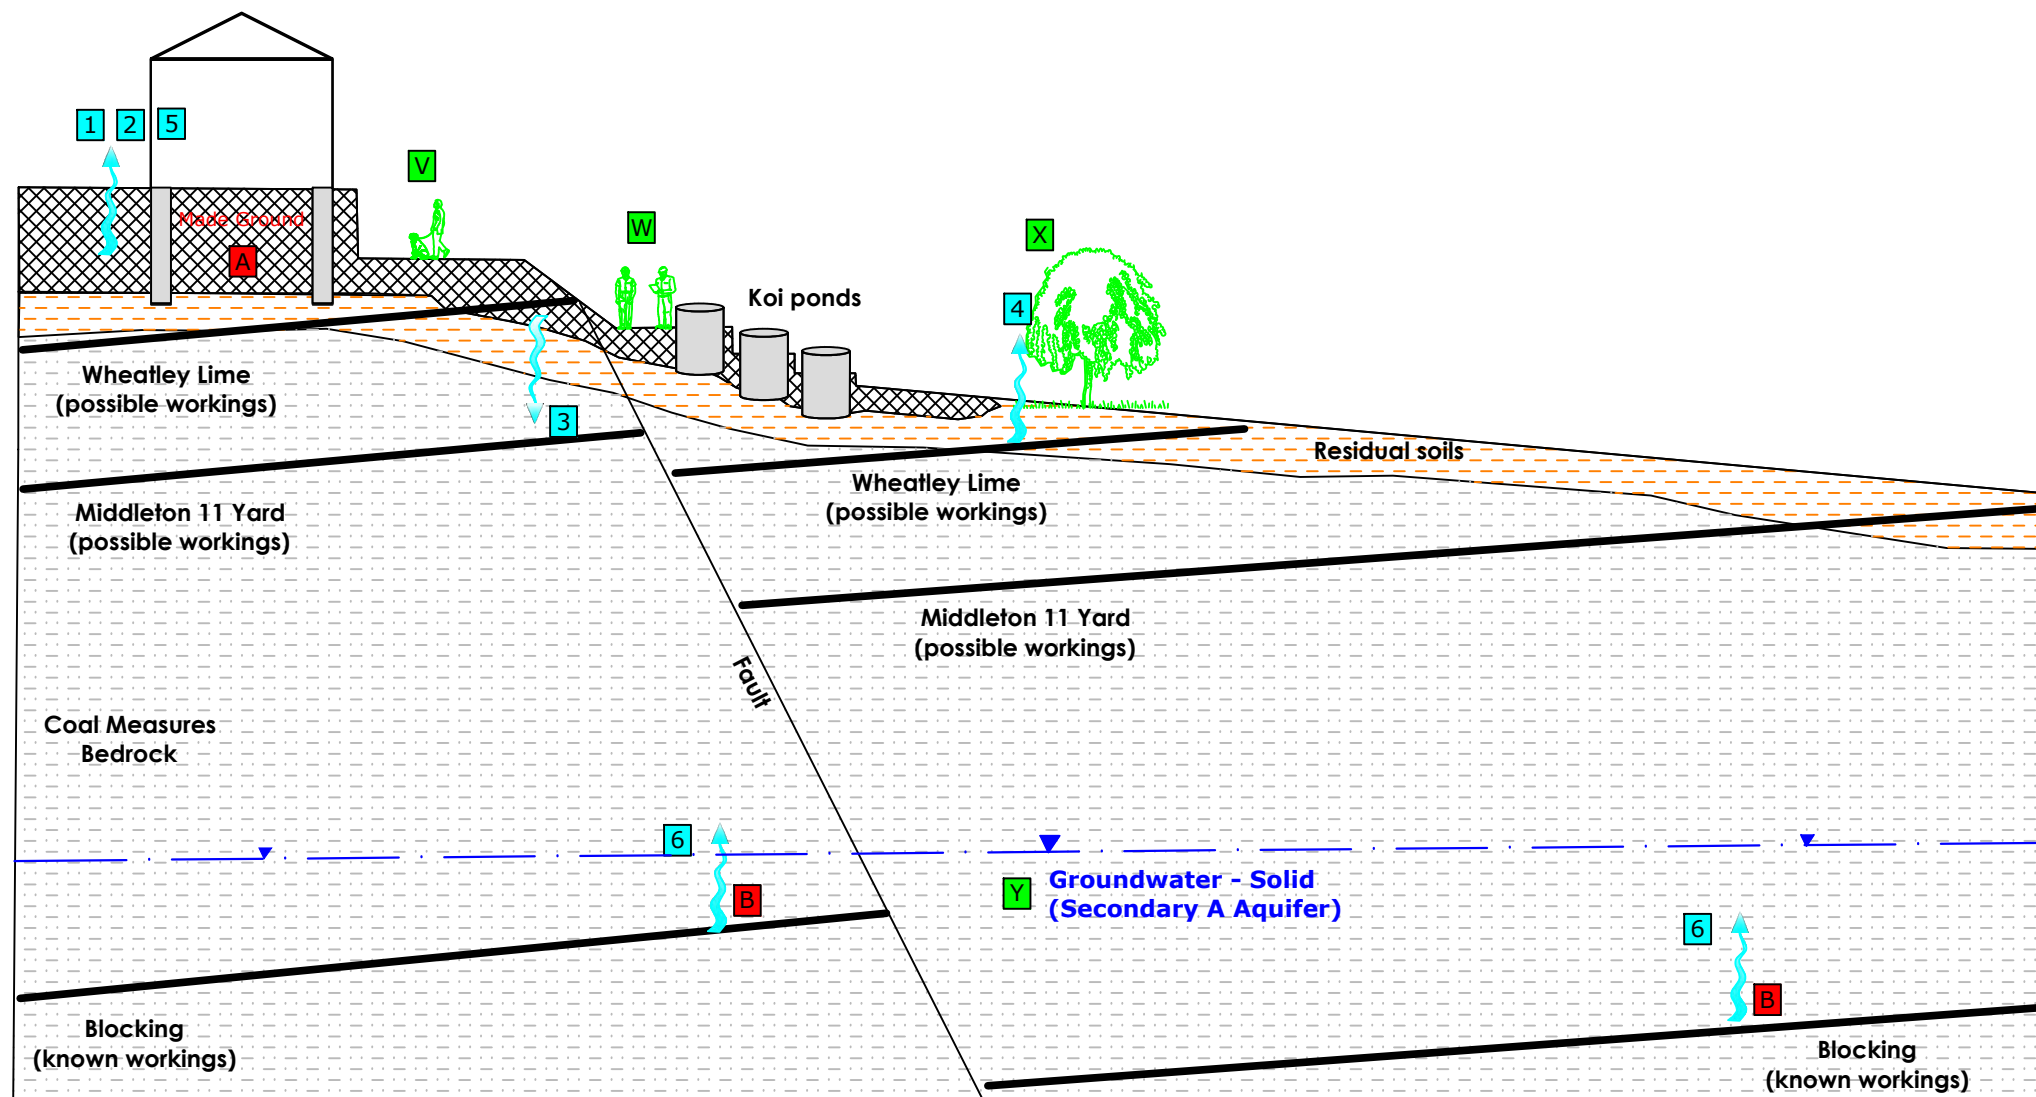
SOURCES	
A	MADE GROUND (INORGANICS & ORGANICS)
B	MINEWORKINGS (HAZARDOUS GAS)

PATHWAYS	
1	DERMAL CONTACT
2	INGESTION/INHALATION
3	LEACHING OF CONTAMINANTS
4	UPTAKE BY PLANTS
5	VOLATILISATION
6	MIGRATION OF GAS

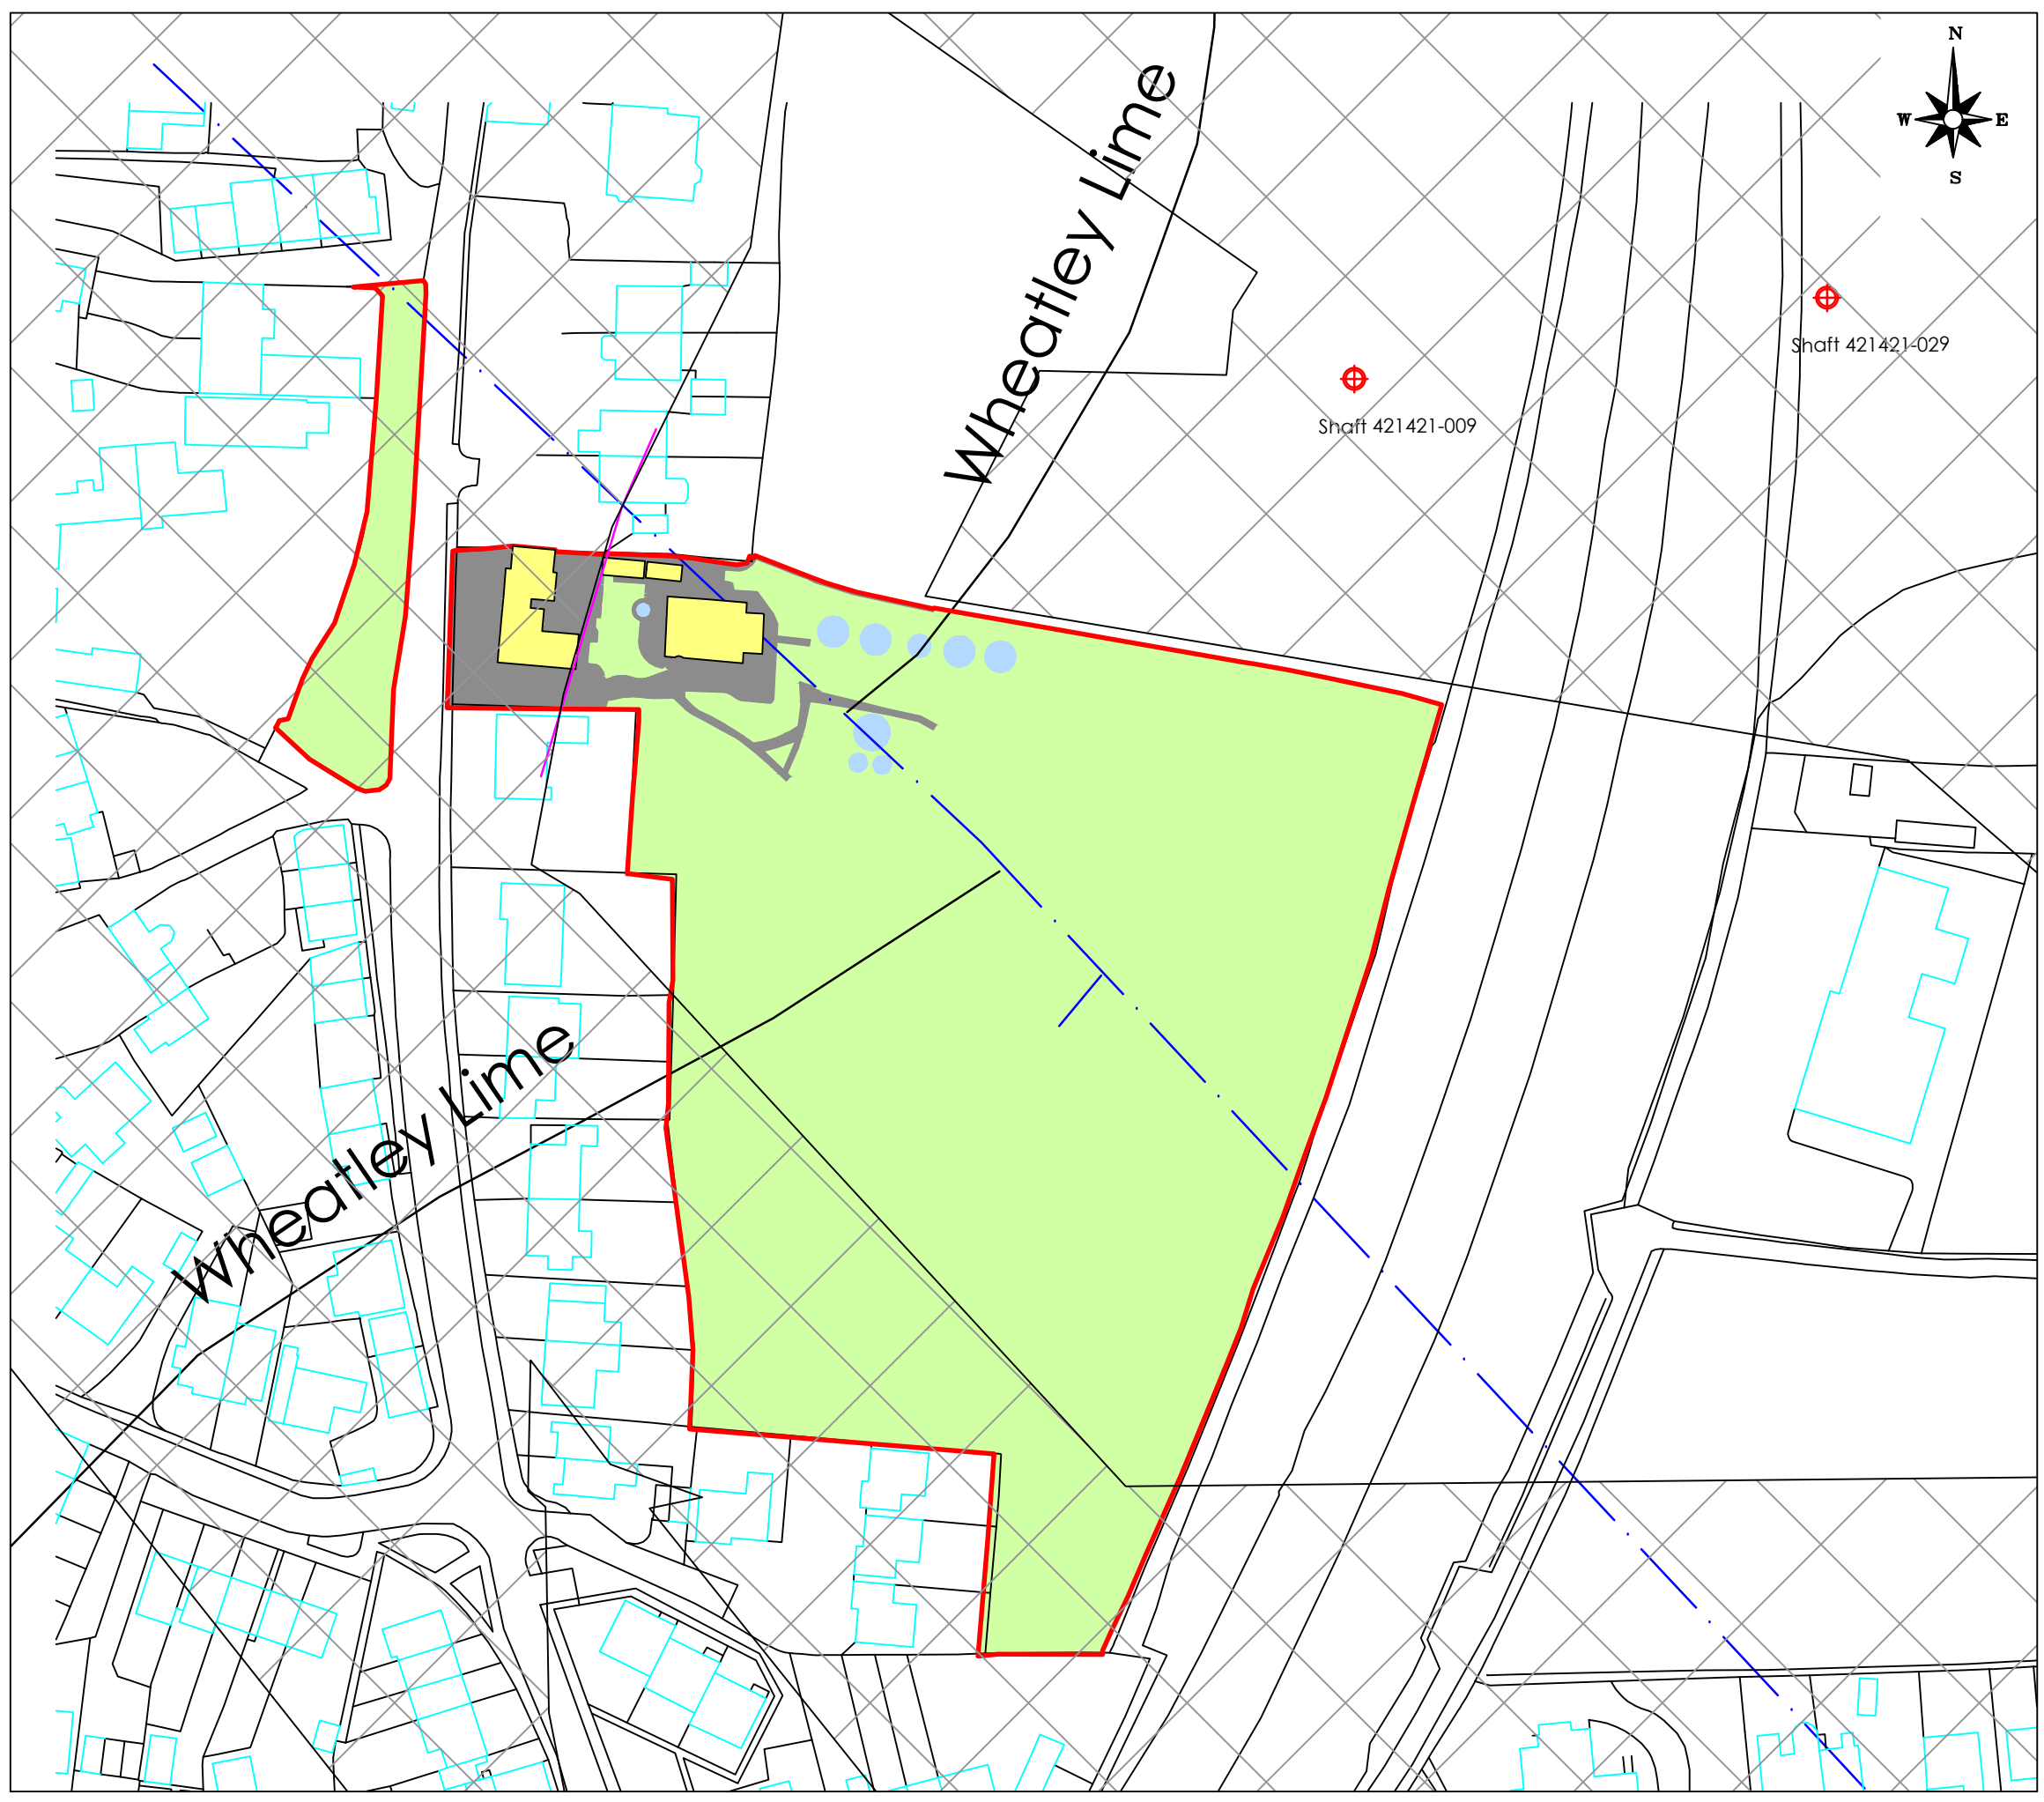
GEOLOGICAL FEATURES

- APPROXIMATE SITE BOUNDARY
- - - APPROXIMATE LINE OF FAULT
- APPROXIMATE COAL SEAM OUTCROP (BGS)
- APPROXIMATE COAL SEAM OUTCROP (CA)
- COAL AUTHORITY MINING DEVELOPMENT HIGH RISK AREA

4.2.5 The approximate outcrop of the Wheatley Lime and the position of the geological fault are shown on Drawing 3433/6. It should be noted that seam outcrops plotted on geological maps have been known to be inaccurate by distances in excess of 100m. However, based on the CA report the outcrop may actually be further west, underlying only 500m² in the far north-west.

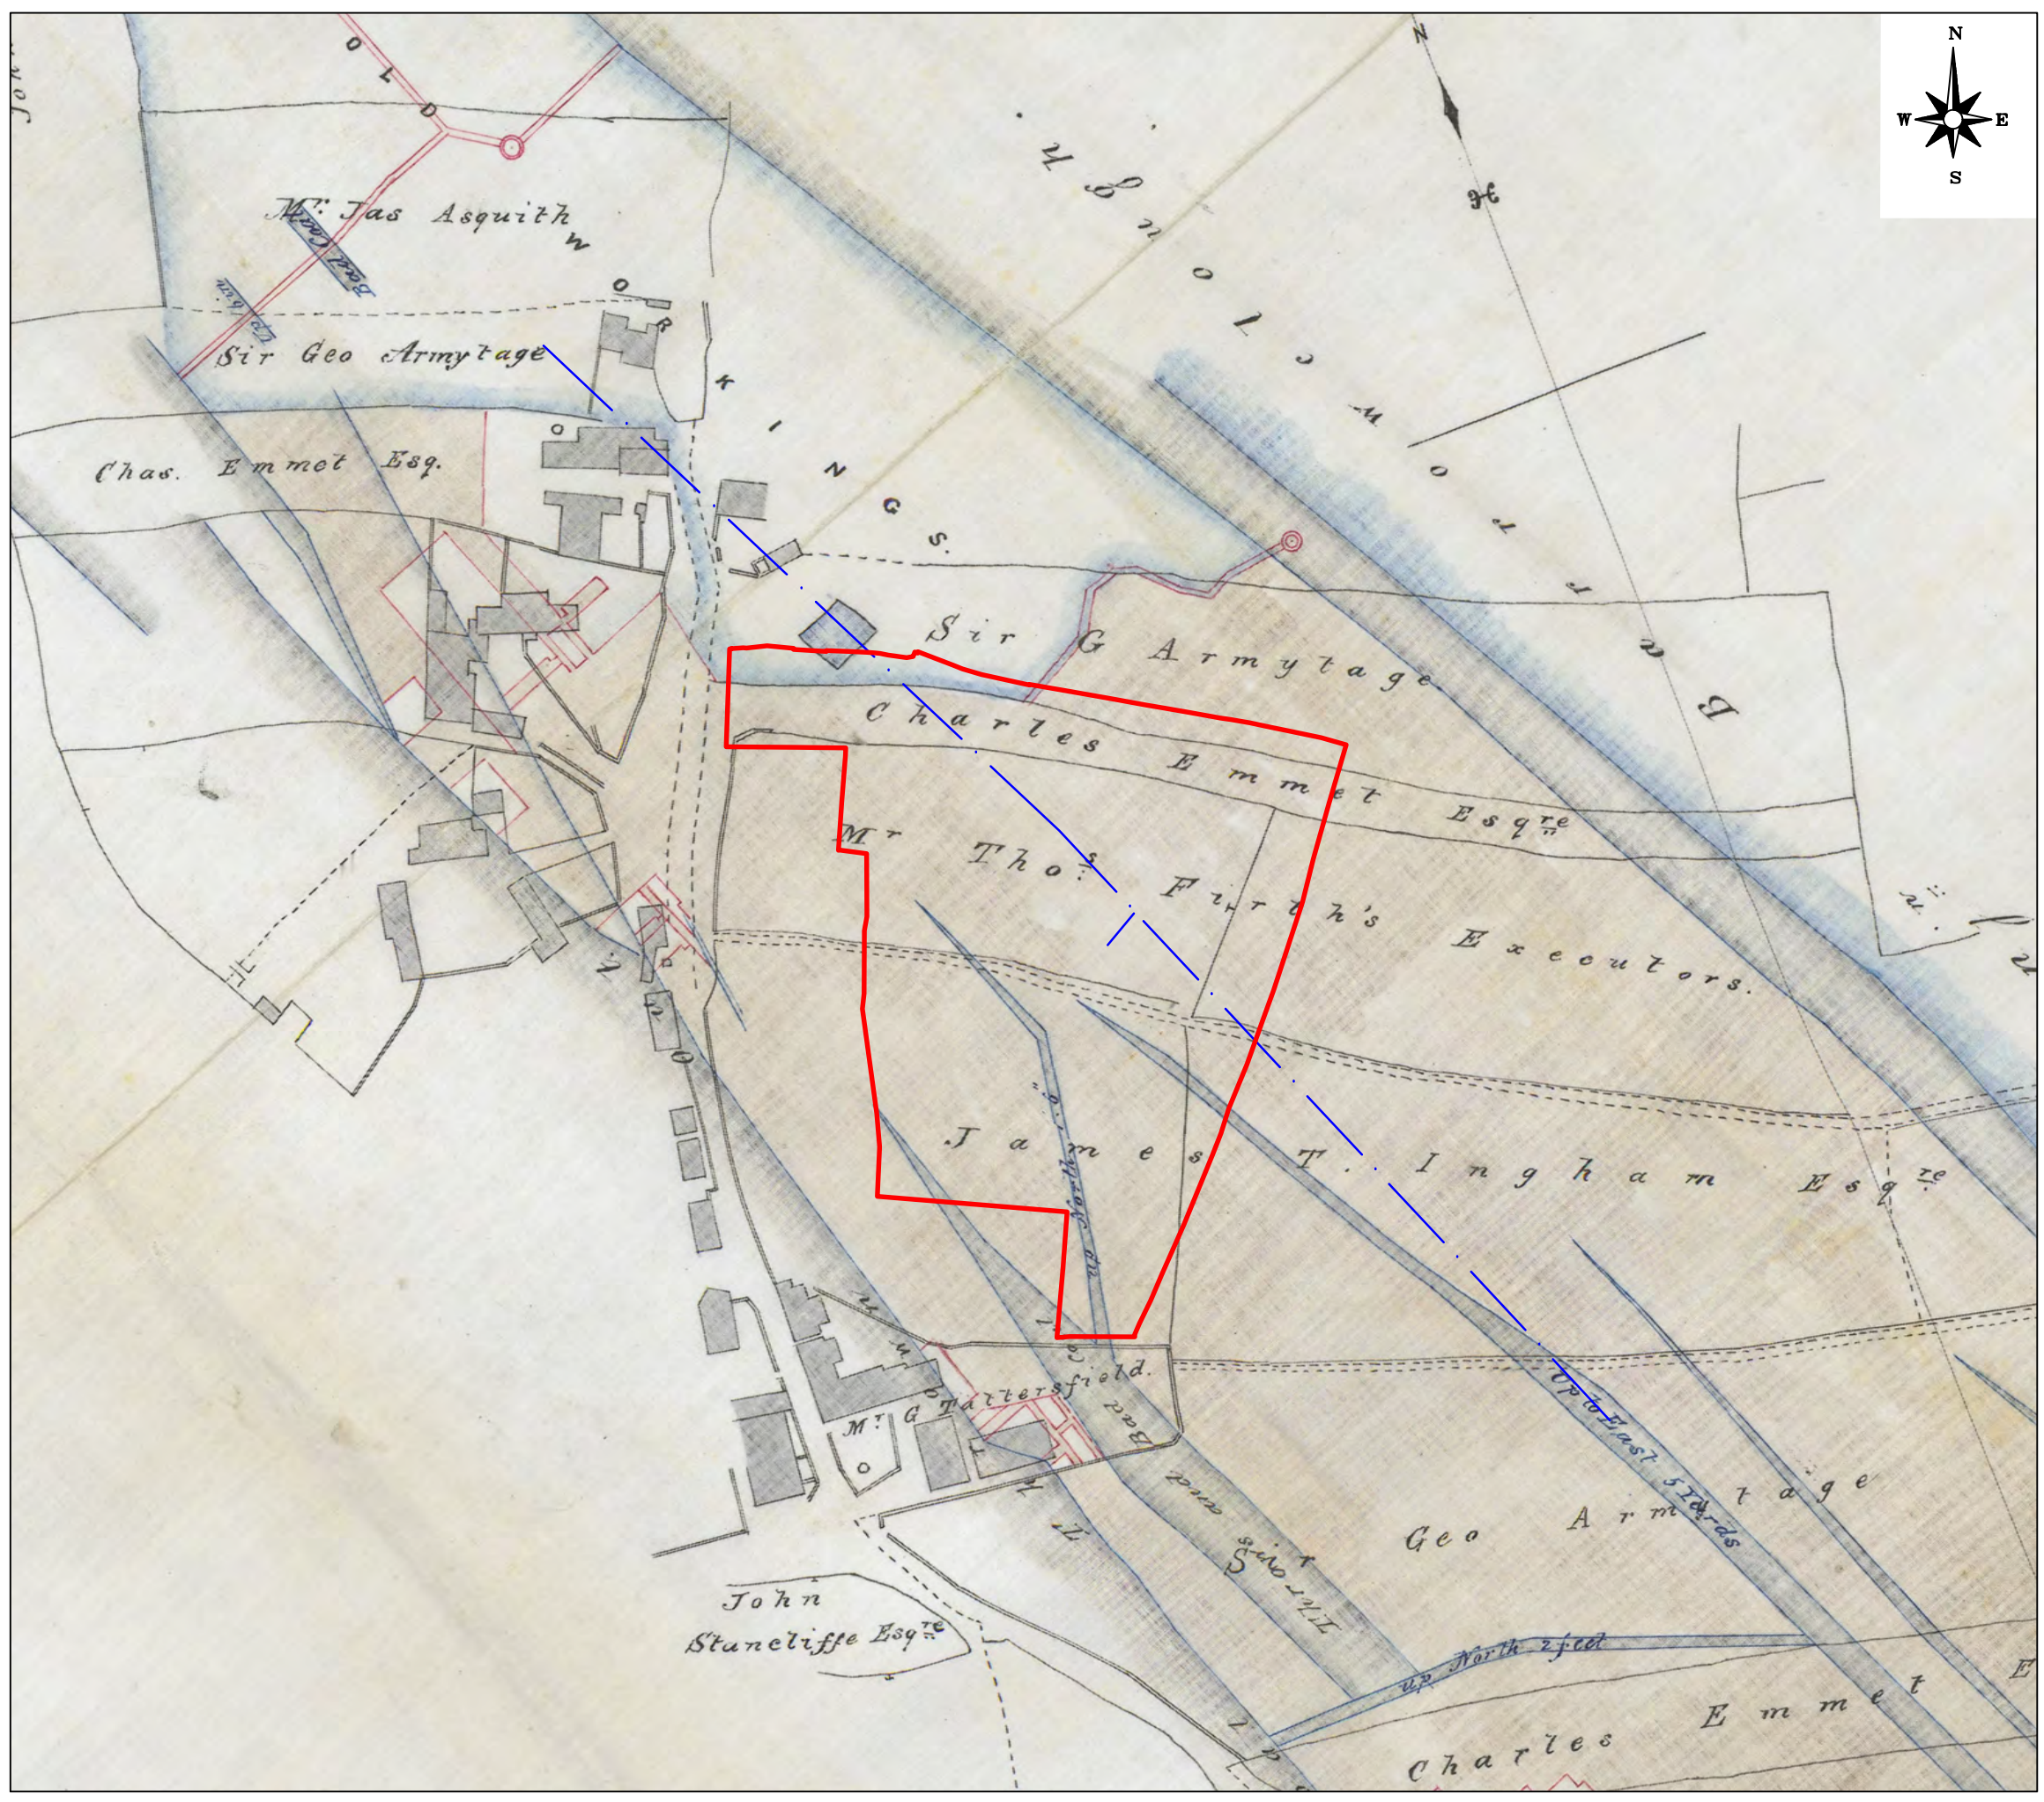
ABANDONMENT PLAN - BLOCKING SEAM

- APPROXIMATE SITE BOUNDARY
- - - APPROXIMATE LINE OF FAULT

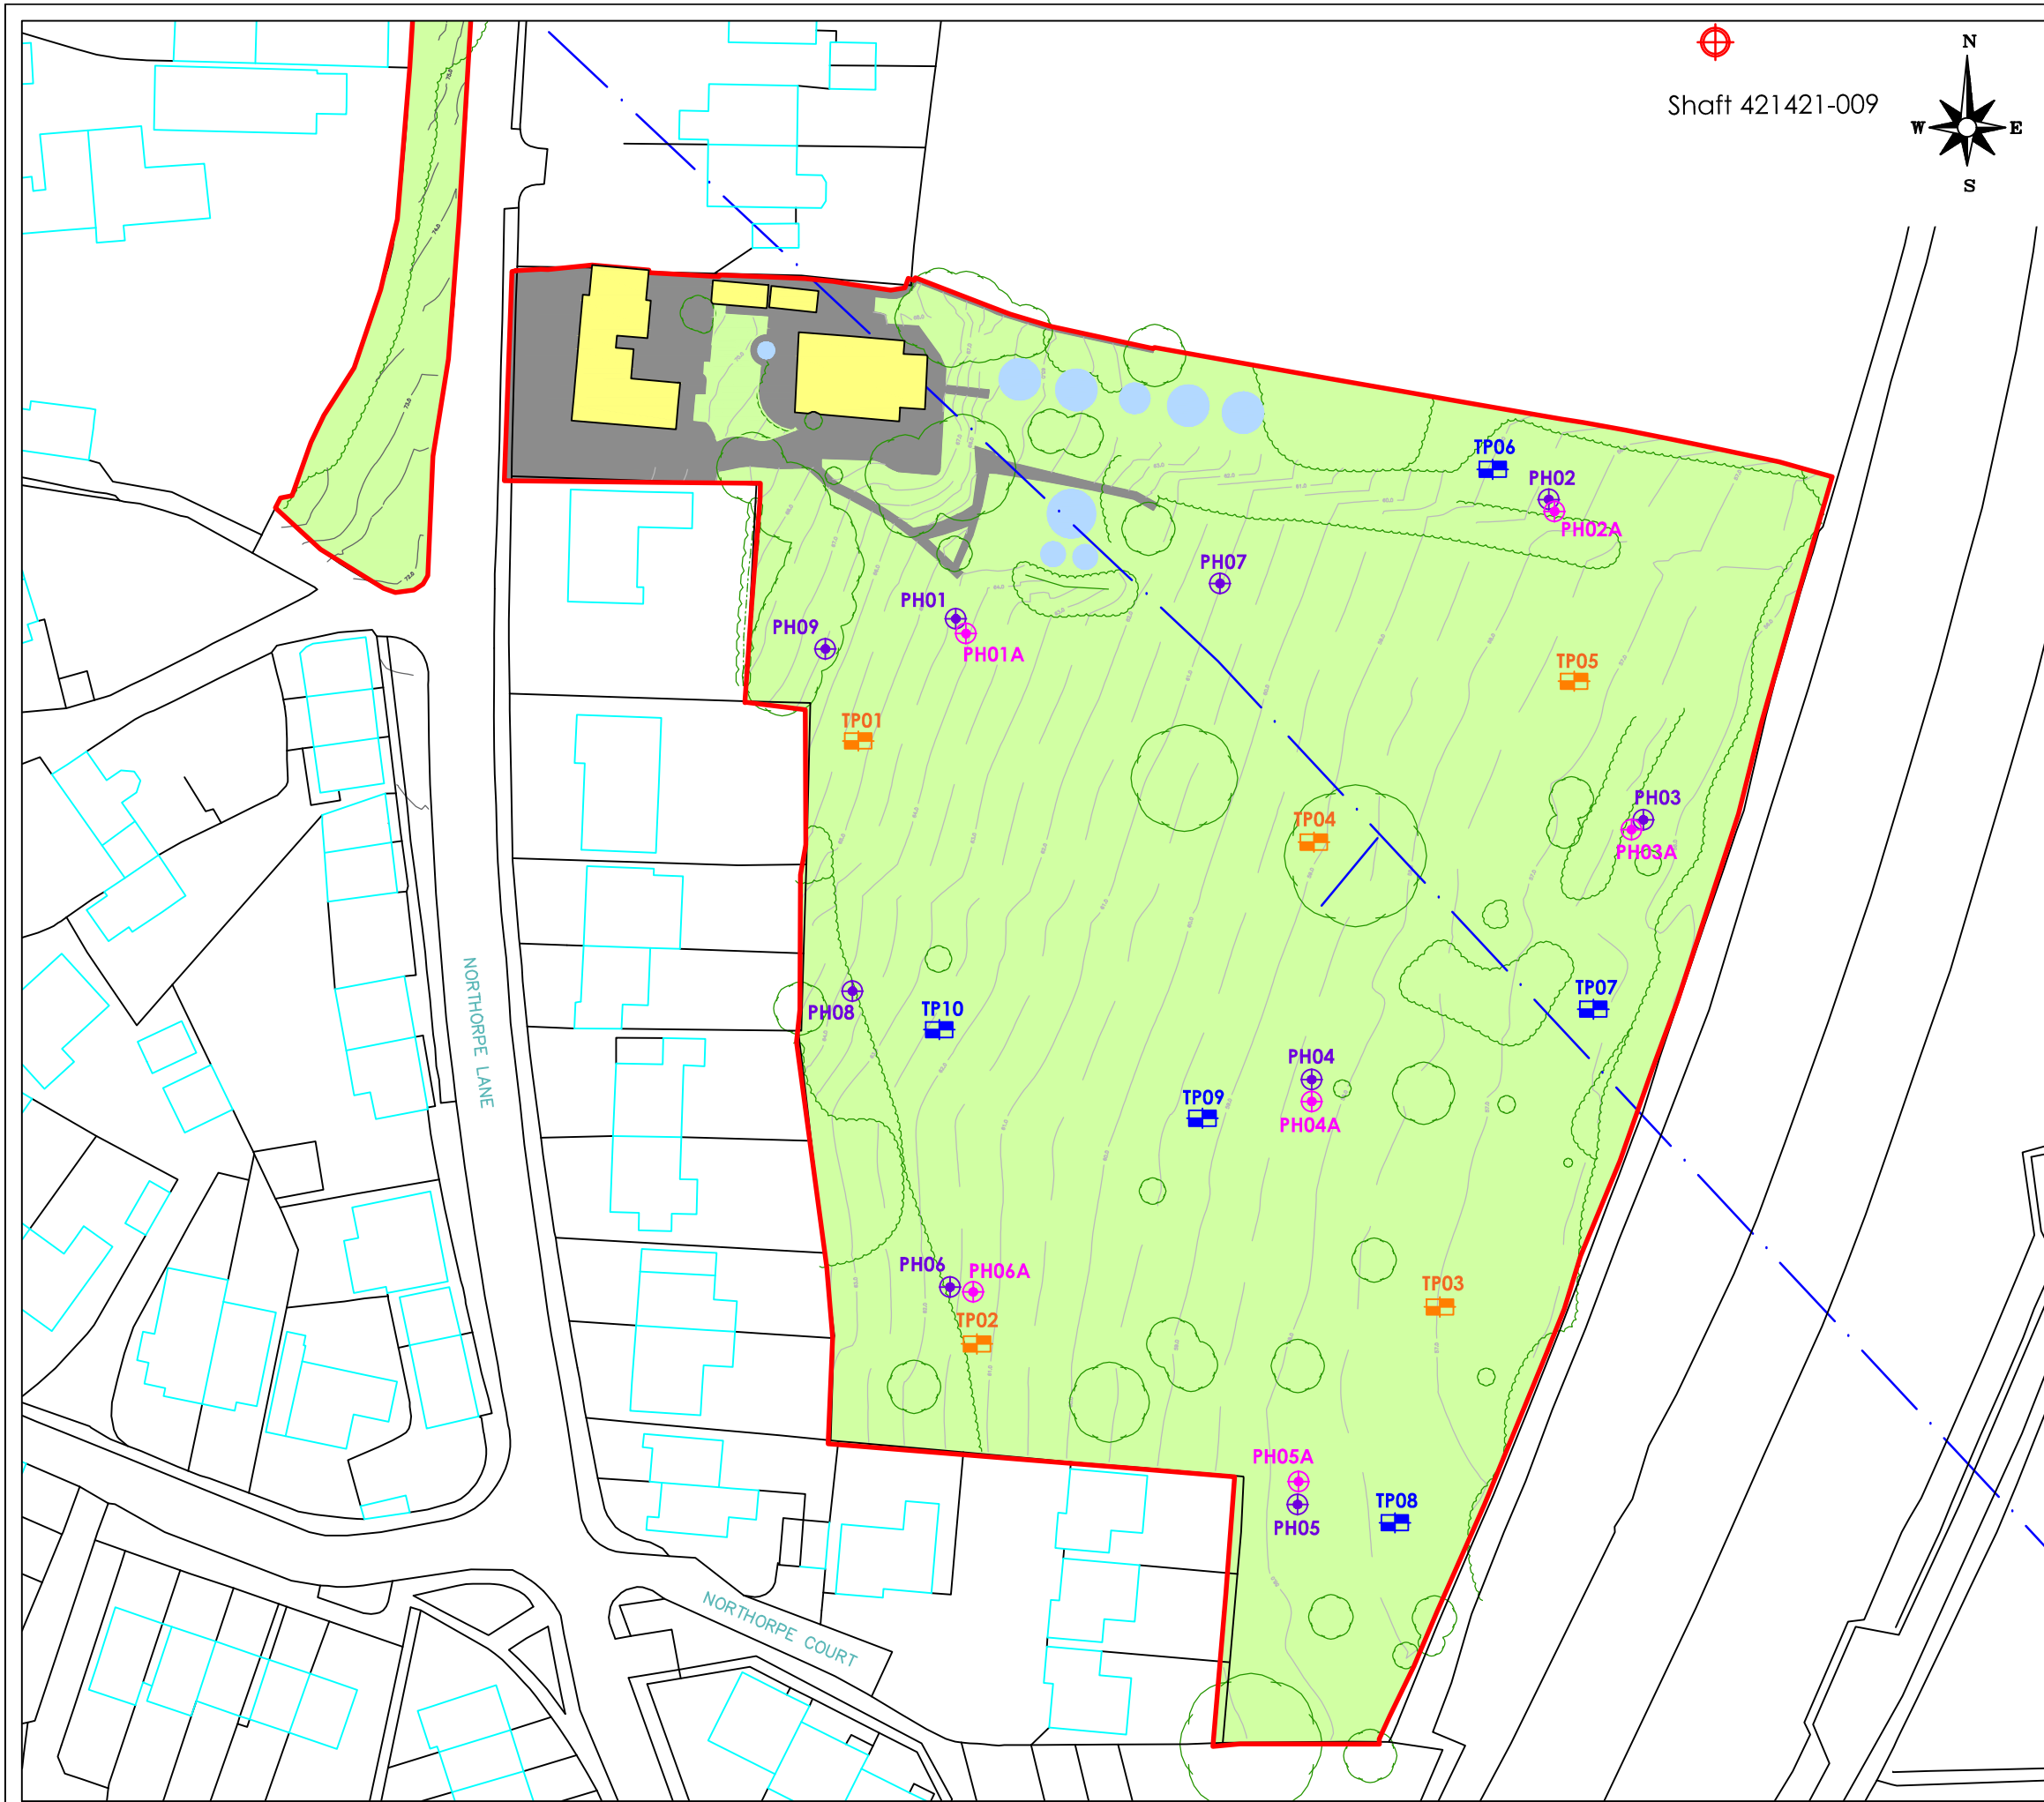
DRAWING TITLE
EXPLORATORY HOLE LOCATIONS

- NOTES
- TRIAL PIT LOCATION
 - SOAKAWAY PIT LOCATION
 - PROBEHOLE LOCATION
 - MONITORING WELL LOCATION
 - APPROXIMATE SITE BOUNDARY
 - APPROXIMATE LINE OF FAULT

- An intrusive ground investigation comprising 10 trial pits and 9 rotary probeholes
 - Assessment of the geotechnical properties of the near surface deposits to enable provision of foundation and highway recommendations

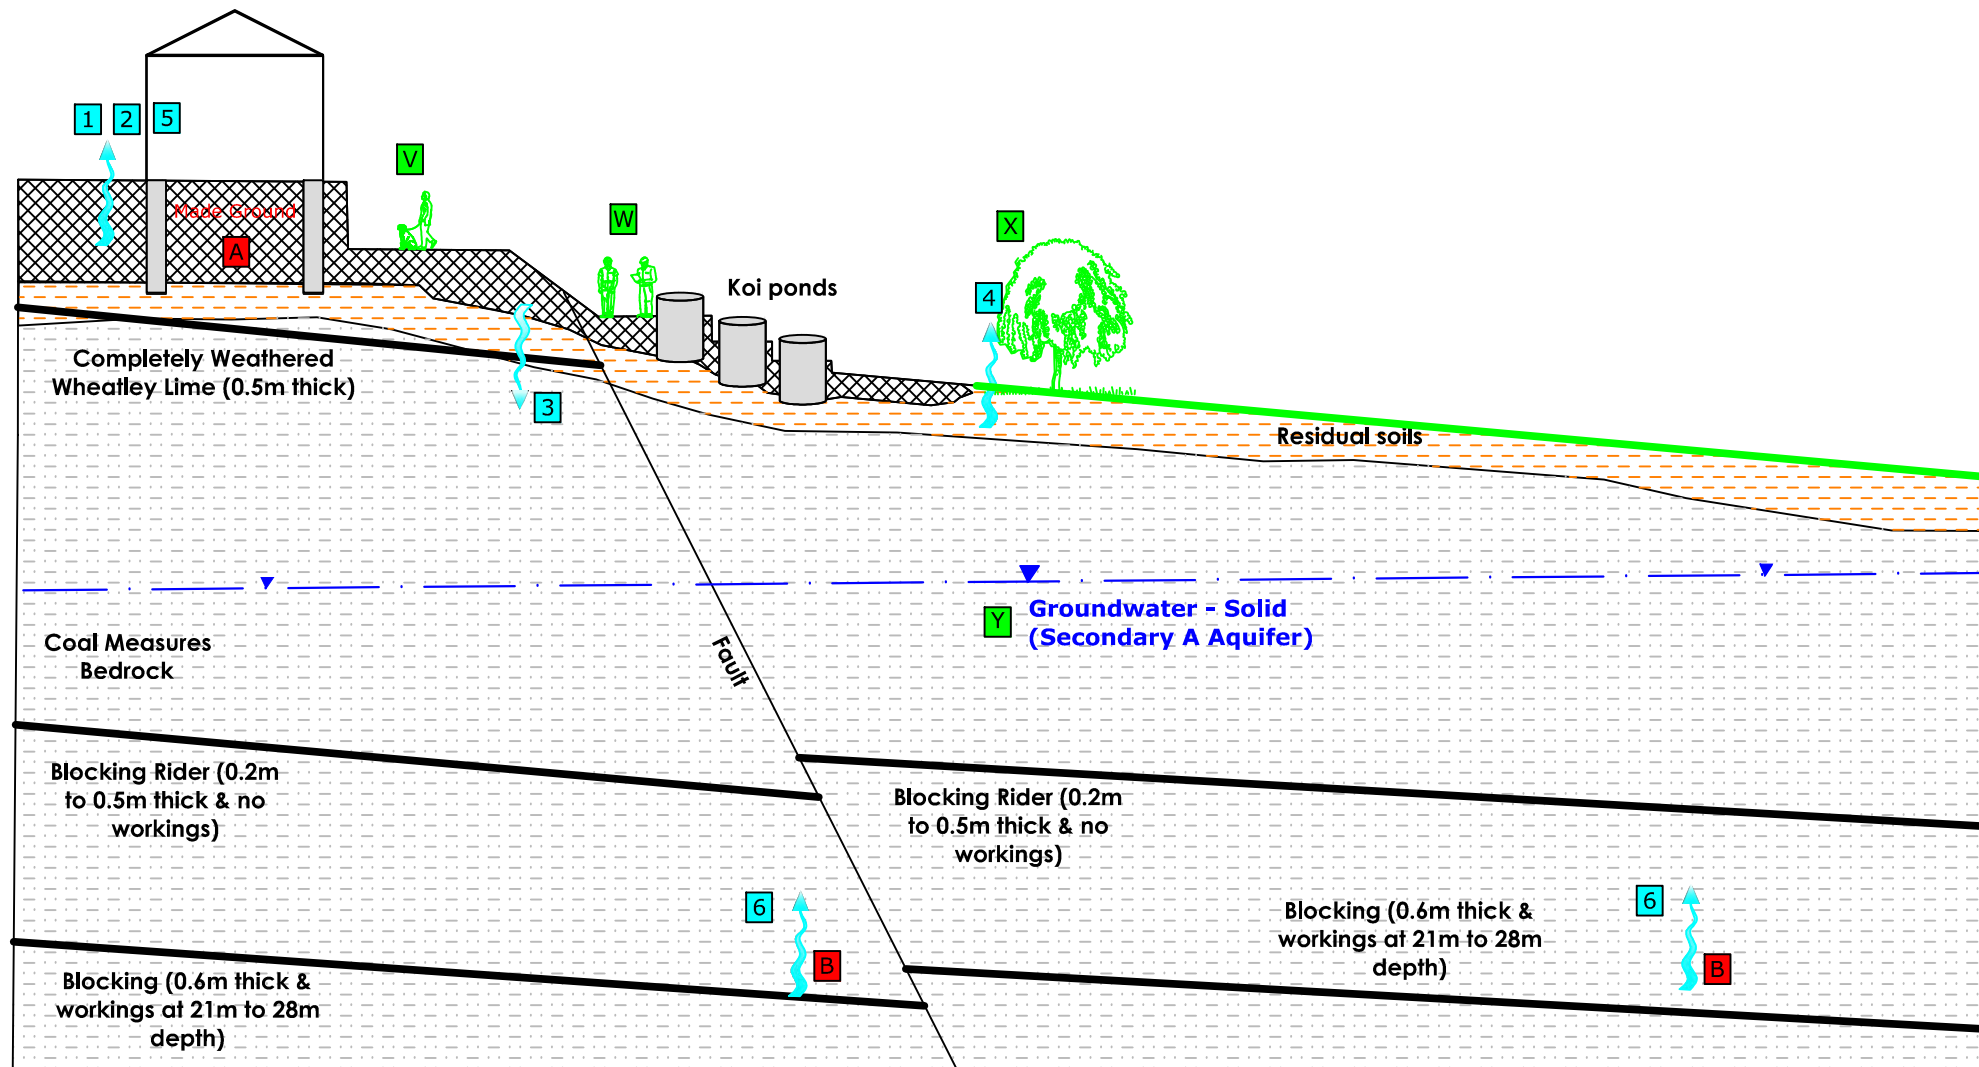
SOURCES	
A	MADE GROUND (INORGANICS & ORGANICS)
B	MINeworkINGS (GAS)

PATHWAYS	
1	DERMAL CONTACT
2	INGESTION/INHALATION
3	LEACHING OF CONTAMINANTS
4	UPTAKE BY PLANTS
5	VOLATILISATION
6	MIGRATION OF GAS

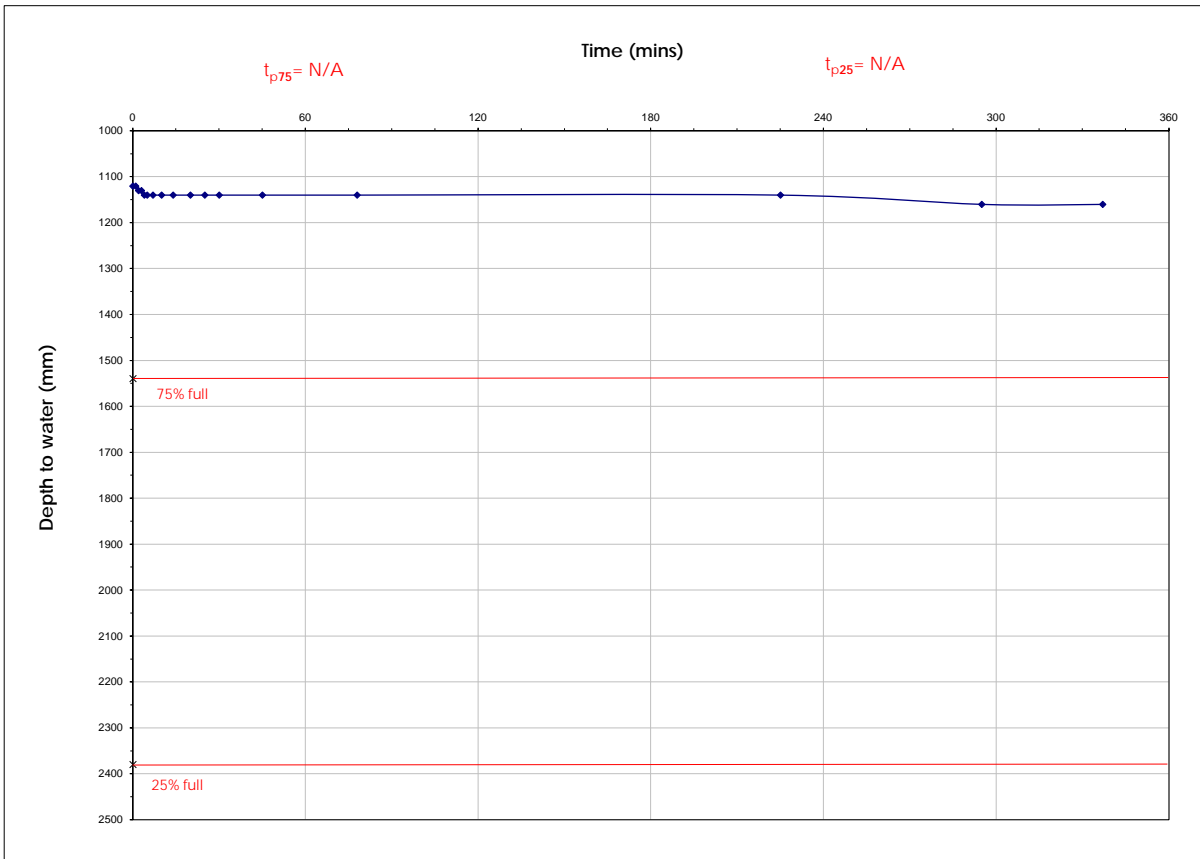
Read from the graph:		
t _{p75} (min)	=	N/A
t _{p25} (min)	=	N/A

Test did not attain 25% Effective depth. Unable to calculate soil infiltration rate

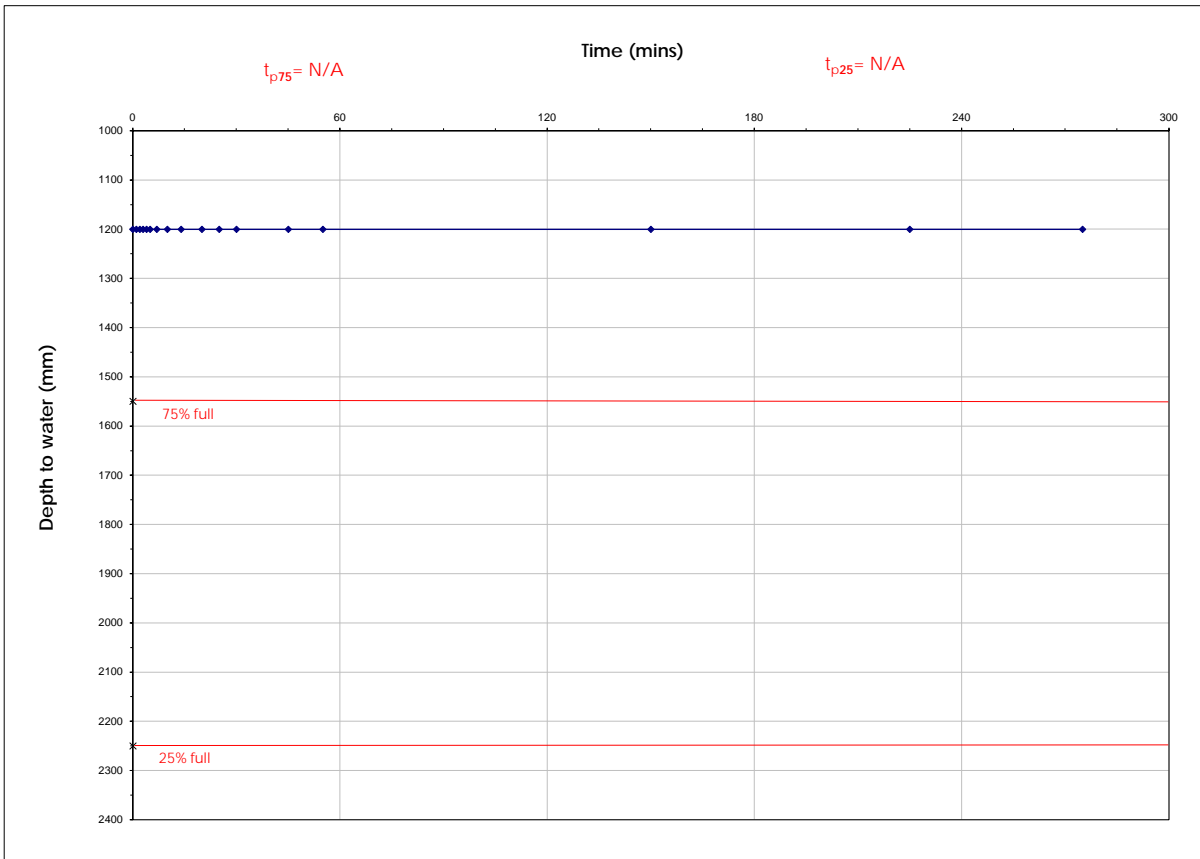
Read from the graph:		
t _{p75} (min)	=	N/A
t _{p25} (min)	=	N/A

Test did not attain 25% Effective depth. Unable to calculate soil infiltration rate

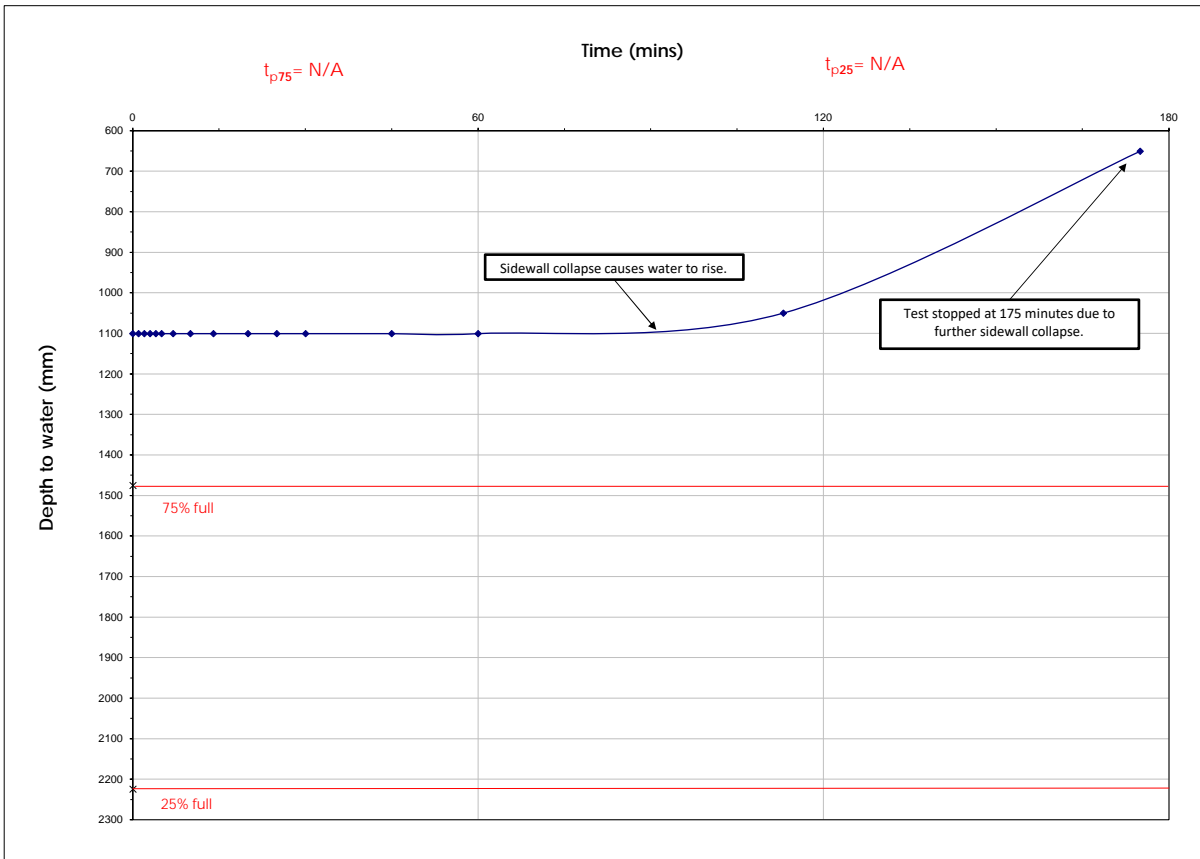
Read from the graph:		
t_{p75} (min)	=	N/A
t_{p25} (min)	=	N/A

Test did not attain 25% Effective depth. Unable to calculate soil infiltration rate

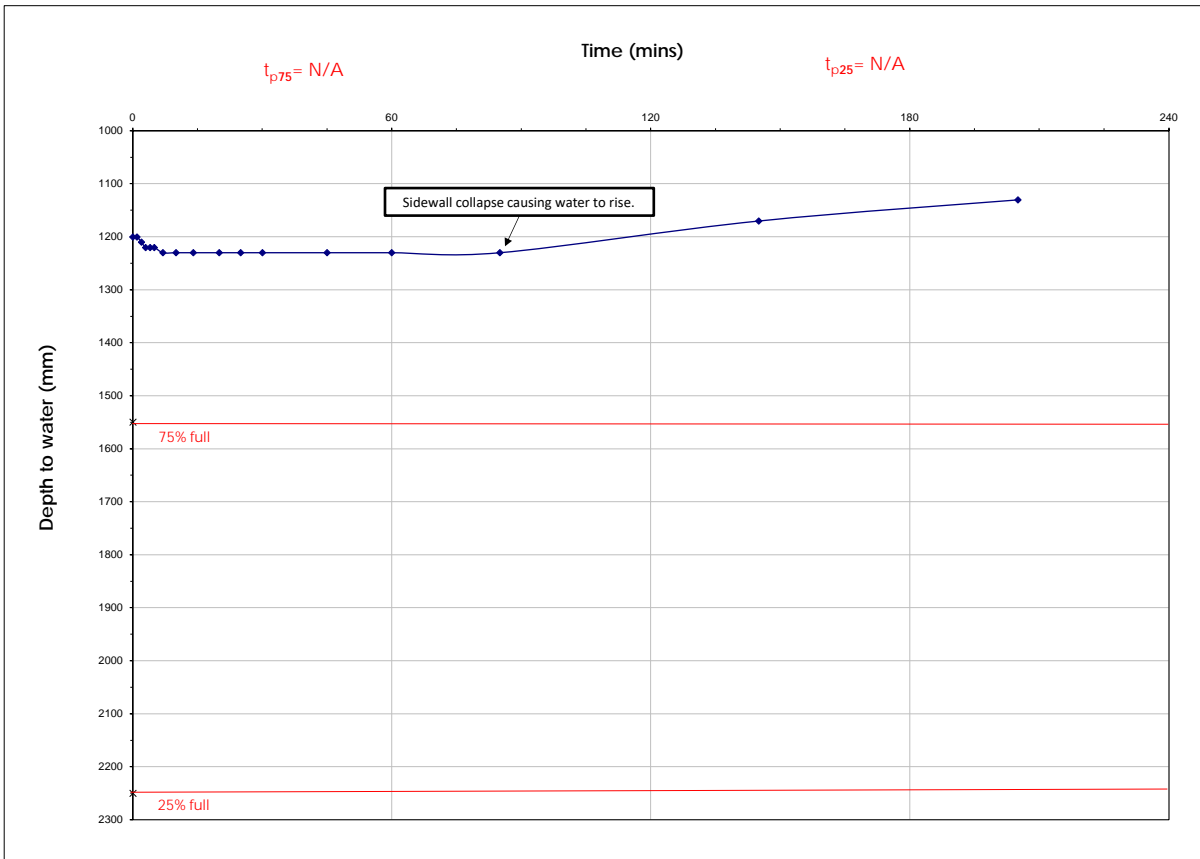
Read from the graph:		
t _{p75} (min)	=	N/A
t _{p25} (min)	=	N/A

Test did not attain 25% Effective depth. Unable to calculate soil infiltration rate

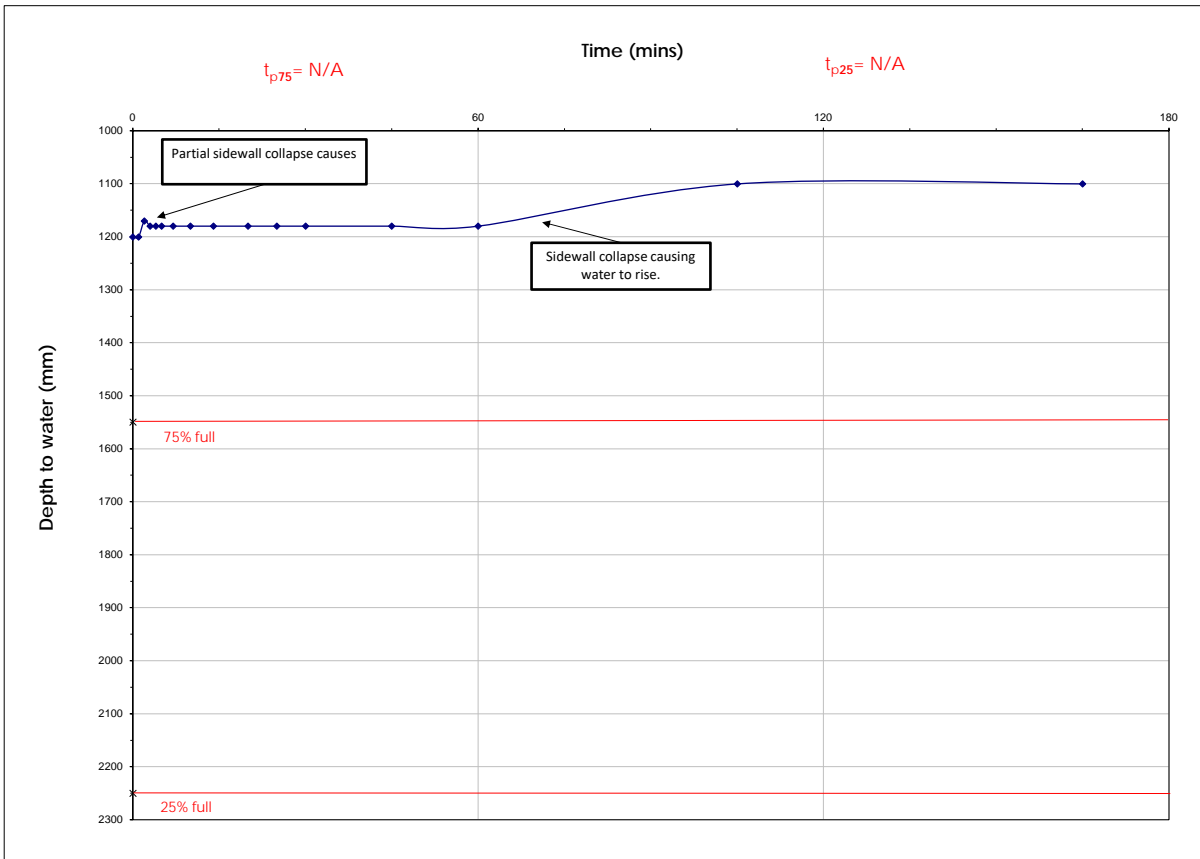
Read from the graph:		
t _{p75} (min)	=	N/A
t _{p25} (min)	=	N/A

Test did not attain 25% Effective depth. Unable to calculate soil infiltration rate
