Land at Northorpe Lane, Mirfield For Newett Homes

Report no: 3433/2C

Date: March 2022

SUMMARY OF GEOENVIRONMENTAL ISSUES

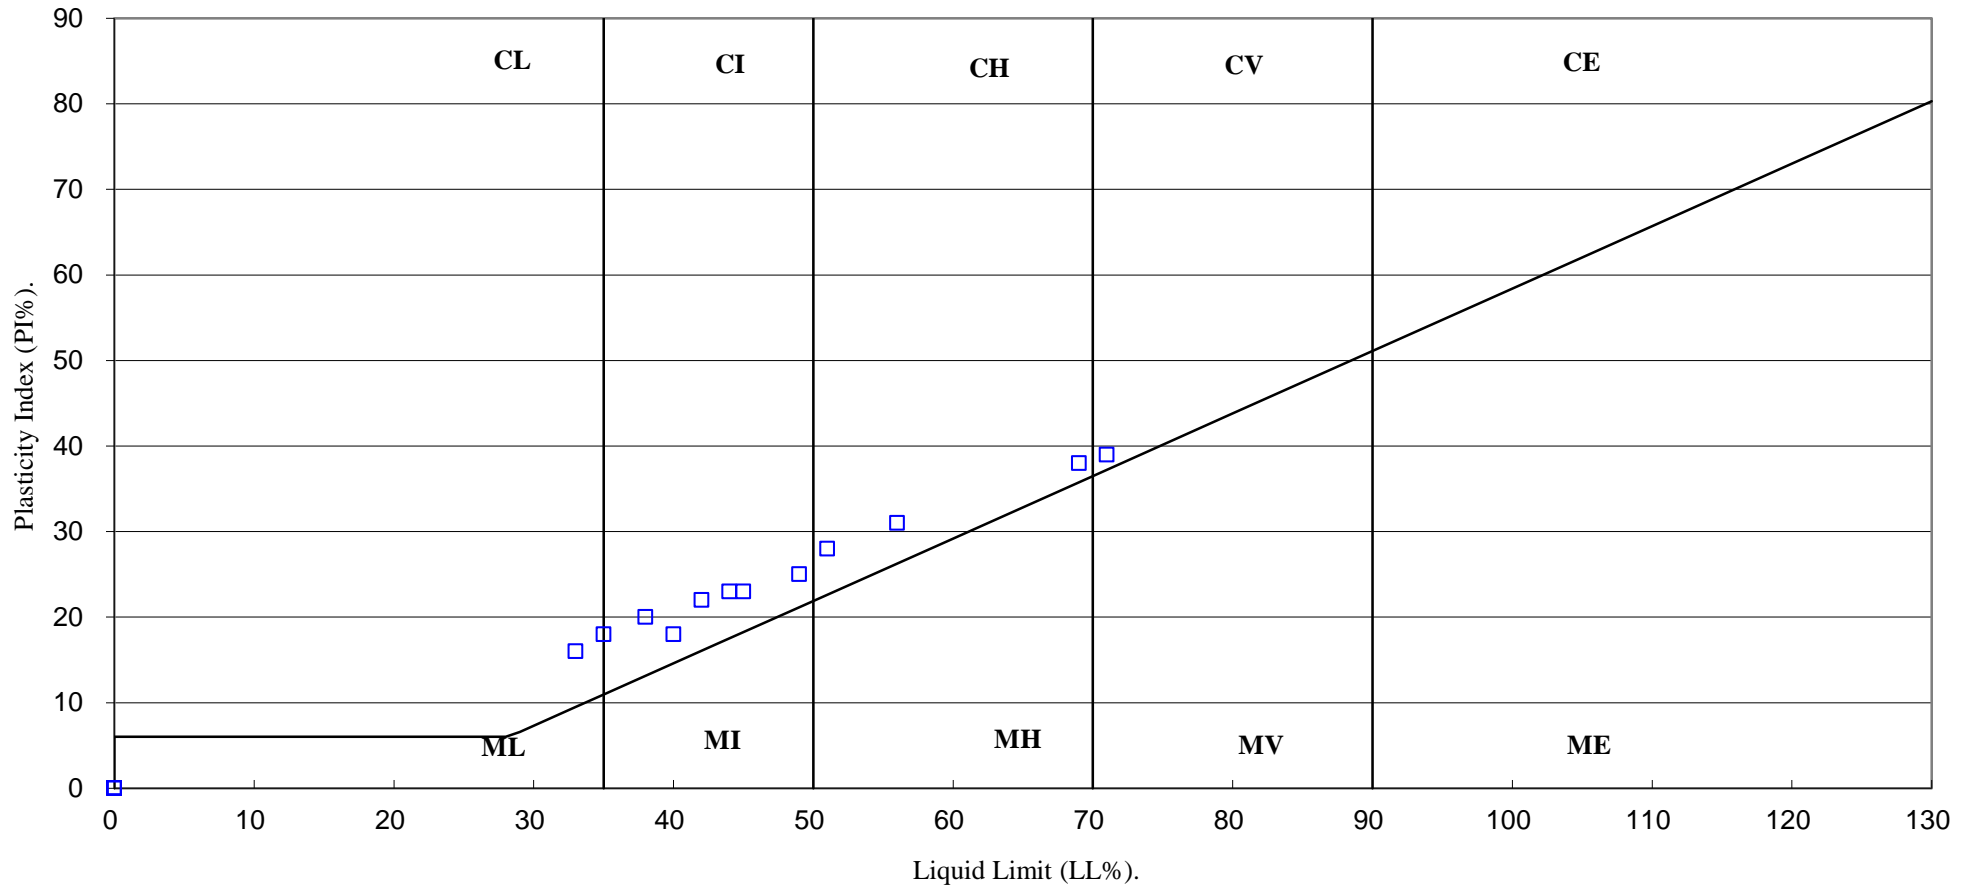
PLASTICITY CHART FOR CASAGRANDE CLASSIFICATION.

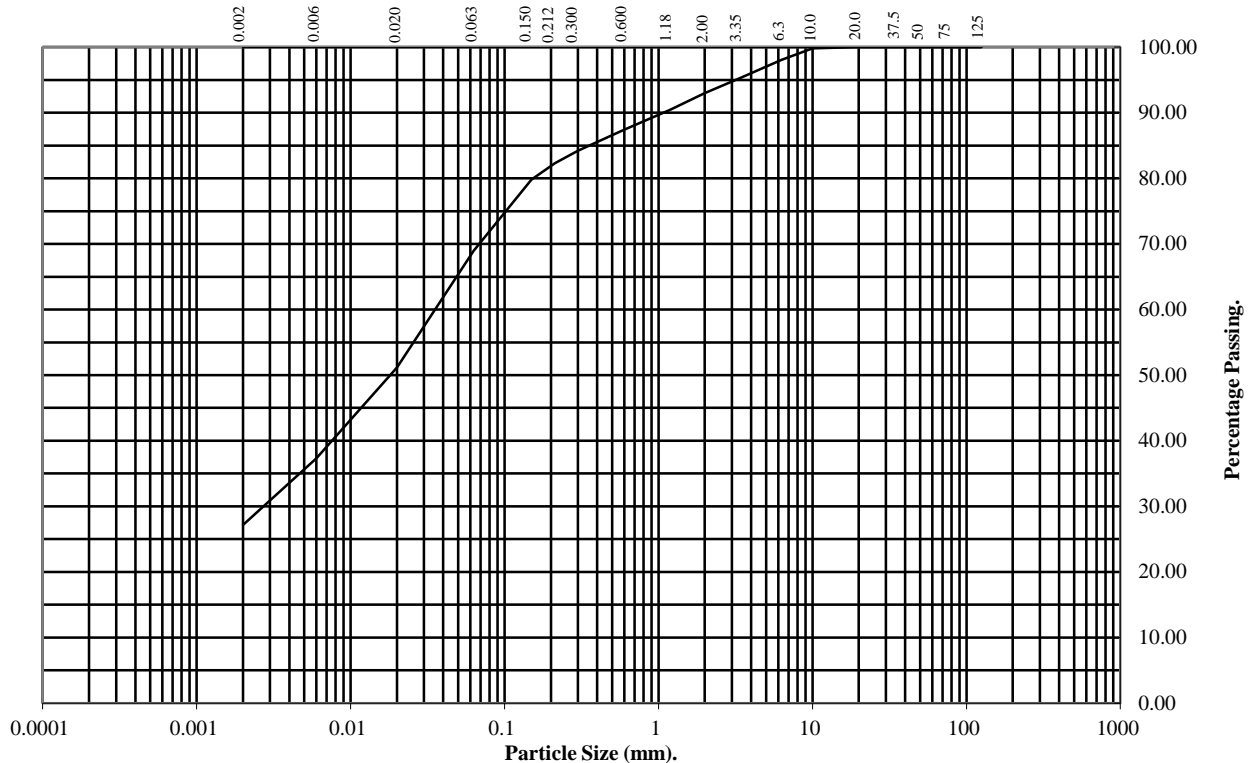
BS Test Sieve (mm)	Percentage Passing
125	100
75	100
50	100
37.5	100
20	100
10	100
6.3	98
3.35	95
2	93
1.18	90
0.6	87
0.3	84
0.212	82
0.15	80
0.063	69

Particle Diameter	Percentage Passing
0.02	51
0.006	37
0.002	27

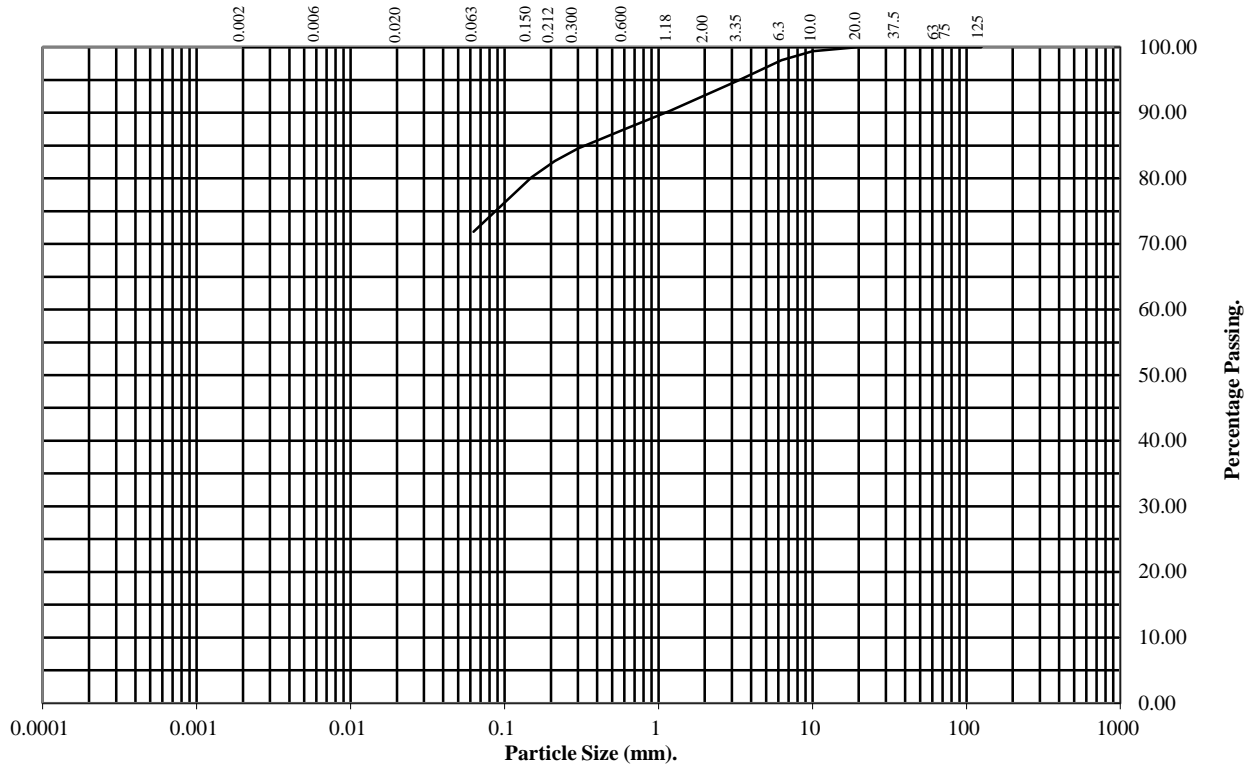
BS Test Sieve (mm)	Percentage Passing
125	100
75	100
63	100
37.5	100
20	100
10	99
6.3	98
3.35	95
2	93
1.18	90
0.6	87
0.3	85
0.212	83
0.15	80
0.063	72

Soil Fraction	Total Percentage
Cobbles	0
Gravel	7
Sand	21
Silt/Clay	72

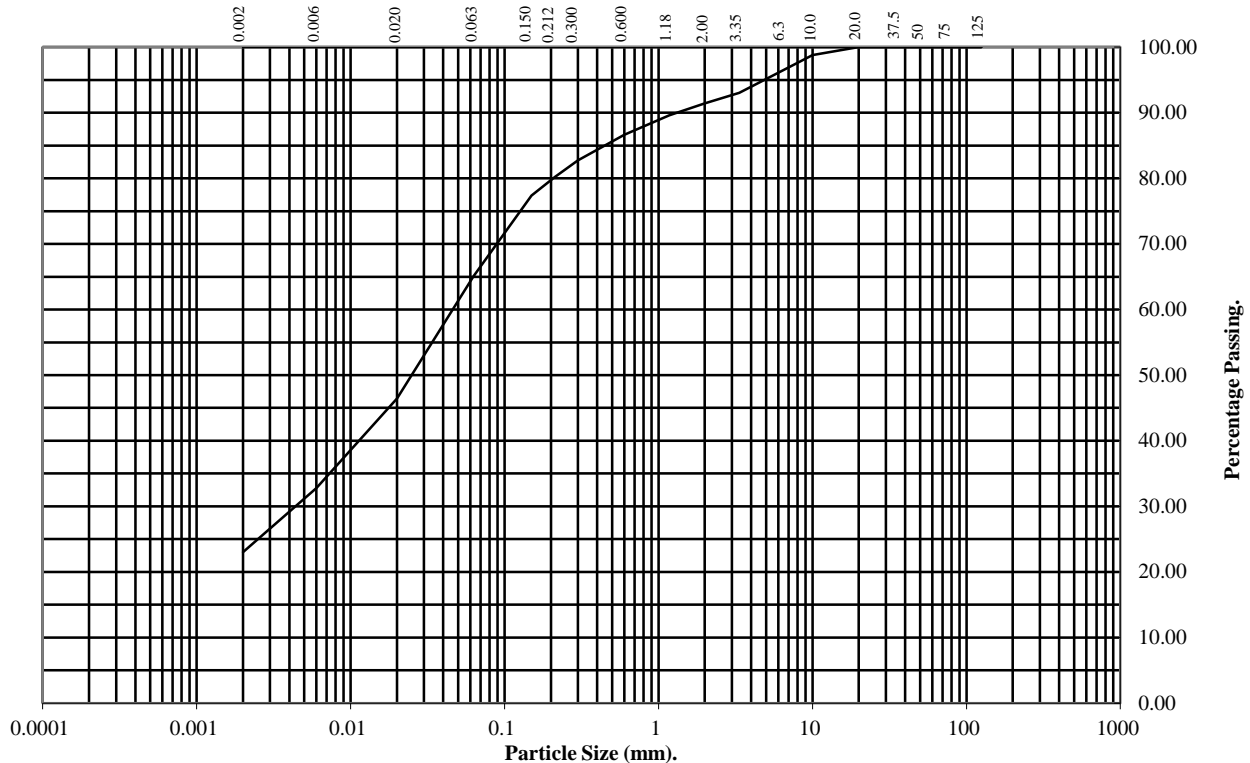
BS Test Sieve (mm)	Percentage Passing
125	100
75	100
50	100
37.5	100
20	100
10	99
6.3	96
3.35	93
2	91
1.18	90
0.6	87
0.3	83
0.212	80
0.15	77
0.063	65

Particle Diameter	Percentage Passing
0.02	46
0.006	33
0.002	23

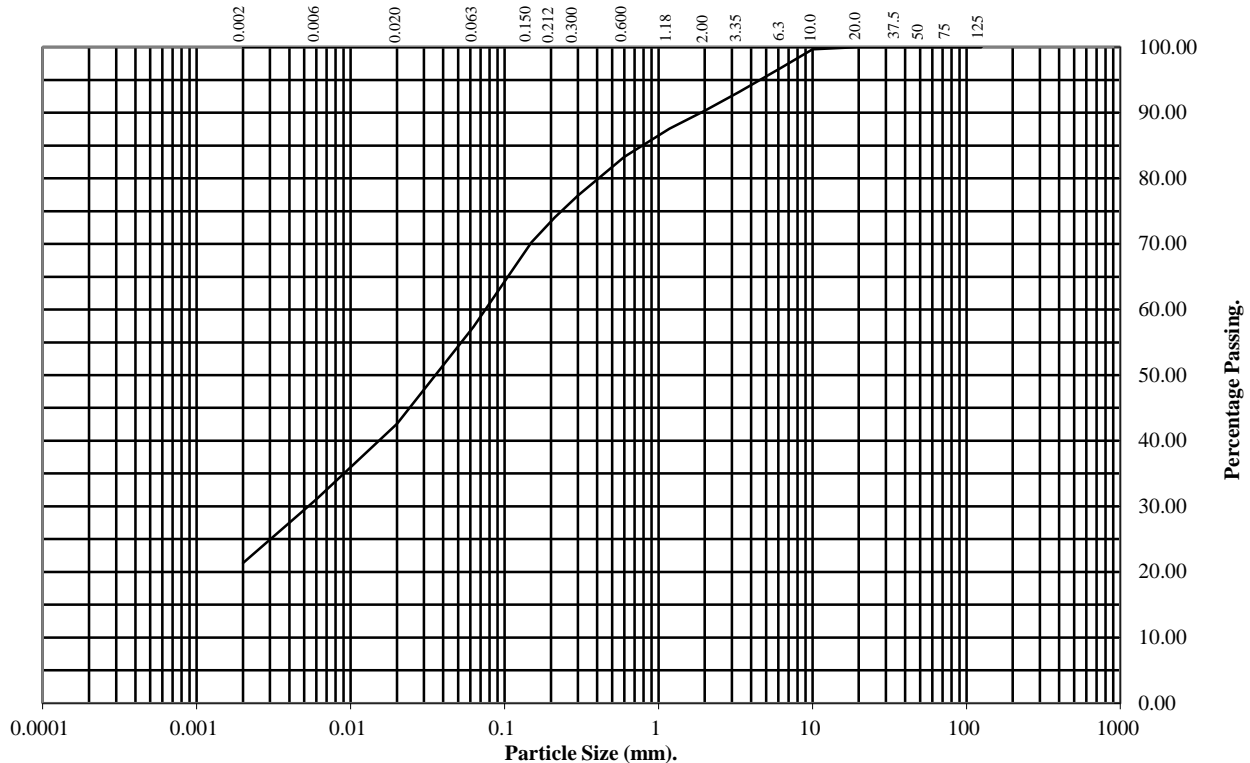
BS Test Sieve (mm)	Percentage Passing
125	100
75	100
50	100
37.5	100
20	100
10	100
6.3	97
3.35	93
2	90
1.18	88
0.6	83
0.3	77
0.212	74
0.15	70
0.063	57

Particle Diameter	Percentage Passing
0.02	43
0.006	31
0.002	21

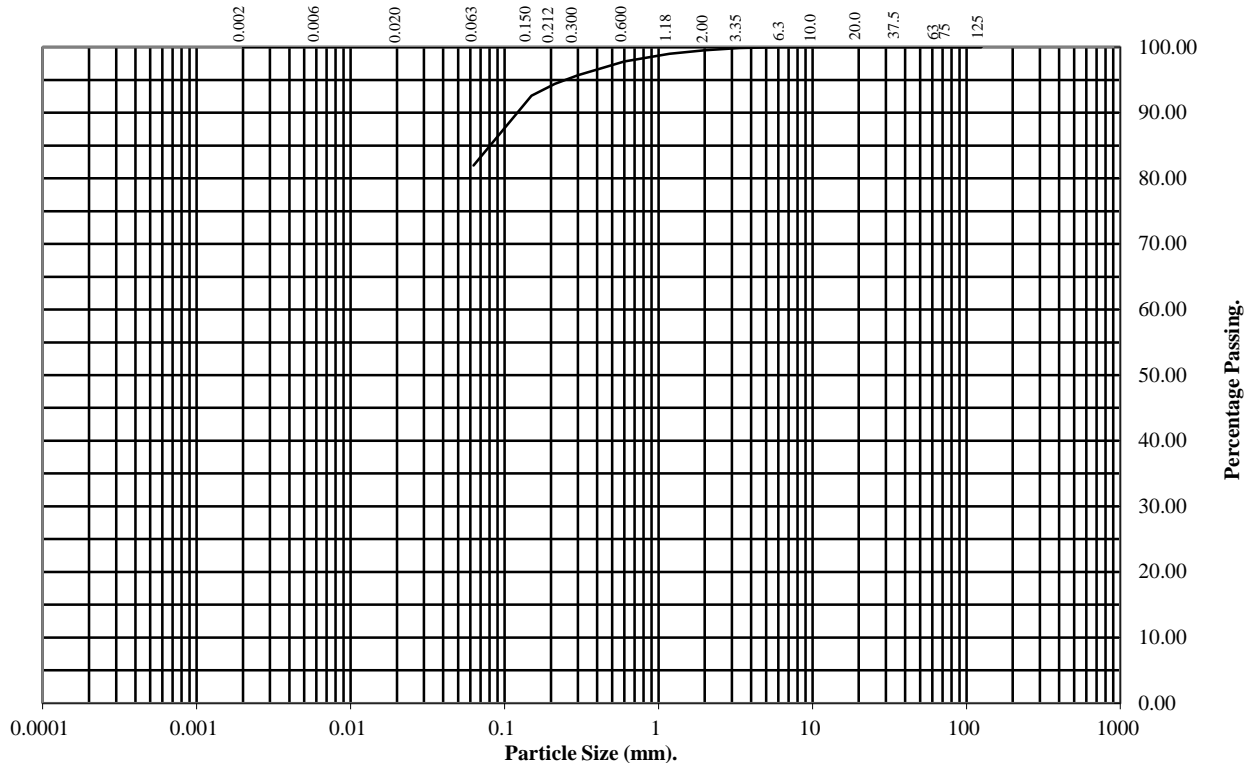
BS Test Sieve (mm)	Percentage Passing
125	100
75	100
63	100
37.5	100
20	100
10	100
6.3	100
3.35	100
2	100
1.18	99
0.6	98
0.3	96
0.212	94
0.15	93
0.063	82

Soil Fraction	Total Percentage
Cobbles	0
Gravel	0
Sand	18
Silt/Clay	82

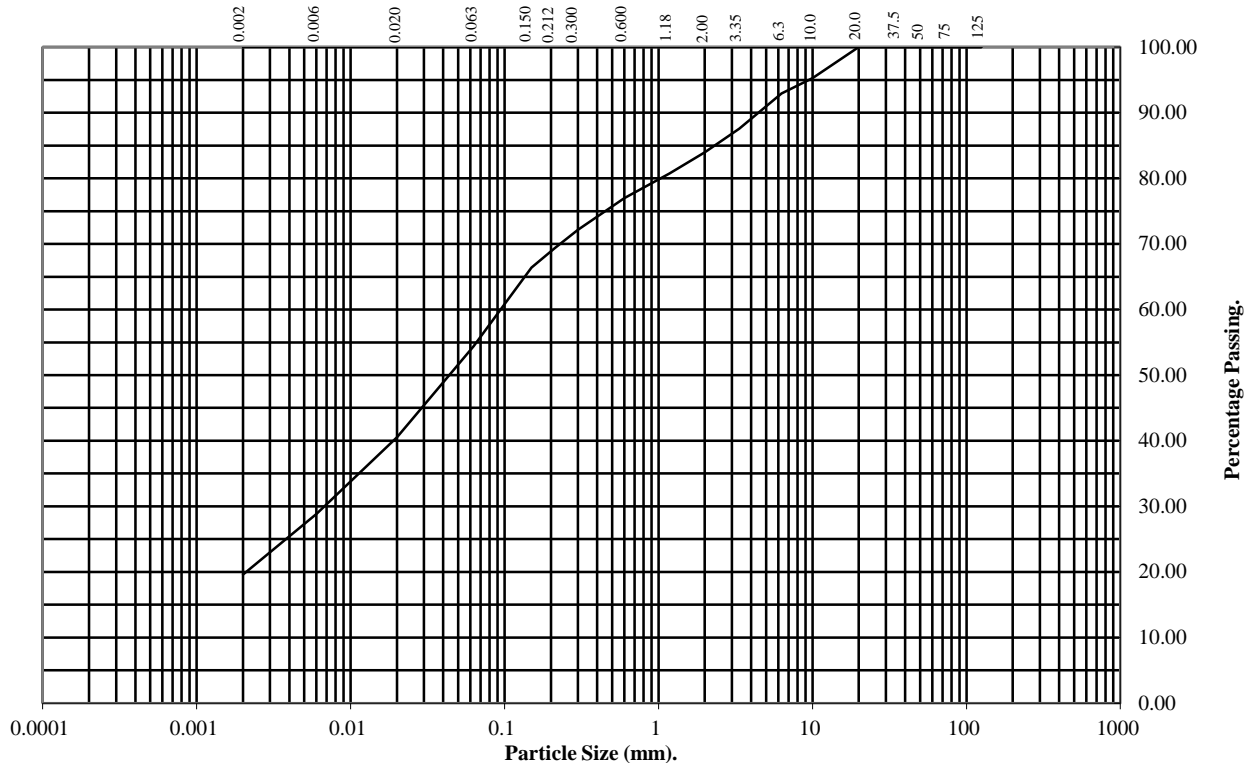
BS Test Sieve (mm)	Percentage Passing
125	100
75	100
50	100
37.5	100
20	100
10	95
6.3	93
3.35	88
2	84
1.18	81
0.6	77
0.3	72
0.212	69
0.15	66
0.063	54

Particle Diameter	Percentage Passing
0.02	41
0.006	29
0.002	20

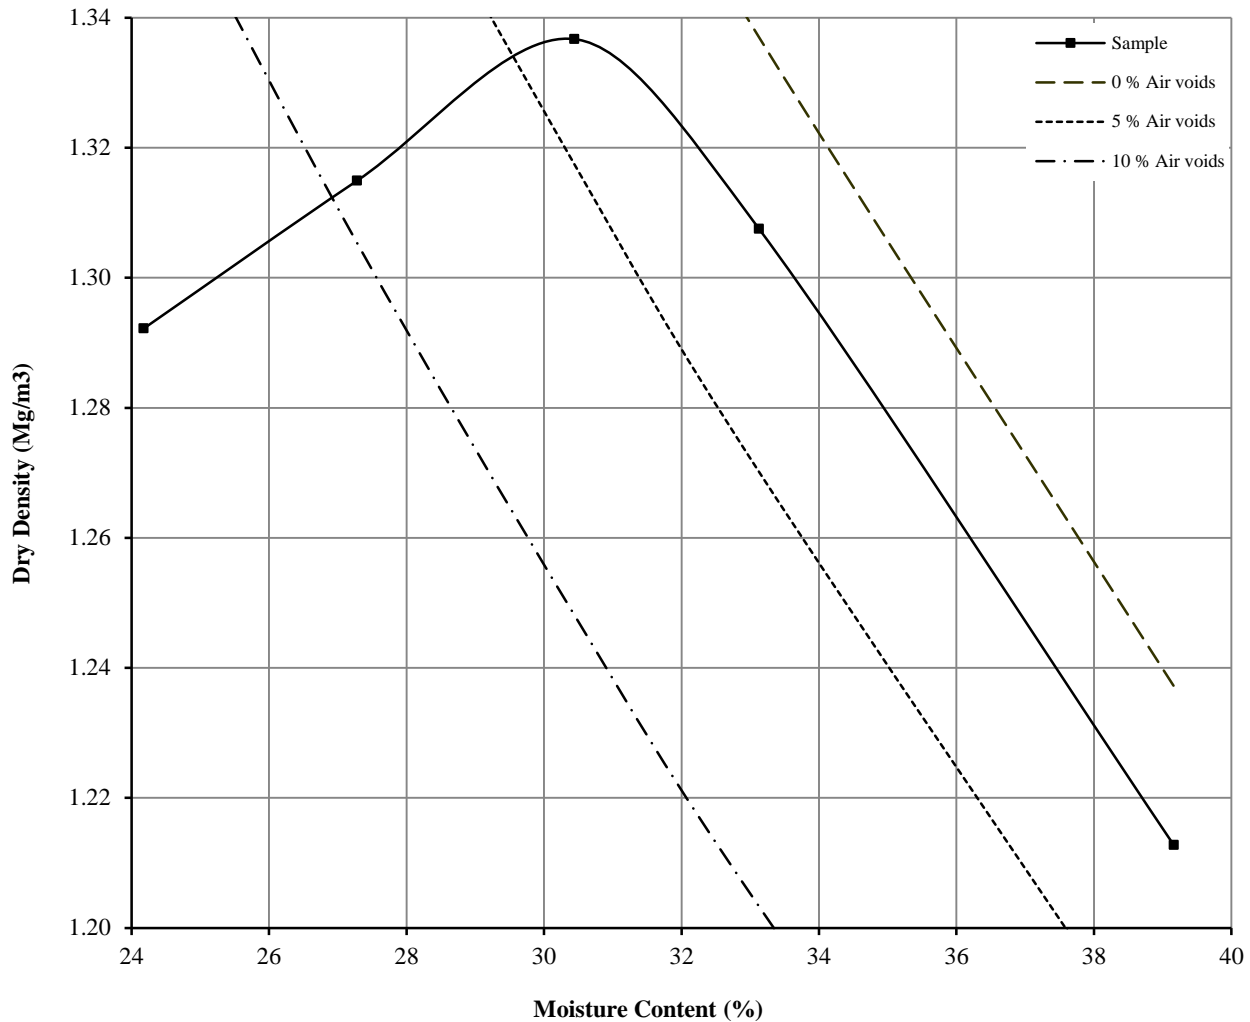
Initial Moisture Content:	39	Method of Compaction:	4.5kg	Separate Samples
Particle Density (Mg/m ³):	2.40	Assumed	Material Retained on 37.5 mm Test Sieve (%):	0
Maximum Dry Density (Mg/m ³):	1.34		Material Retained on 20.0 mm Test Sieve (%):	0
Optimum Moisture Content (%):	30			
Remarks See summary of soil descriptions

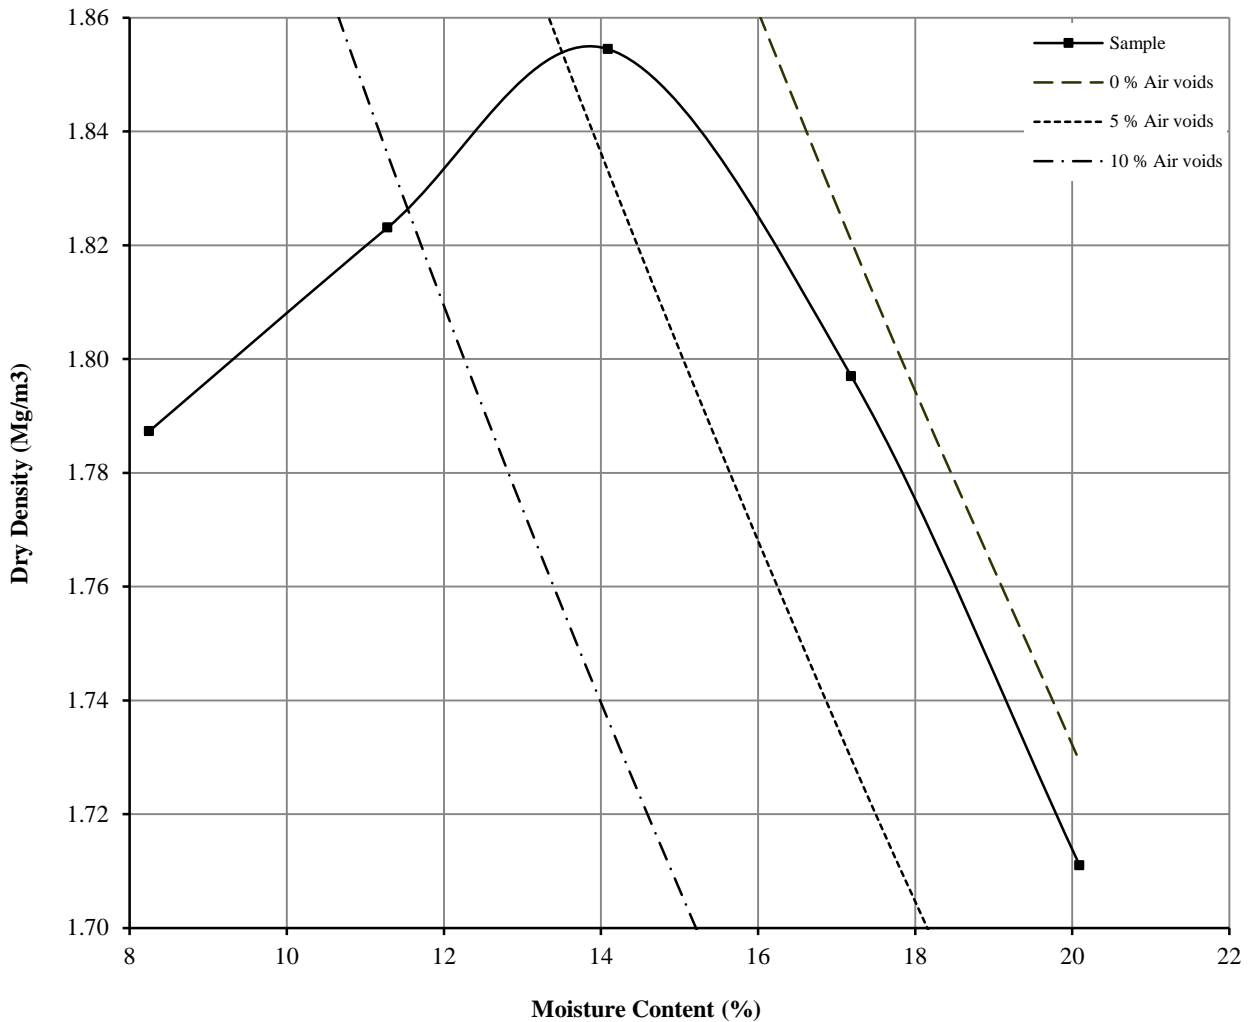
Initial Moisture Content:	26	Method of Compaction:	4.5kg	Separate Samples
Particle Density (Mg/m ³):	2.65	Assumed	Material Retained on 37.5 mm Test Sieve (%):	0
Maximum Dry Density (Mg/m ³):	1.85		Material Retained on 20.0 mm Test Sieve (%):	0
Optimum Moisture Content (%):	14			
Remarks See summary of soil descriptions

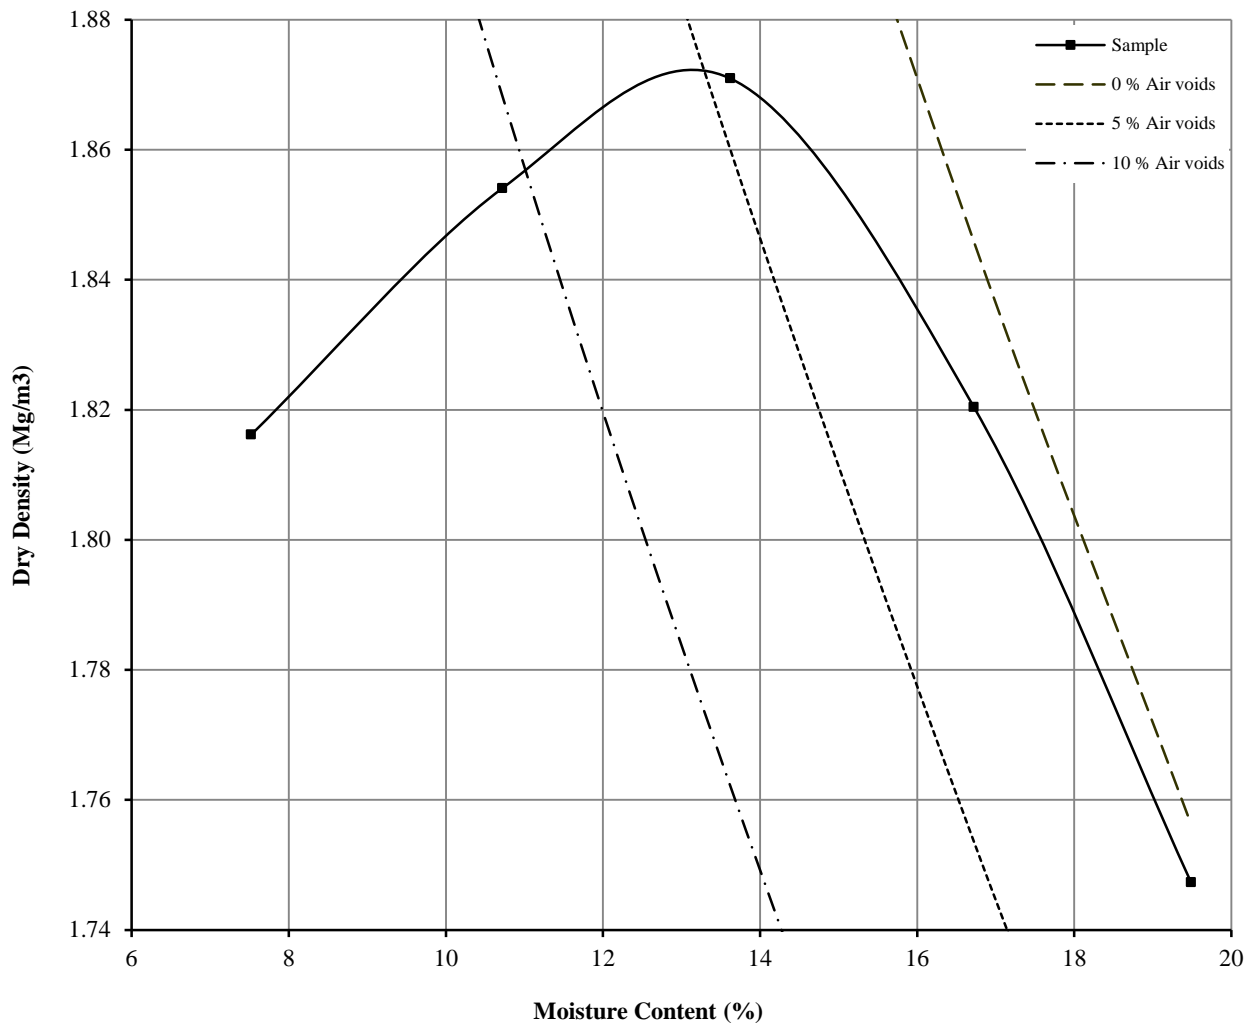
Initial Moisture Content:	26	Method of Compaction:	4.5kg	Separate Samples
Particle Density (Mg/m ³):	2.67	Assumed	Material Retained on 37.5 mm Test Sieve (%):	0
Maximum Dry Density (Mg/m ³):	1.87	Material Retained on 20.0 mm Test Sieve (%):	0	
Optimum Moisture Content (%):	14			
Remarks See summary of soil descriptions

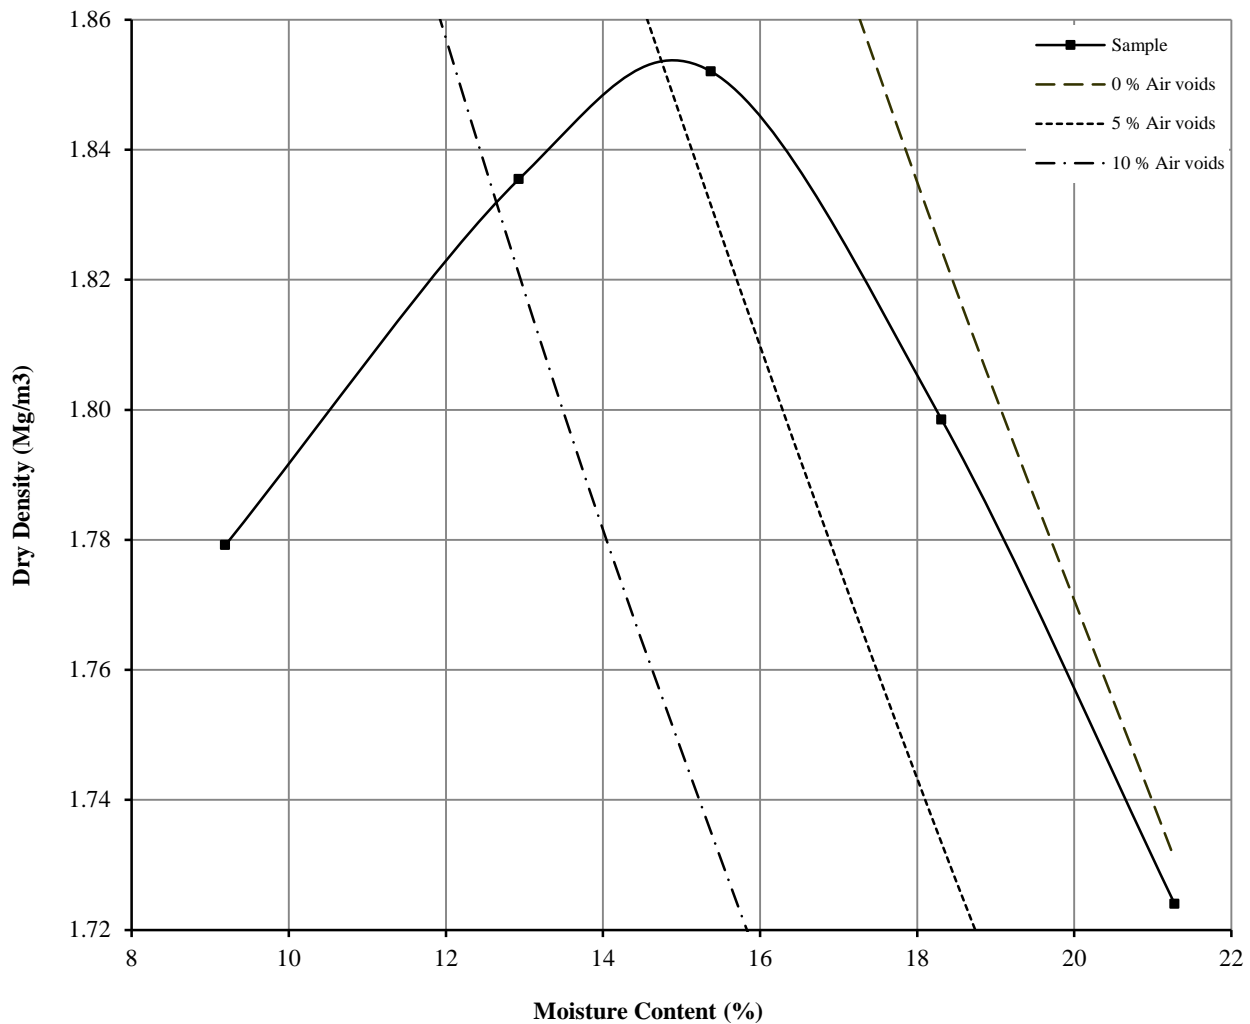
Initial Moisture Content:	18	Method of Compaction:	4.5kg	Separate Samples
Particle Density (Mg/m ³):	2.74	Assumed	Material Retained on 37.5 mm Test Sieve (%):	0
Maximum Dry Density (Mg/m ³):	1.85	Material Retained on 20.0 mm Test Sieve (%):	0	
Optimum Moisture Content (%):	15			
Remarks See summary of soil descriptions
