# North Bierley WWTW, Bradford

## Ground Investigation Report

Curtins Ref: 065646-CUR-00-XX-RP-GE-001

Site Address: North Bierley WWTW, Bierley, BD12 7ES

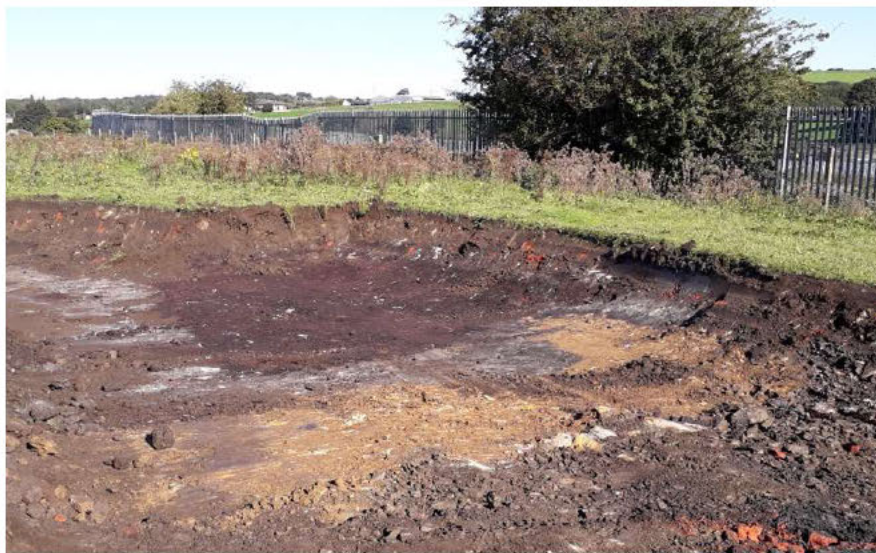
**Plate 6.3.2:** Potential landfill.

In the approximate location of the Valley Pit shaft, a fill area of loose brown red sandy gravelly ash with whole glass bottles was recorded in a triangular shape, similar to that seen on historic maps by the Valley Pit. This fill material is interpreted to be a potential unrecorded historical landfill. The soils overlying this potential landfill material were white and interpreted as lime.

A photograph of the infilled area is presented in plate 6.3.2.

An unrecorded historical landfill has been identified at the site. The composition of the material indicates a low organic content with no visual evidence of organic inclusions. The anticipated age of infilling with minimal observed organic content, indicates a low gassing potential of this material.

The presence of an unrecorded 'landfill' will need to be considered within foundation design, with potential for further investigation and assessment.
