**Bradley Villa, Huddersfield  
A641 Bradford Road Site Access Junction and Shepherds  
Thorn Lane Ped/Cycle Access**

**Response Report to Road Safety Audit Stage 1**

# ROAD SAFETY AUDIT

## STAGE 1

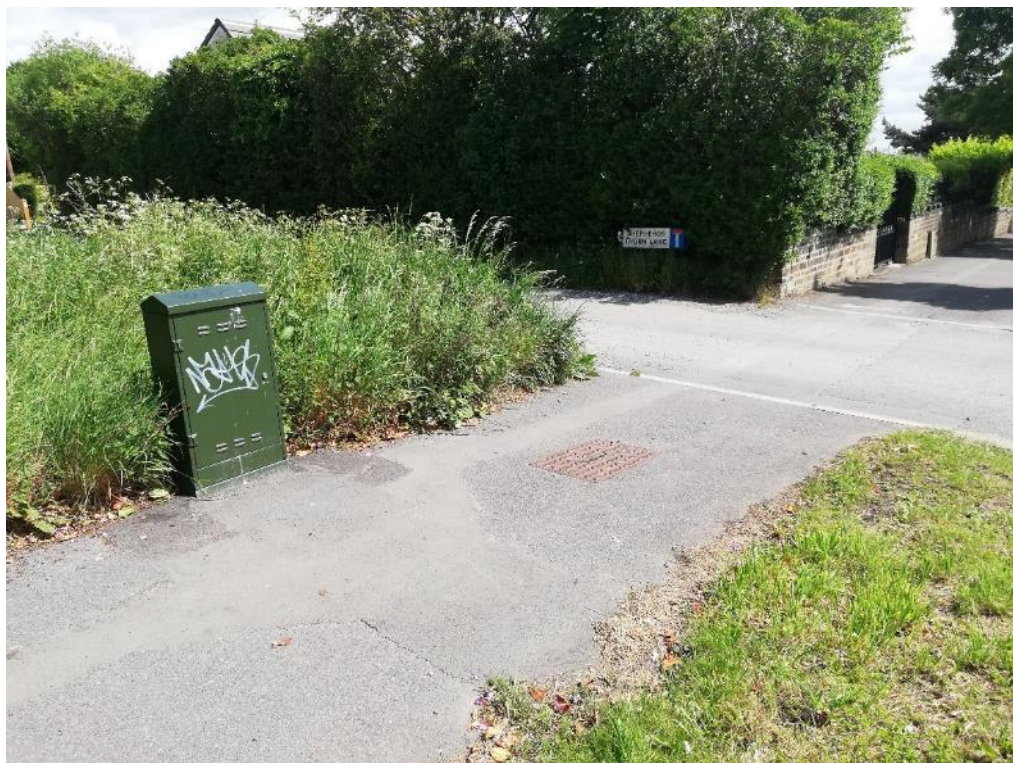
### 1.7 Problem: Utility cabinet and underground services at the start of shared footway/cycleway warning paving

The Audit team noted that a utility cabinet and underground services chamber is located at the start of the proposed shared footway/cycleway onto Shepherds Thorn Lane. Cyclists turning to use the lane have the potential to strike the cabinet in close proximity, especially if a pedestrian is walking at the same time. Accessing the adjacent underground services chamber may also result in cyclists utilising the proposed Shepherds Thorn Lane carriageway and conflicting with vehicles, albeit vehicular movements here would be minimal.

Photograph 1: Utility Cabinet and underground services chamber at the end of Shepherds Thorn Lane

It is recommended that clarity is provided with regard to the existing position of both services and a detailed assessment carried out as to whether there is scope to move these services away from the start of the proposed shared use path, or the path is relocated to suit.

Increase visibility / prominence of utility cabinet (by ensuring proposed verge vegetation / grass is maintained at low level) so no blind spots are created which potentially lead to conflict points.

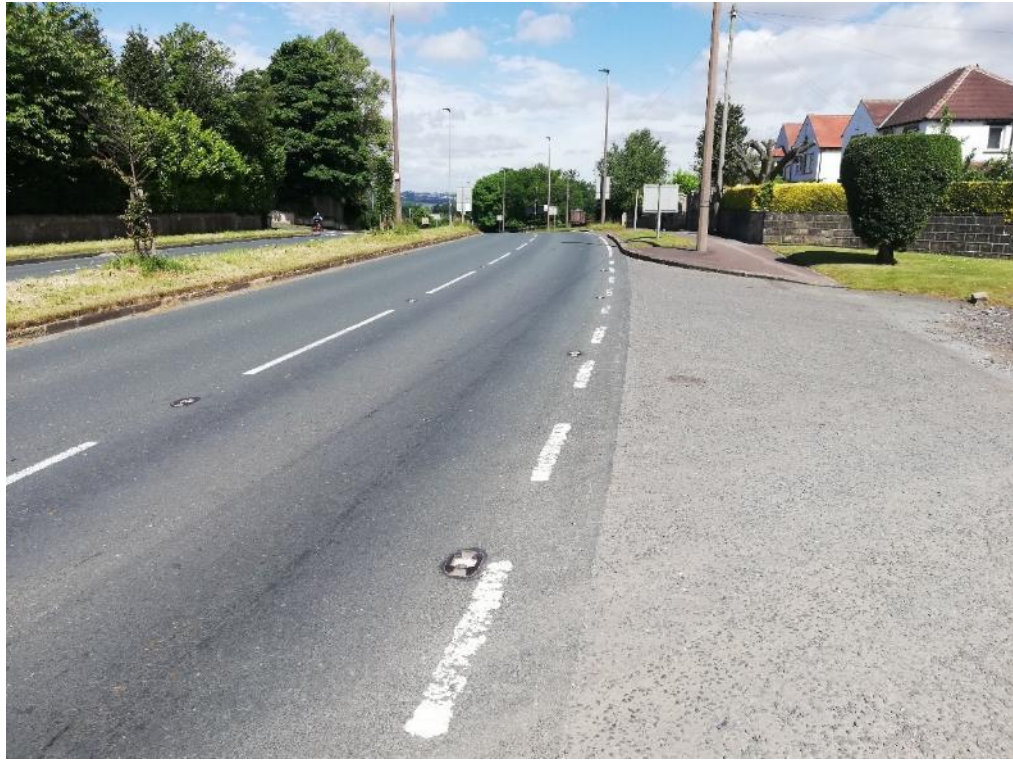
The Audit team noted that the vertical alignment of the A641 Bradford Road north of the proposed site access junction could result in restricted visibility. No information is provided on Drawing No. 19154/GA/01 as to whether the 2.4m x 120m junction visibility splay can be achieved in the vertical plane due the existing crest in the road.

As a consequence of the above, there is the potential for vehicles exiting the site to be struck by oncoming vehicles travelling at speed if adequate visibility is not provided.

Photograph 2: Proposed site access junction location - visibility looking right along  
A641 Bradford Road

It is recommended that the design team assess whether the visibility to the north from the site access is achievable in the vertical plane or not. If not, then an alternative form of junction control may be necessary.

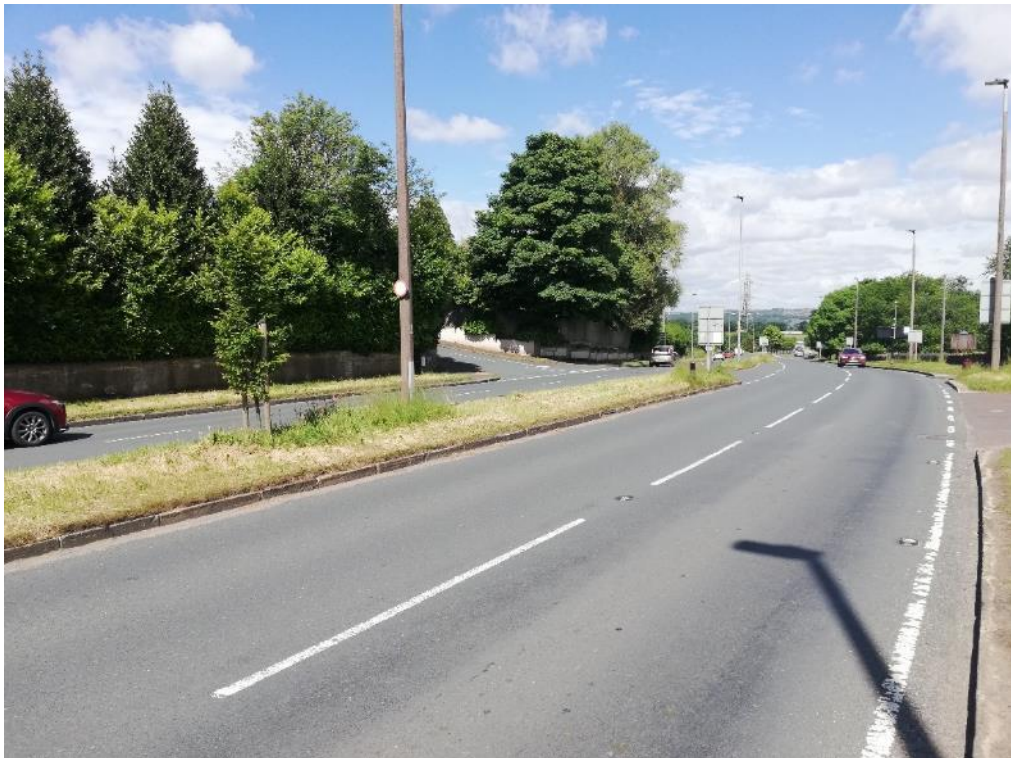
**Summary:** *Blank roundels attached to lamp posts may confuse drivers and are unnecessary*

The Audit team observed 2no. blank roundels which appear to have previously been speed limit signs. No speed limit is given within these signs which may lead to driver confusion, attracting unwarranted attention and sudden slowing down or speeding up.

Photograph 3: Blank speed limit roundel along A641 Bradford Road adjacent to proposed site access

It is recommended that both these repeater signs are removed to avoid confusion or speeds limits re-instated within them.

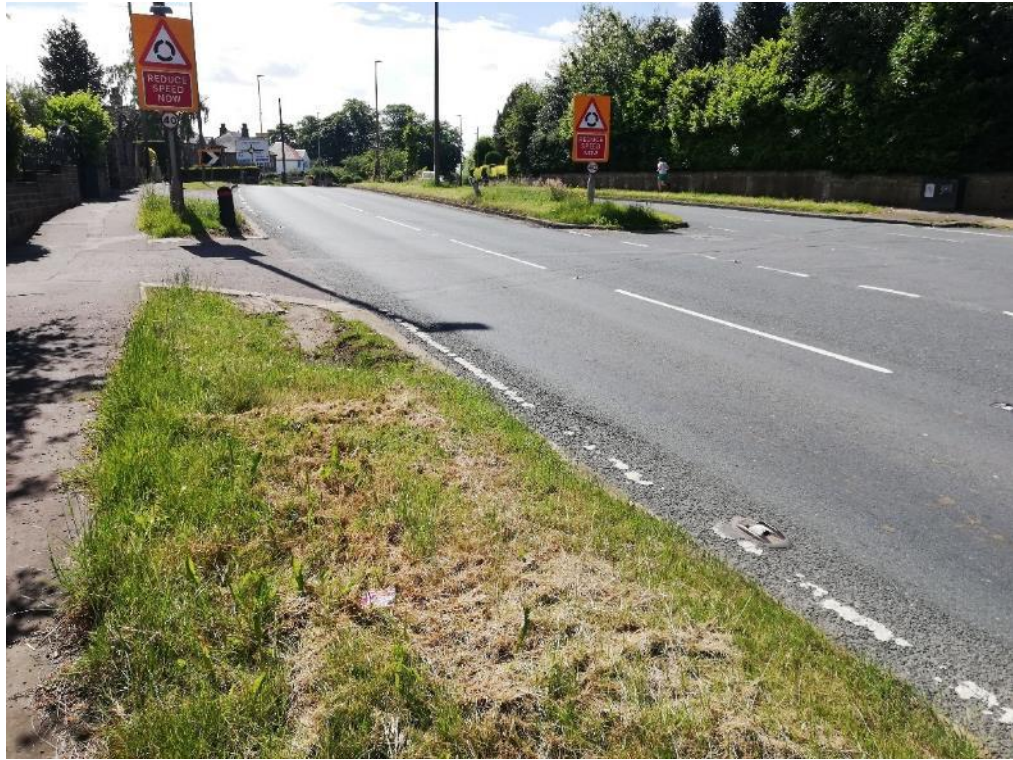
The audit team noted that vehicles travelling southbound were travelling at speed and potentially more than 40mph, the relocation of these signs south east of the site access may result in vehicles travelling at too high a speed upon approach to the proposed Toucan crossing and Bradley Bar Roundabout further south. This may result in loss of control, veering and collisions.

Photograph 4: Existing 2no. roundabout signs warning drivers to reduce speed

It is recommended that clarity is provided in regard to the exact relocation of all three signs, in particular the roundabout warning signs. A revised plan showing where the signs are to be relocated is recommended. An assessment of the distance the signs are located from the busy roundabout can then be made, particularly in light of vehicle speeds and driver anticipation. It is noted that these signs are quite large and so might obstruct the forward view of the new traffic signals but given warning signs are recommended for the latter above, it is recommended that these could be stacked and located further from the signals rather than closer to the roundabout.

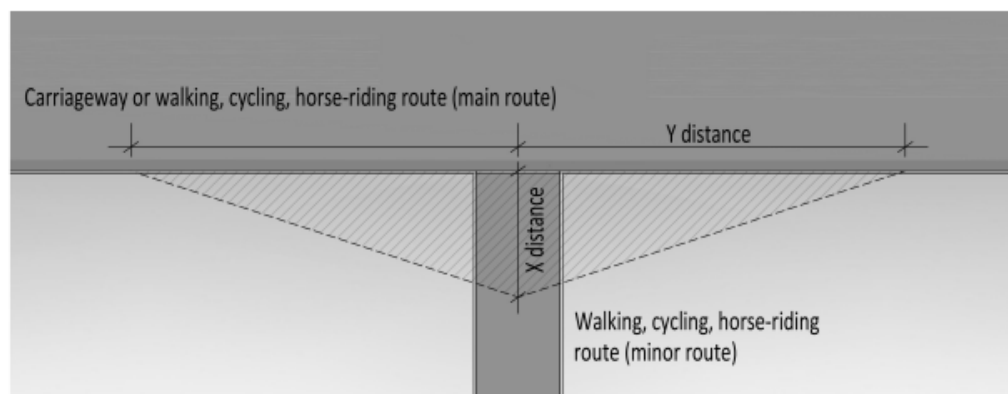
**Figure E/5.1N Visibility splay 'x' and 'y' distances for walking, cycling and horse-riding routes**

The Audit Team notes that for cyclists at shared use crossings, the desirable minimum "x" distance is 2.5m as set out in table E/5.2 of DMRB CD 143. This is based on cyclists approaching a main route crossing perpendicularly, this is not the case at the proposed Toucan crossing point.

Visibility splay "x" distances for pedestrians, cyclists (on shared use facilities only) and equestrians at junctions and crossing points shall be provided in accordance with Table E/5.2.
