## **PHASE 2: GROUND INVESTIGATION REPORT**

**PROPOSED RESIDENTIAL DEVELOPMENT**

**LAND ADJACENT TO SCAR MILLS**

**Project No: 20-153**

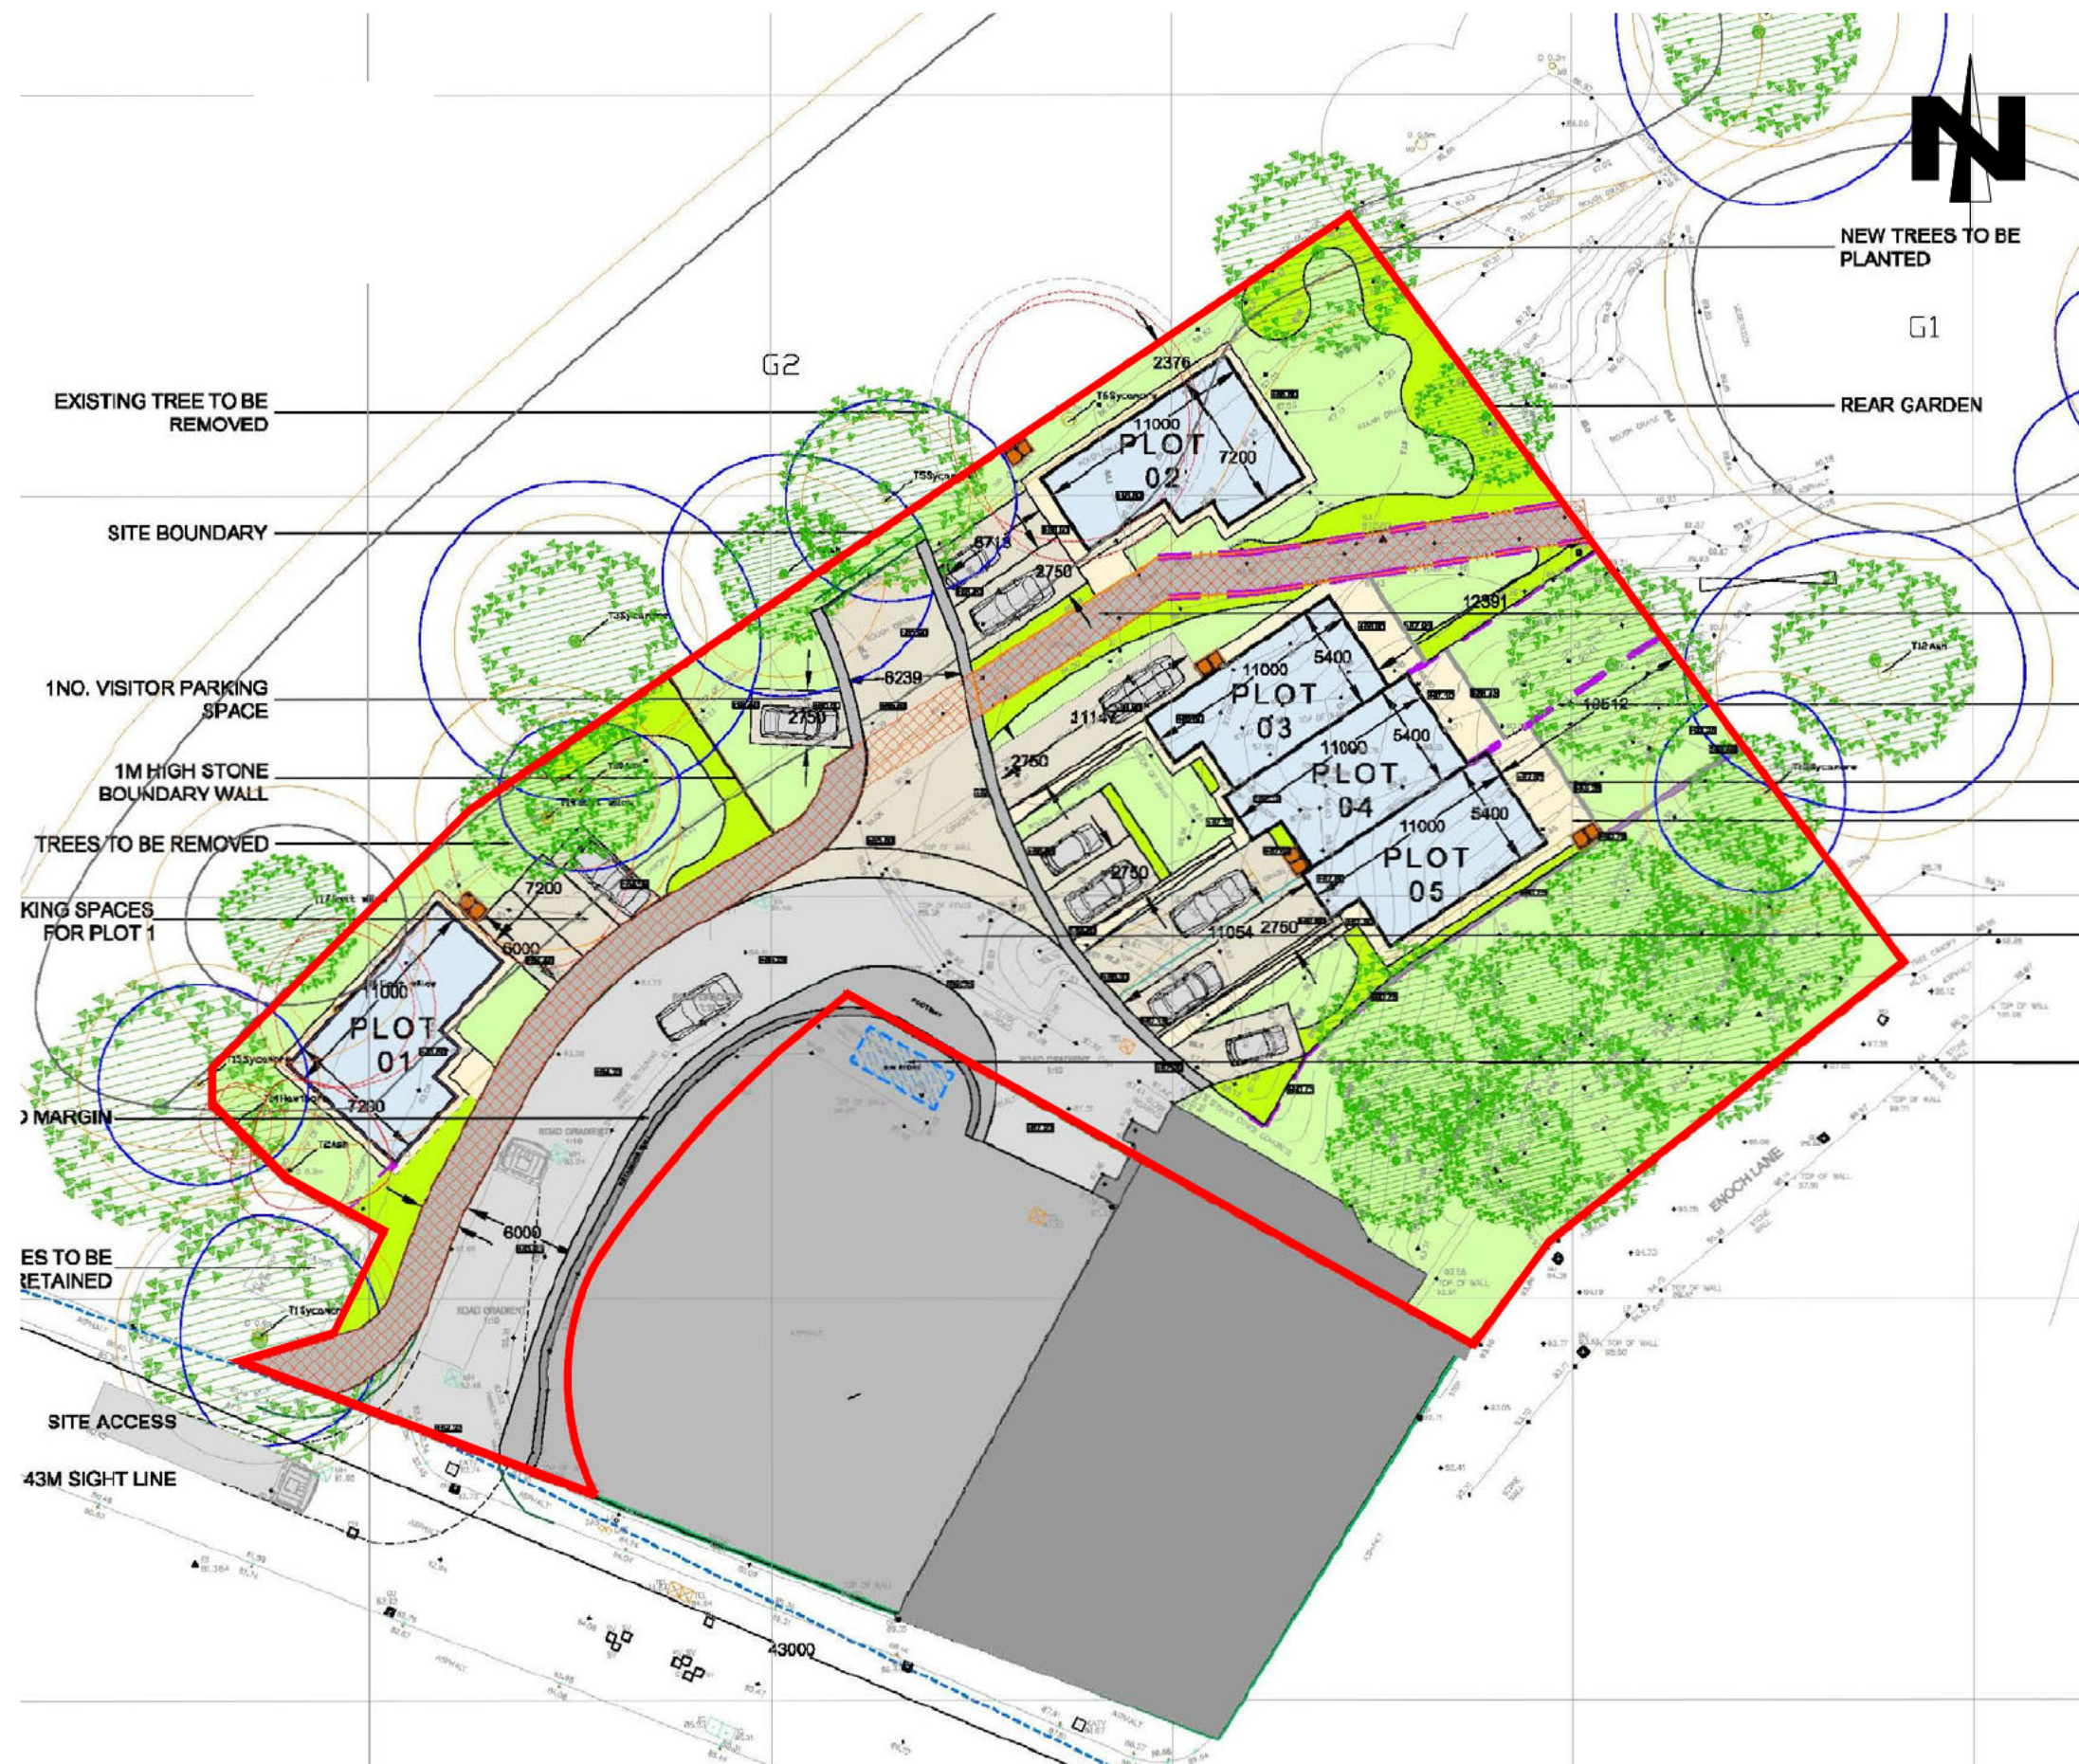
**Borehole & Trial Pit Location Plan**

The intrusive investigation works comprised 3 no. windowless sampling boreholes (WS01 – WS03), incorporating the installation of combined gas and groundwater monitoring wells and 5 no. mechanically excavated trial pits (TP01 – TP05). The positions of which can be seen on the Borehole & Trial Pit Location Plan, a copy of which can be seen in Appendix II. It should be noted that this plan should be used for orientating purposes only, as the positions shown are approximate, and the plans are not to a standard scale.
