**Environmental  
Geotechnical  
Specialists**

Ref: 48 Stile Common Road, Newsome HD4 6DE.

Further to the most recent consultation from the local authority, and in addition to site investigation undertaken at the site, a gas risk assessment has now been undertaken and is the subject of this letter report.

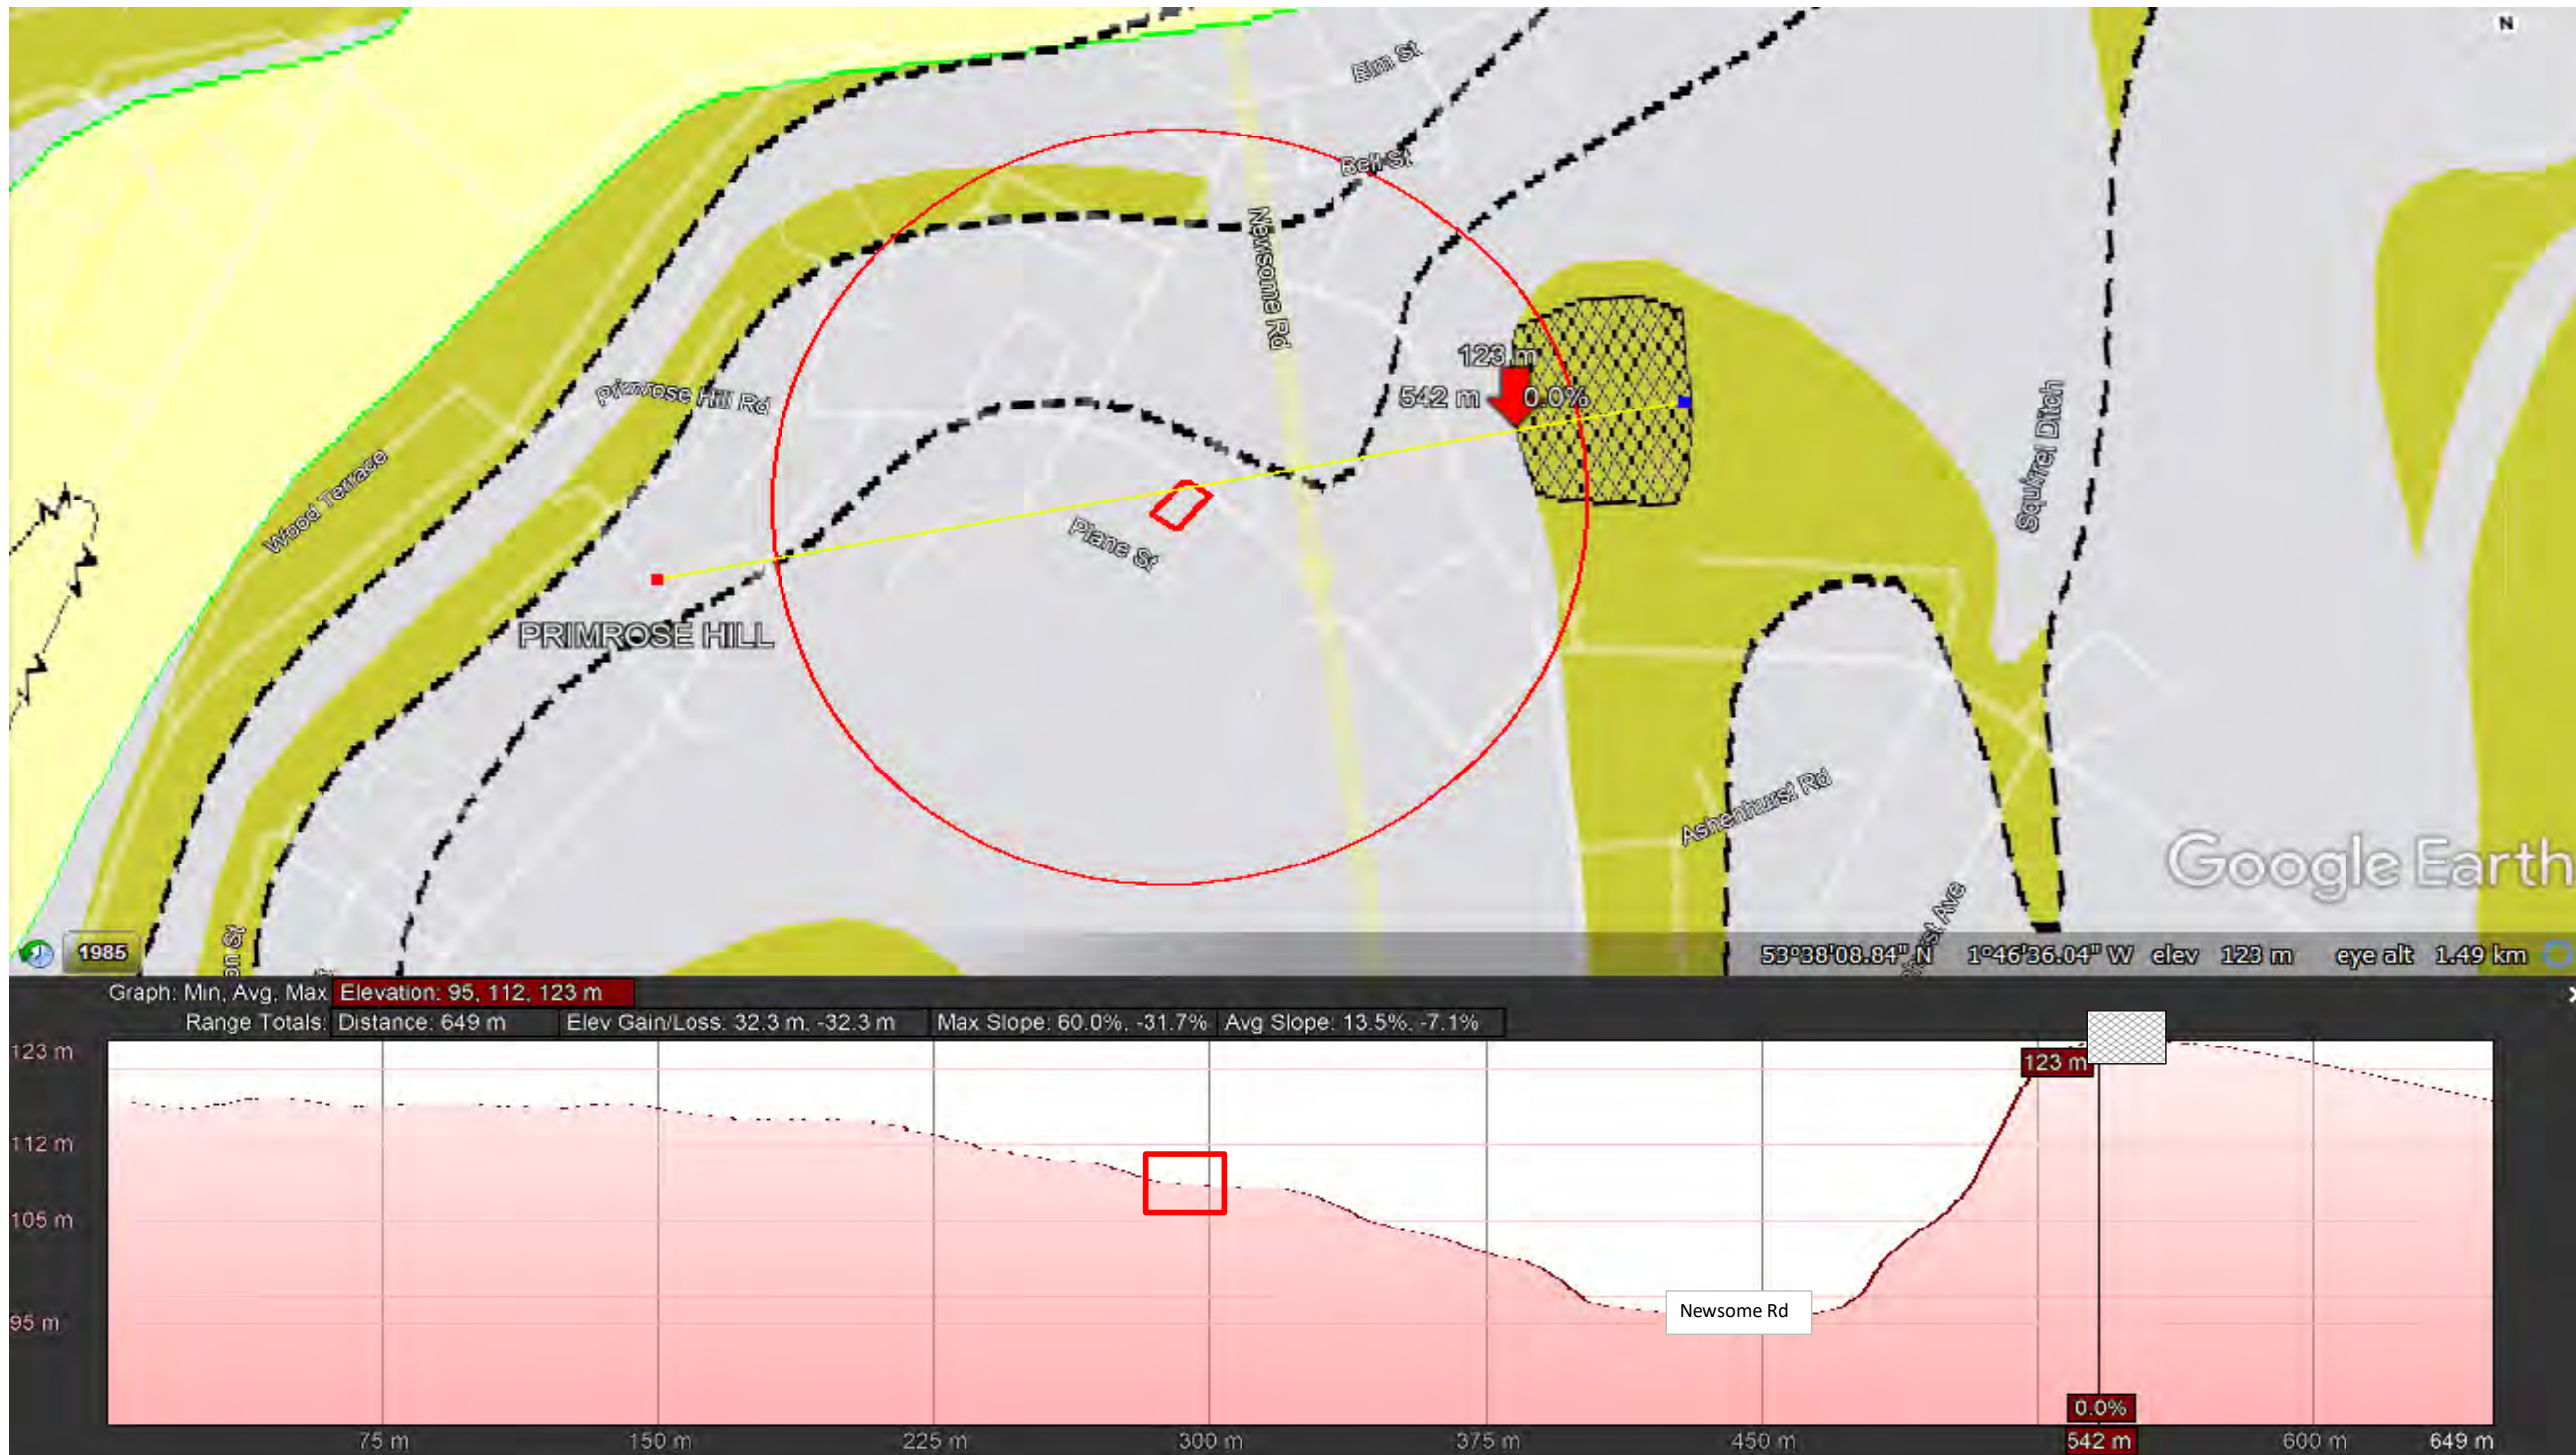
Red circle has a 250m radius.
