EXTENDED PHASE 1 HABITAT SURVEY & DAYTIME BAT SURVEY

YANGTZE, HALIFAX ROAD,
LIVERSEDGE, WEST YORKSHIRE

MARCH 2021

**RACHEL
HACKING
ECOLOGY**

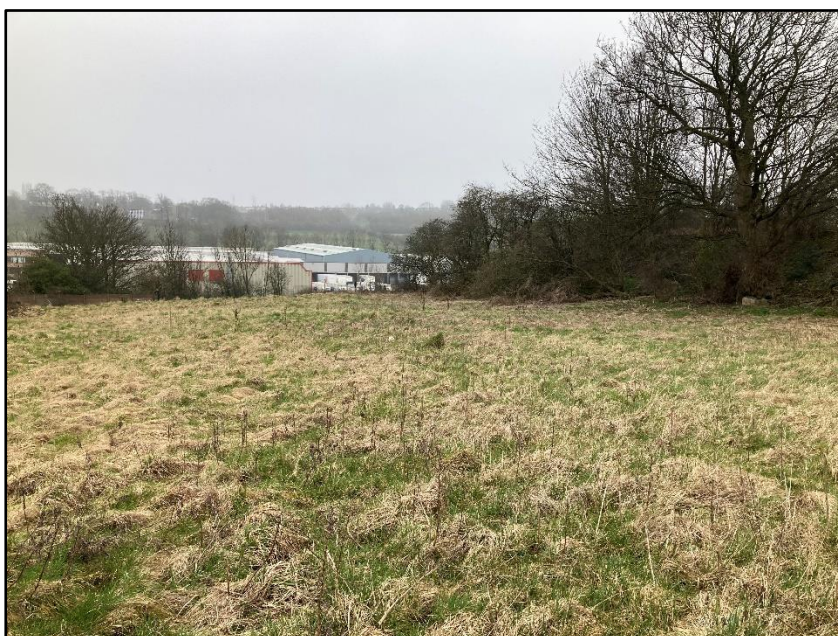
- 3.2 This habitat is one of the most abundant on site (see Photograph 1). The grassland is unmanaged resulting in a mixed sward height. Dominant grass species include Perennial Rye-grass *Lolium perenne*, Cock's-foot *Dactylis glomerata*, Red Fescue *Festuca rubra* and Yorkshire Fog *Holcus lanatus*. Commonly occurring herbaceous species include Dandelion *Taraxacum officinale* agg., Ribwort Plantain *Plantago lanceolata*, Common Ragwort *Jacobaea vulgaris* and White Clover *Trifolium repens*.

Photograph 1 showing the poor semi-improved grassland

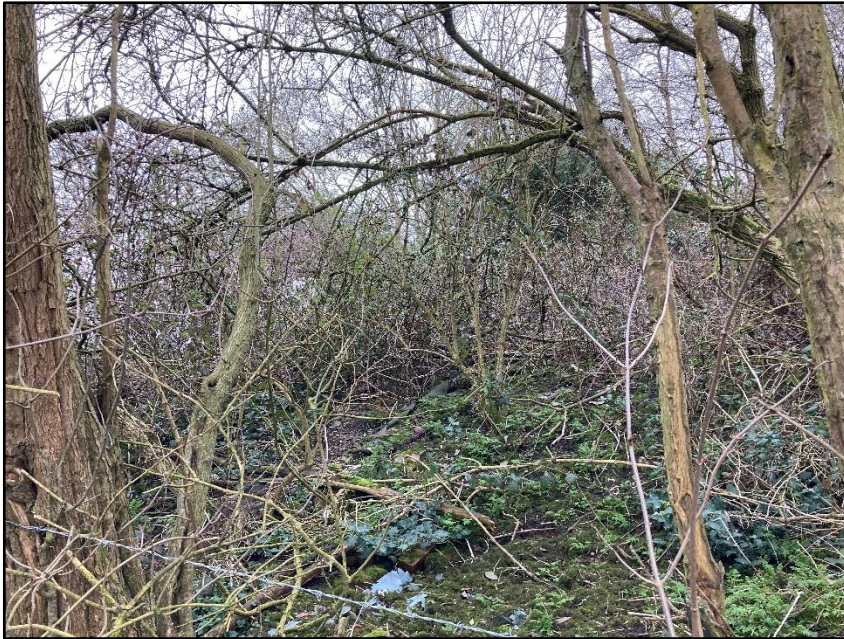
- 3.3 Scrub is present on site as both continuous and scattered features. Areas of continuous scrub dominate along the western boundary and central areas of the site (see Photograph 2). Scattered scrub is found in small quantities across the site (see Photograph 3). Scrub species present include Elder *Sambucus nigra*, Bramble *Rubus fruticosus* agg., Hawthorn *Crataegus monogyna*, Pampas Grass *Cortaderia* sp., Rosebay Willowherb *Chamaenerion angustifolium*, Cleavers *Galium aparine*, Japanese Knotweed *Reynoutria japonica*, Common Nettle *Urtica dioica*, Cock's-foot *Dactylis glomerata*, Common Ragwort *Jacobaea vulgaris*, Lesser Burdock *Arctium minus*, Cow Parsley *Anthriscus sylvestris*, Holly *Ilex aquifolium* and Garden Privet *Ligustrum ovalifolium*.

Photograph 2 showing the area of continuous scrub

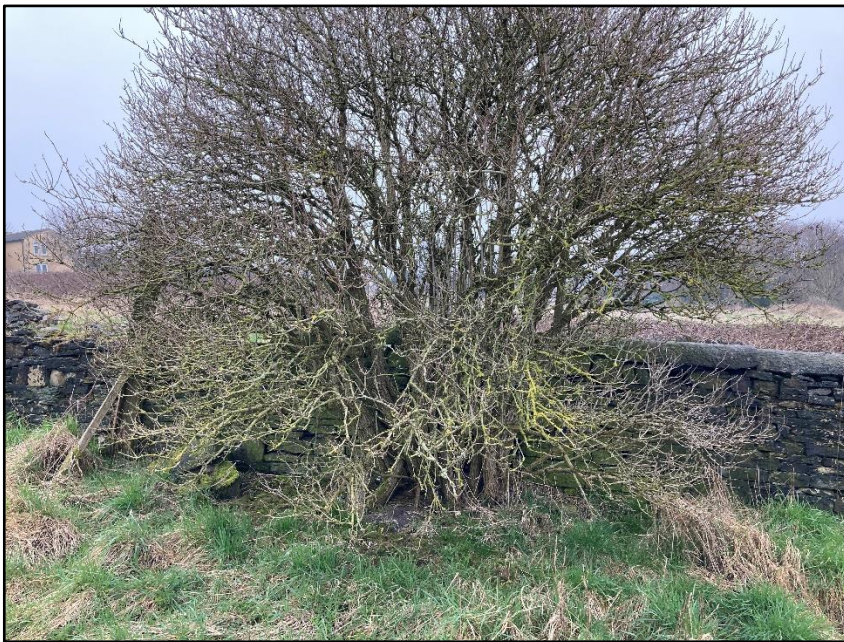
Photograph 3 showing a stand of scattered scrub

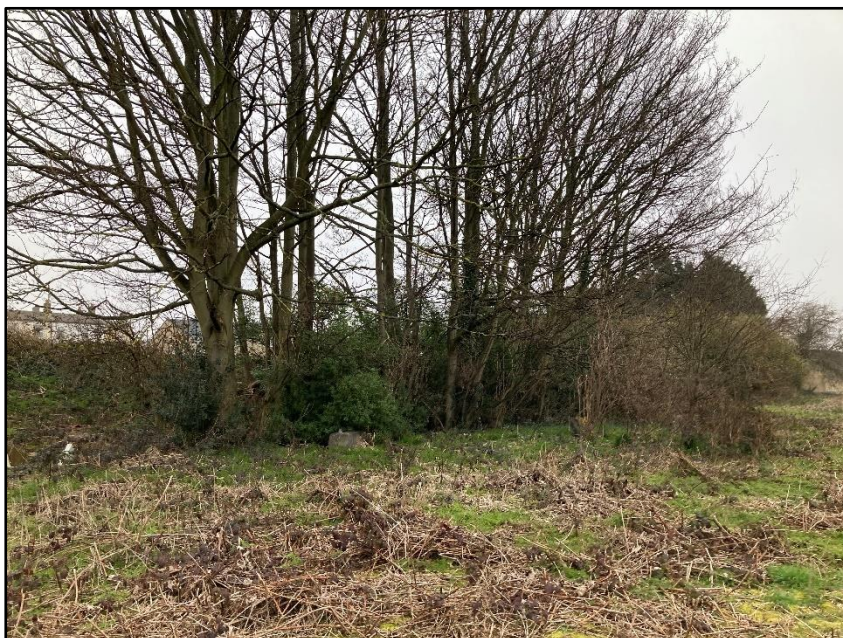
- 3.5 Scattered trees are found across the site. The trees vary in age from juvenile to early mature (see Photograph 4). Tree species include Sycamore *Acer pseudoplatanus*, Ash *Fraxinus excelsior*, Elder *Sambucus nigra*, Goat Willow *Salix caprea*, Paper-bark Birch *Betula papyrifera*, Wild Cherry *Prunus avium*, Leyland Cypress *Cupressus leylandii*, Hawthorn *Crataegus monogyna* and Blackthorn *Prunus spinosa*.

Photograph 4 showing some of the trees on site

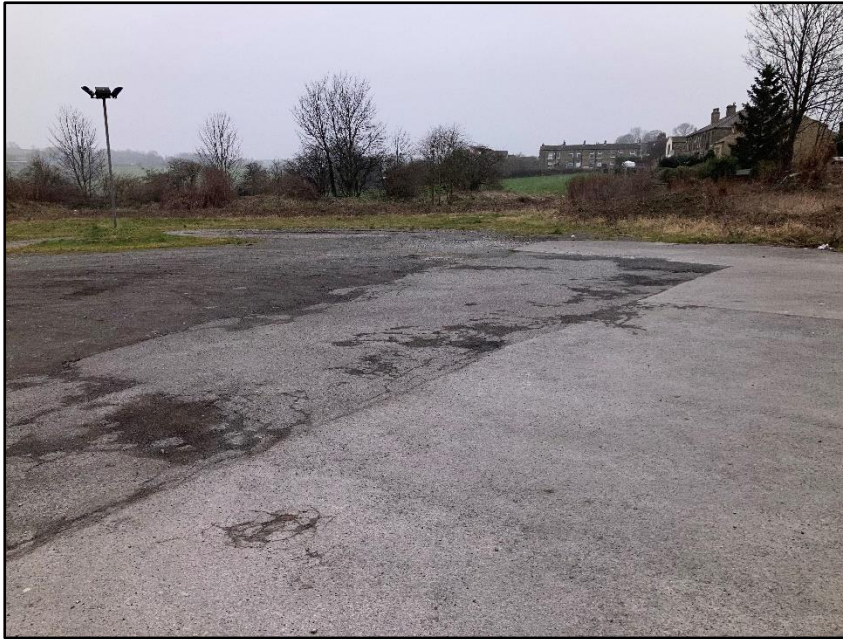
- 3.6 This habitat is present within the north-eastern corner of the site and comprises a hardstanding access road and parking area (see Photograph 5). Ephemeral/short perennial species have established within cracks and crevices and around the peripheries of the hardstanding areas.

Photograph 5 showing an area of hardstanding bare ground

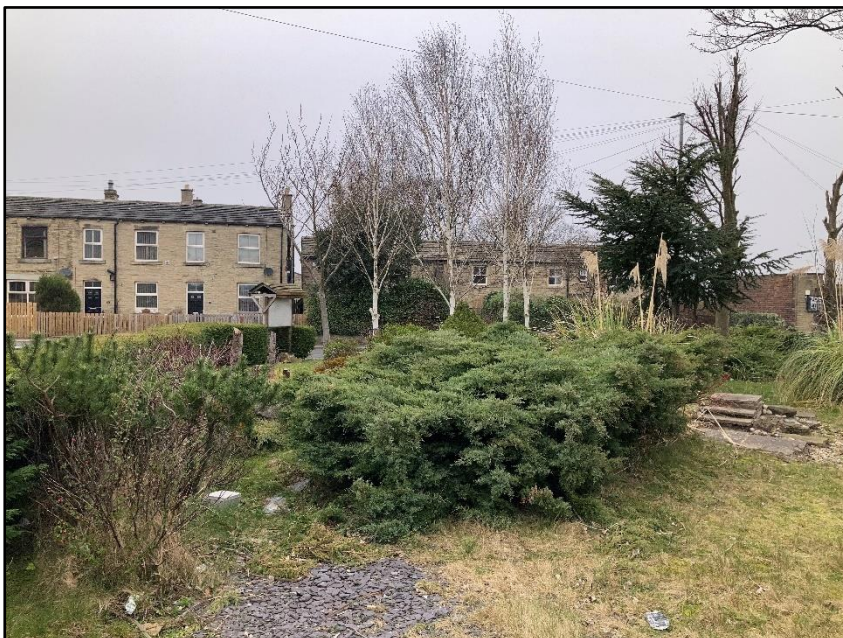
- 3.7 Introduced shrub beds are located with the amenity garden space in the north-eastern corner of the site (see Photograph 6). Species comprise Pampas Grass *Cortaderia* sp., Hebe sp., Wilson’s Honeysuckle *Lonicera nitida*, Bamboo sp., Leyland Cypress *Cupressus leylandii*, Dog Rose *Rosa canina*, Oregon-grape *Mahonia aquifolium* and Cotoneaster sp.

Photograph 6 showing one of the introduced shrub beds

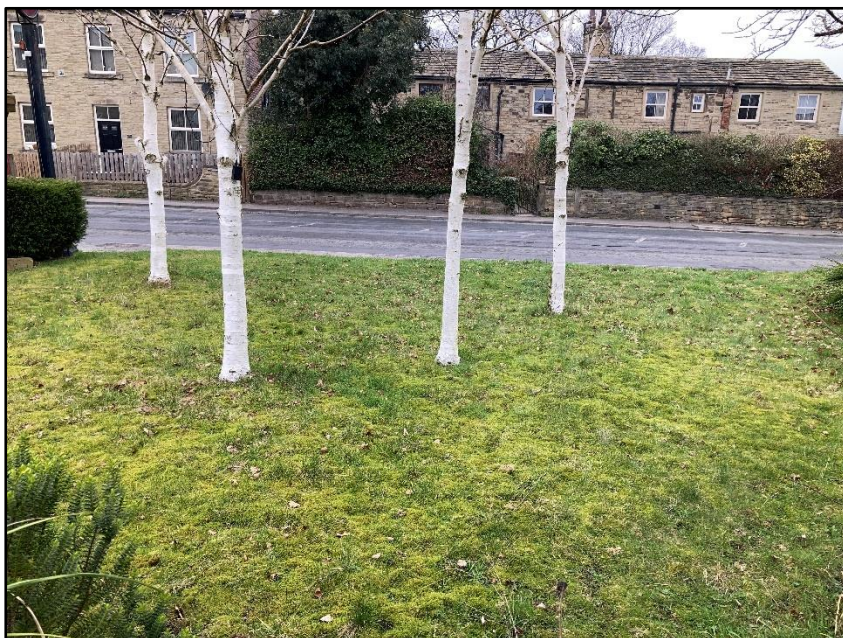
- 3.8 Amenity grassland is located in the north-eastern corner of the site (see Photograph 7). The grass is regularly mown resulting in a short sward height. Abundant species include Perennial Rye-grass *Lolium perenne*, Yorkshire Fog *Holcus lanatus*, Dandelion *Taraxacum officinale* agg., White Clover *Trifolium repens*, Creeping Buttercup *Ranunculus repens*, Broad-leaved Dock *Rumex obtusifolius* and Mosses.

Photograph 7 showing the amenity grassland on site

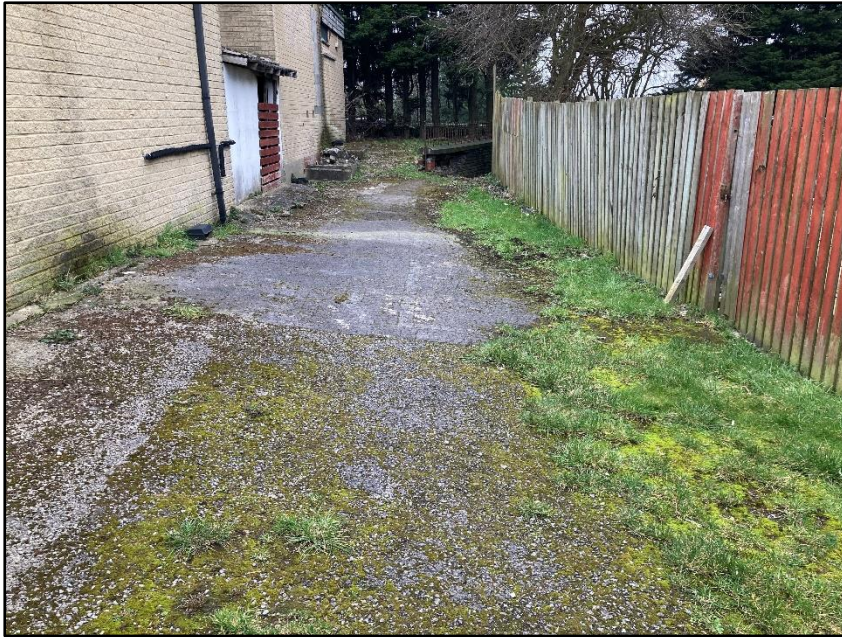
- 3.9 This habitat has established over some areas of hardstanding within the north-eastern corner of the site (see Photograph 8). Dominant species are Annual Meadow-grass *Poa annua*, Wavy Bitter-cress *Cardamine flexuosa*, Red Dead-nettle *Lamium purpureum*, mosses, Dandelion *Taraxacum officinale* agg., Yorkshire Fog *Holcus lanatus* and Herb-Robert *Geranium robertianum*.

Photograph 8 showing the ephemeral/short perennial

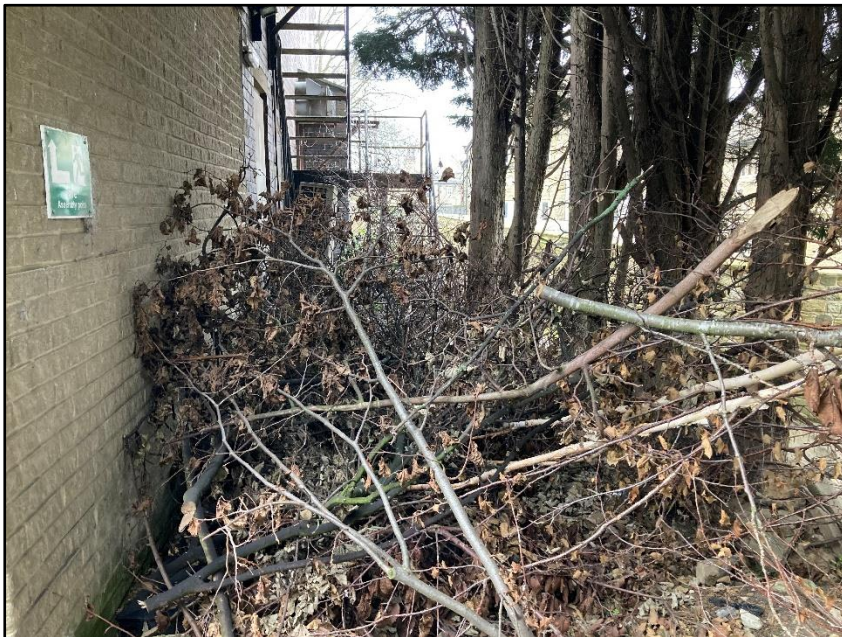
- 3.10 Spoil piles consisting brash are located on the eastern boundary of the site and within one of the large areas of poor semi-improved grassland (see Photograph 9).

Photograph 9 showing one of the spoil piles

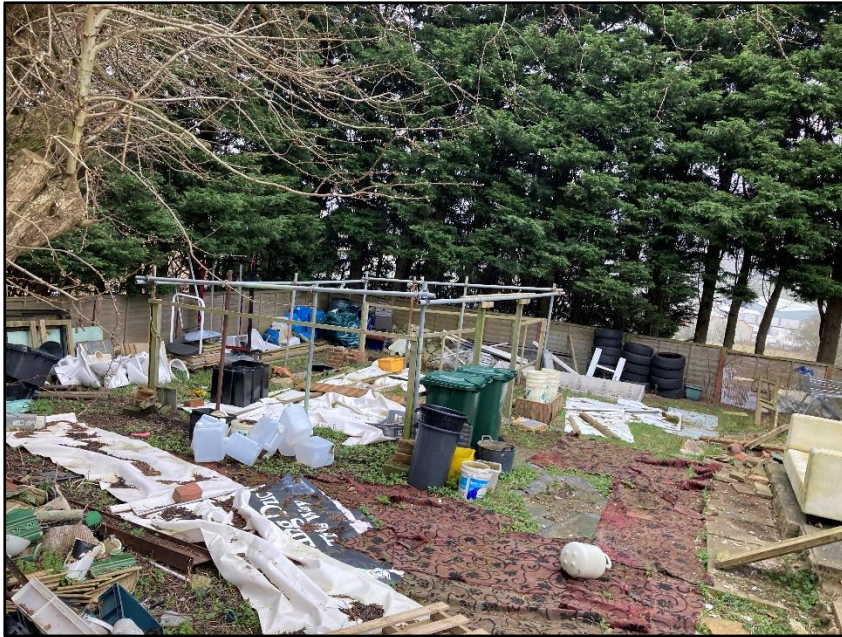
- 3.11 This habitat is located towards the north-eastern boundary of the site and consists areas of hardstanding paving covered with carpet, building materials and general waste (see Photograph 10).

Photograph 10 showing the area of bare ground/spoil

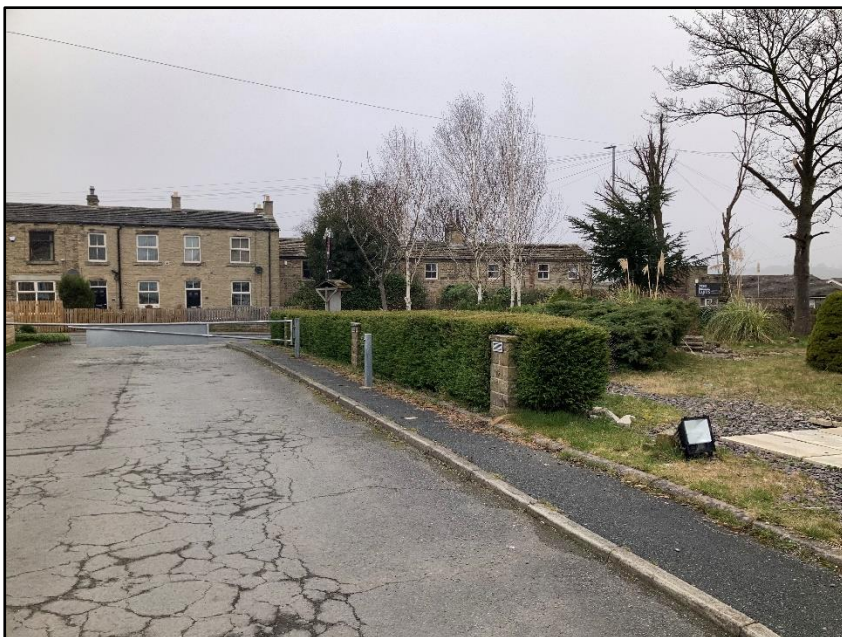
- 3.13 A small stretch of Cypress *Chamaecyparis/Cupressocyparis* sp. hedgerow runs parallel along the access road from the northern boundary. The hedgerow is approximately 1.2 metres high and well-managed (see Photograph 11).

Photograph 11 showing the intact hedgerow

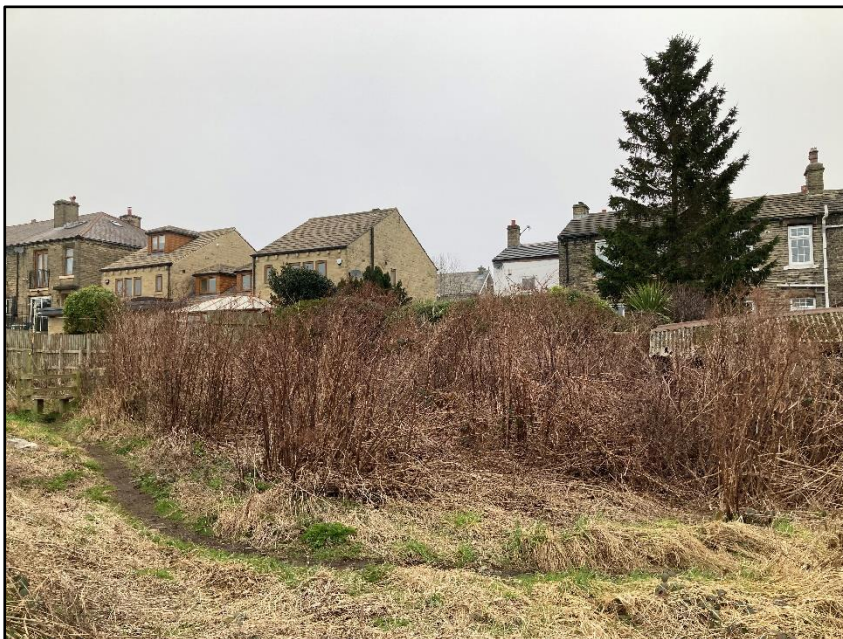
- 3.16 There is Japanese Knotweed *Reynoutria japonica* present along the western and southern boundaries (see Photograph 12). These are present amongst the areas of continuous scrub but have been mapped separately.

Photograph 12 showing one of the expanses of Japanese Knotweed

5.2 The Japanese Knotweed should be carefully removed from site using a recognised methodology for the affected areas. This should be either long-term herbicide application or short-term digging out and removal off-site to a licensed landfill or digging out and deep burial with a suitable barrier membrane on-site.

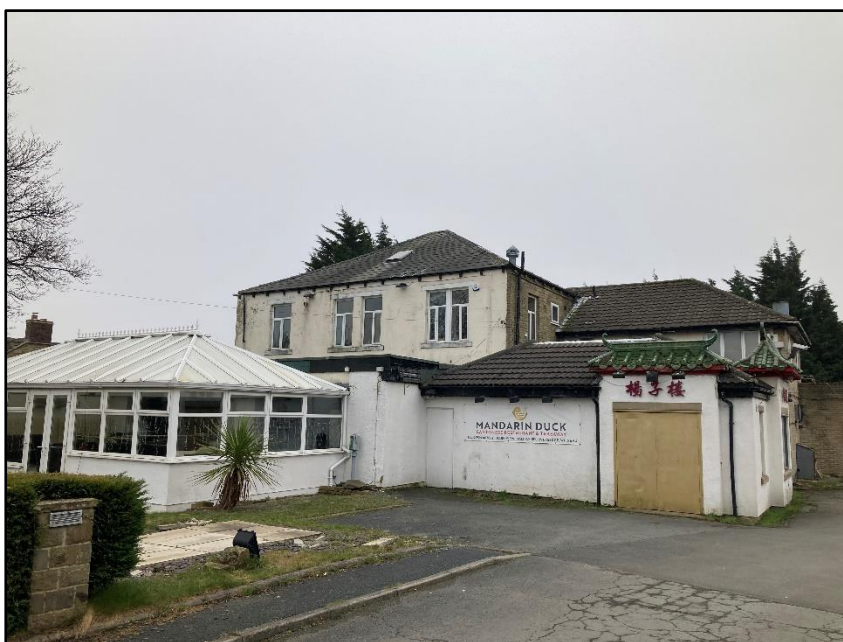
- 3.21 The building comprises an original stone-built central element alongside various single and two storey extensions (see Photograph 13). Sections of the external masonry have been rendered. The render is in reasonable condition, free from cracks or crevices bats may exploit. The masonry to the rear of the property has not been rendered and appears in good condition and well-sealed with mortar (see Photograph 14).

Photograph 13 showing the building on site

- 3.22 The uPVC window and door frames are in good condition and well-sealed to the surrounding masonry (see Photograph 15). An attached conservatory is located on the northern side of the building (see Photograph 13). This is in reasonable condition with no potential entry points found.

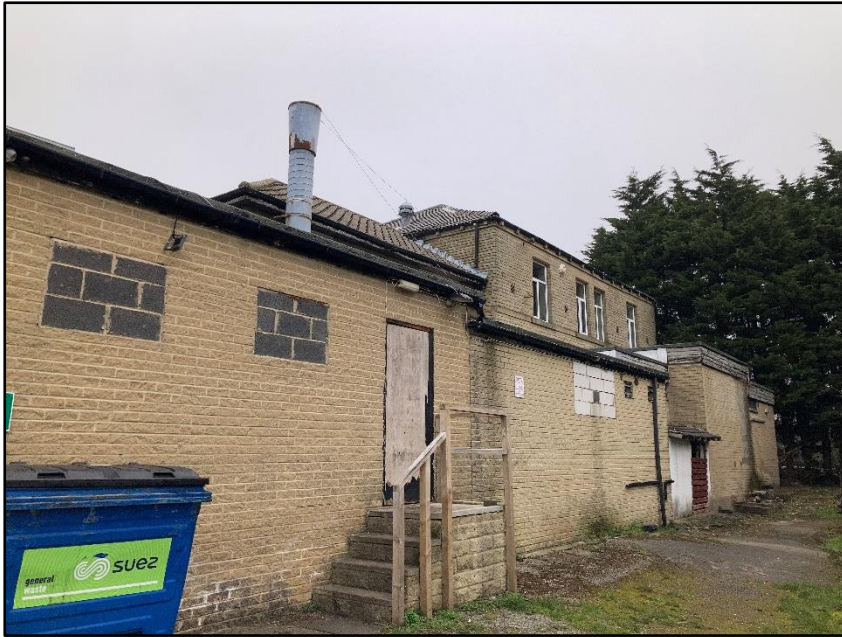
Photograph 14 showing the exposed masonry across the rear of the property

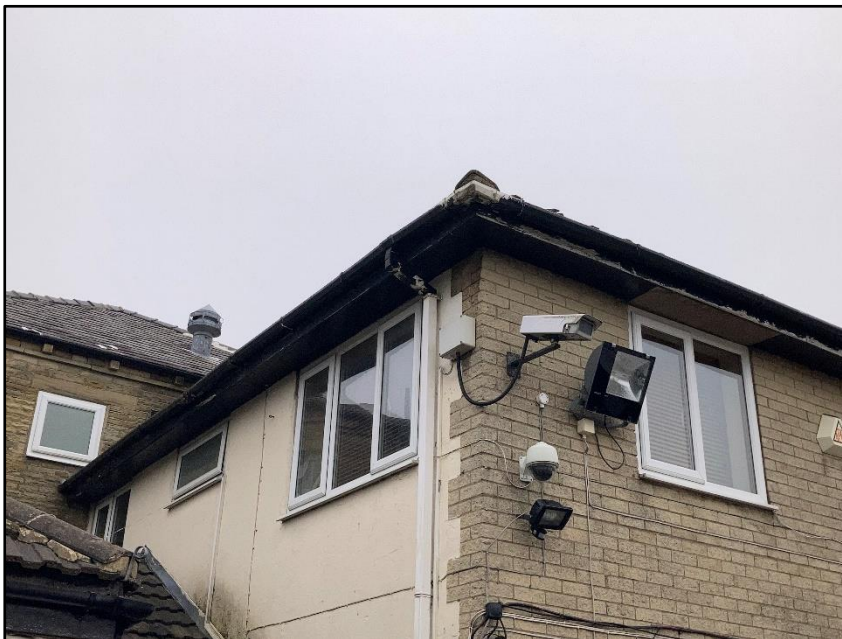
Photograph 15 showing the exterior of the building

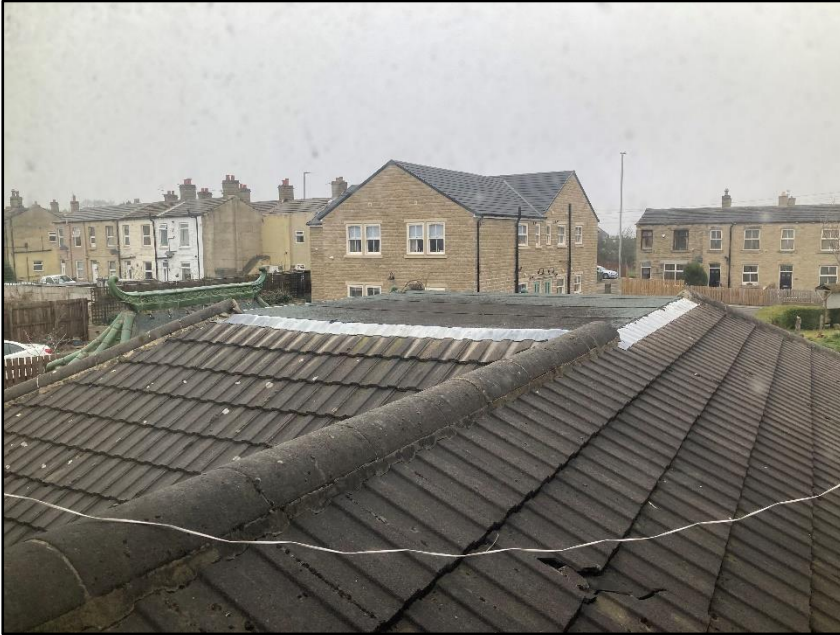
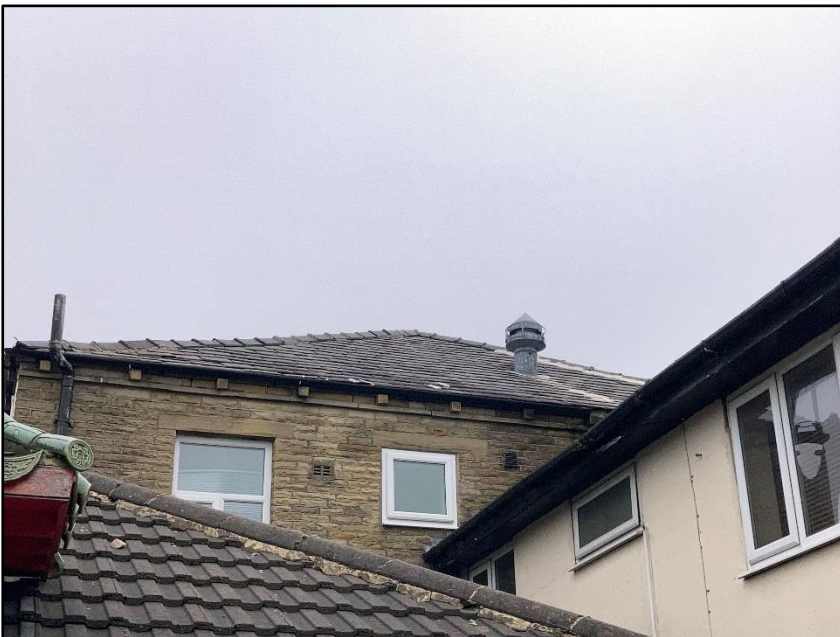
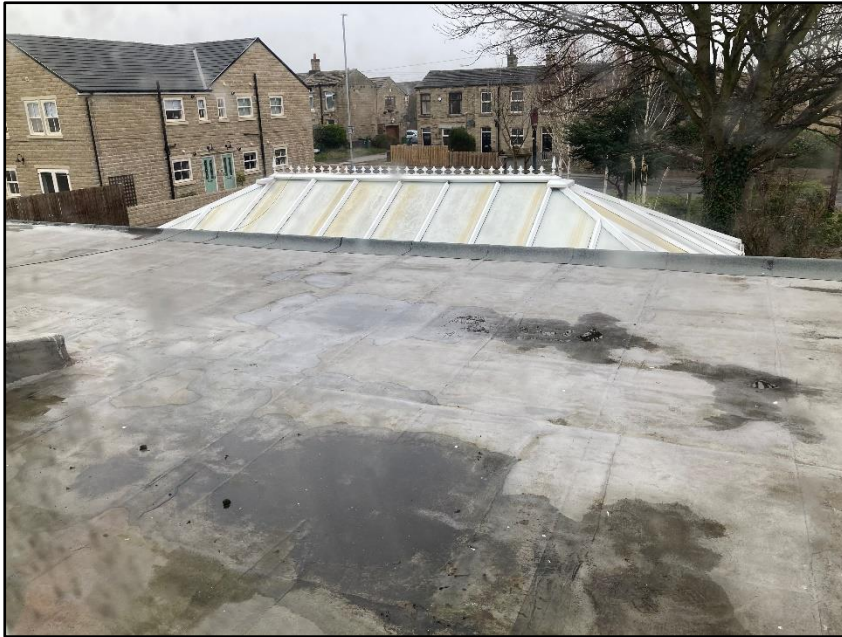
- 3.23 The building consists of pitched, hipped, sloped and flat roof sections (see Photographs 16, 17 and 18). The flat roofs are covered with a bitumen-based membrane which appears in good condition and is well-sealed to the roof edges. The sloped, pitched and hipped roof sections are covered with slate and concrete roof tiles. The tiles are largely

present and intact. However, damaged and slipped tiles are present across some of the sections of roofs.

Photograph 16 showing a section of roof

Photograph 17 showing a section of roof

Photograph 18 showing a section of roof

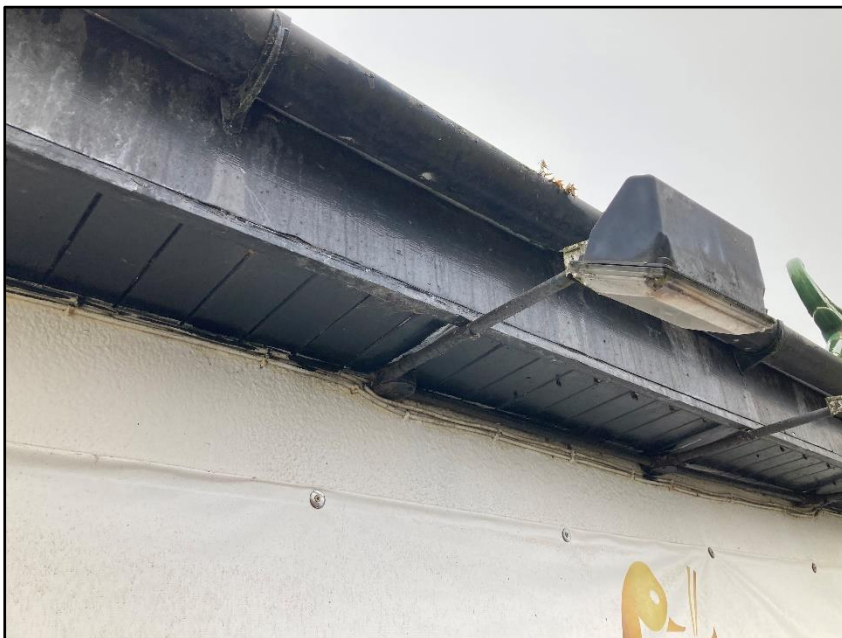
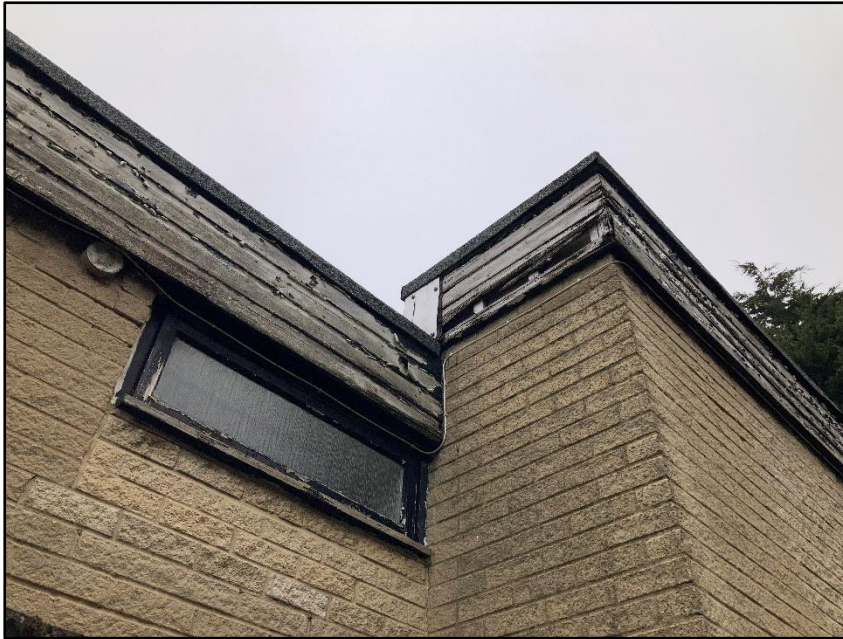
- 3.24 Wood bargeboards and soffits are located at many of the roof edges (see Photographs 19 and 20). These are largely in good condition and fitted flush to the surrounding walls and roof sections. However, some sections are showing signs of aesthetic degradation and missing sections of board. These were inspected further and were found to be shallow and not lead to any further cavities.

Photograph 19 showing a section of bargeboards and soffits

Photograph 20 showing a section of bargeboards

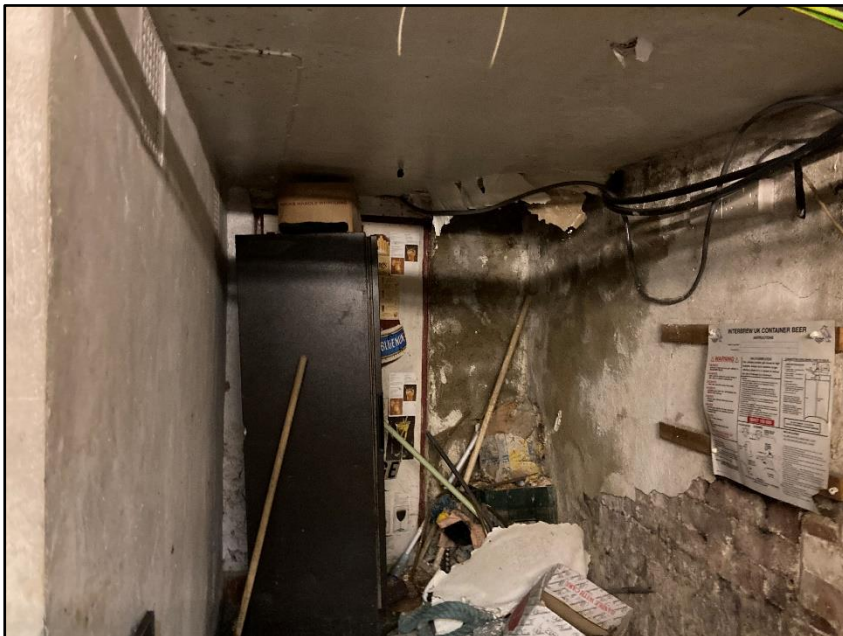
- 3.25 As aforementioned, the differing sections of the building are set over one and two-storeys with a basement level also present within the building.
- 3.26 The small basement is easily accessed via an internal staircase. No access points were located along the external walls and no evidence of bat activity was found (see Photograph 21).

Photograph 21 showing the basement

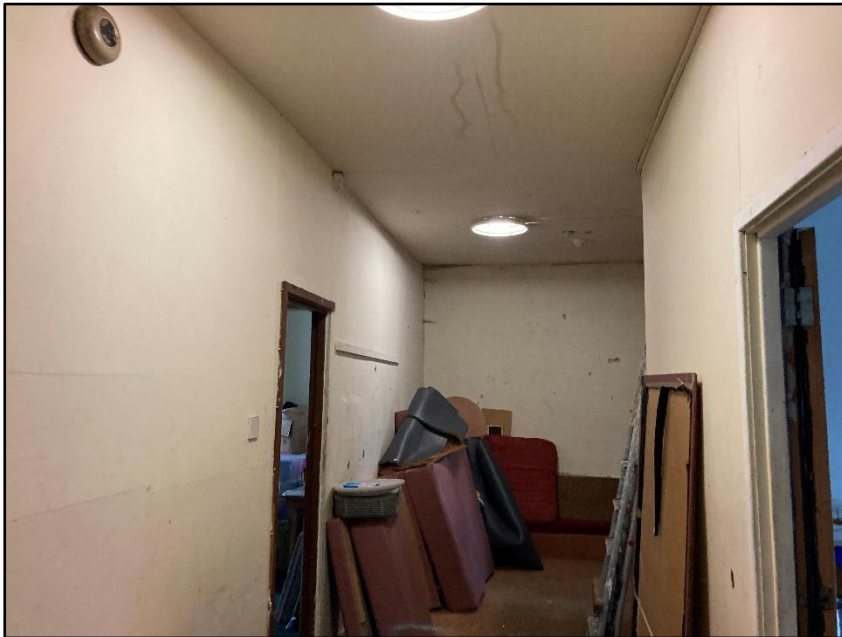
Photograph 22 showing the interior of the building

- 3.27 The internal spaces of the building consist of typical restaurant rooms such as dining areas, bar area, kitchen, toilet facilities, storerooms, and entrance foyer (see Photographs 22, 23 and 24).

- 3.28 The internal rooms are in reasonable condition and well-sealed with no features or habitat associated with roosting bats. Roof voids are located across many of the differing roofs. A small void is present between the flat roof section of the building and the suspended ceiling below (see Photograph 25). This was found to be well-sealed and cobwebbed with no evidence of bat activity or occupancy.

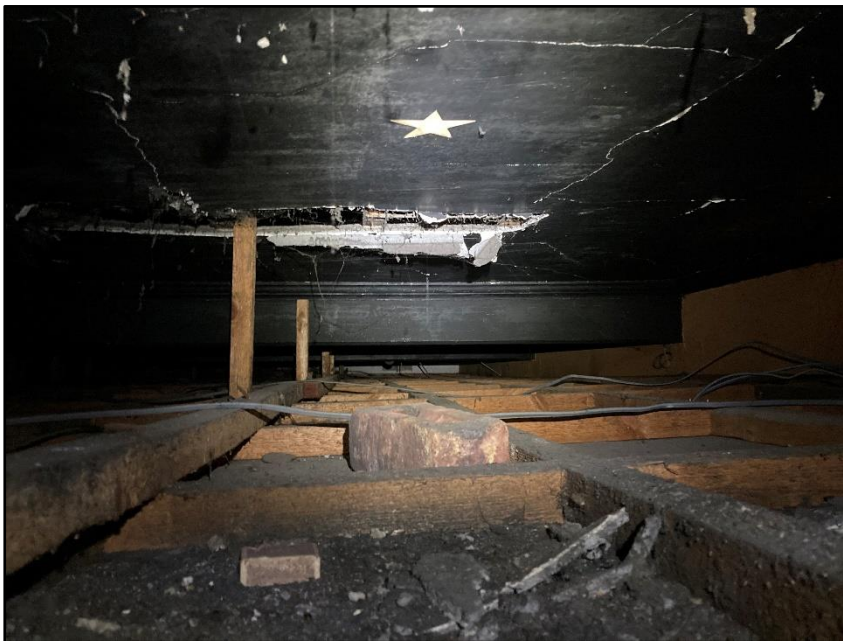
Photograph 25 showing the small void between the underside of the flat roof and the suspended ceiling

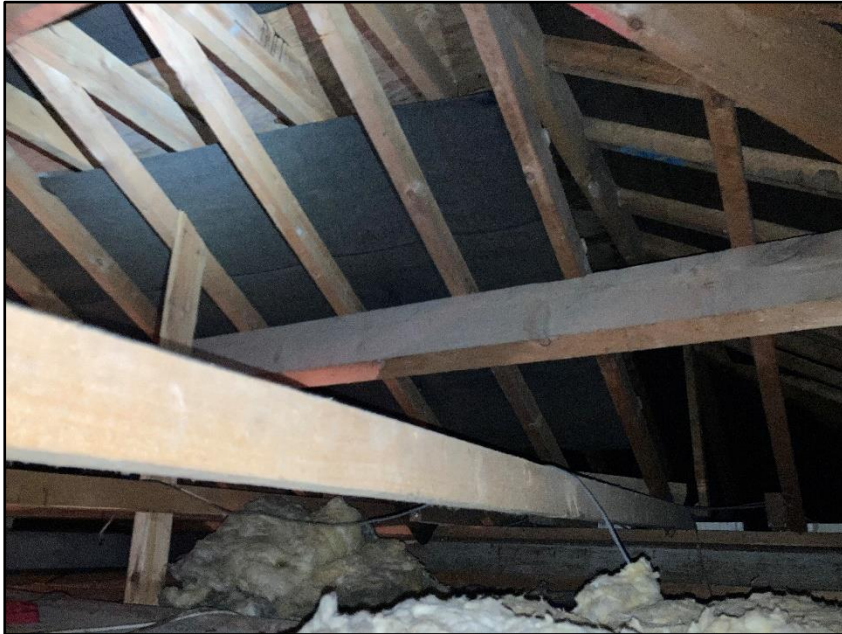
- 3.29 The roof voids below the sloped, pitched and hipped roofs are in reasonable condition. The roof timbers are free from cracks and crevice's bats may exploit. Many of the

underside of the roofs are covered with felt (see Photograph 26). The felt, where present, is in good condition with only a few rips and tears present. Damaged roof tiles have allowed some water ingress resulting in damp cool conditions and damage to the ceilings below (see Photograph 27).

Photograph 26 showing one of the roof voids

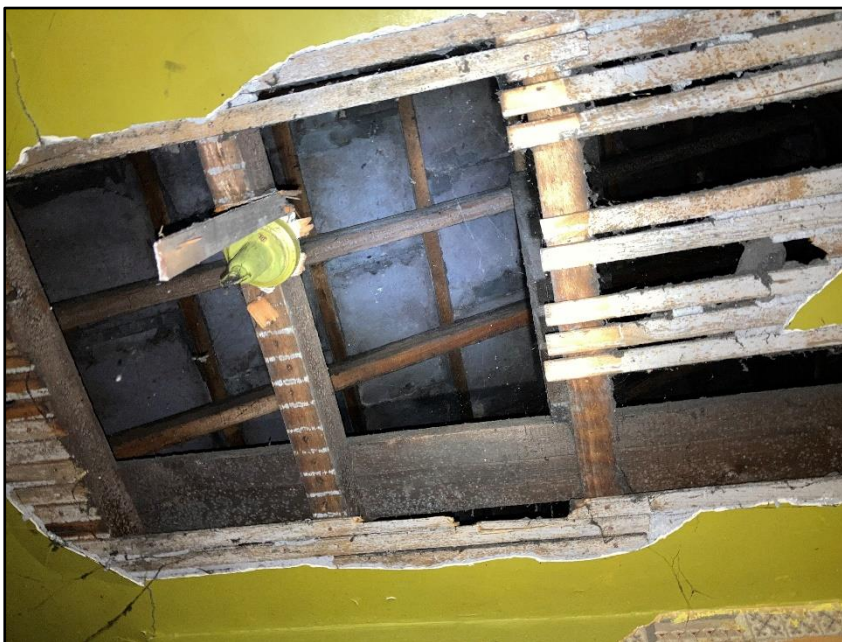
Photograph 27 showing the underside of one of the roof sections

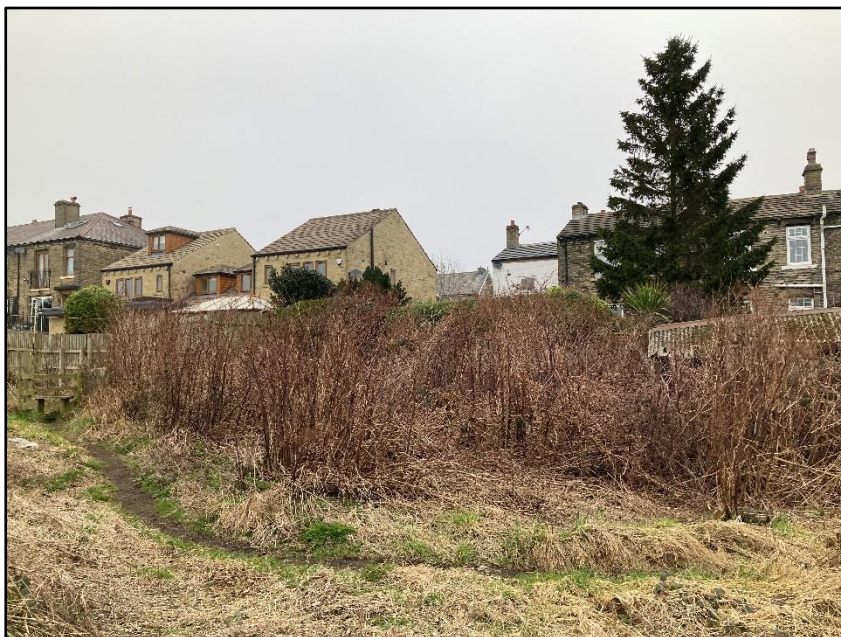
- 3.37 Japanese Knotweed is located on site (see Photograph 29). The locations can be found on the phase 1 habitat map at the back of this report. This is a non-native, invasive species listed on Schedule 9 Part II (plants) of the Wildlife and Countryside Act 1981 (as

amended). A remediation/removal strategy can be conditioned as part of any subsequent planning application approval.

Photograph 29 showing one of the stands of Japanese Knotweed located on site

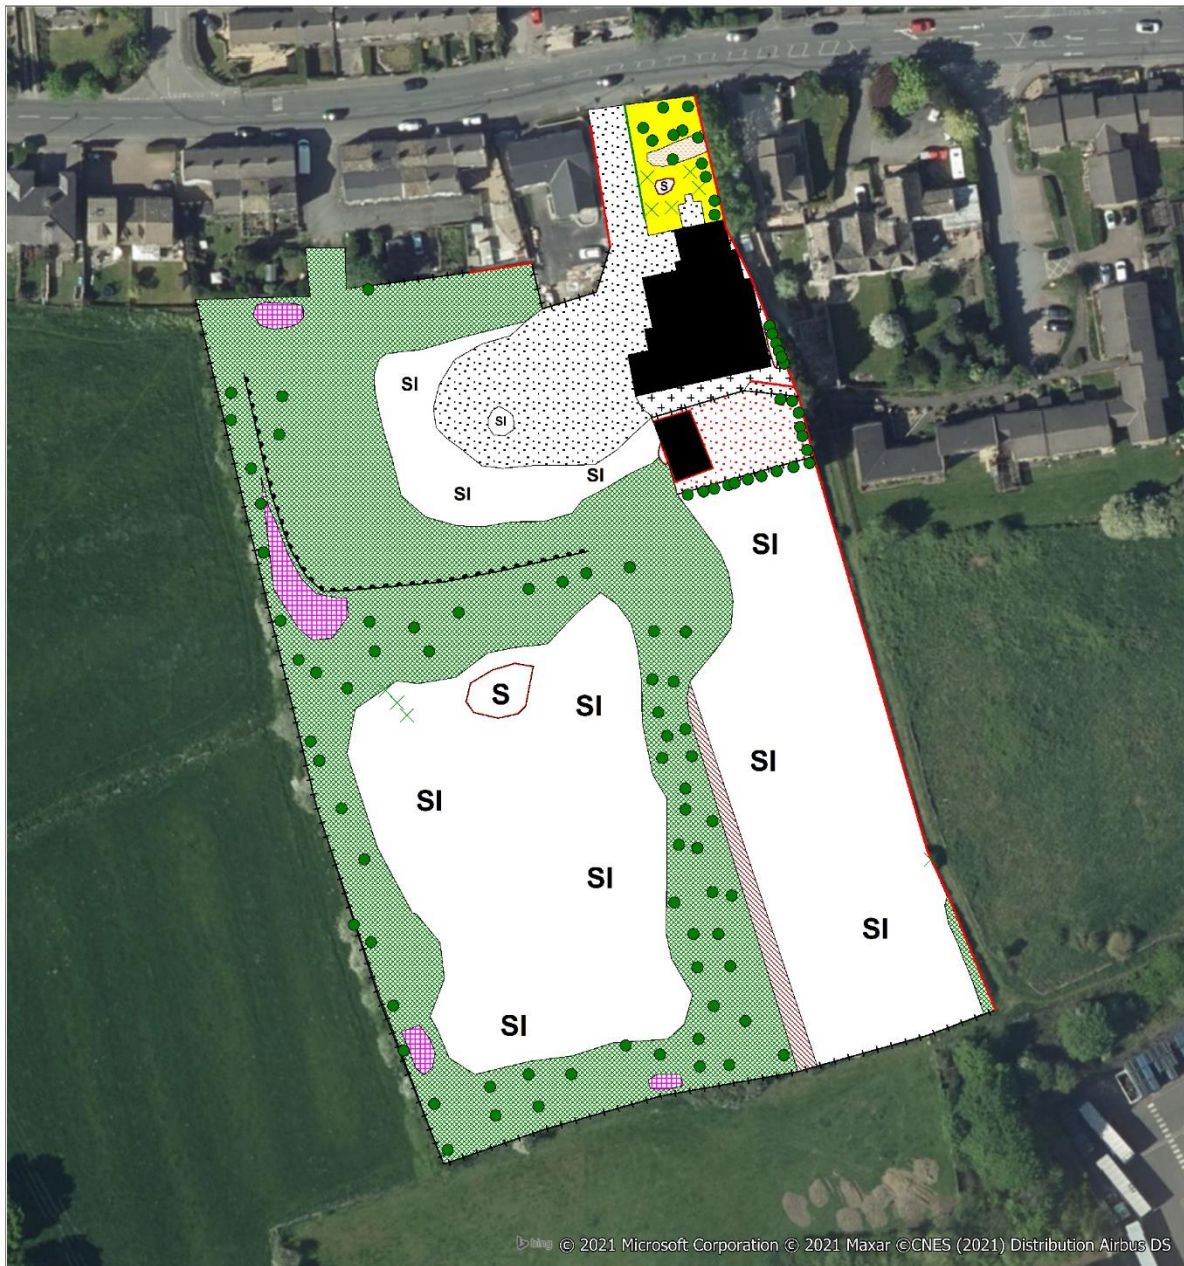
PHASE 1 HABITAT MAP

- 3.1 The Phase 1 Habitat Map can be found at the back of the report. The habitats on the proposed development site are described below.
