# Preliminary Geoenvironmental Investigation

## Land at Yew Tree Farm, Farnley Tyas For Radcliffe Developments Ltd

Report no: 3381/1

Date: June 2021

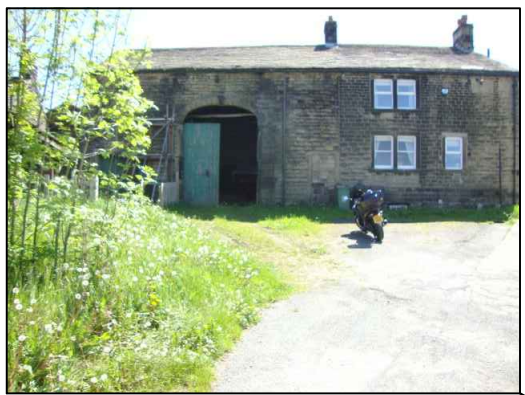
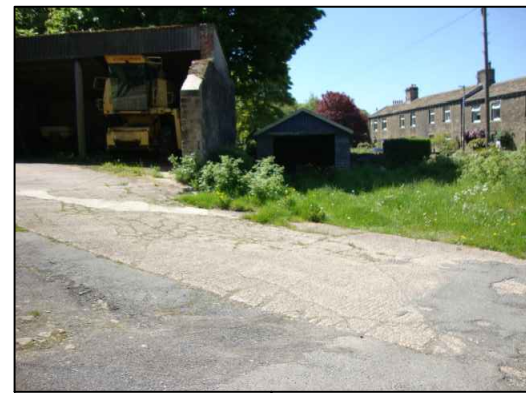
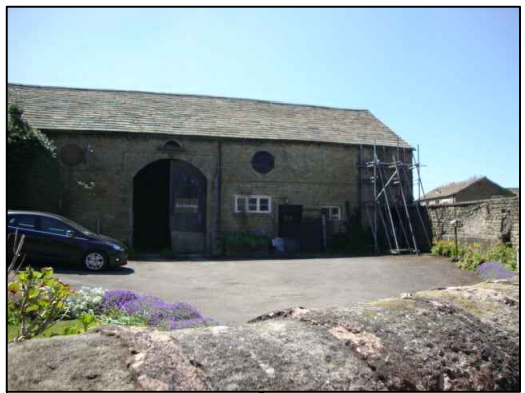
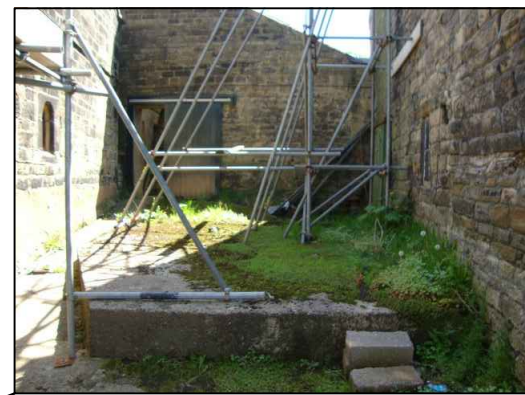
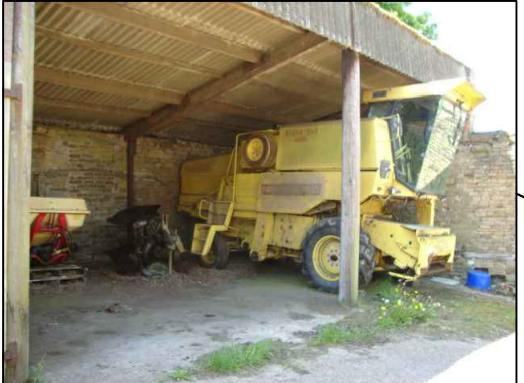
| SCALE | NOT TO SCALE | SHEET | A3 | DRAWING NO. | 3381/4 | REVISION |

- 2.2.3 A selection of site photographs are included on Drawing 3381/4.
- 2.2.4 The site is currently in use as a farm though at the time of the walkover no livestock was present within the farmyard or associated barns. Numerous buildings of various age and construction are present, with areas of concrete, tarmac, stone paving, rough gravel, grass and dense vegetation.
- 2.2.5 Access is from three separate points to the north from 'The Village'.
- 2.2.6 Three fuel/oil storage tanks were noted including:
- an old cylindrical steel tank that appears to no longer be in use
  - a relatively new plastic bunded waste oil tank
  - a relatively new plastic bunded fuel tank on a raised plinth

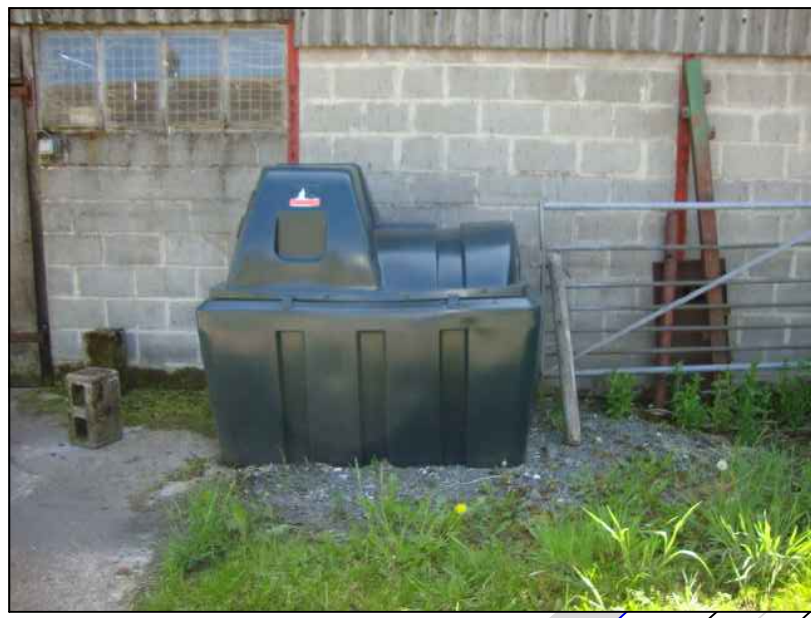
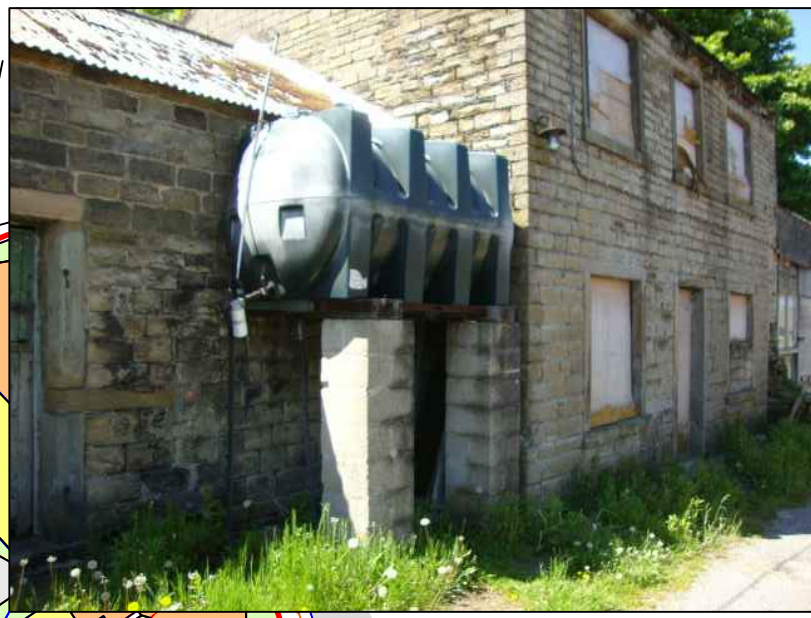
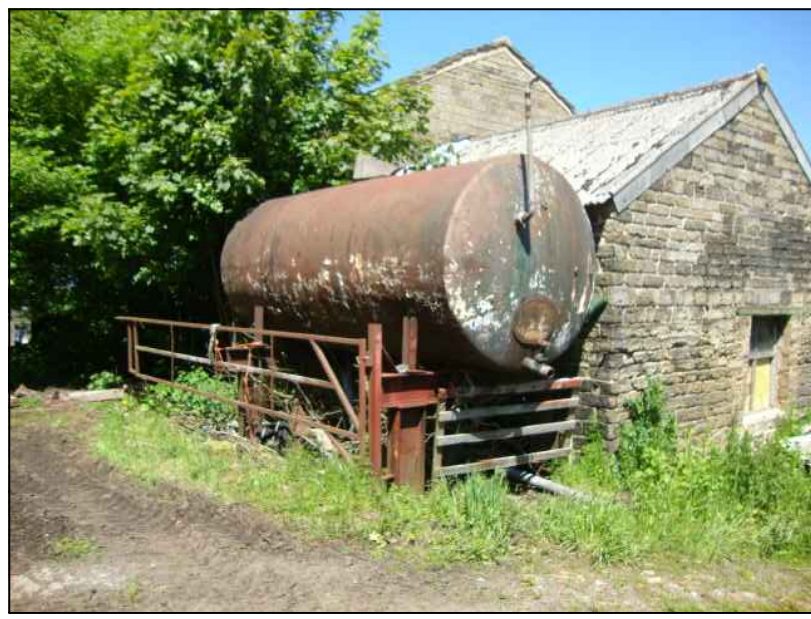
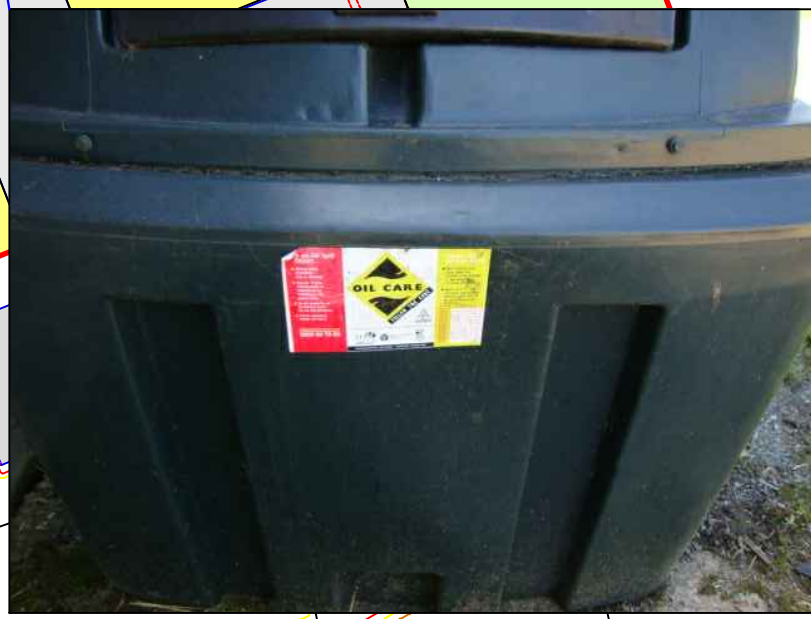
| SCALE | NOT TO SCALE | SHEET | A3 | DRAWING NO. | 3381/5 | REVISION |

- 2.2.20 Comprises a relatively modern portal frame barn with low blockwork walls and upper sheet metal cladding. Used for storage of machinery and the parking of cars.
- 2.2.21 A relatively modern plastic bunded waste oil tank is located adjacent to the outside of the northern wall on concrete hardstand. No evidence of leakage or spillage was noted.

- 2.2.23 Comprises a single storey, stone built outbuilding which was locked at the time of the walkover.
- 2.2.24 A plastic bunded fuel tank with dispensing pump is located adjacent to the outside of the eastern wall. No evidence of spillage or leakage was noted, although the base of the plinth which stands on rough grass was slightly overgrown.
- 2.2.25 A much larger, older, cylindrical fuel tank is located adjacent to the outside of the western wall of Building 13. The base of the tank is also heavily overgrown though no evidence of spillage or leakage was noted.
