# Geoenvironmental Appraisal

## Land at Crosland Hill, Huddersfield For Redrow Homes

Report no: 3649/2A

Date: March 2021

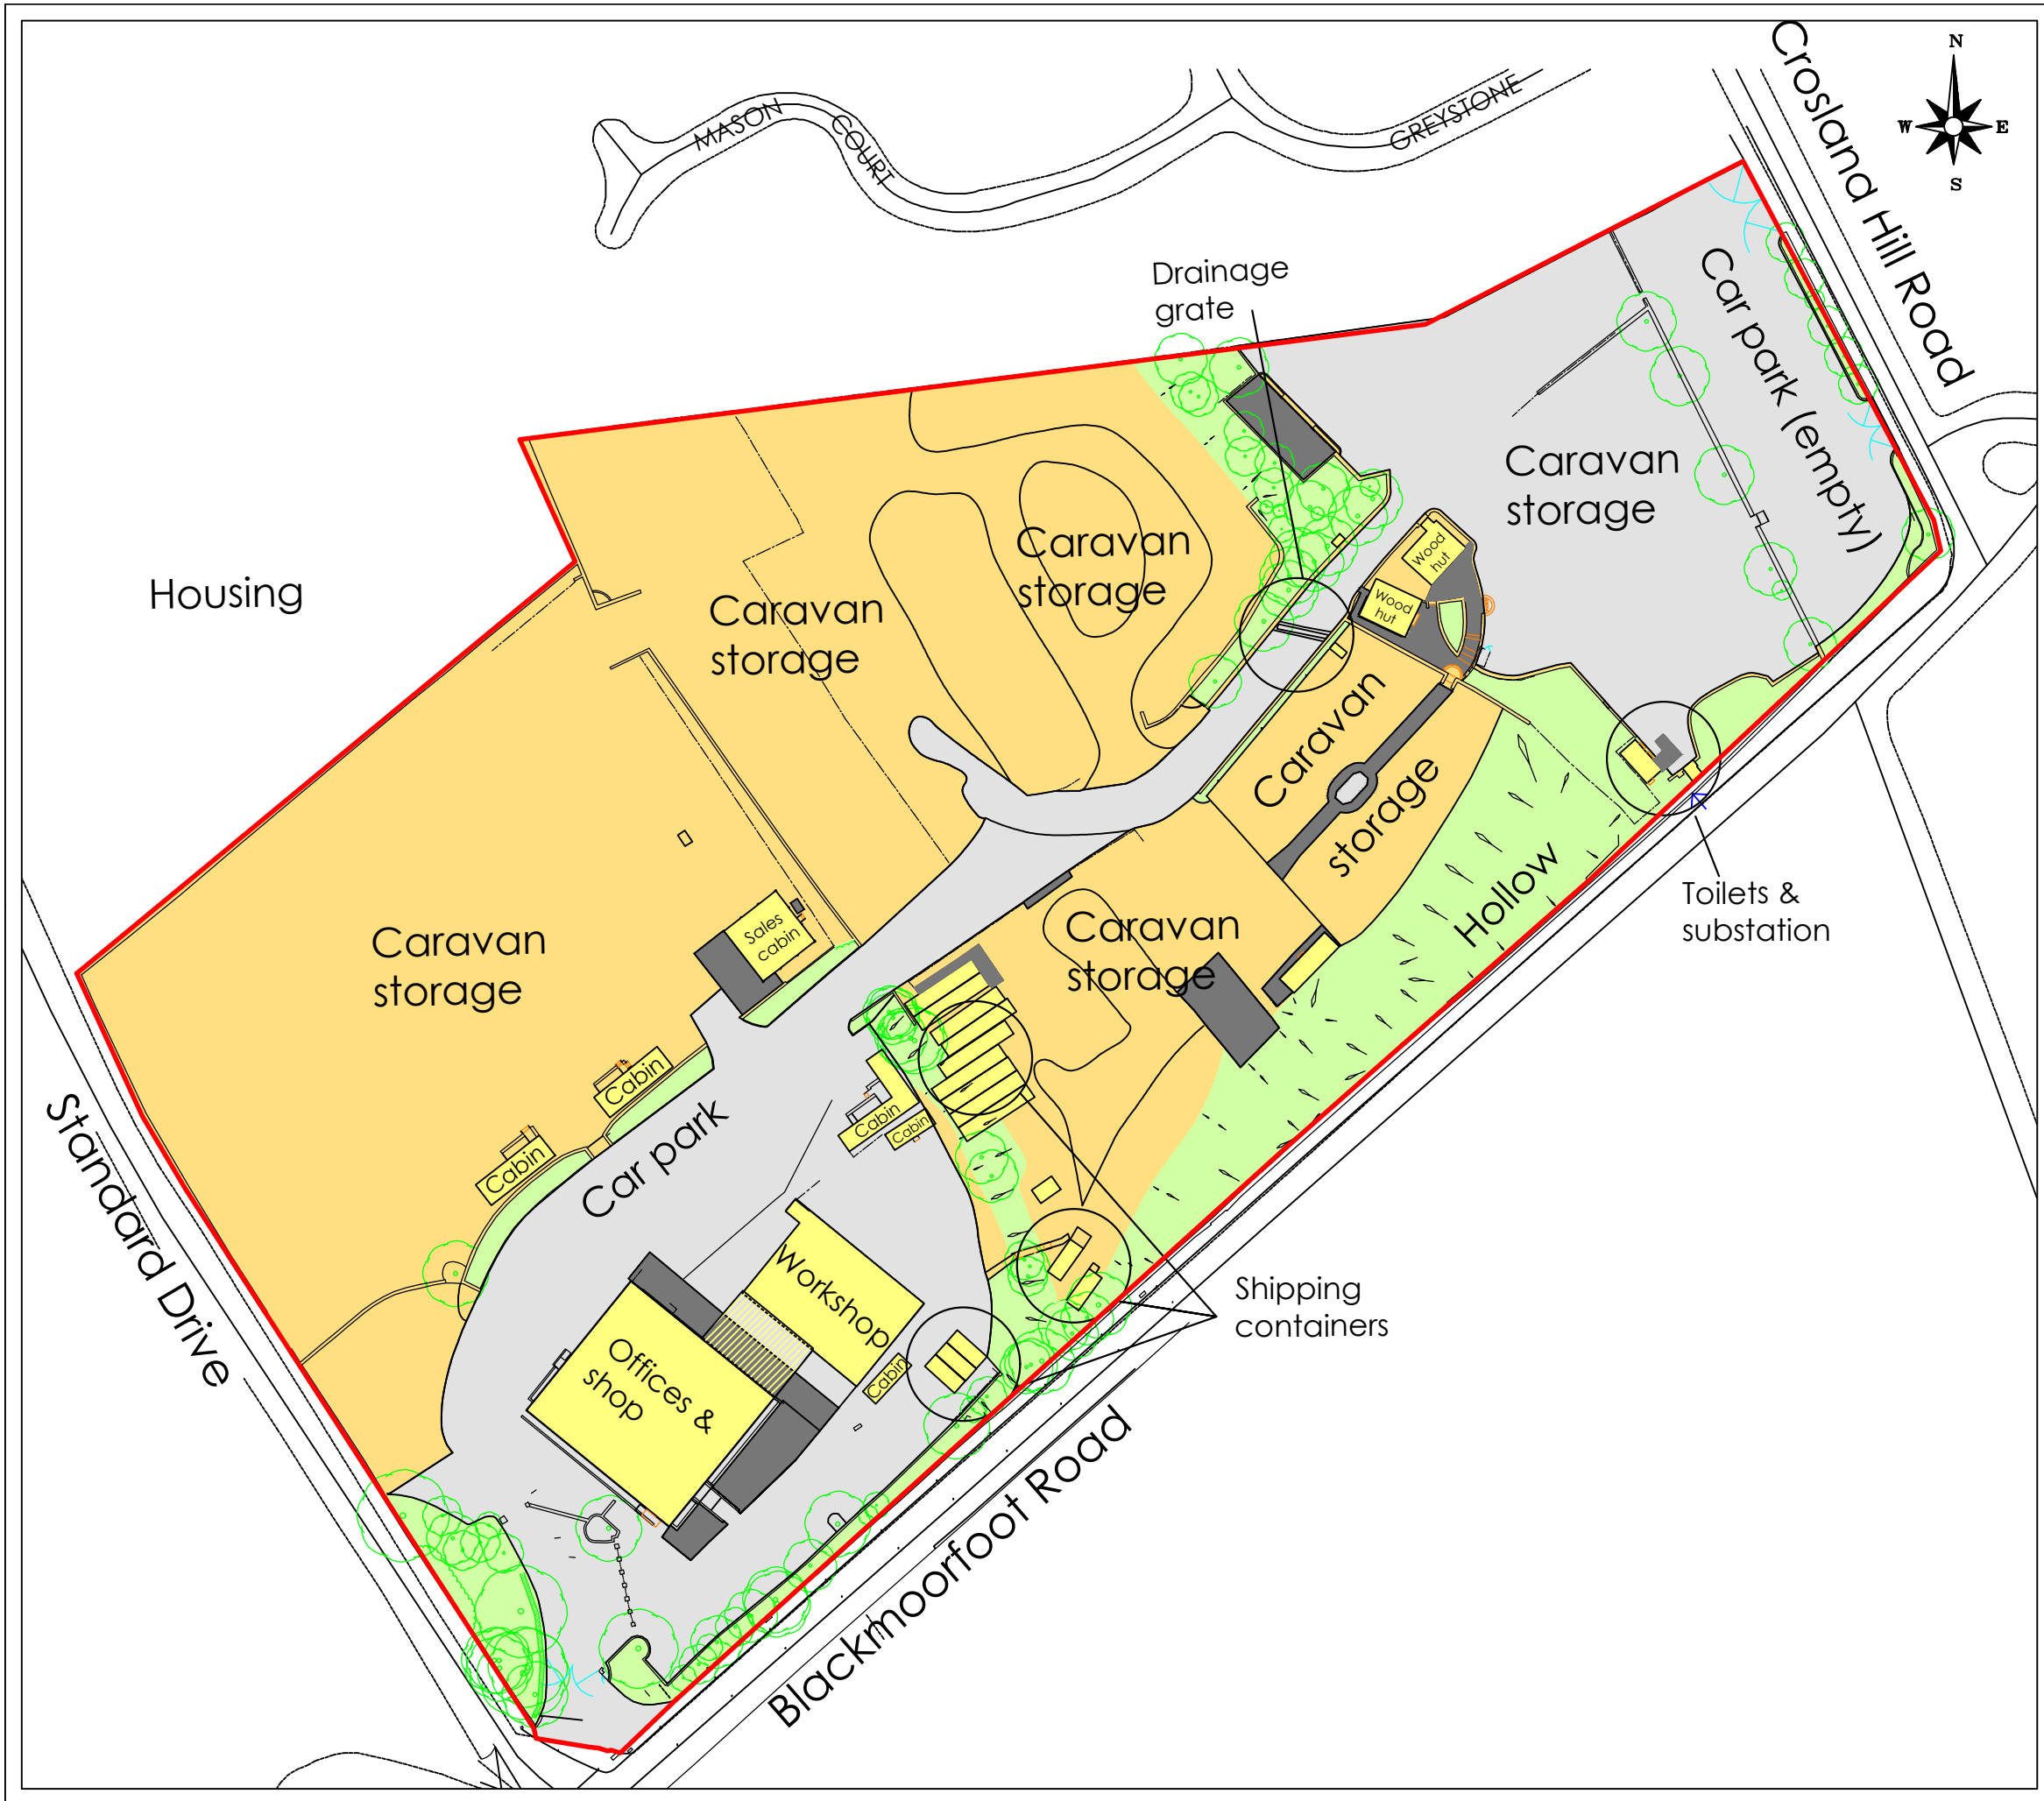
| SCALE | SHEET | DRAWING NO. | REVISION |
|---|---|---|---|
| 1:1,000 | A3 | 3649/3 | |

- GRASS & OVERGROWN AREAS
- BUILDING
- GRAVEL OR HARDCORE SURFACING
- TARMAC HARDSTAND
- CONCRETE PAVING/HARDSTAND/BRICK PAVING
- APPROXIMATE SITE BOUNDARY

- 8.3.2 About 15% of the site area is occupied by buildings.
- 8.3.3 Drawing 3649/3 shows the approximate areas of buildings and hardstand.
- 8.3.4 Constraints associated with ongoing usage of the site have prevented trenching to determine the nature of building foundations and the nature of any floor slabs. However, the existing buildings will have foundations and below ground structures should be anticipated.

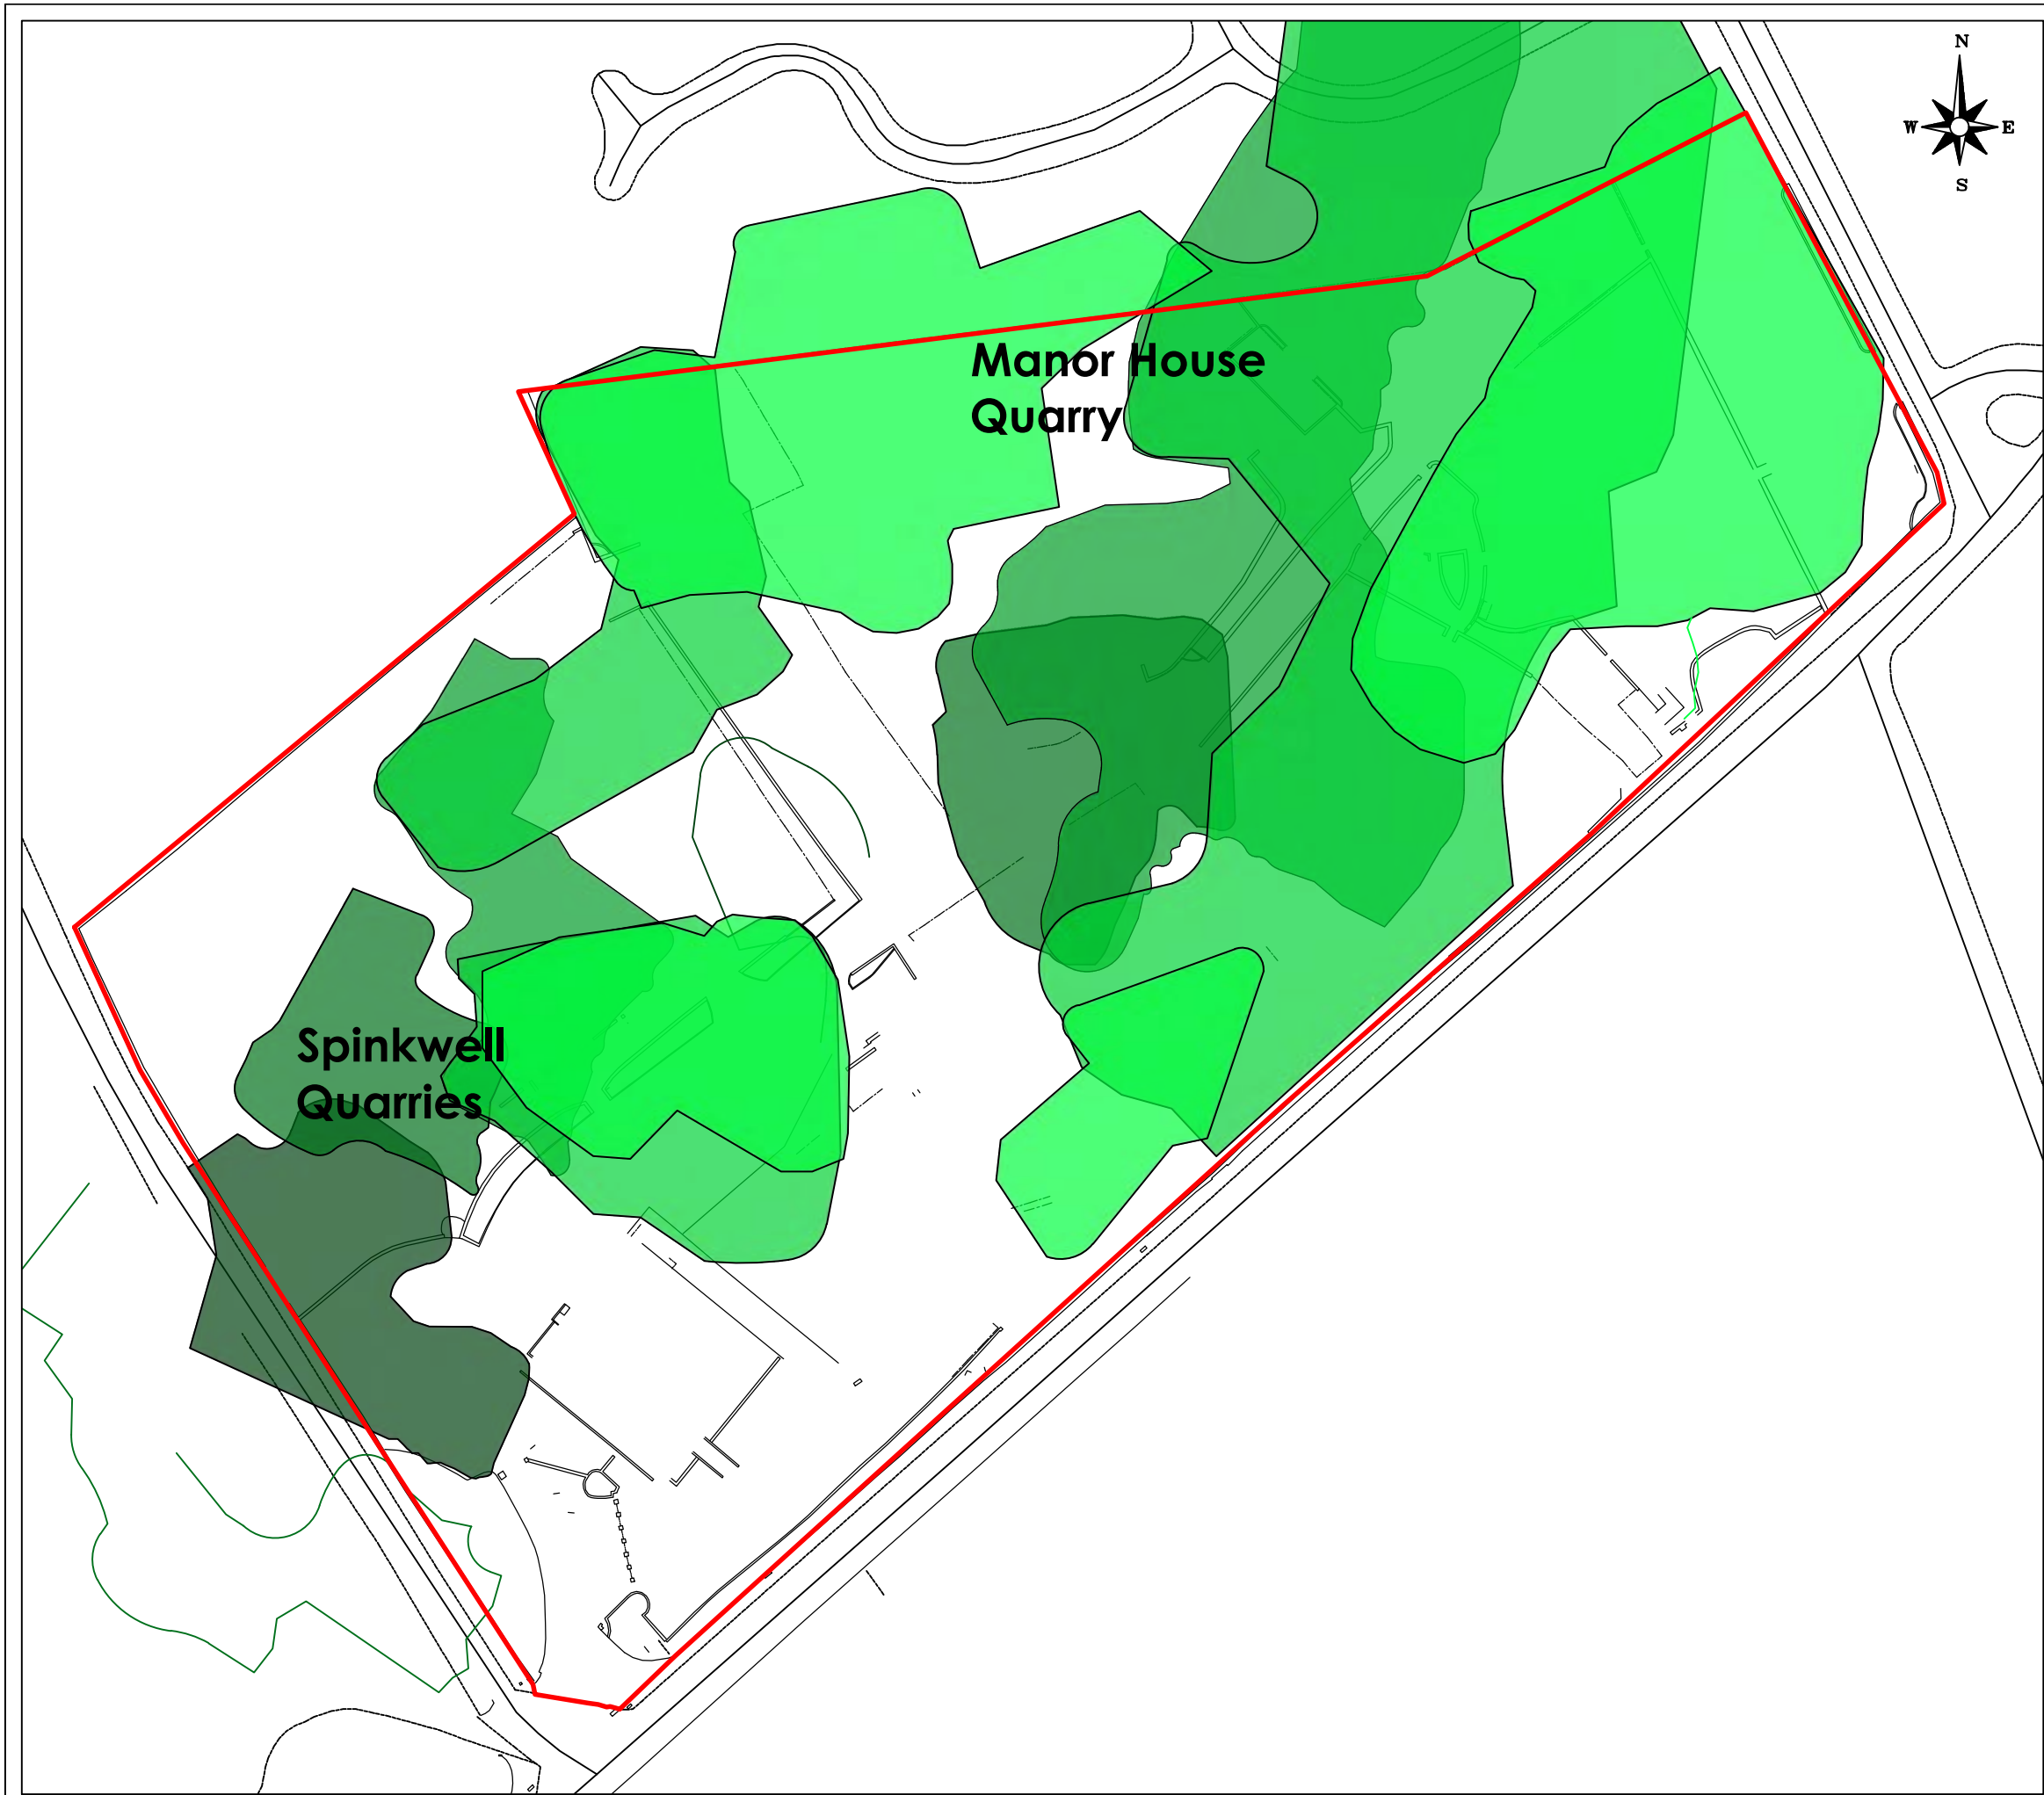
| SCALE | 1:1,000 | SHEET | A3 | DRAWING NO. | 3649/3a | REVISION | |

- Quarry 1892
- Quarry 1906
- Quarry 1916
- Quarry 1938
- Quarry 1960

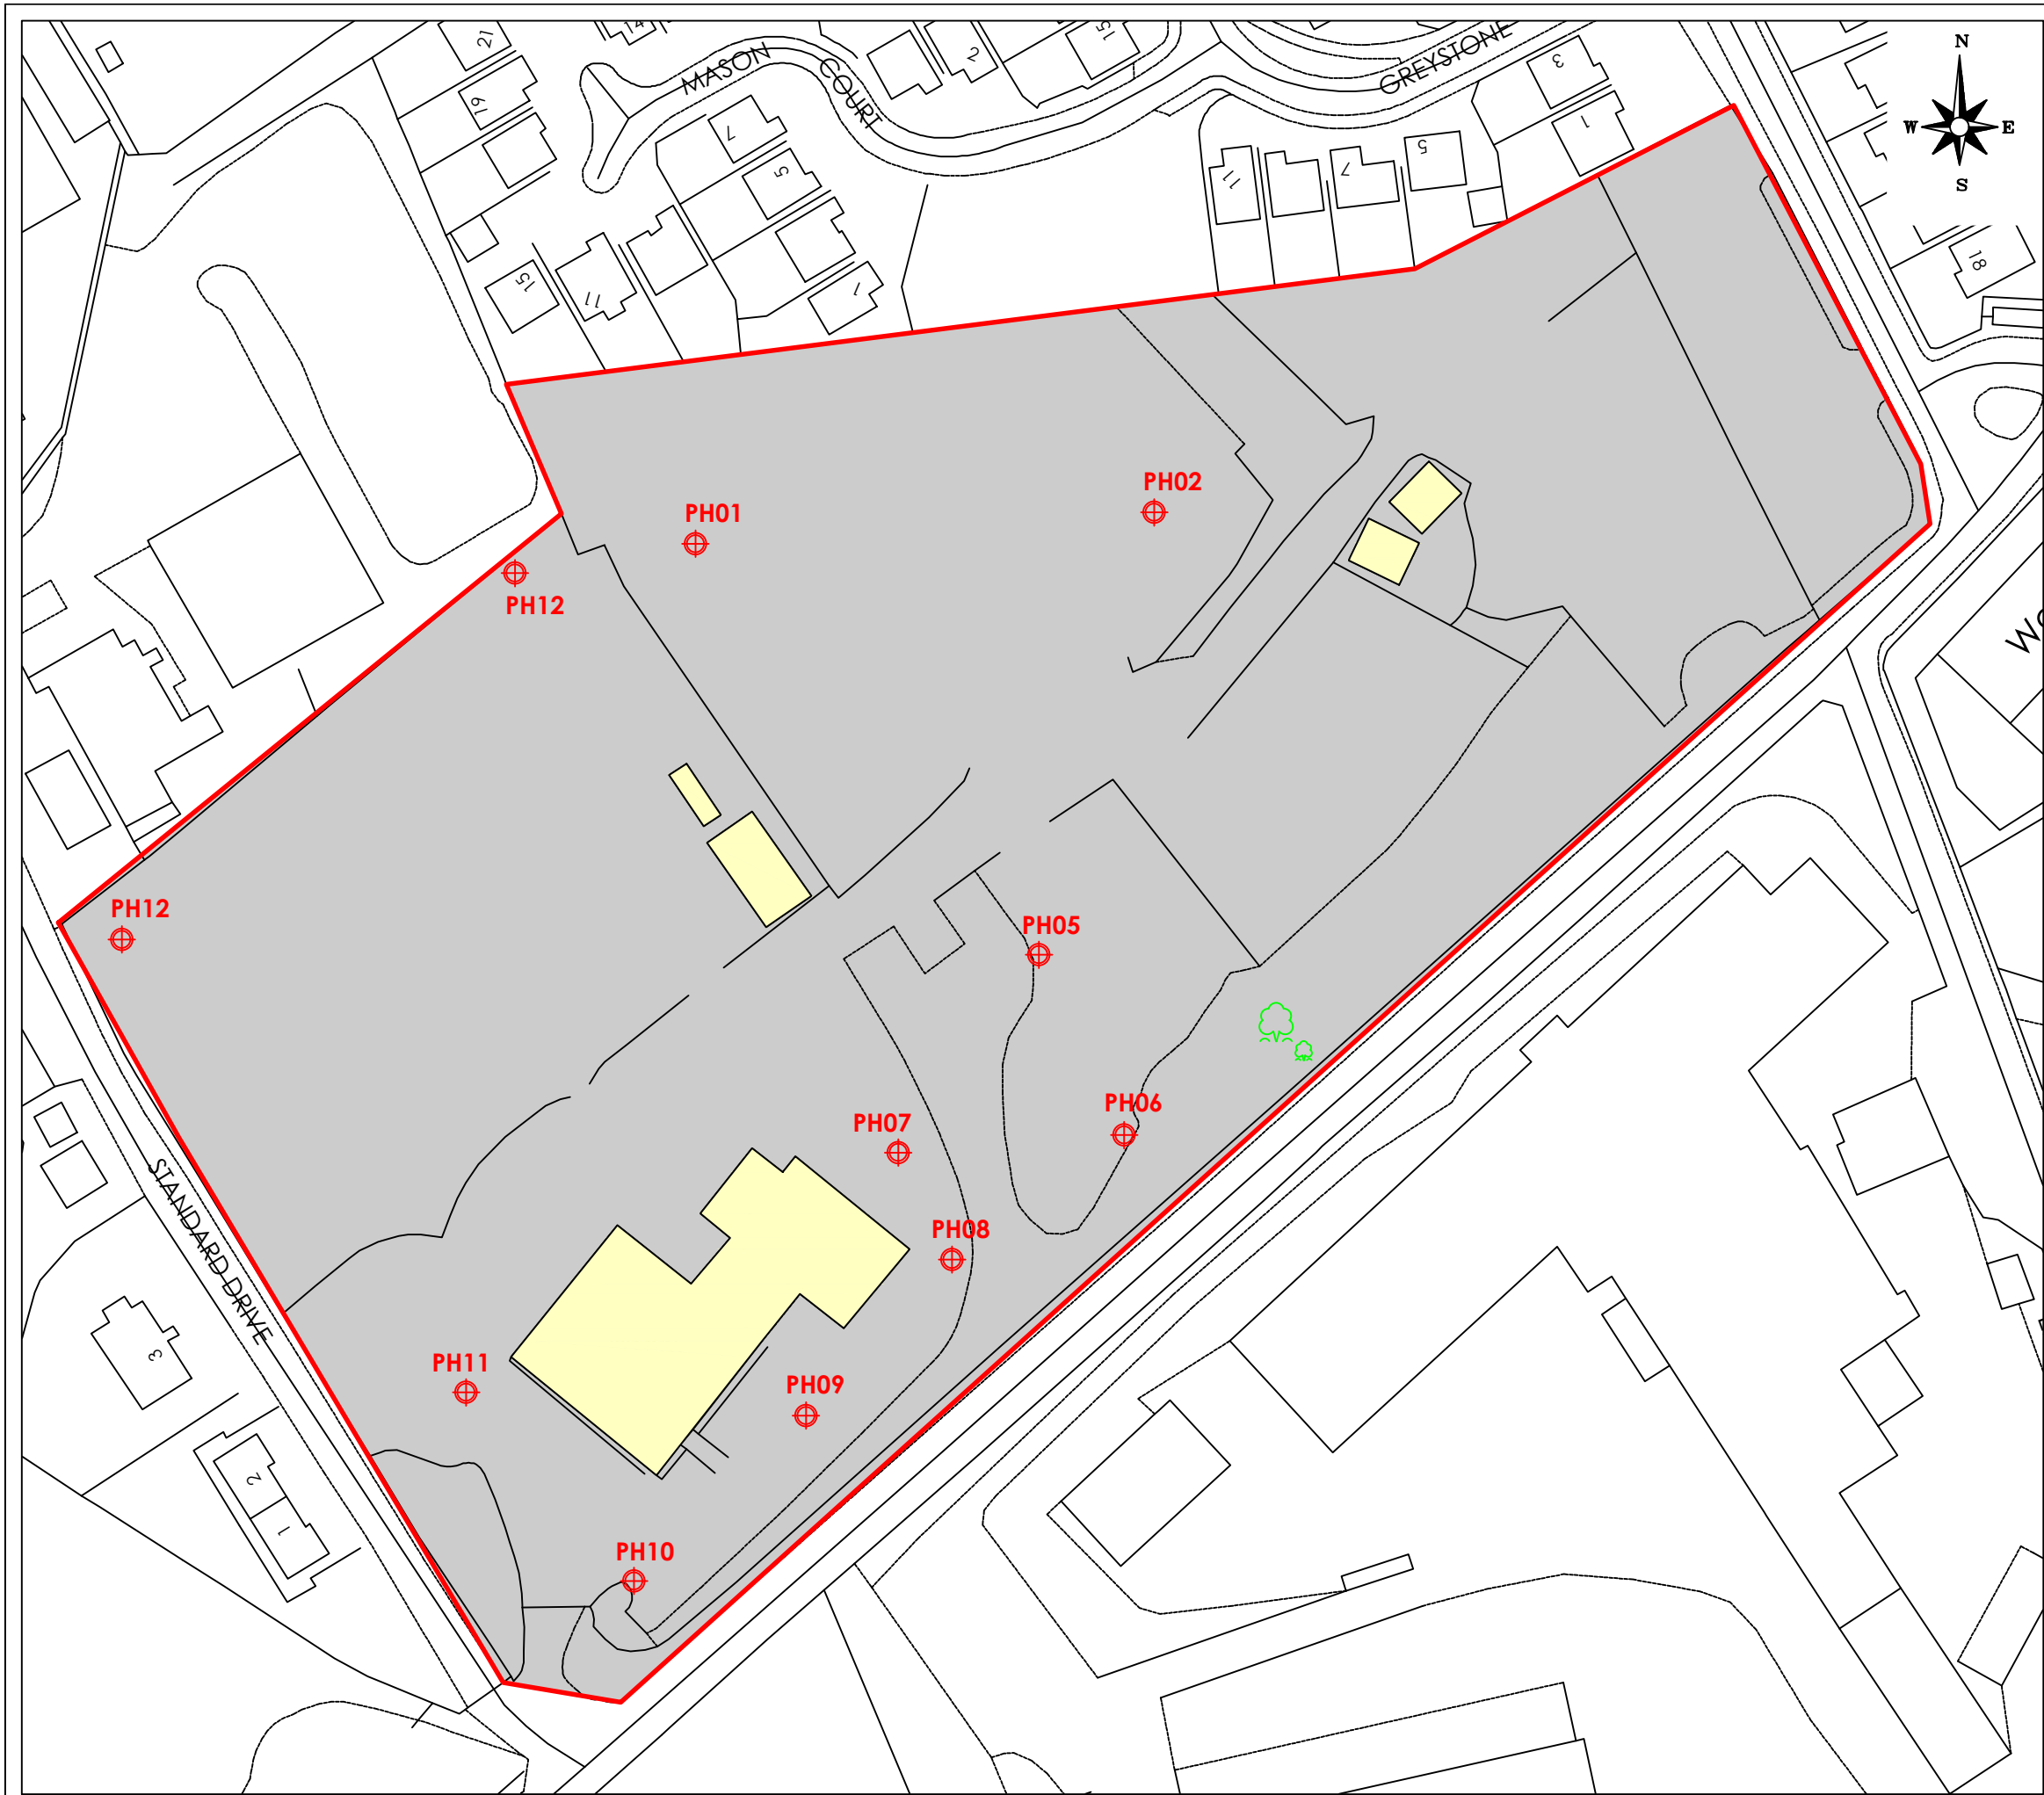
| SCALE | 1:1000 | SHEET | A3 | DRAWING NO. | 3649/6 | REVISION | |

WINDOW SAMPLE LOCATION;  
ADVANCED BY QDS ON 12th/13th  
DECEMBER 2002

### 5.2.2 The locations of QDS's exploratory holes are shown on Drawing 3649/6 and ground conditions are summarised in the Table below:

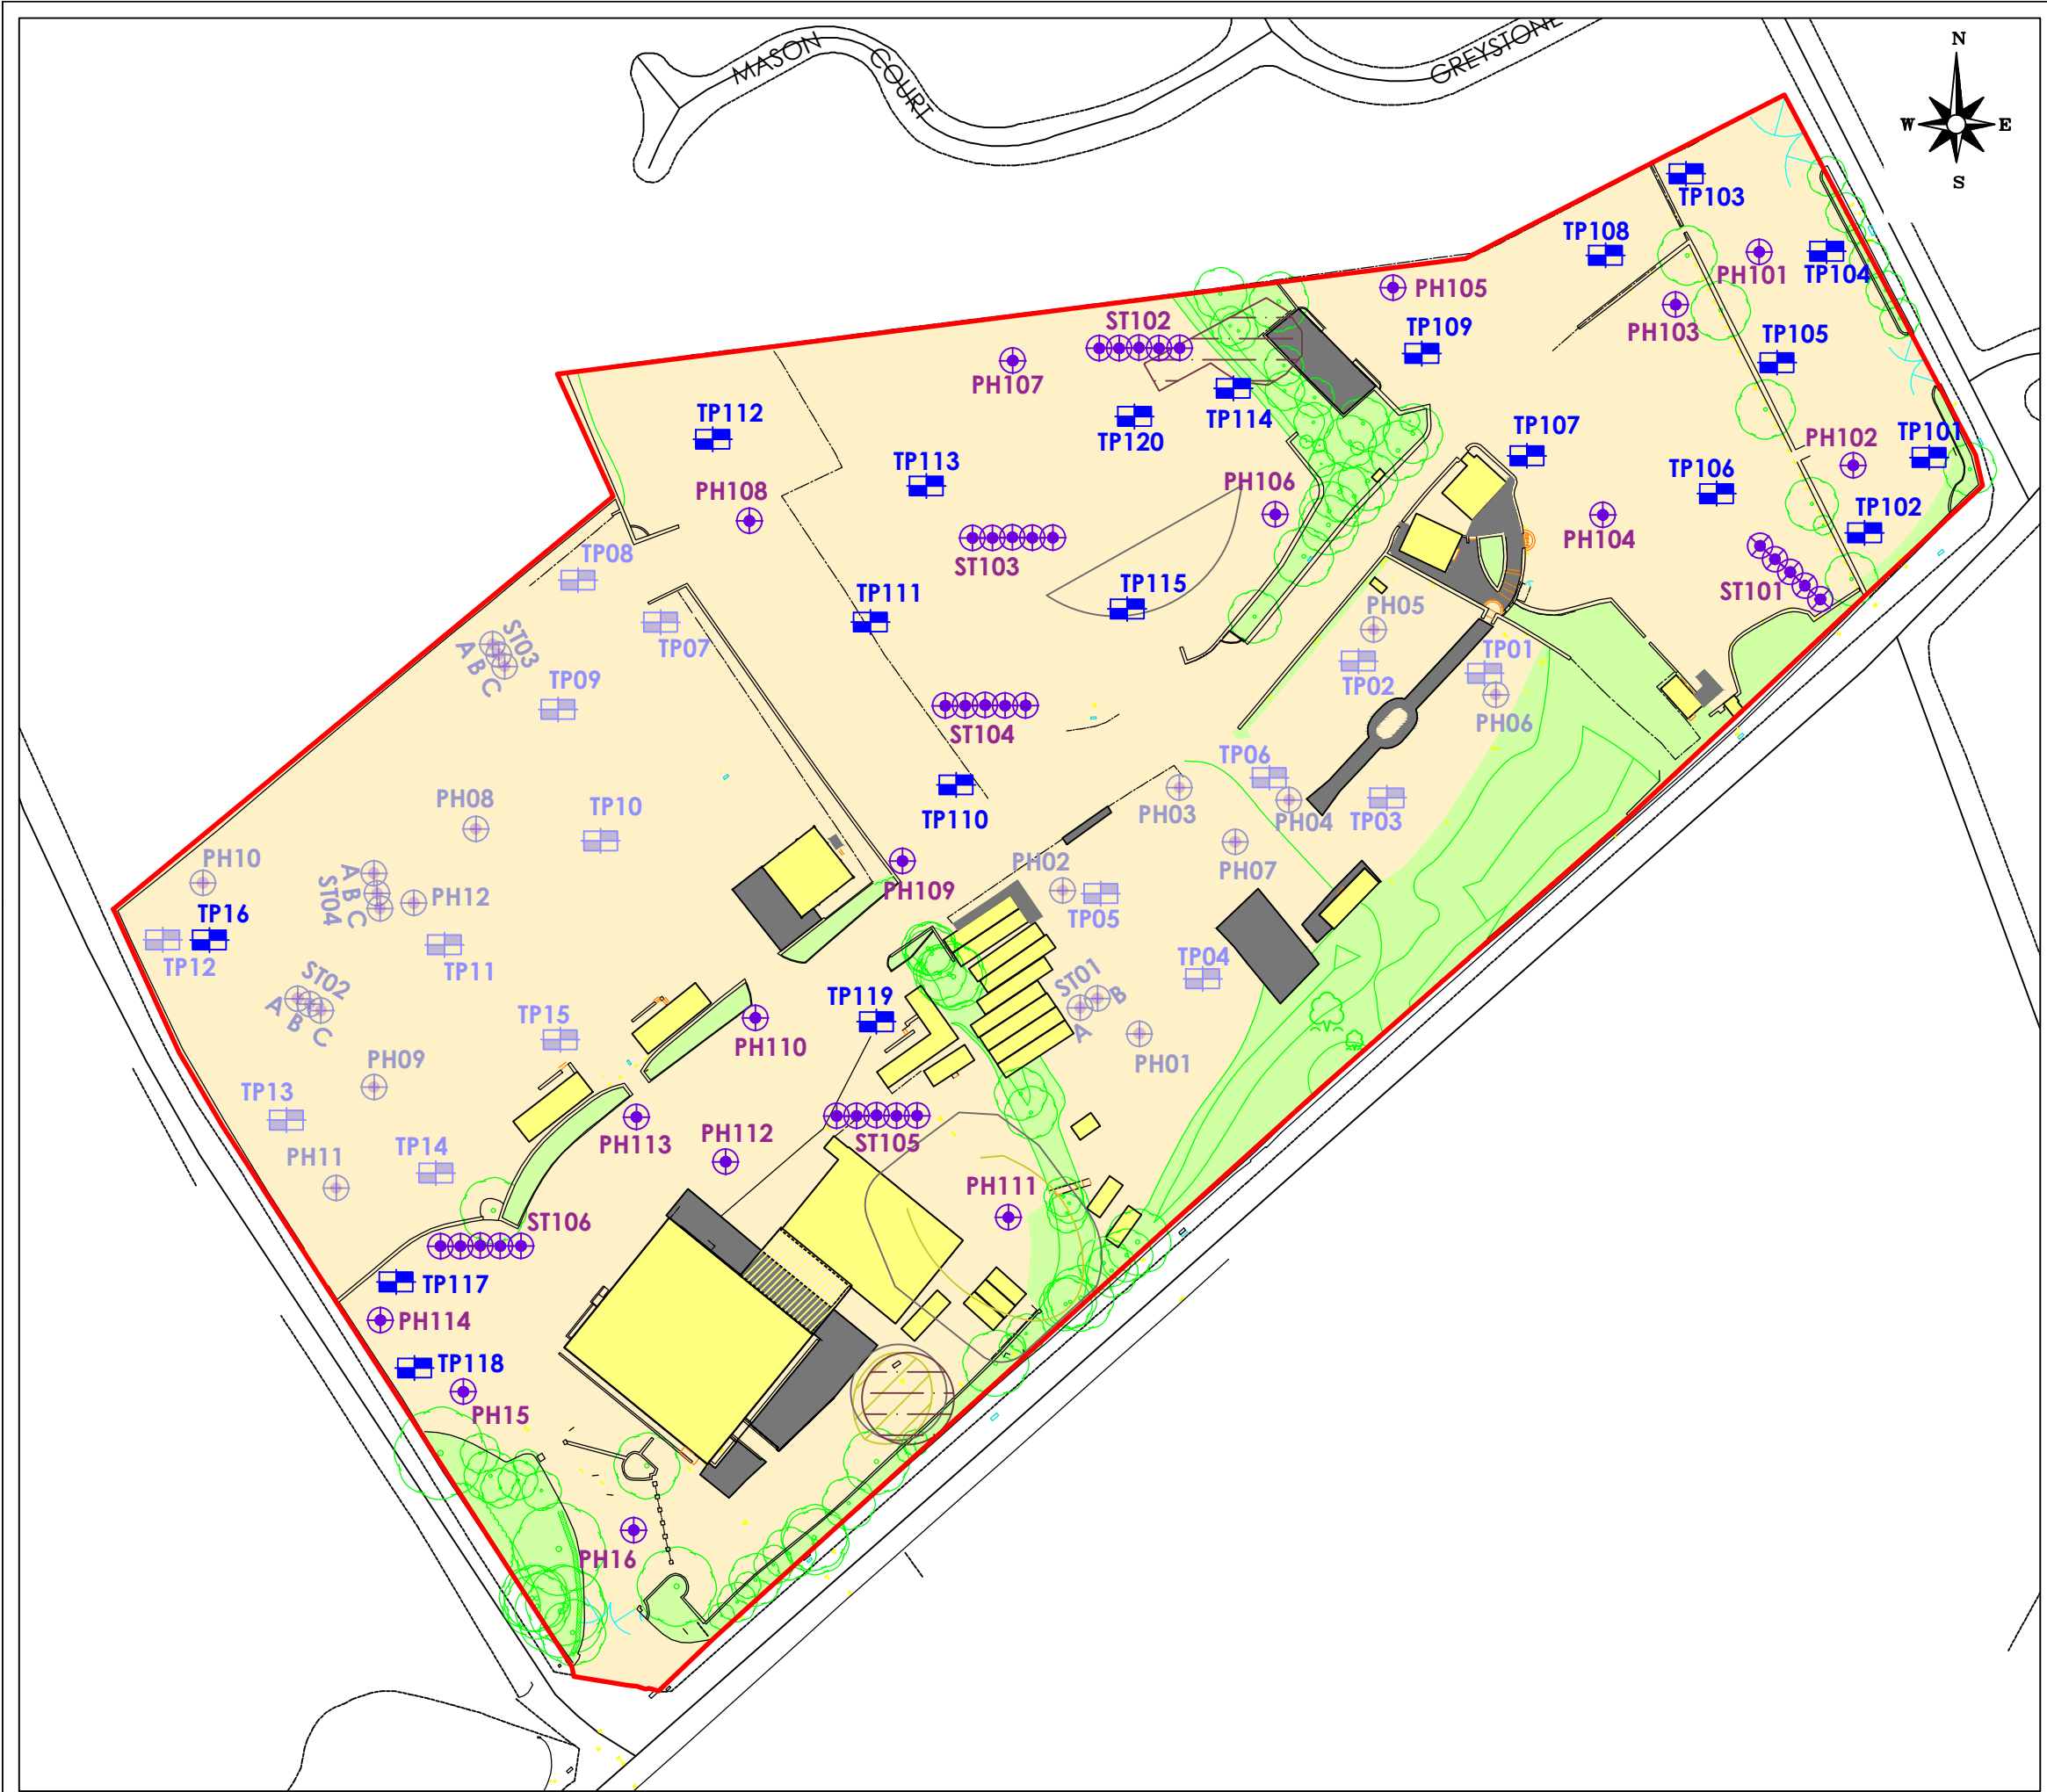
| SCALE | 1:1000 | SHEET | A3 | DRAWING NO. | 3649/7 | REVISION | |

- TRIAL PIT LOCATION (LITHOS 2021)
- PROBEHOLE LOCATION (LITHOS 2020)
- STITCH PROBEHOLE LOCATION (LITHOS 2021)
- TRIAL PIT LOCATION (LITHOS 2020)
- PROBEHOLE LOCATION (LITHOS 2020)
- STITCH PROBEHOLE LOCATION (LITHOS 2020)
- APPROXIMATE SITE BOUNDARY

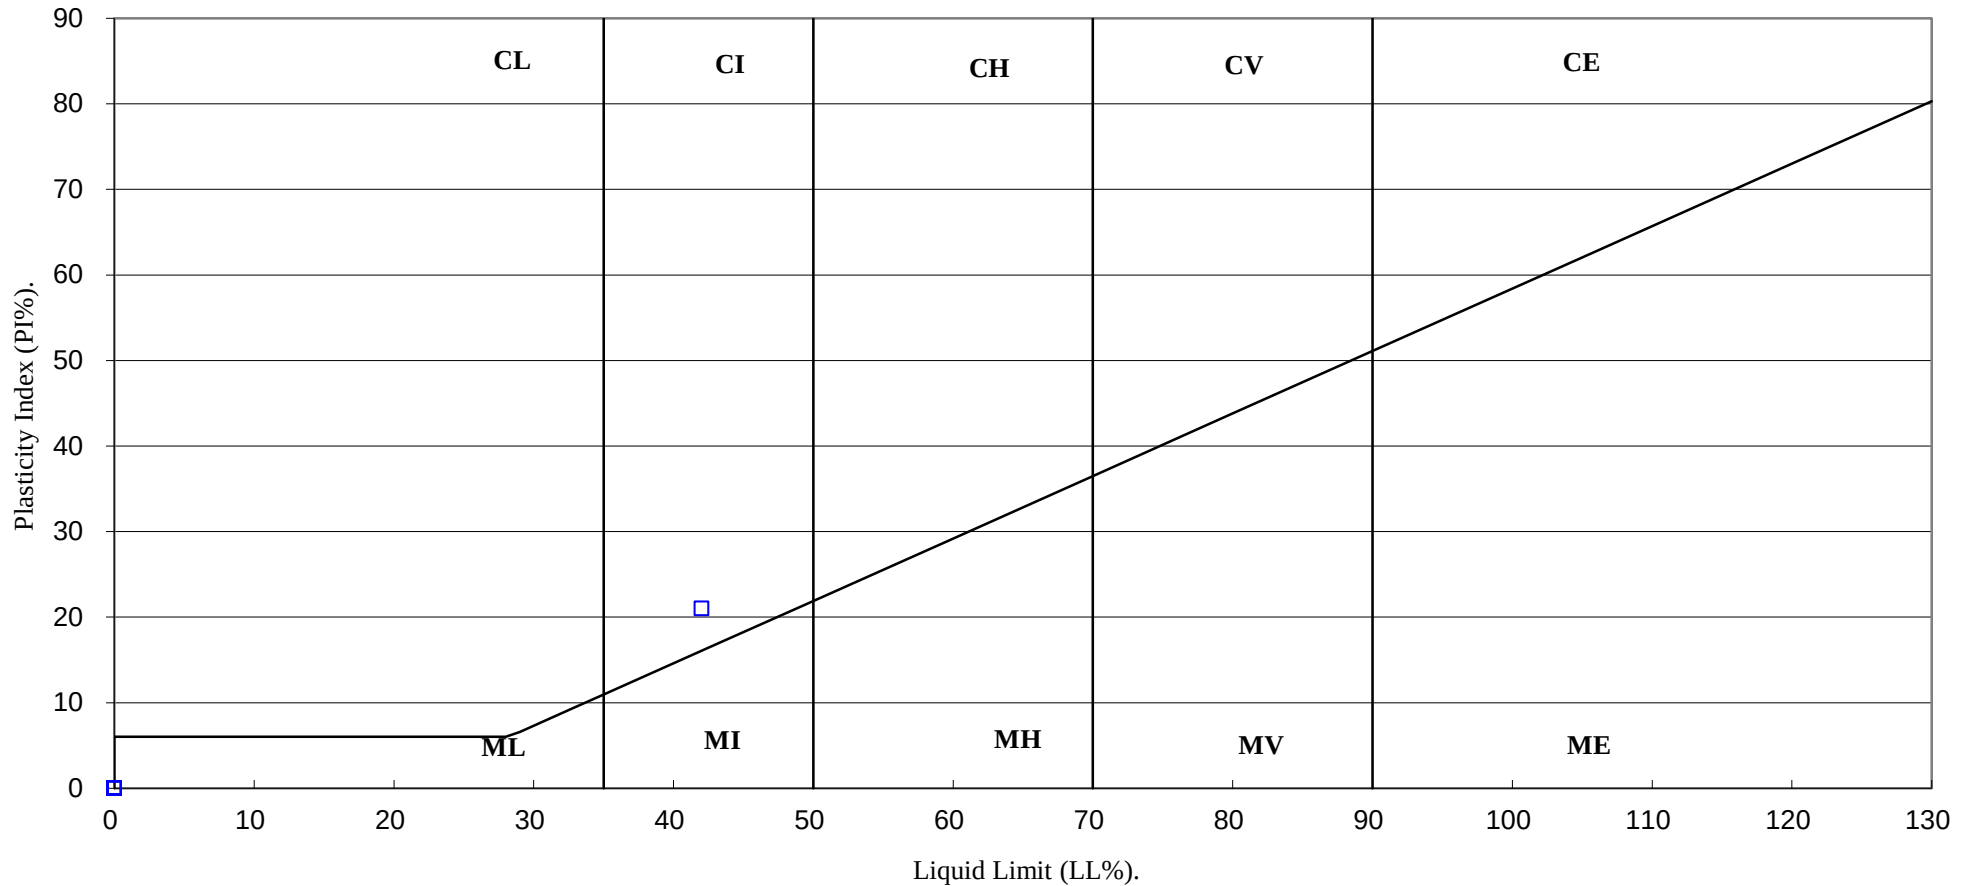
# PLASTICITY CHART FOR CASAGRANDE CLASSIFICATION.
