## GeoEnvironmental Desk Study

Knowl Grove

Mirfield

**Report No. A3800/20**

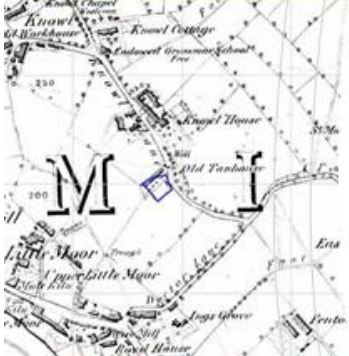
<p><b>Earth Environmental &amp; Geotechnical Ltd</b></p> <p><b>Tel:</b> 0161 975 6088  <b>Email:</b> info@earthenvironmental.co.uk  <b>Web:</b> www.earthenvironmental.co.uk</p>	<p><b>SITE PHOTOGRAPHS</b></p>  
<p><b>Job No.:</b> A3800/20</p>	<p><b>Site:</b> Knowl Grove, Mirfield</p>
<p><b>Plate 1 Viewing southeast showing the site entrance from Knowl Grove. Note the metal fence along the southwest boundary.</b></p>	<p><b>Plate 2 Viewing southeast showing the location of the 2 soakaways and site drainage.</b></p>

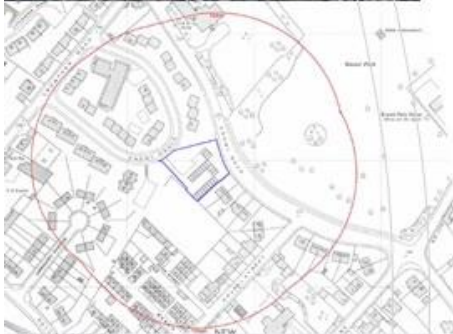
<p><b>Date:</b> 23<sup>rd</sup> November 2020</p>	<p><b>Date:</b> 23<sup>rd</sup> November 2020</p>
<p><b>Plate 3 Viewing northeast showing the eastern part of the site and the storage compartment fronts.</b></p>	<p><b>Plate 4 Viewing east showing the northern part of the site and the north boundary. Note the location of the bus shelter.</b></p>

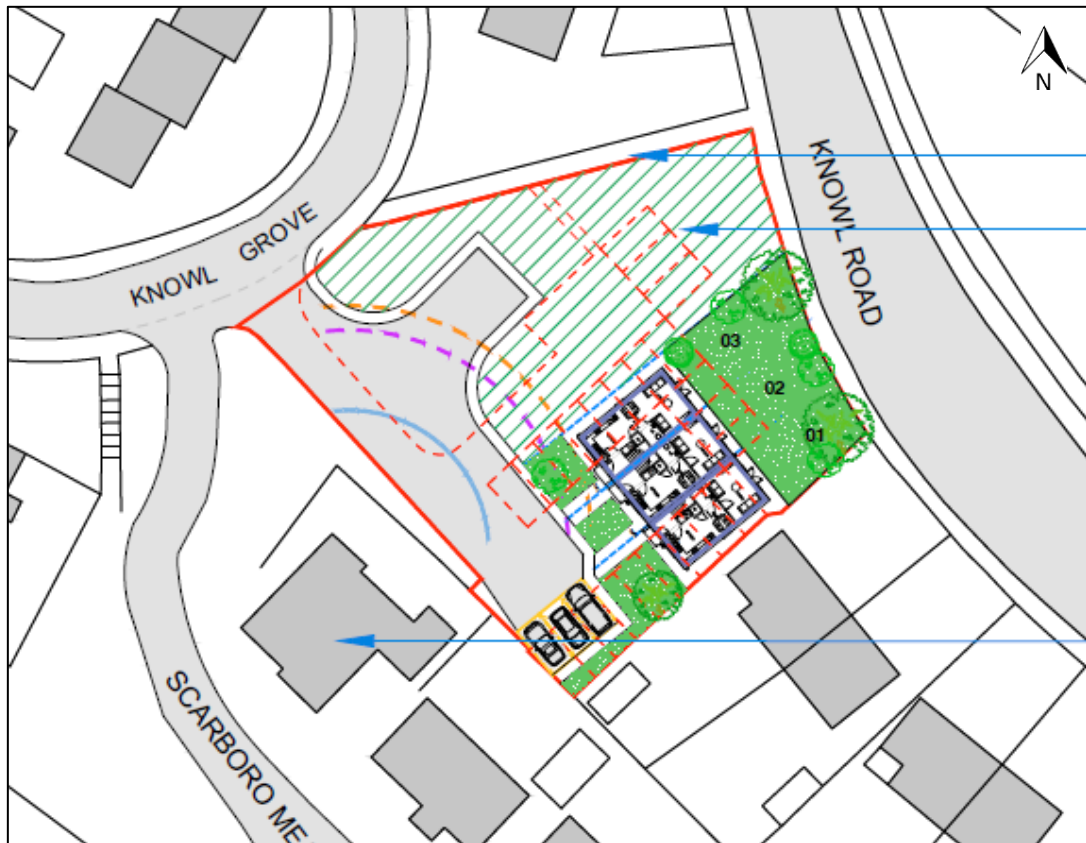
**Figure 1 Proposed Development Plan**

- 1.1 Earth Environmental & Geotechnical Ltd has been commissioned by BTP Architects on behalf of Kirklees Neighbourhood Housing Ltd (the Client) to undertake a Phase I GeoEnvironmental Desk Study for the proposed development on the land southeast of Knowl Grove, Mirfield.
- 1.2 It is understood that the Client wishes to construct three new residential properties with associated soft landscaping and driveways.
- 1.3 Existing vehicle access will be retained.
- 1.4 A proposed development plan for the site is shown in Figure 1 below.

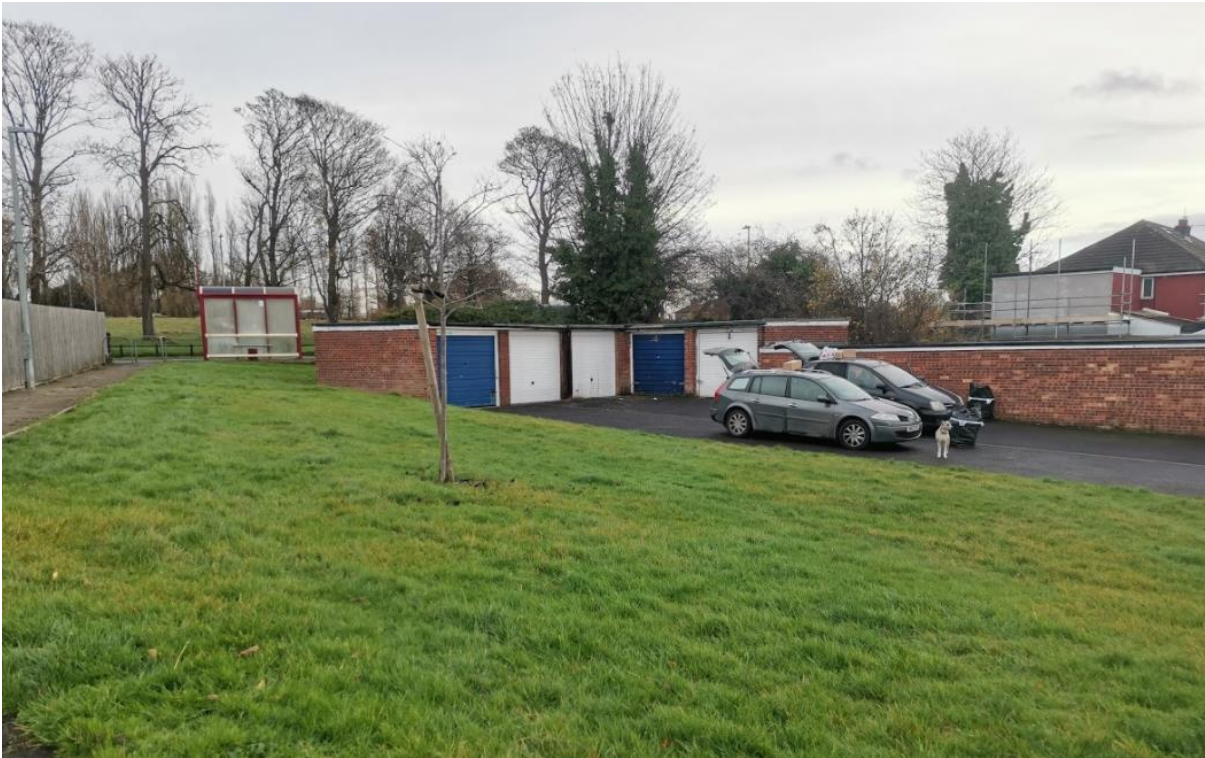
**Figure 3 Site Photograph**

- 2.1 The site is located in Mirfield, Kirklees, West Yorkshire approximately 0.25km from Mirfield Town Centre. The approximate National Grid Reference for the centre of the site is SE 20154 20197 (X: 420154, Y: 420197) with the closest postcode being WF14 9RF.
- 2.2 The site is a near rectangular shaped parcel of land with current access via Knowl Grove to the west. The maximum dimensions of the proposed site are 44m north to south and 51m west to east. The site occupies an area of approximately 0.14Ha.
- 2.3 The site is currently occupied by 22 storage compartments and soft cover landscaping with a bus shelter in the northern corner of the site.
- 2.4 The general surrounding area comprises predominantly of residential dwellings.
- 2.5 A location plan is shown below as Figure 2, together with a recent site photograph as Figure 3 (overleaf).
