## GeoEnvironmental Site Investigation Report

Ings Road

Liversedge

**Report Ref: A3914/21/SI**

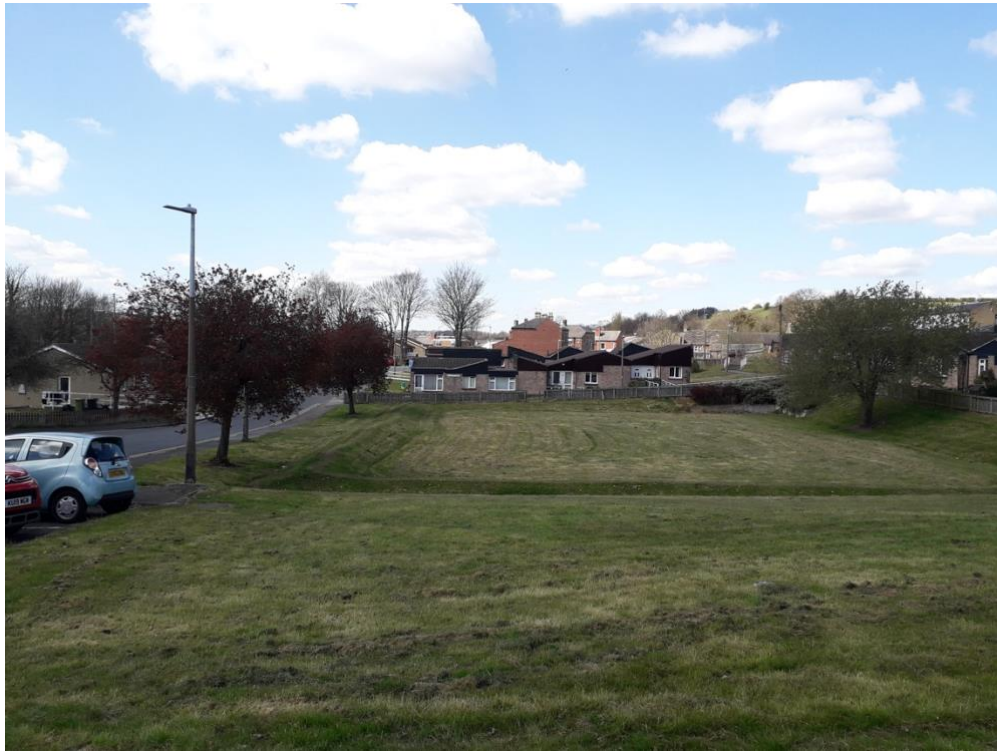
**Figure 2: General Site Photographs**

View across the site, facing west

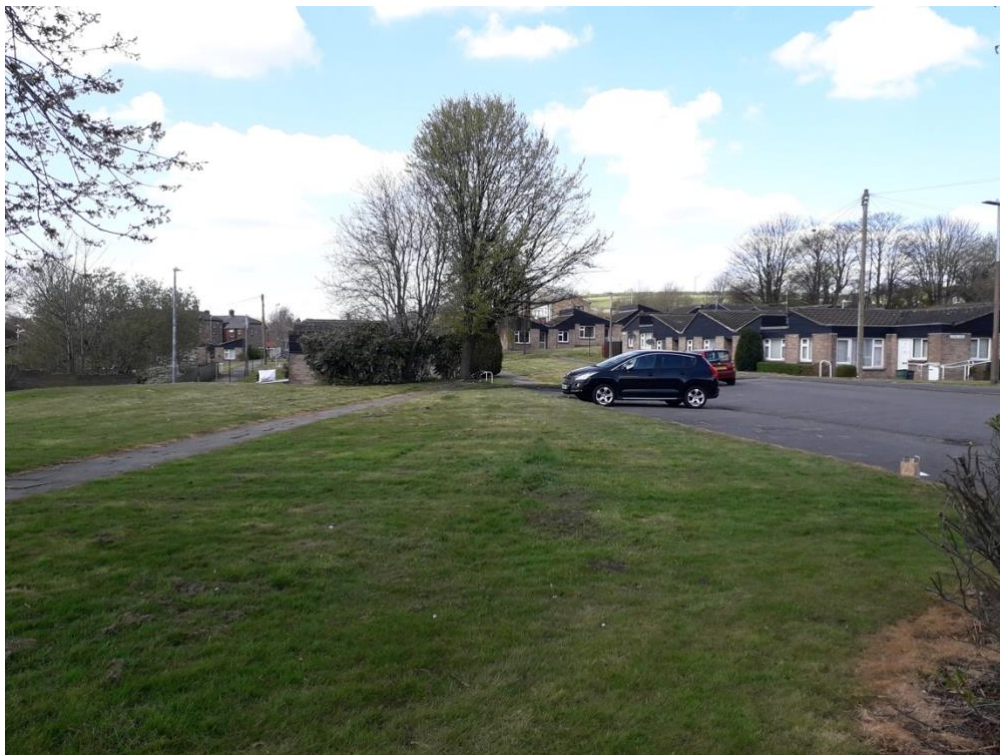
View across the site, facing south west

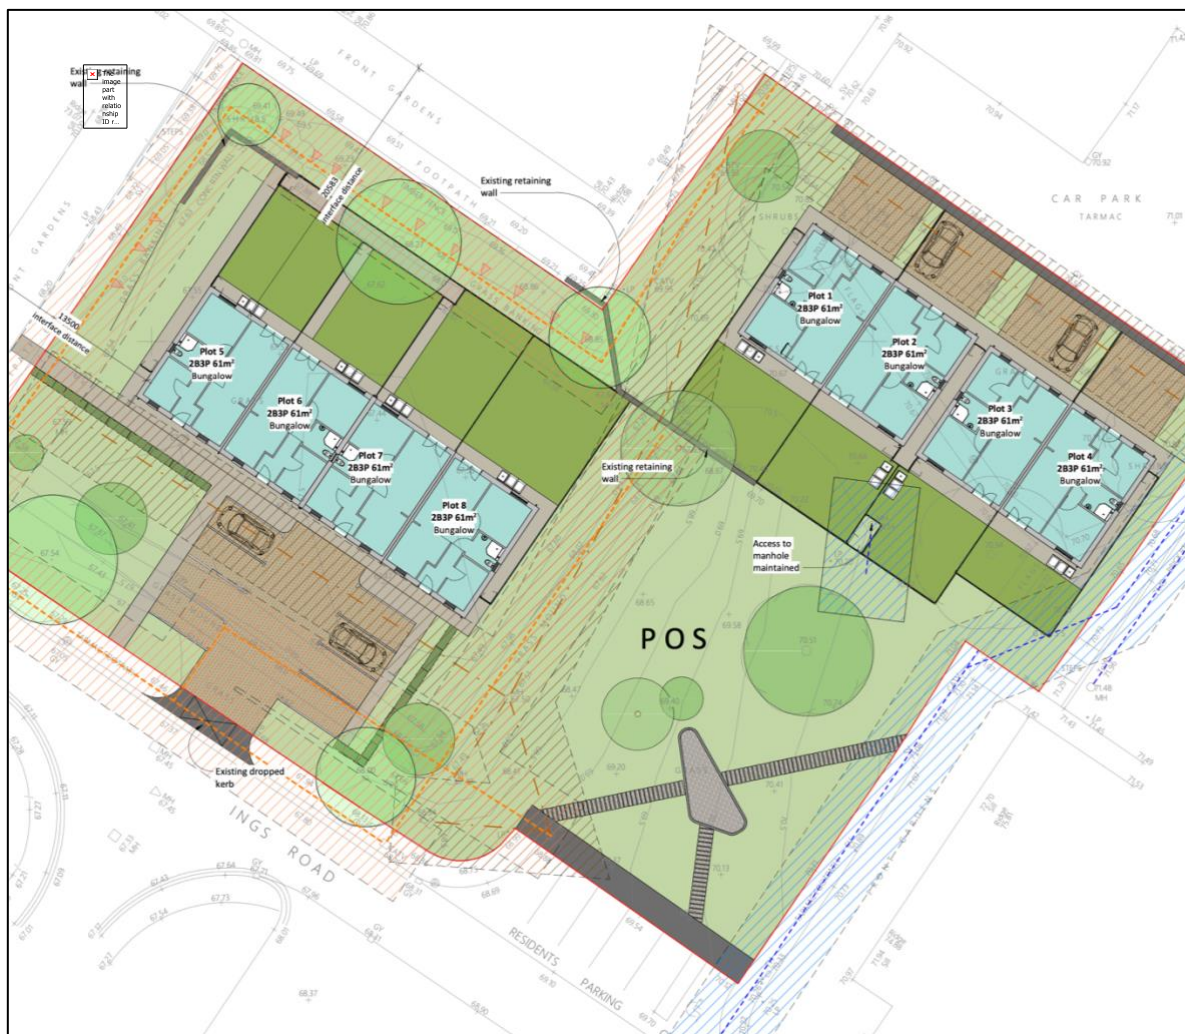
**Figure 3: Proposed Development Plan**

It is understood that the Client intends to build eight residential bungalows on site with associated soft landscaping and off-street parking. An area of public open space is proposed for the land in the southern central portion of the site. Access will be provided from Ings Road to the south and Listing Court to the north.
