BADGER HEY FARM.

BAT SURVEY.

Ref No: 210866.

Date: 25th August 2021.

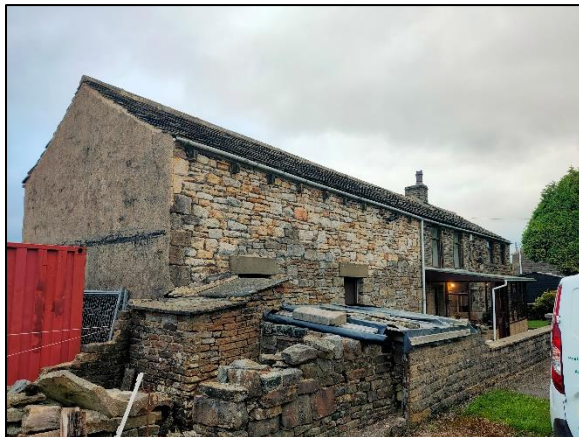
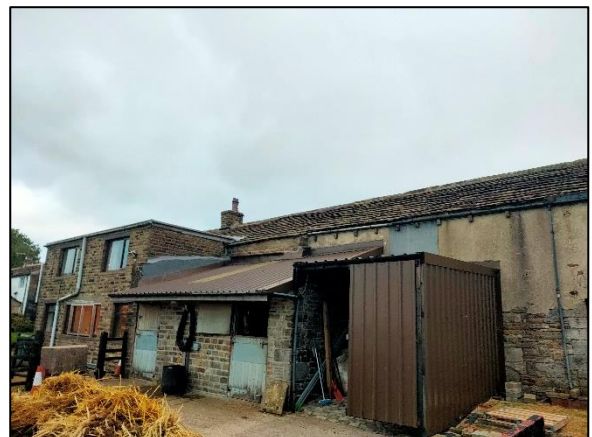
3.2.2. The photographs below show the surveyed building from both the front and the rear.

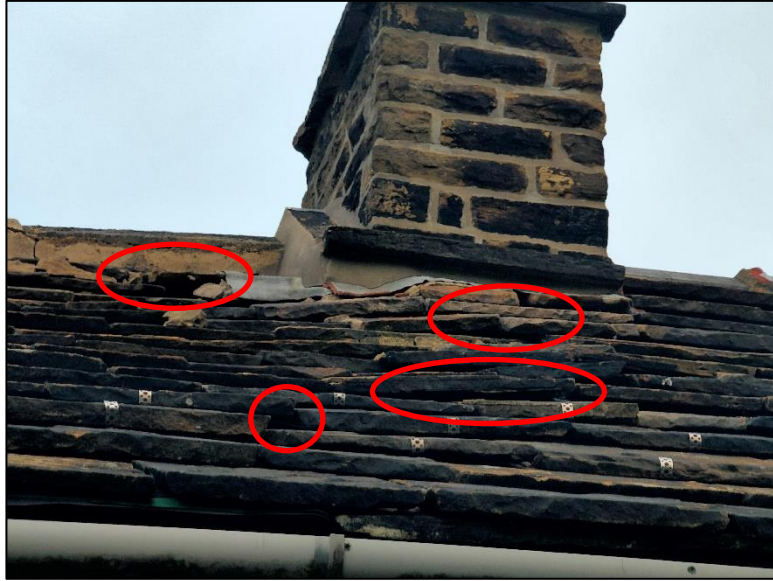
3.3.3. Externally, however, the roof is in a generally poor condition, with lifted or warped tiles throughout much of the roof leaving gaps below the tiles. The property is situated high in the moors and exposed to frequent high winds and other bad weather, leaving the stone tiles vulnerable to erosion over the years. An example of this is shown in the photograph below.

3.3.7. To summarise, no bats or their field signs, such as droppings or insect remains were identified and the surrounding area provides poor foraging grounds and generally inhospitable habitat for bats. There are also no records of bats within 1km of the property. However, the gaps under the roof tiles could prove to be suitable for roosting bats. Therefore, the property has been assessed as providing **low potential** for roosting bats, and as such, a dusk emergence was carried out.

4.1. The building was assessed as providing a **low potential** for roosting bats due to the presence of some gaps below the roof tiles. However, during the dusk emergence survey, no bats were seen to emerge from the building and no other bat activity was recorded within the survey area.

5.3. To compensate for the loss of potential habitat, it is recommended that at least one bat roof tile is incorporated into the design of the new property.

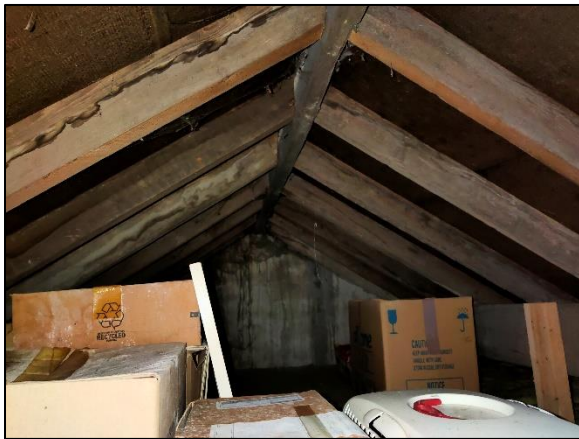
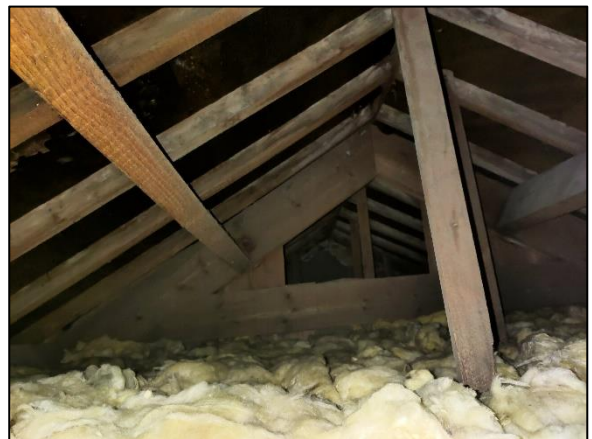
3.3.2. The property is two stories with a loft space which spans the length of the property; the loft is partitioned halfway through. Both loft spaces were inspected but the loft hatches are not big enough to fit through. The lofts were all lined internally with no light entering the loft space. No access points directly into the loft space were found and no bats, or their field signs, were identified.

3.3.4. The eastern section of the loft is shown below on the left, and the larger western section is shown below on the right.

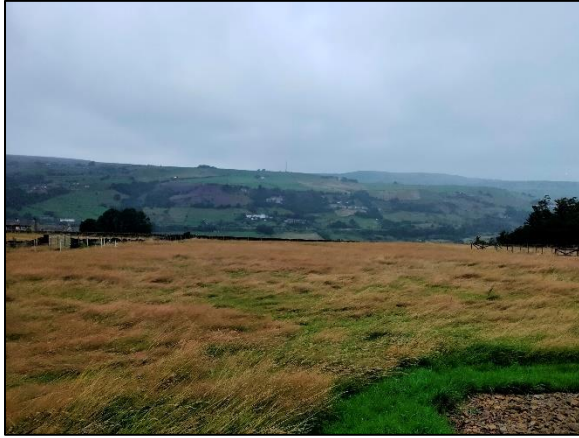
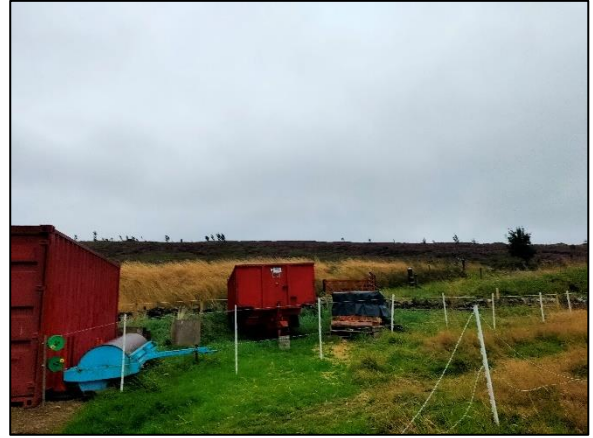
3.3.6. As mentioned above, the location of the property is located atop a valley in the moors and as such is frequently exposed to extreme weather such as high winds. There is very little suitable foraging habitat for bats with the surrounding area which comprises arable land and heathland. Photographs of the surrounding areas are shown below.

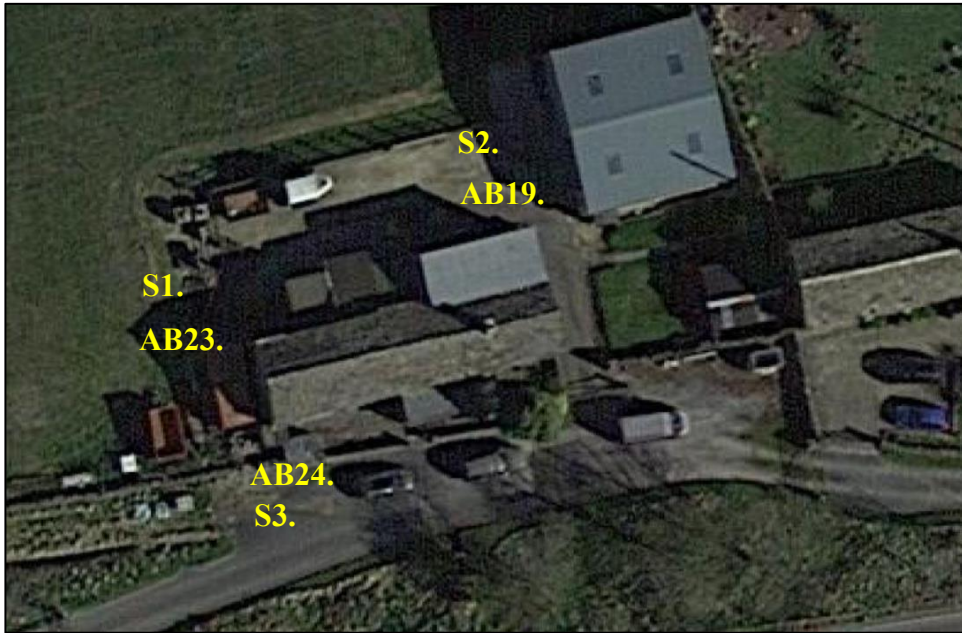
3.4.3. The aerial photograph below shows the building letters and where the Surveyors (S) and Anabats (AB) were positioned.

3.4.5. No bats were seen or heard by any of the three surveyors during the entirety of the survey, and the Anabats positioned with the surveyors recorded no bat activity.
