Our Ref C2187/21/E/3364
5th of November 2021

Ref: Proposed Development at Land off Stoney Bank Lane, New Mill.

CONSTRUCTION MANAGEMENT PLAN

PARTICLE SIZE DISTRIBUTION

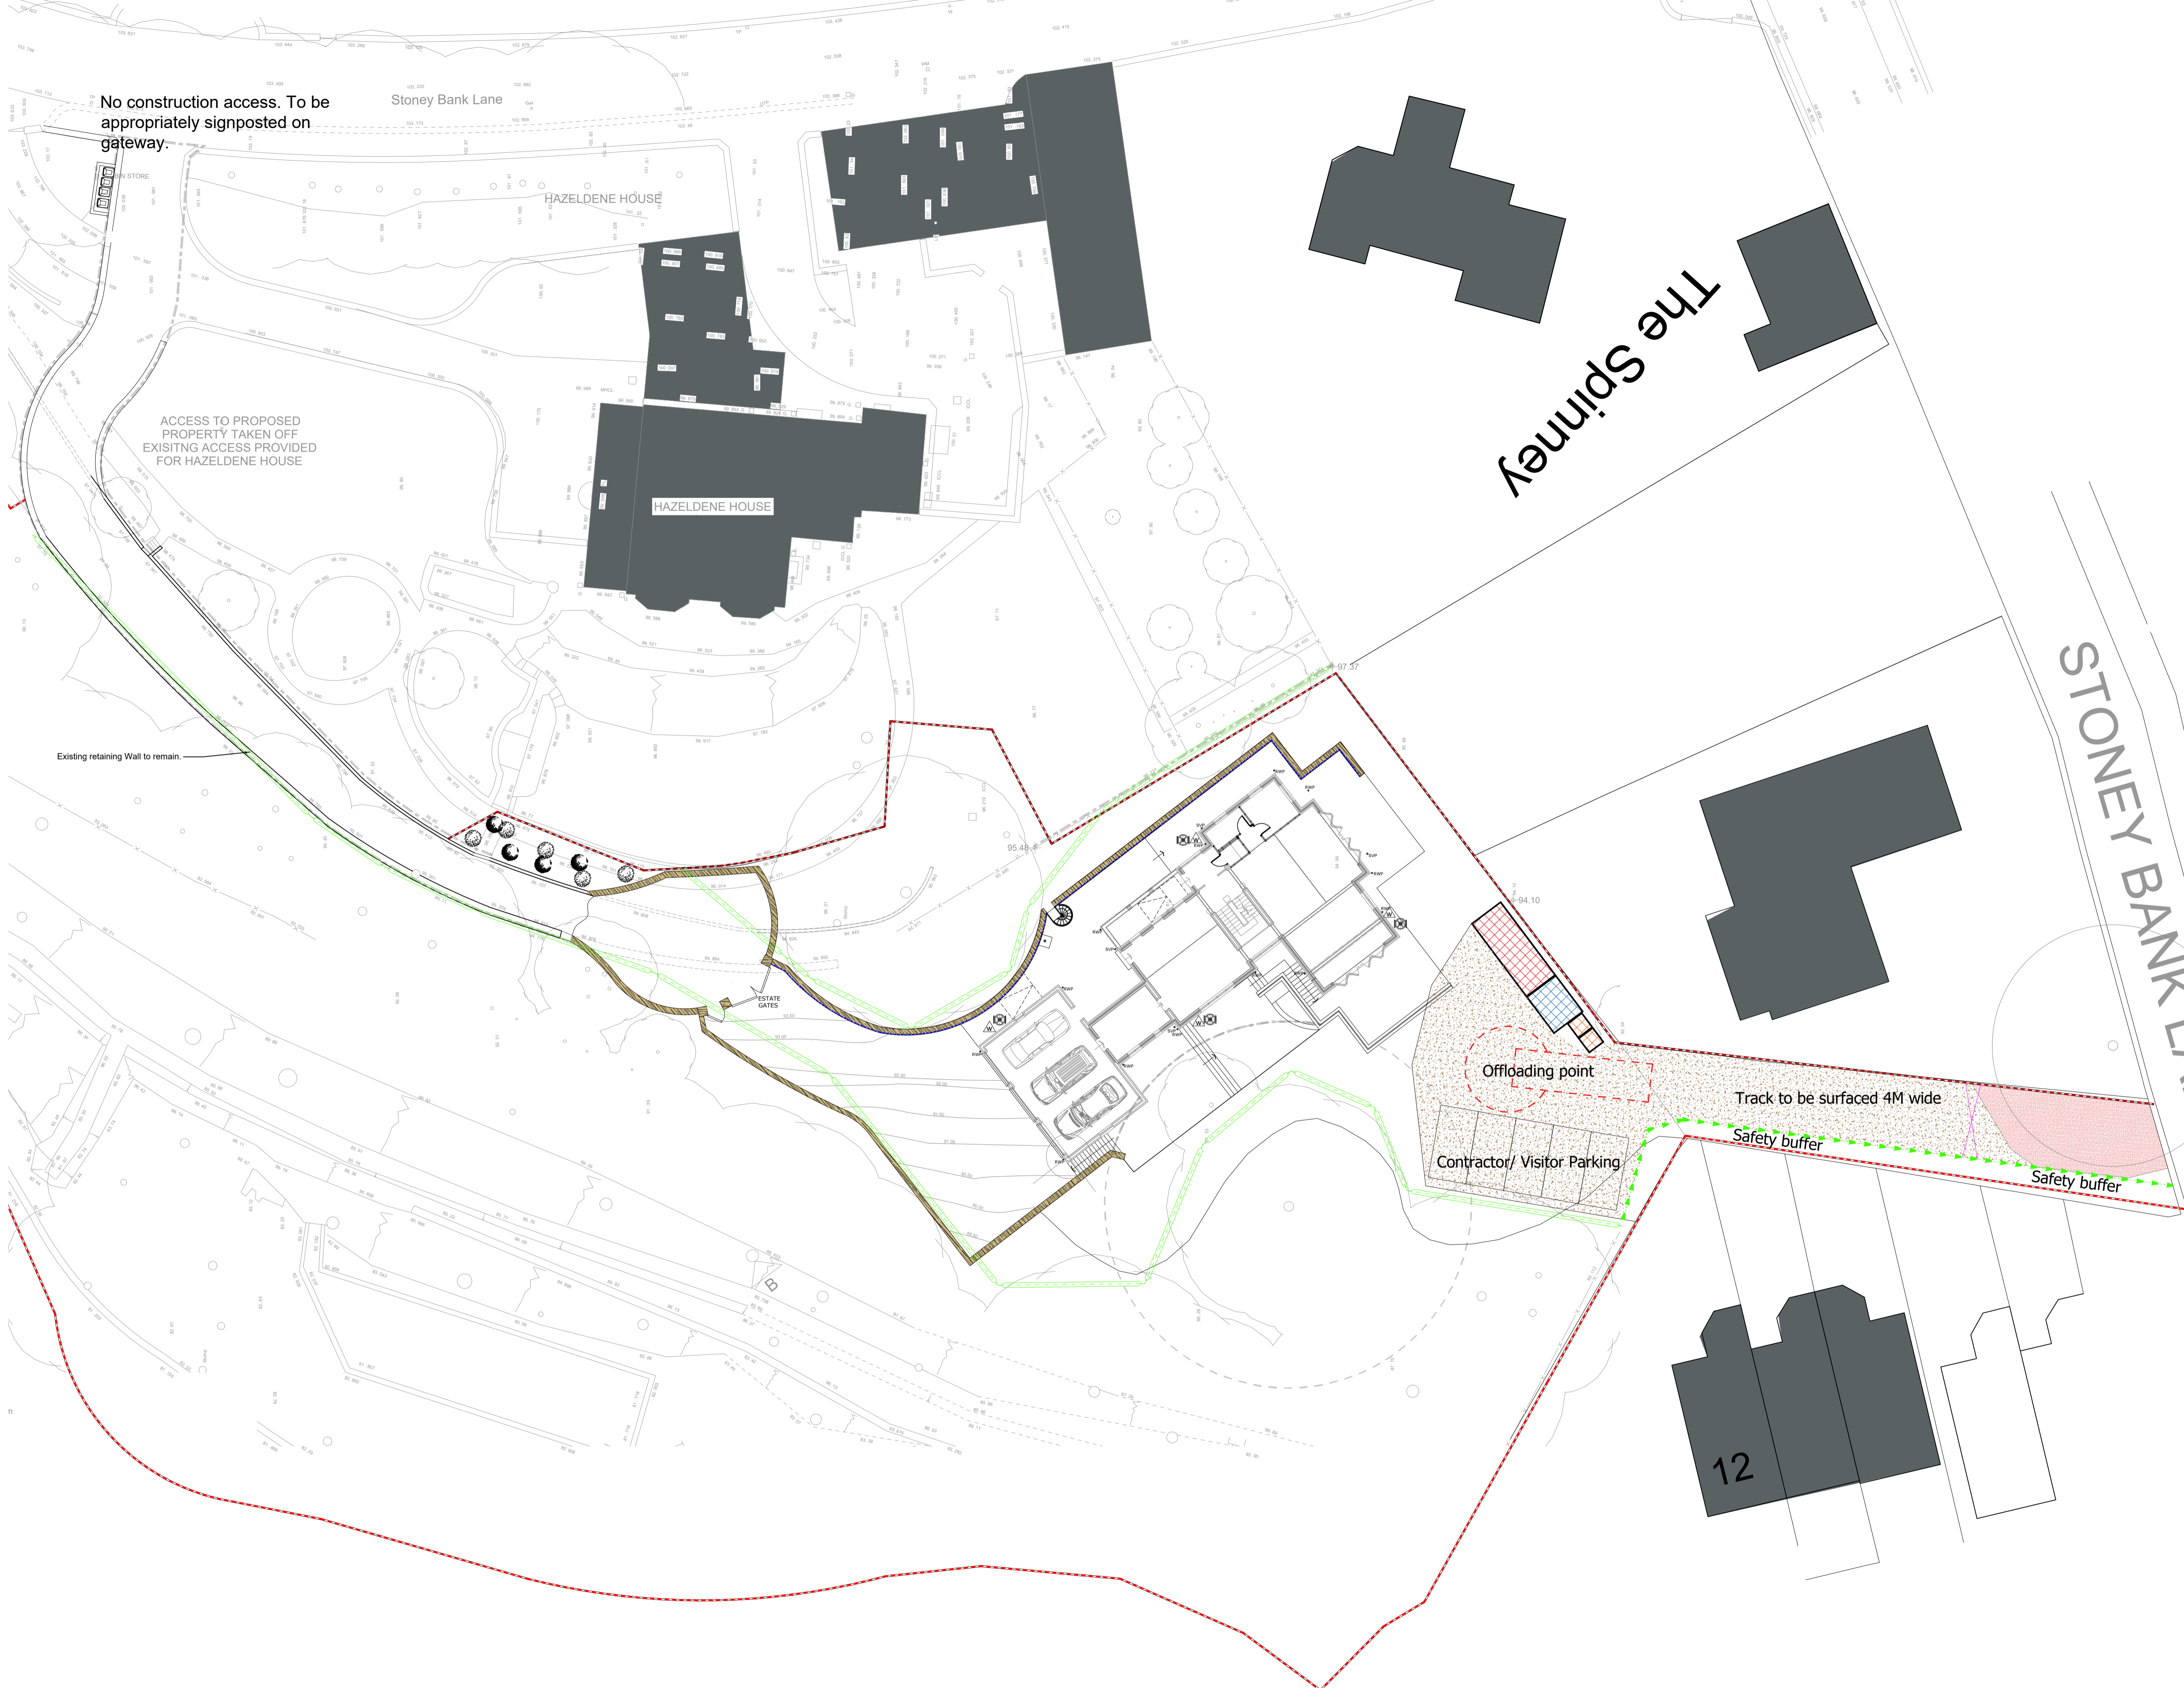
- LEGEND**
- Tree root protection barrier installed in accordance with arboricultural method statement.
 - 1m high safety fencing to delineate edge of gravel track.
 - Locking site security gates fitted with relevant safety signage for operations on site.
 - Proposed site office cabin sited on temporary support to be offloaded by HIAB.
 - Proposed site canteen/ welfare unit.
 - Portaloo.
 - Crushed gravel temporary site surfacing.
 - Crushed gravel temporary site surfacing. To be laid in accordance with tree root protection method statement using a 'no dig' solution.

Description: **PROPOSED CONSTRUCTION MANAGEMENT PLAN**

As per the attached site plan, the temporary access route runs parallel with the rear gardens of certain properties on Old Mill Lane. Indeed, it should be appreciated that the site is situated on a slope, such that the properties on Old Mill Lane are situated at a lower elevation. It would appear that during the construction of those properties, a cut and fill exercise was undertaken in to the slope, whereby the southern boundaries of these properties (i.e. rear gardens) incorporated a retaining structure. Publically available historical street view images, in addition to recent observations from Stoney Bank Lane, suggest these retaining features comprise a series of sandstone boulders, which are now predominantly covered by vegetation. The temporary access route for the development is up and beyond these retaining features. With reference to the attached site plan, it can be seen that a safety buffer has been put in place to keep the roadway away from the edge and top of the wall.

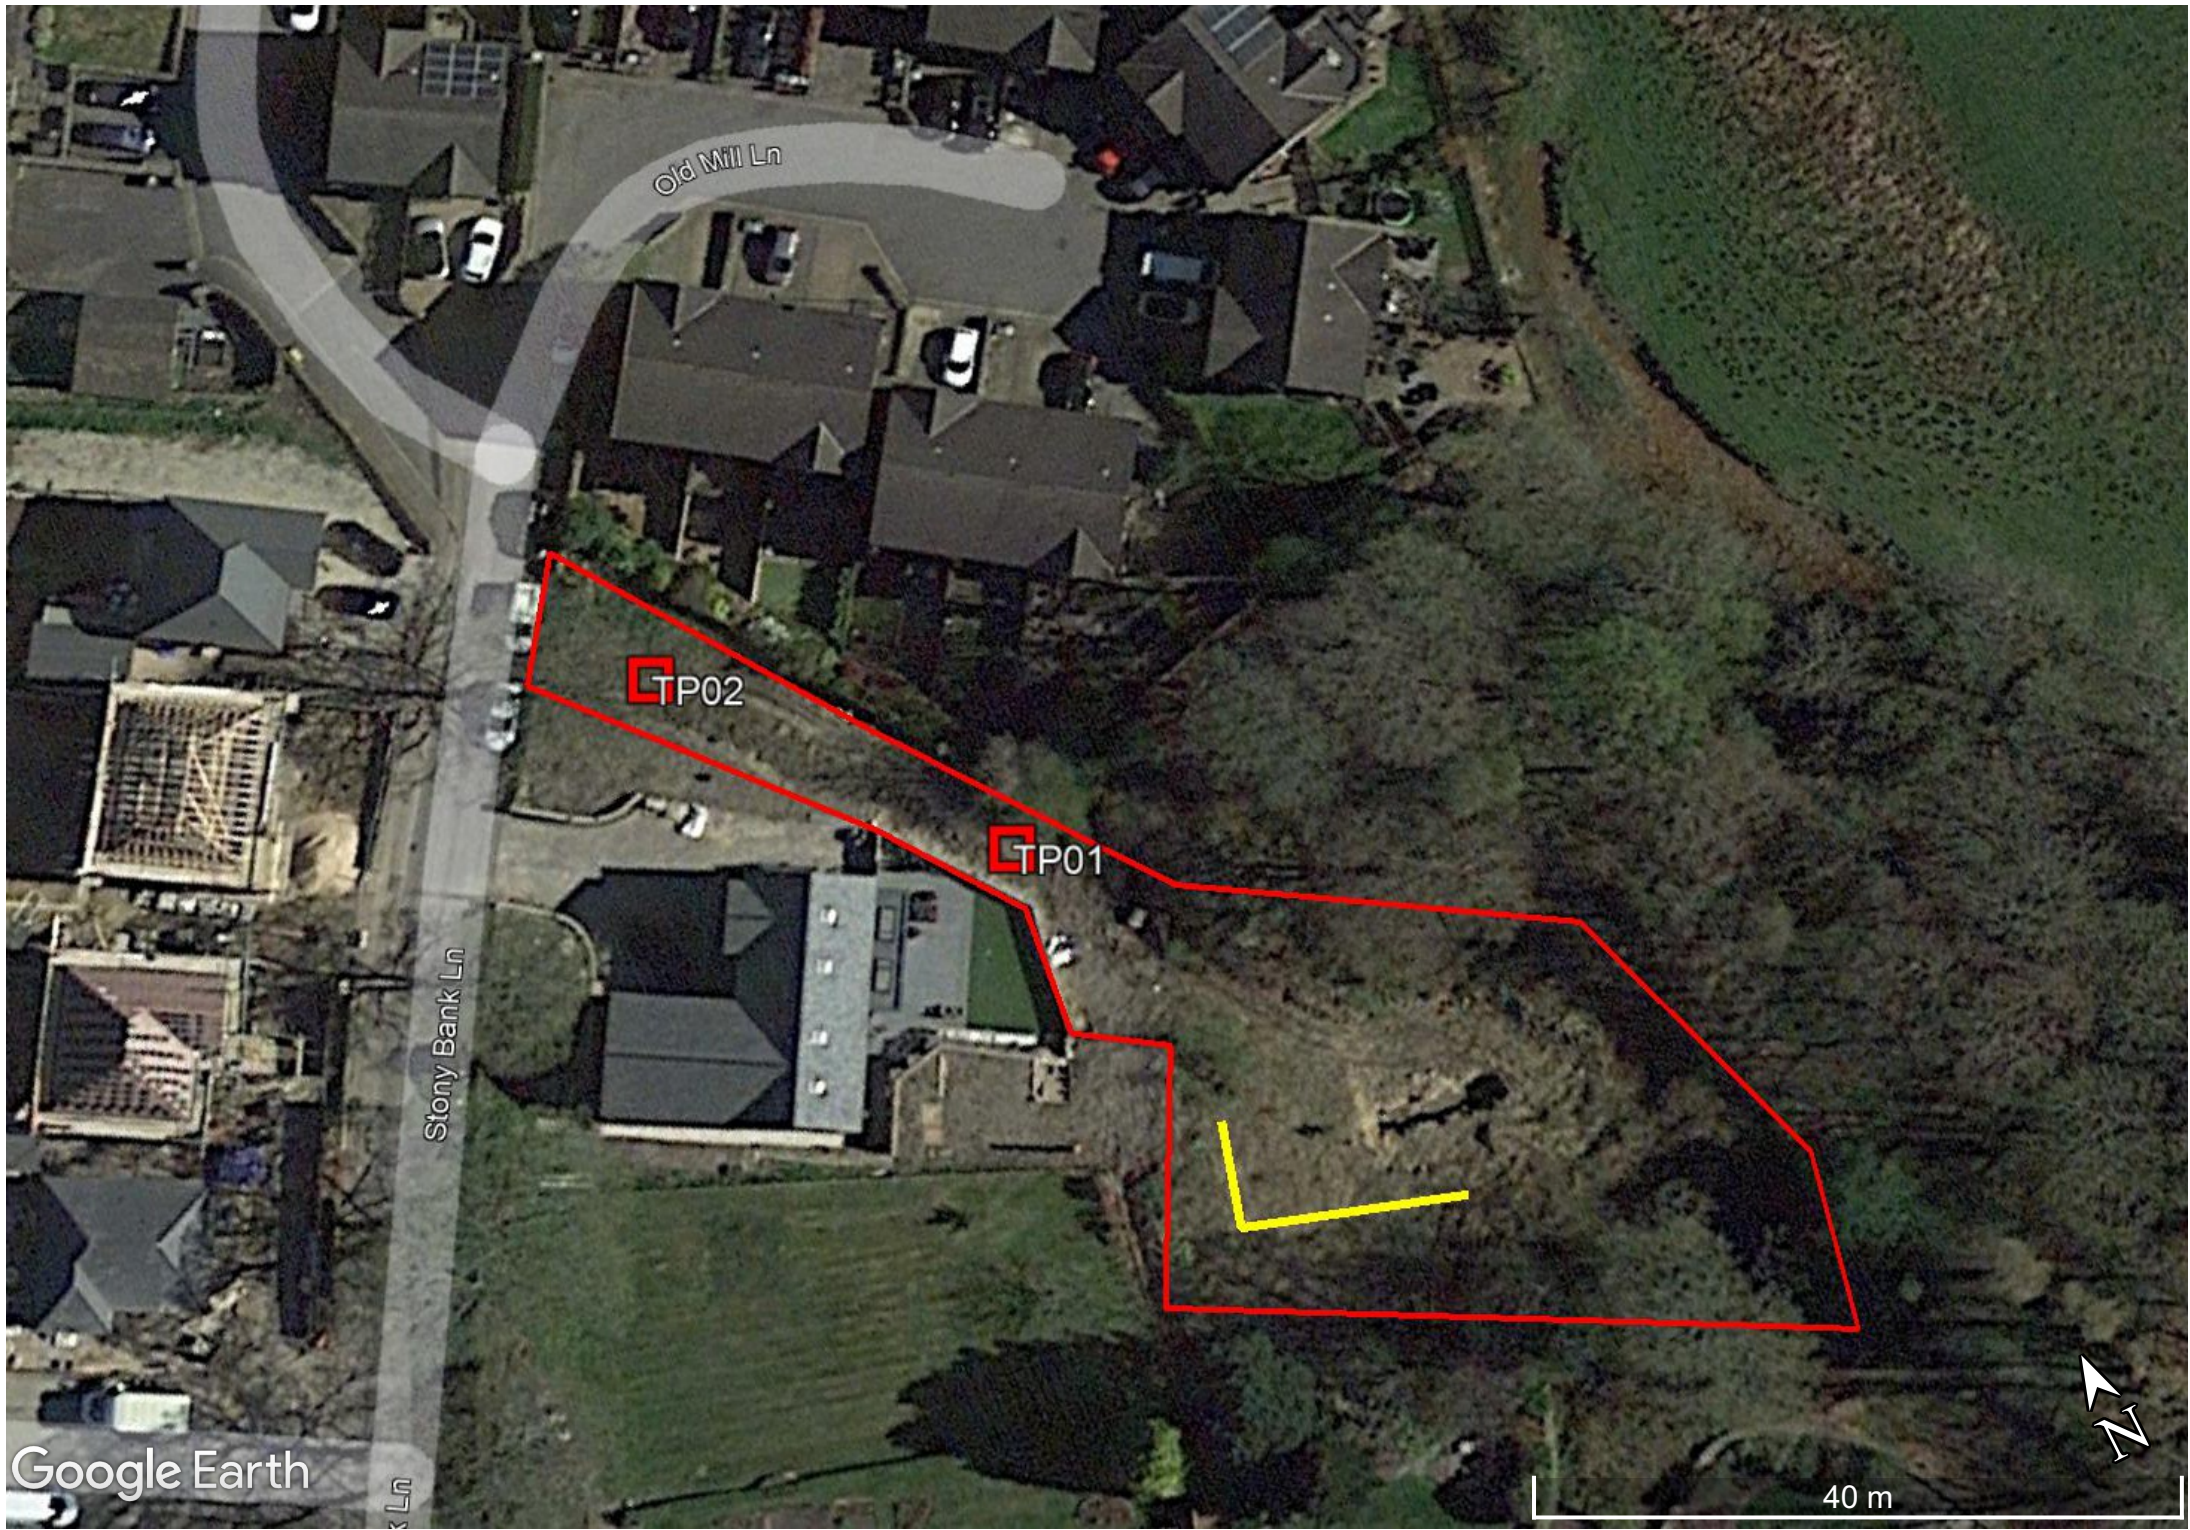
Old Mill Ln

TP02

TP01

Stony Bank Ln

A site visit was undertaken on the 1st of November 2021, whereupon trialpits were excavated on the temporary access route with a tracked excavator in order to reveal the nature of the near surface soils; approximate positions are annotated on the attached plan. Suitable samples were sealed and returned to the laboratory for logging and subsequent testing. The soils were described in general accordance with BS5930: 2015+A1: 2020, and full descriptions are given on the trialpit records which are appended to this letter. However, to summarise, beneath the capping of concrete and sub-base, sub-angular and tabular gravels, cobbles and boulders of medium- to coarse-grained sandstone were revealed to be present in a silty, very sandy matrix.

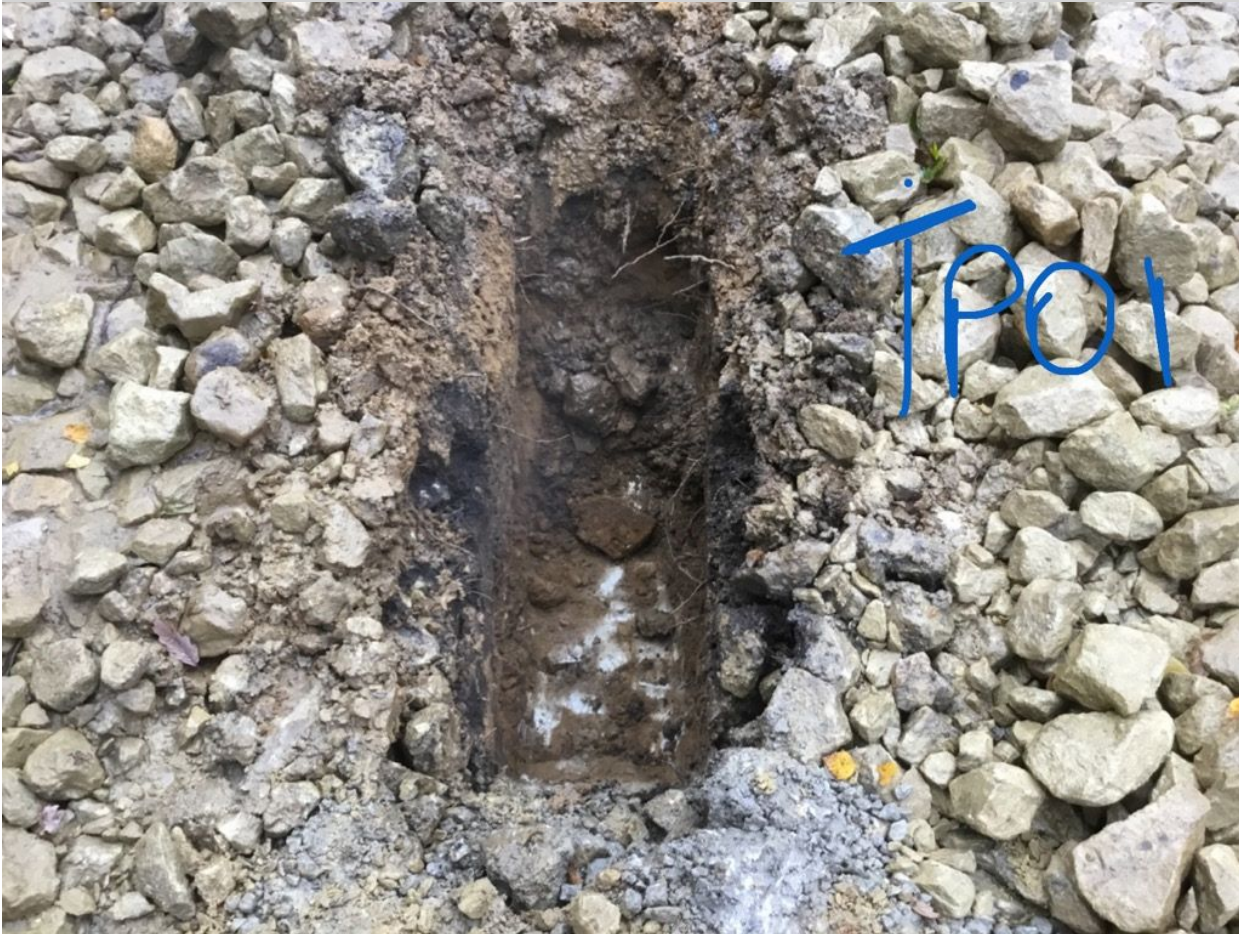
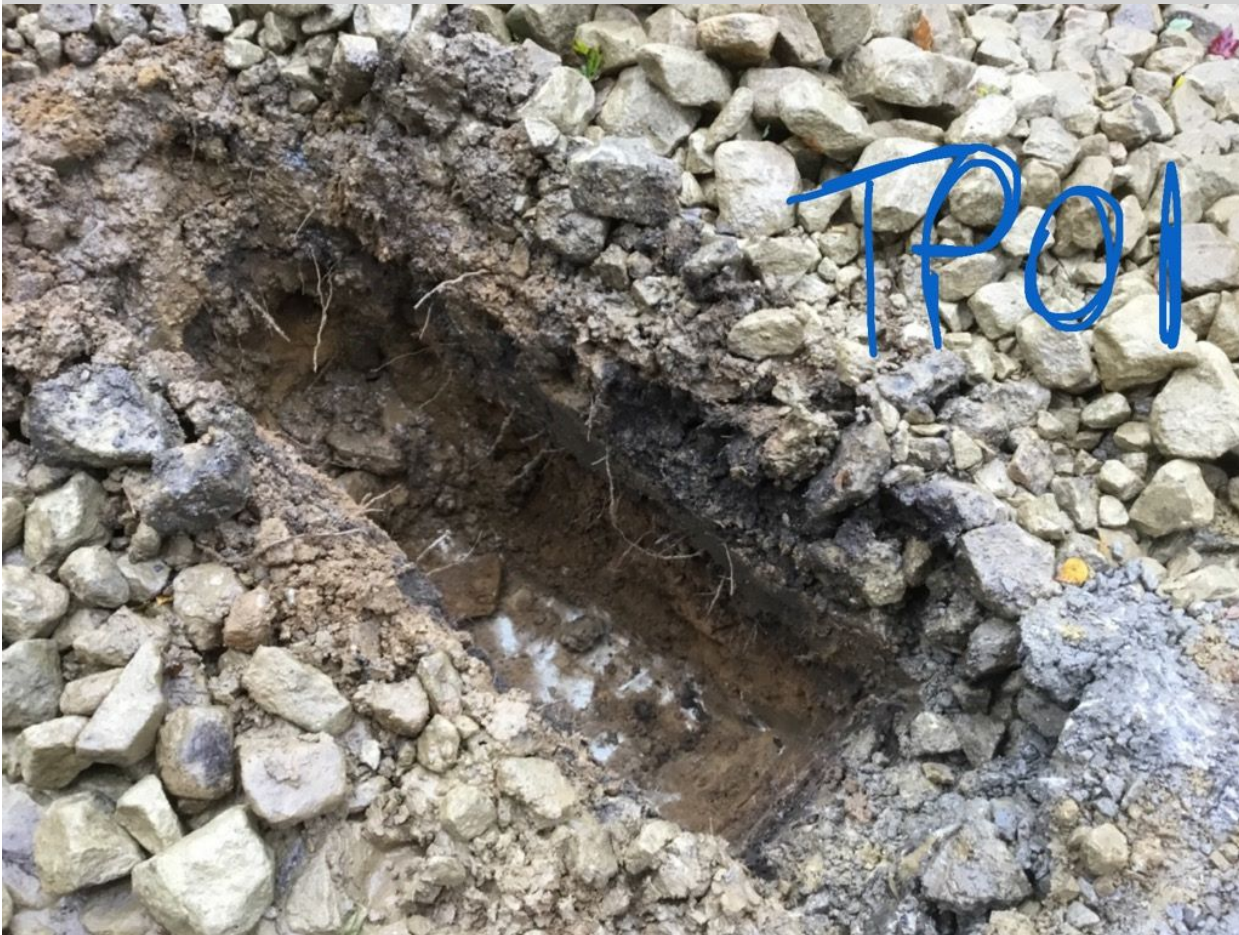
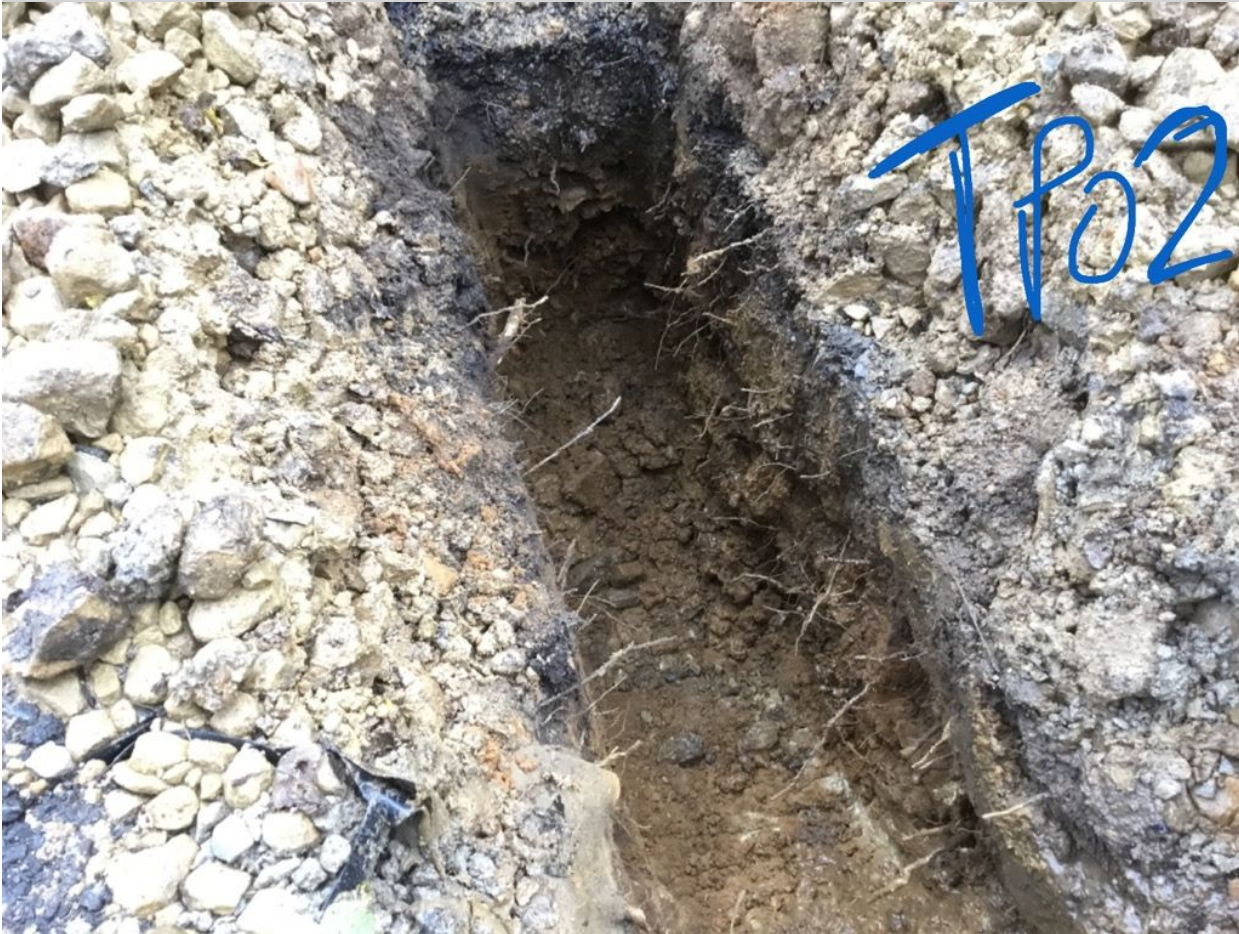
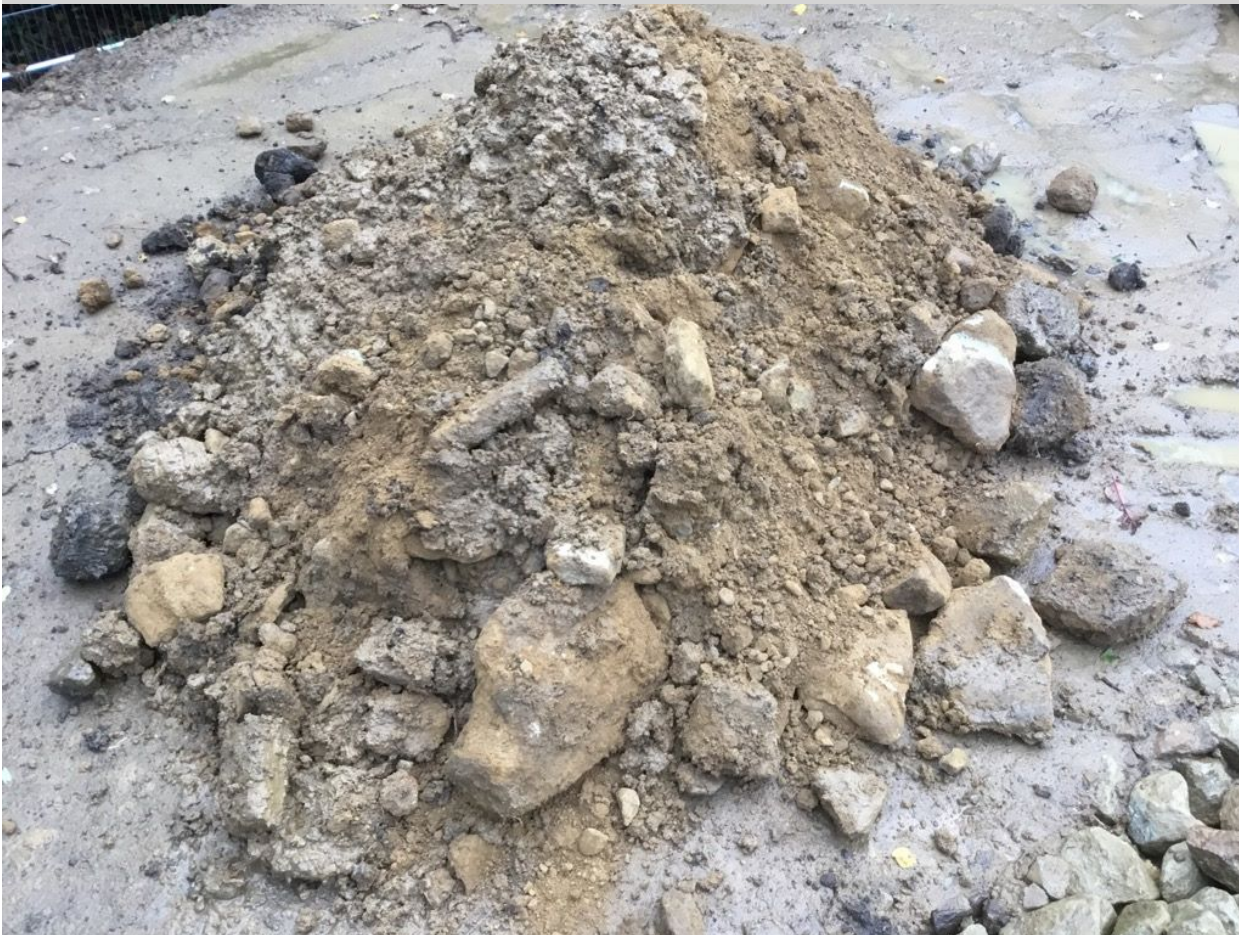
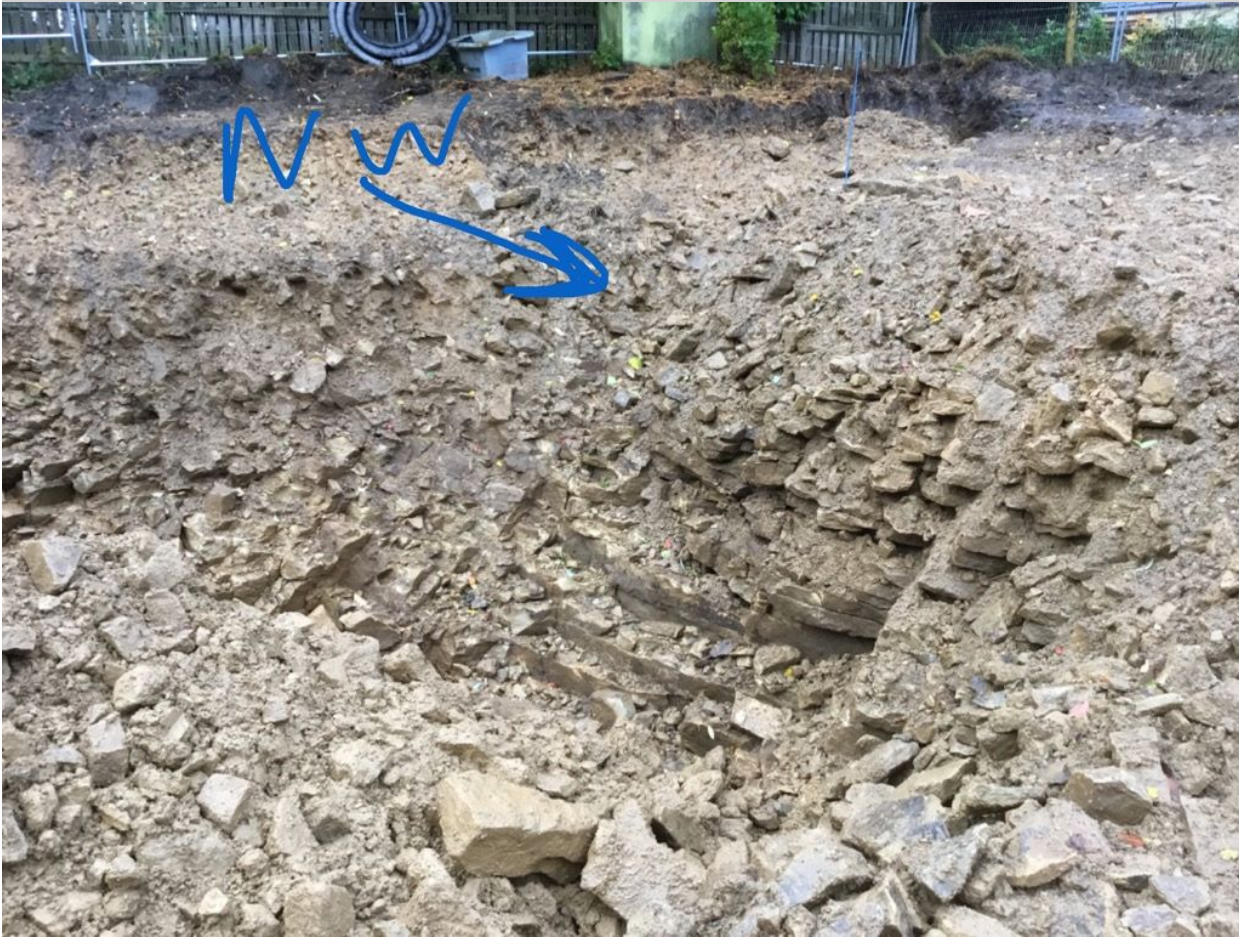
It should be noted that upon arriving at the site, a large excavation had been undertaken to the south (rear) of the site. Whilst positioned slightly away from the access route, the excavation presented an opportunity to analyse a cross-section and vertical face of the sandstone (Rough Rock) which is now known to underlie the site. Whilst it was not possible to enter the excavation at the time of the site visit, it was evident that the rock was generally dipping at shallow angles of between 5° and 10° to the north/north-west. Moreover, it was evident that there was a limited thickness of the weathered fraction above the rock. As such, it is fair to consider that the top of the rock head caused refusal within the trialpits; refusal at 0.85m in TP01 and at 1.05m in TP02.

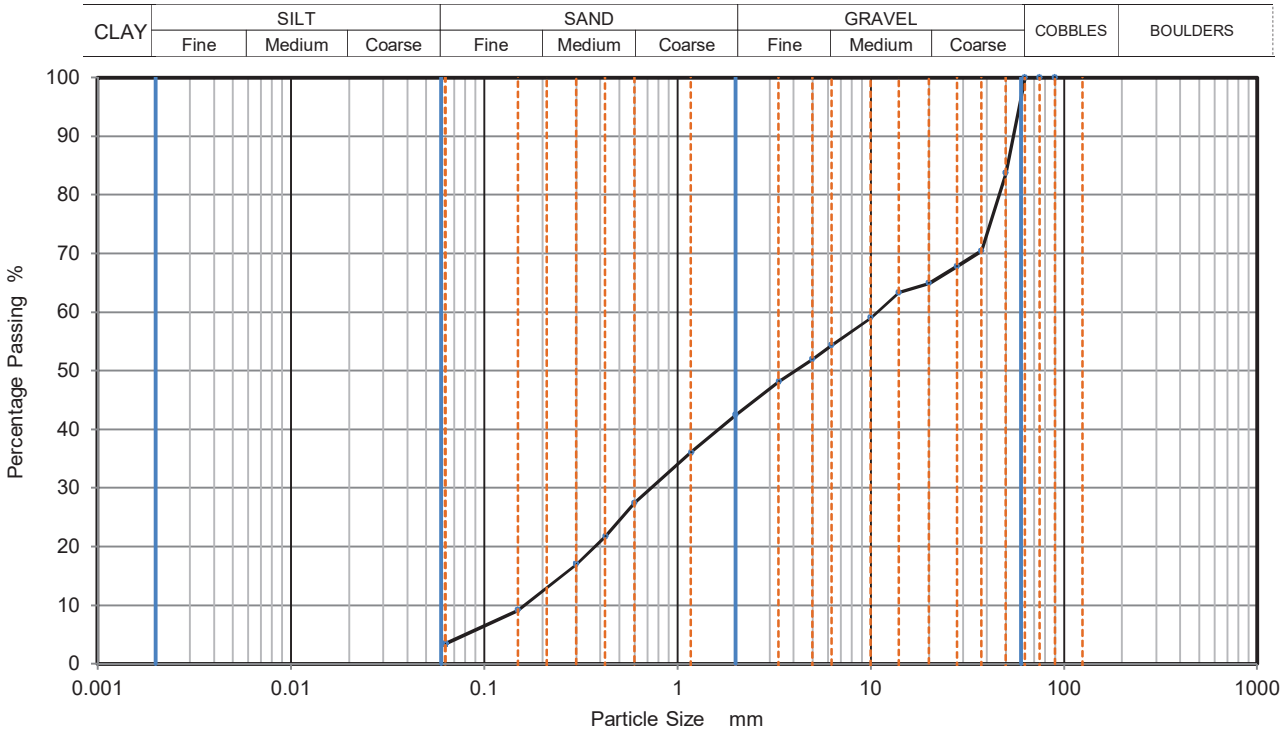
Job Ref	C2187/21/E/3364
Borehole/Pit No.	TP01

Site Name	Land off Stoney Bank	Sample No.	1	
Soil Description	Brown silty very sandy GRAVEL. Low cobble content.	Depth, m	0.40	
Specimen Reference	D1	Specimen Depth	0.4 - 0.8 m	
Test Method	ISO 17892 -4, by sieving on pre-dried or dry sample		KeyLAB ID	RGS_202111030

Sieving		Sedimentation	
Particle Size mm	% Passing	Particle Size mm	% Passing
	100		
90	100		
75	100		
63	100		
50	84		
37.5	70		
28	68		
20	65		
14	63		
10	59		
6.3	54		
5	52		
3.35	48		
2	42		
1.18	36		
0.6	27		
0.425	22		
0.3	17		
0.15	9		
0.063	3

Dry Mass of sample, g	7140
Sample Proportions	% dry mass
Very coarse	0
Gravel	58
Sand	39
Fines <0.063mm	3
Grading Analysis	
D ₁₀₀ mm	63
D ₆₀ mm	10.8
D ₃₀ mm	0.735
D ₁₀ mm	0.162
Uniformity Coefficient	67
Curvature Coefficient	0.31

In order to classify the material overlying the rockhead, a particle size distribution (dry sieve) was undertaken on the finer fraction of the material (gravels, sands and silts). The test result sheets are appended to this letter.
