AMA Designer's Response

Proposed Residential Development – Westgate, Cleckheaton

Proposed Housing Development
A643 Westgate Cleckheaton

Road Safety Audit: Stage 1-S278 and S38

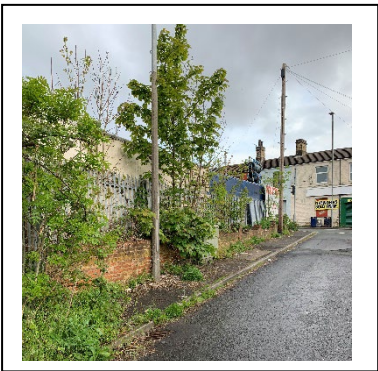
PROBLEM		1-1
Location:	Quarry Road and Iron Street.	
Summary:	A lack of suitable pedestrian footways, poor carriageway condition and pedestrian barrier will increase the risk of pedestrian/vehicle and cycle vehicle collisions.	
<p>The drawings provided show that a new pedestrian link will be provided between the development and Quarry Road. Currently there is only a short section of heavily overgrown footway available and is shown in the photograph below.</p>

<p>The development will increase the number of pedestrians on Quarry Road and as such will also increase the risk of pedestrian/vehicle collisions.</p> <p>The Audit Team were also concerned that cyclists may also use this route and especially children. Without suitable street furniture cyclists could ride straight out onto Quarry Road increasing the risk of cycle/vehicle collisions.</p> <p>In addition, a new pedestrian link will also be provided from the site onto Brick Street. No footways are proposed and therefore pedestrians will be required to walk across an area of uneven ground and within the carriageway.</p> <p>The development will increase pedestrian usage of Brick Street and therefore will also increase the risk of pedestrian trips and falls.</p>

Ensure that the existing short section of footway along the side of Quarry Road which is overgrown and in a poor condition is made safe for pedestrians. Also, consider the need for some form of barrier to slow cyclists and prevent them from riding directly onto Quarry Road.

Pedestrian routes connections to Brick Street and Quarry Road will be added at detailed design.

RECOMMENDATION		
<p>Ensure that the existing short section of footway along the side of Quarry Road which is overgrown and in a poor condition is made safe for pedestrians. Also, consider the need for some form of barrier to slow cyclists and prevent them from riding directly onto Quarry Road.</p> <p>It will be necessary to provide footways for pedestrians exiting the site onto Brick Street. If pedestrians are expected to walk in the road, then the developer needs to consider remedial action that will make the existing uneven carriageway into a safe environment for pedestrians to use.</p>

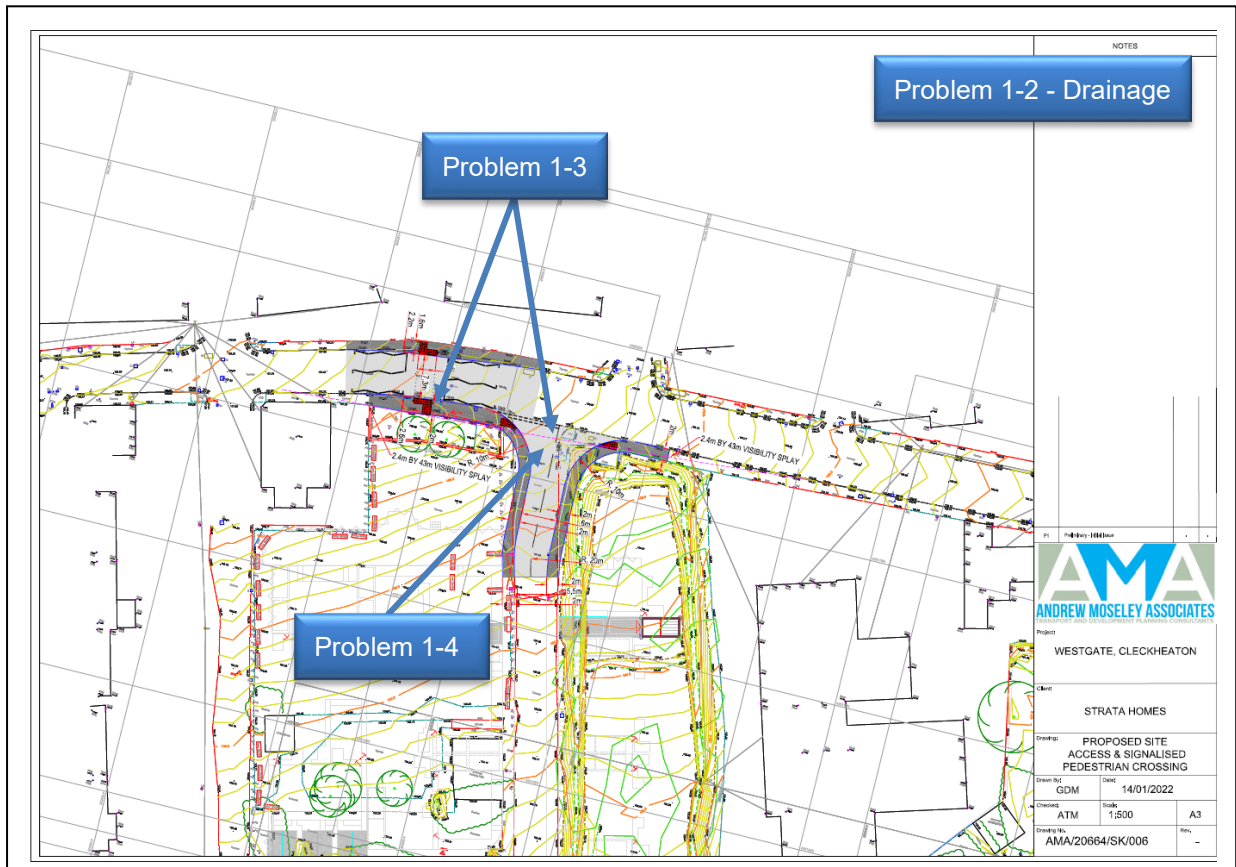
Appendix 2 – Problem Location Plan

This section details the findings of this Stage 1 Road Safety Audit. All locations of identified problems are illustrated on the plan included at **Appendix 2**.

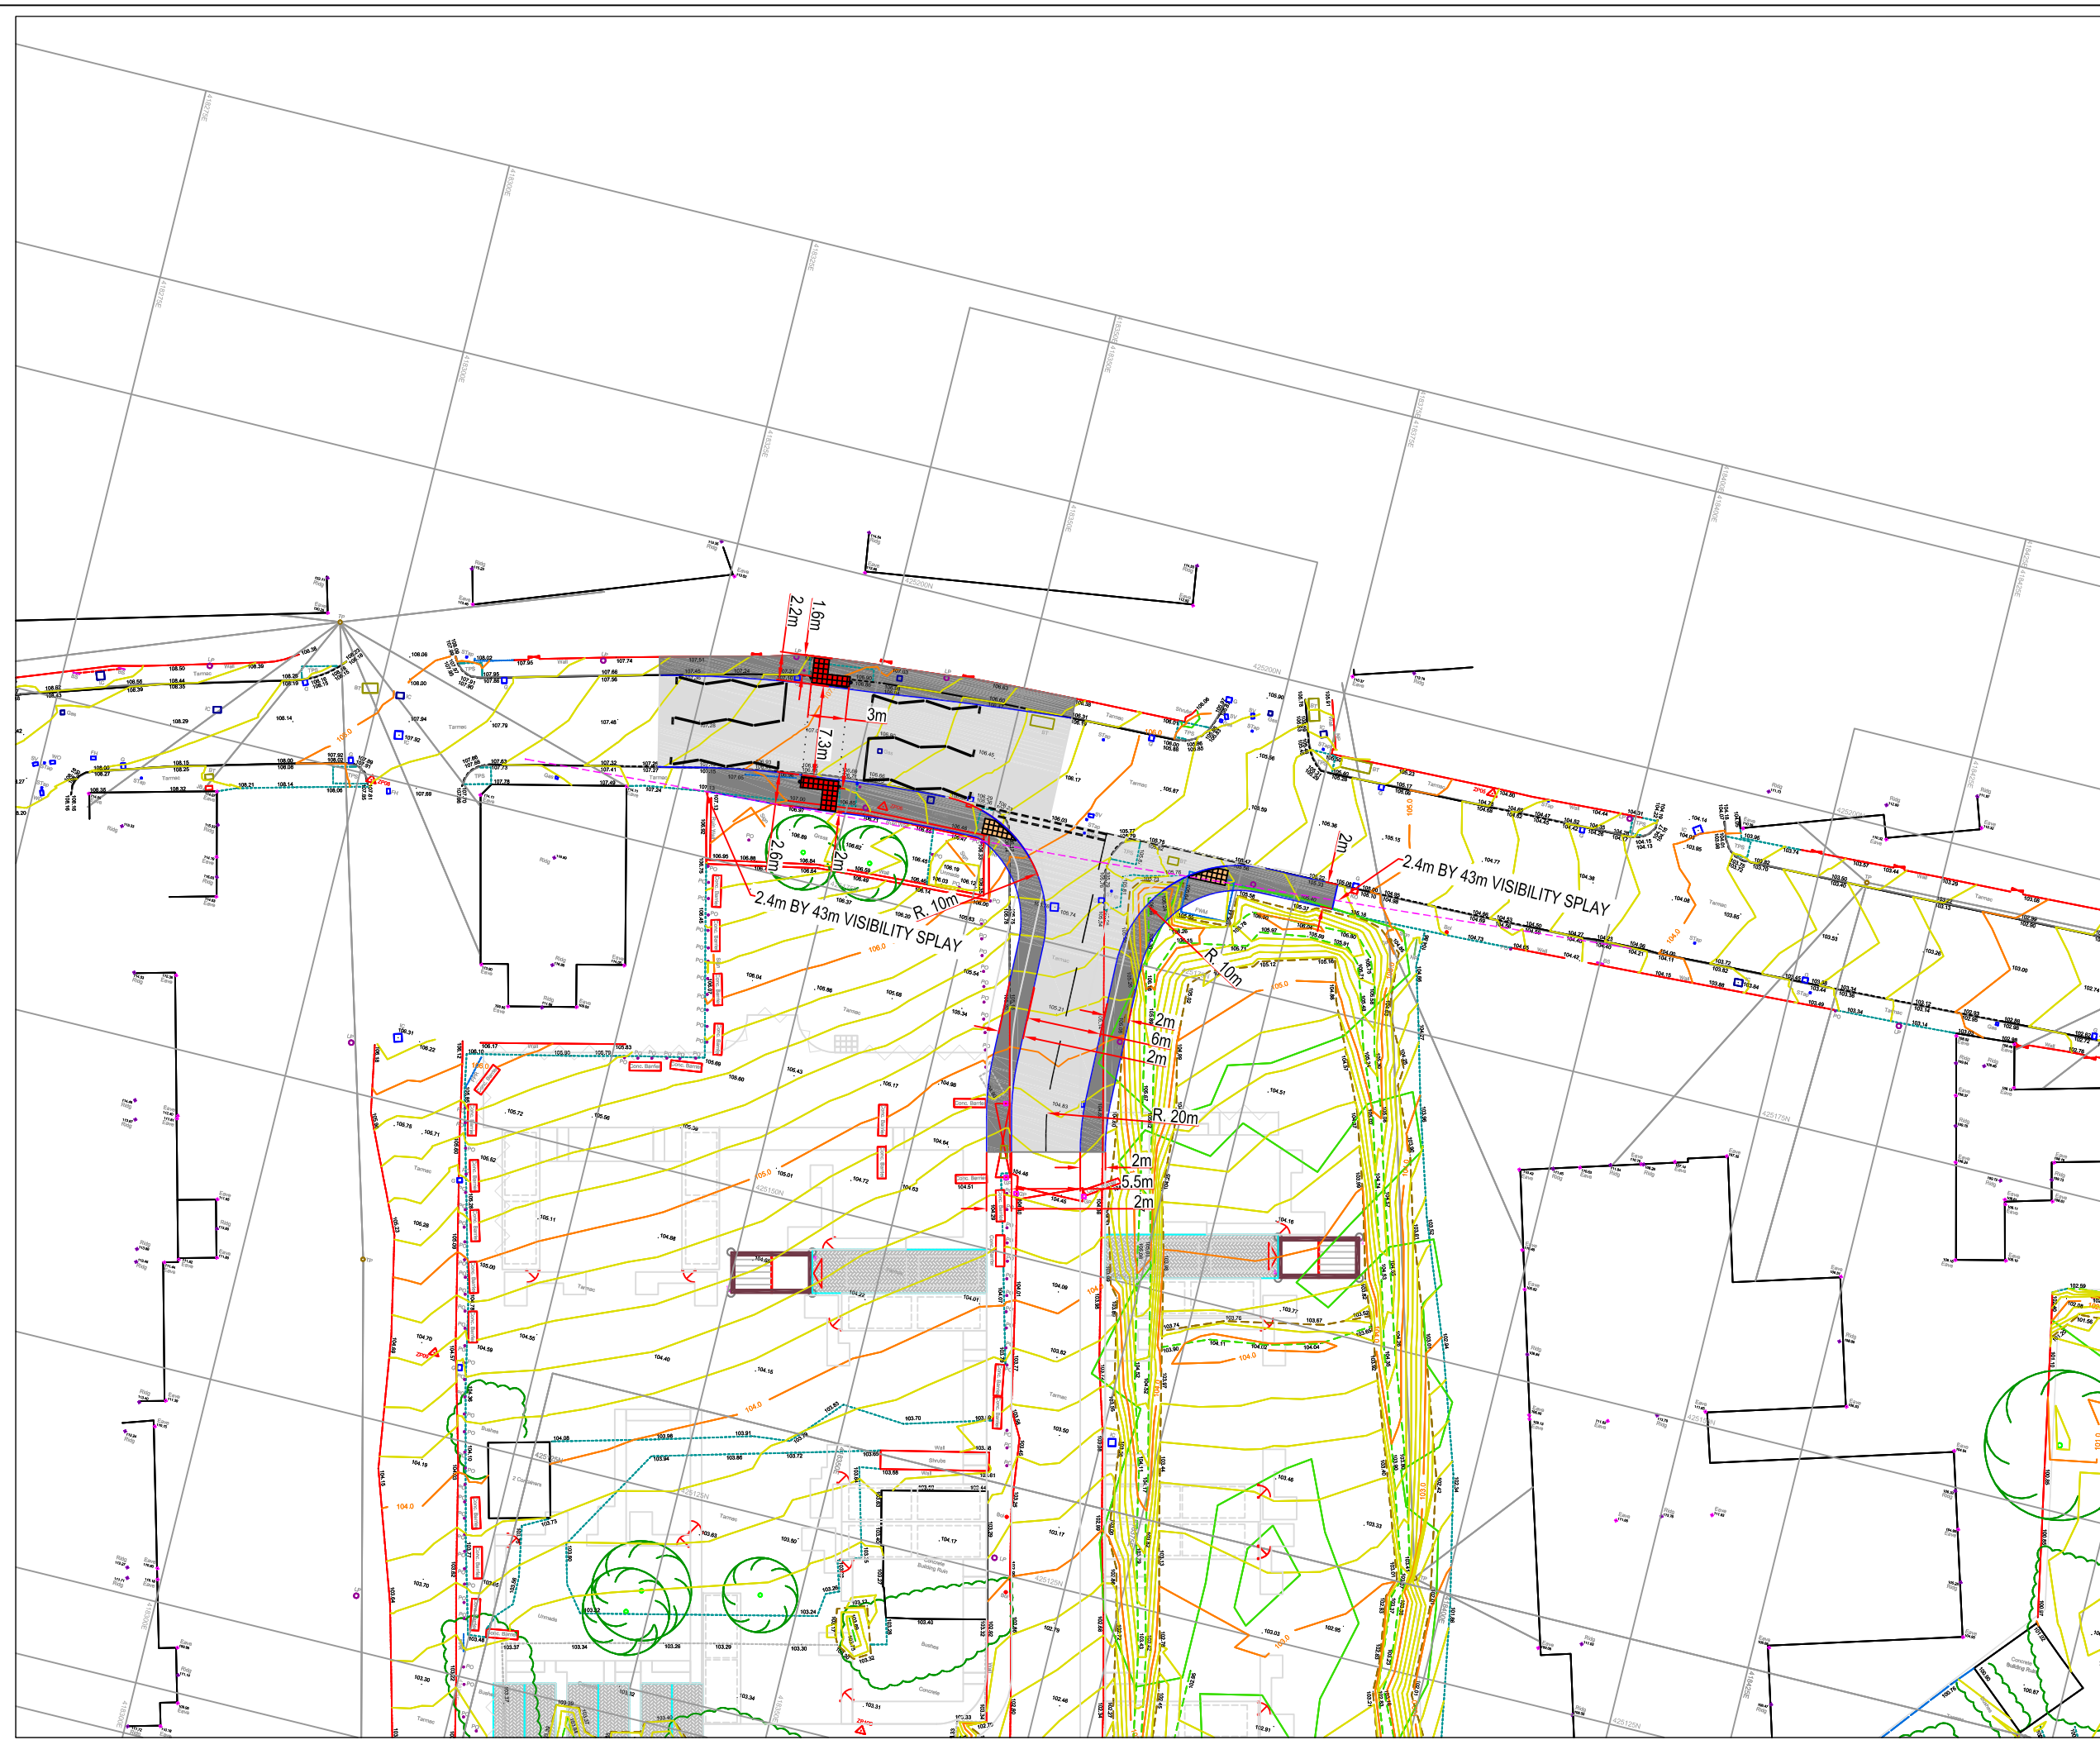
The uncontrolled access crossing and the signal controlled pedestrian crossing to the west of the application site have been updated to comply with DfT standards. Details of the pedestrian crossings are provided in SK006, attached at **Appendix B**.

Provide buff coloured tactile at uncontrolled crossings and provide tactile paving layouts that meet the required standard at controlled crossings.

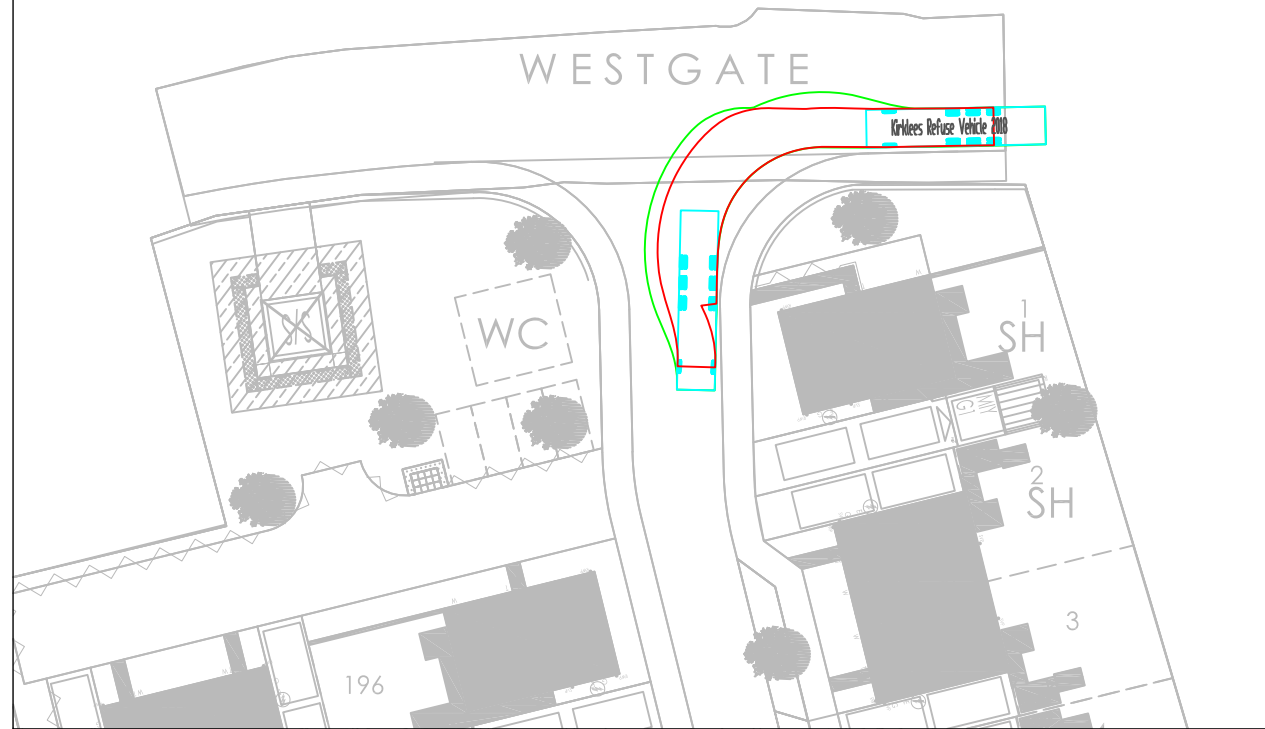
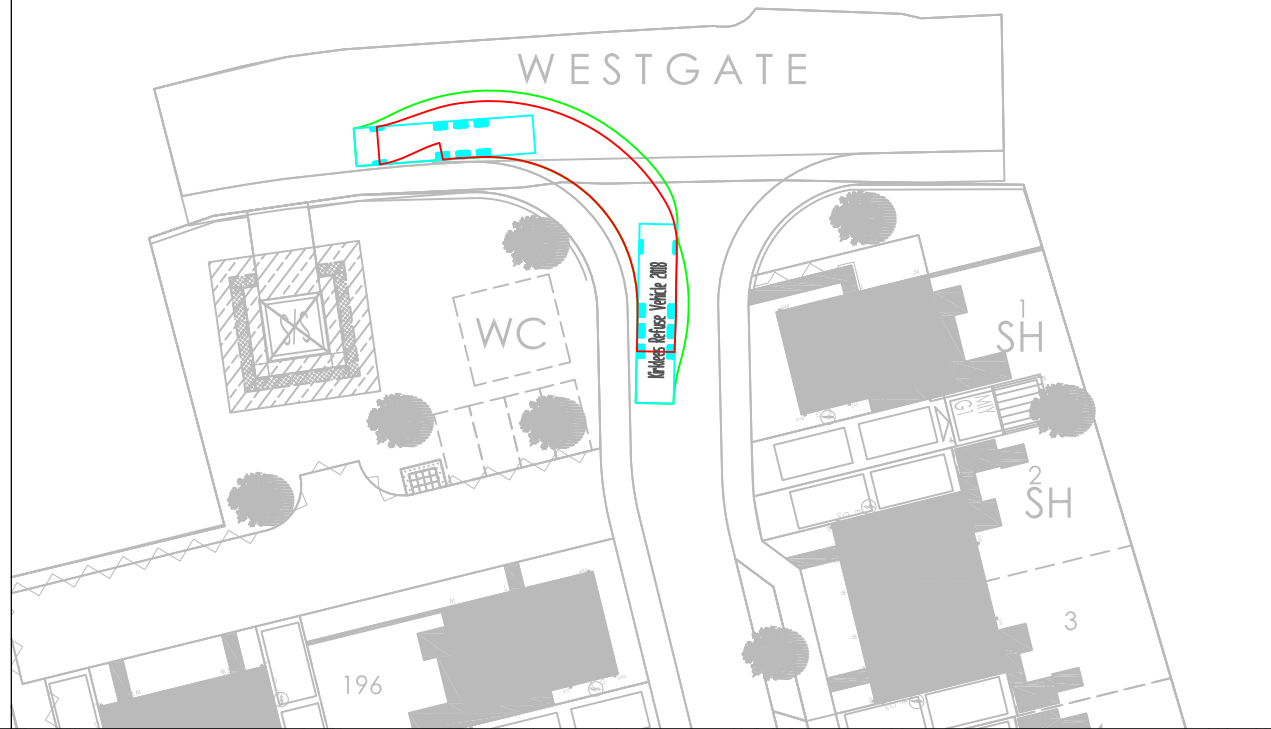
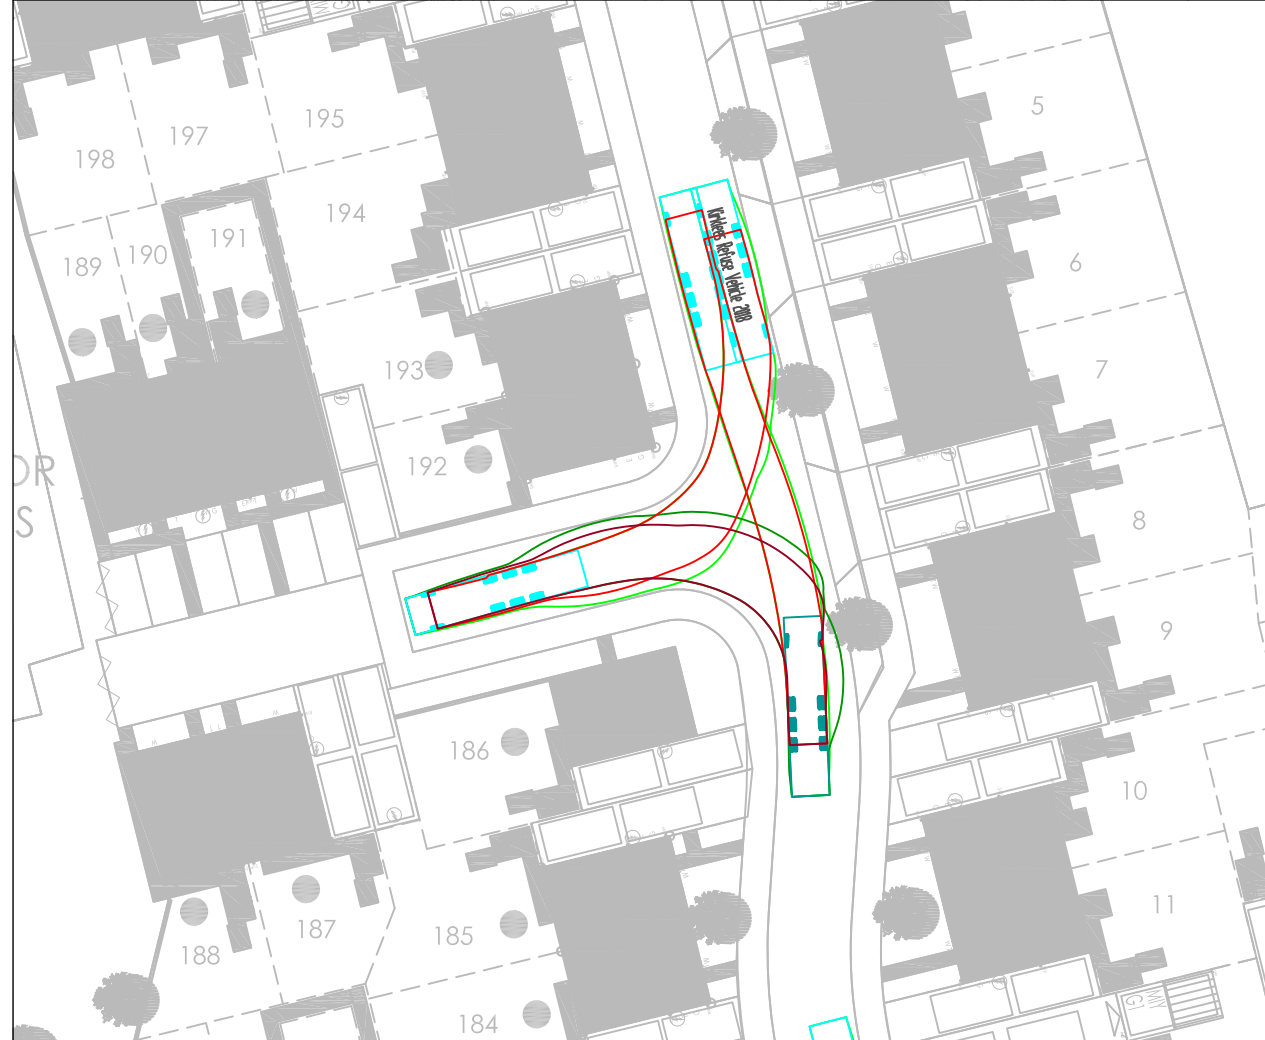
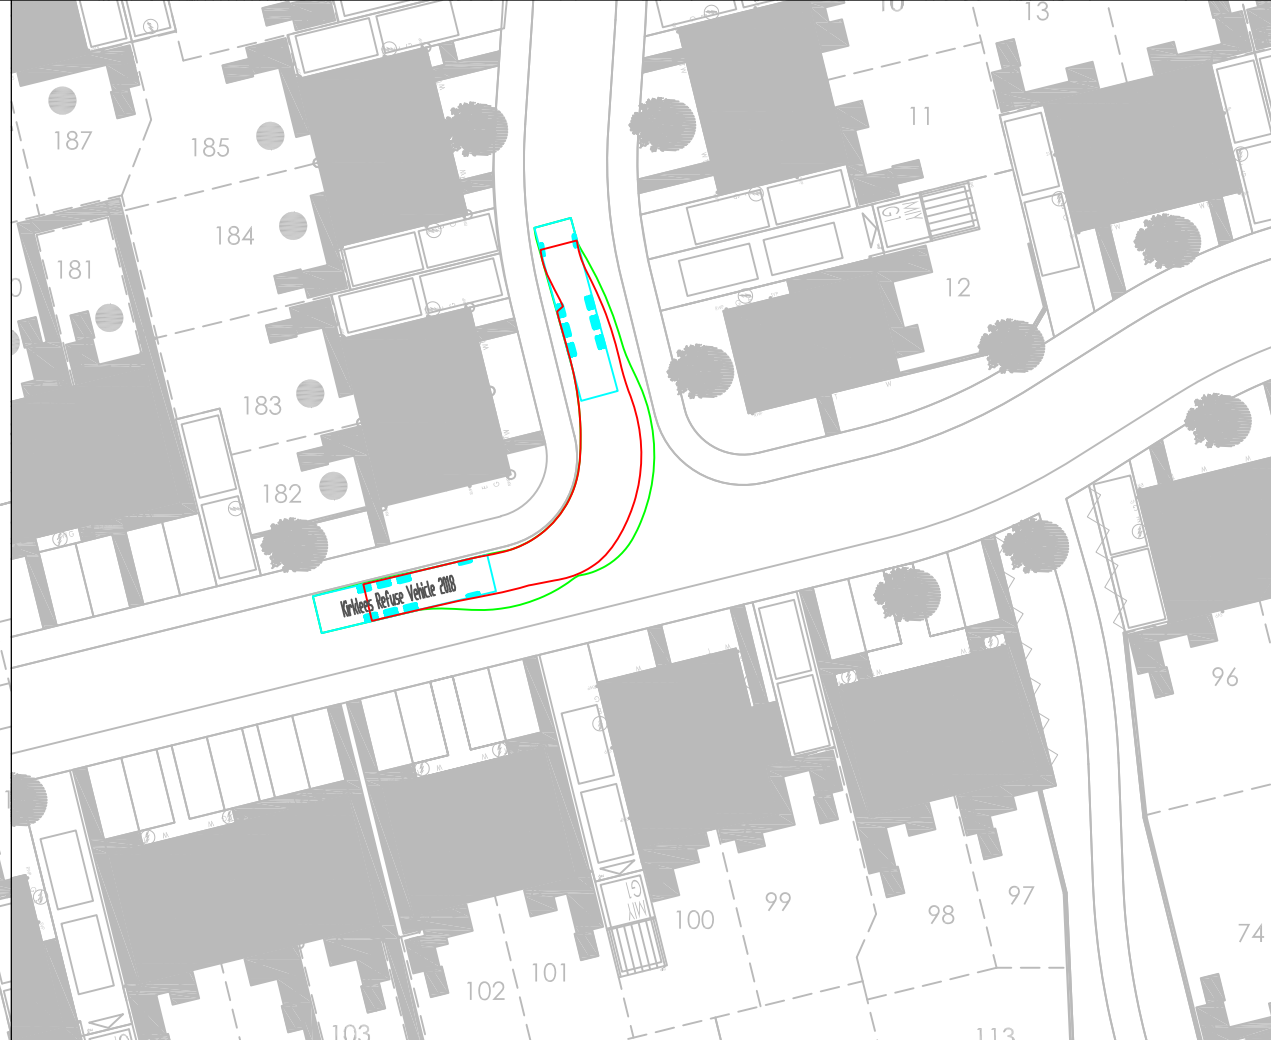
Drawing No. AMA/20664/ATR/006.1 Rev. -

Swept Path Analysis of a 'Kirklees Refuse Vehicle 2018' has been tracked around the proposed access and internal layout to ensure that the road layout is safe and functional. Details of the swept path analysis is provided in **Appendix C** to this Designers Response.

Kirklees Refuse Vehicle 2018	11.850m
Overall Length	2.500m
Overall Width	3.749m
Overall Body Height	0.302m
Min Body Ground Clearance	2.490m
Track Width	5.00s
Lock to lock time	11.000m
Wall to Wall Turning Radius

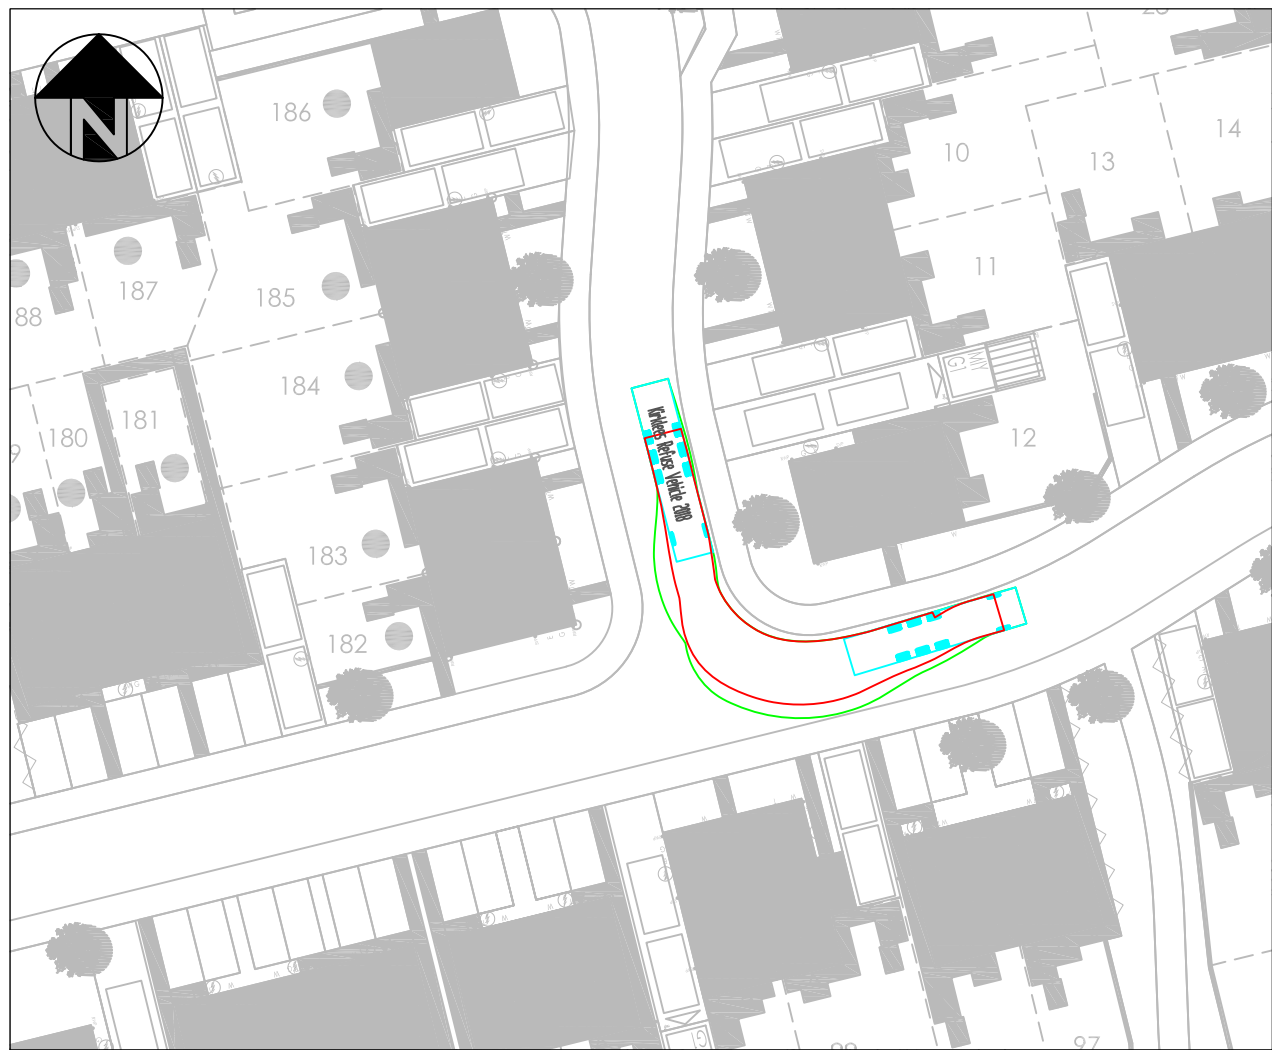
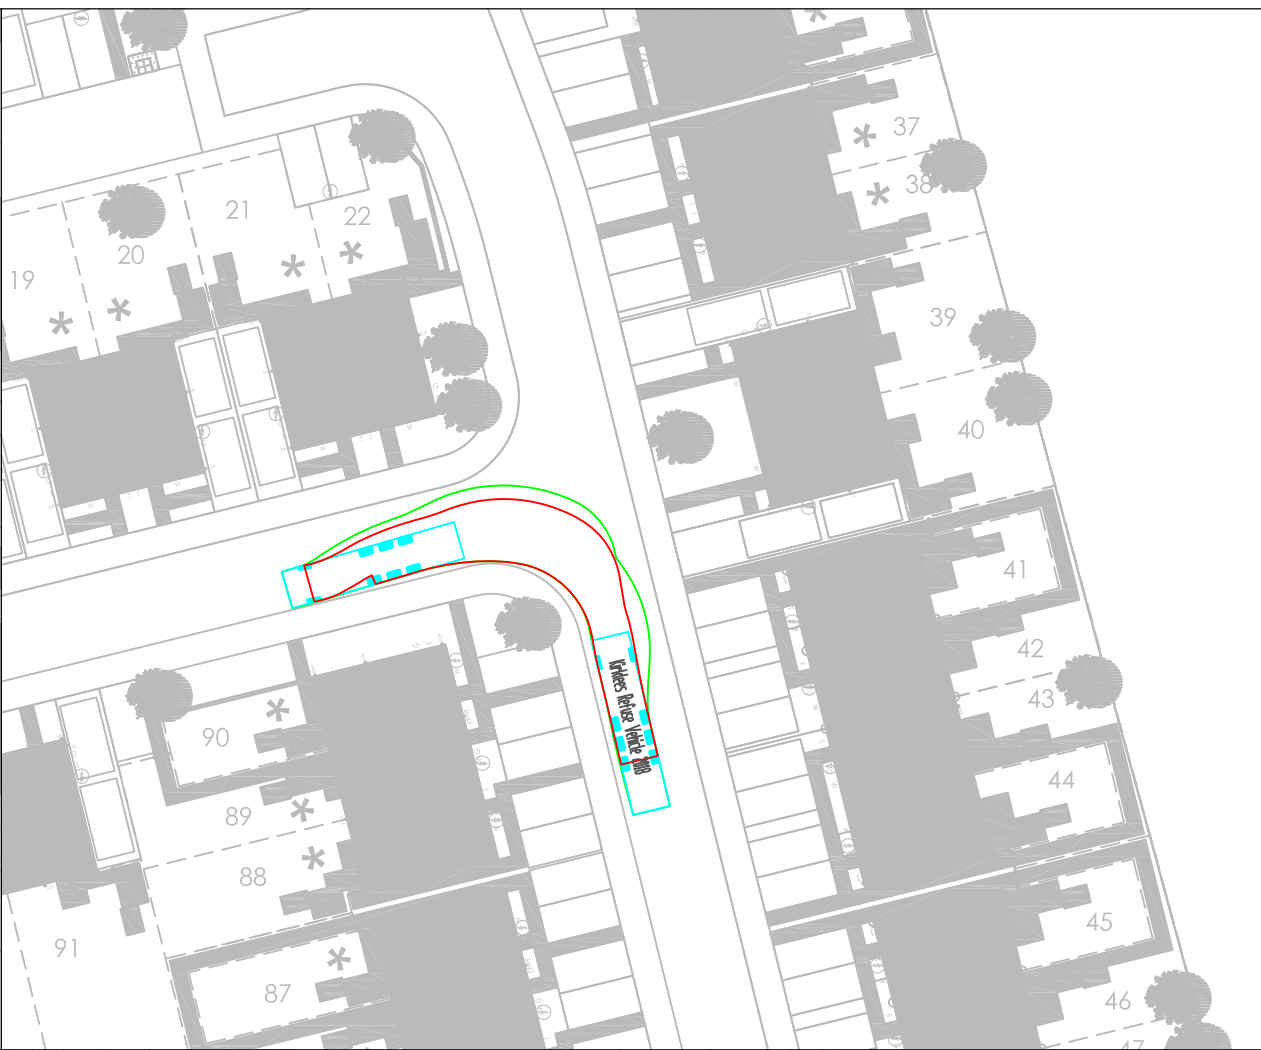
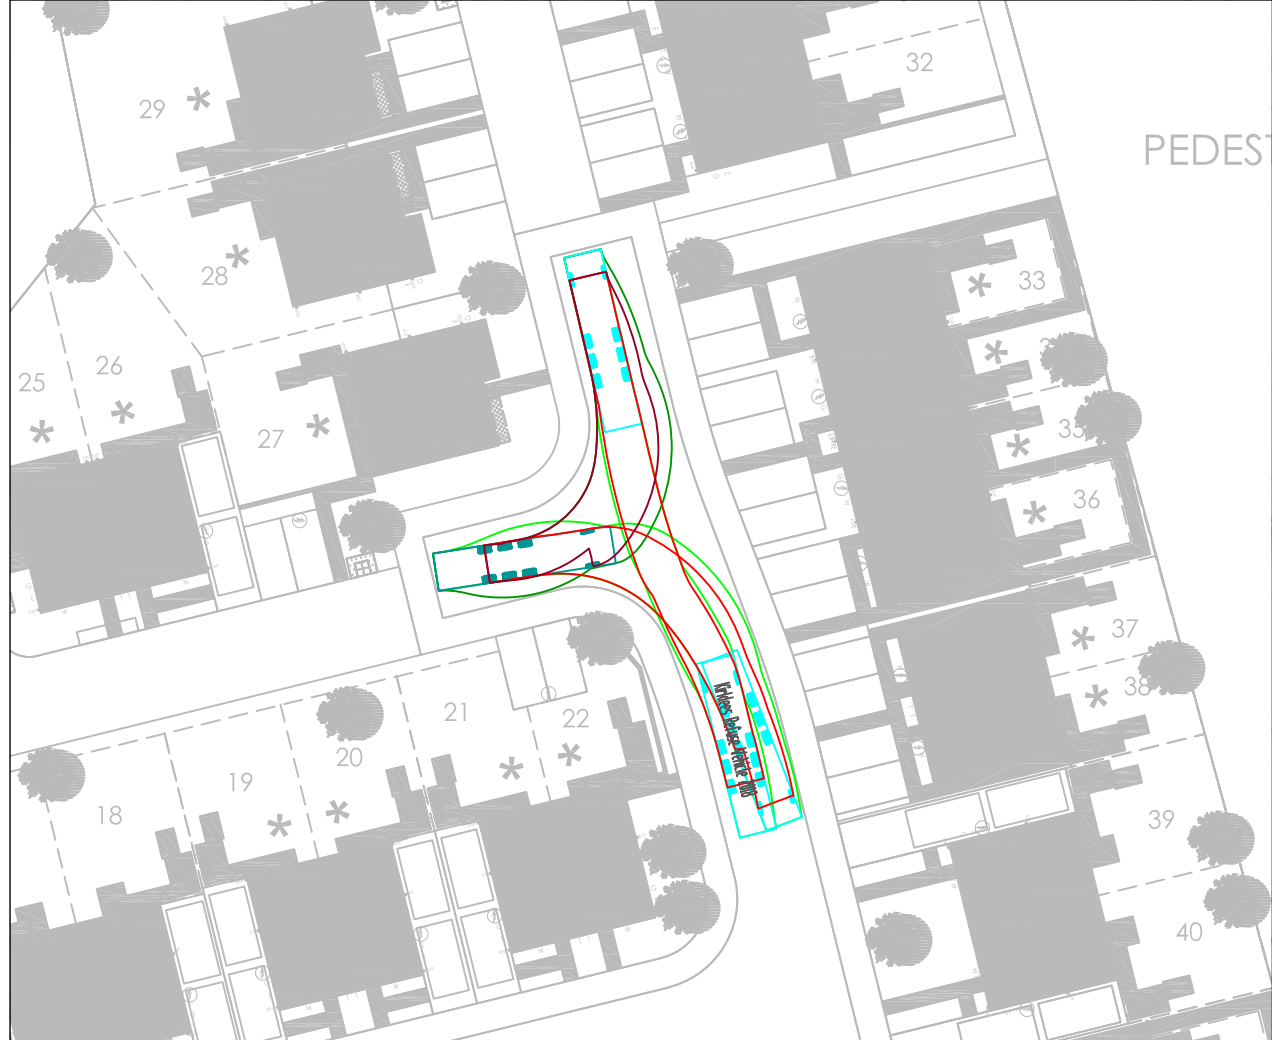
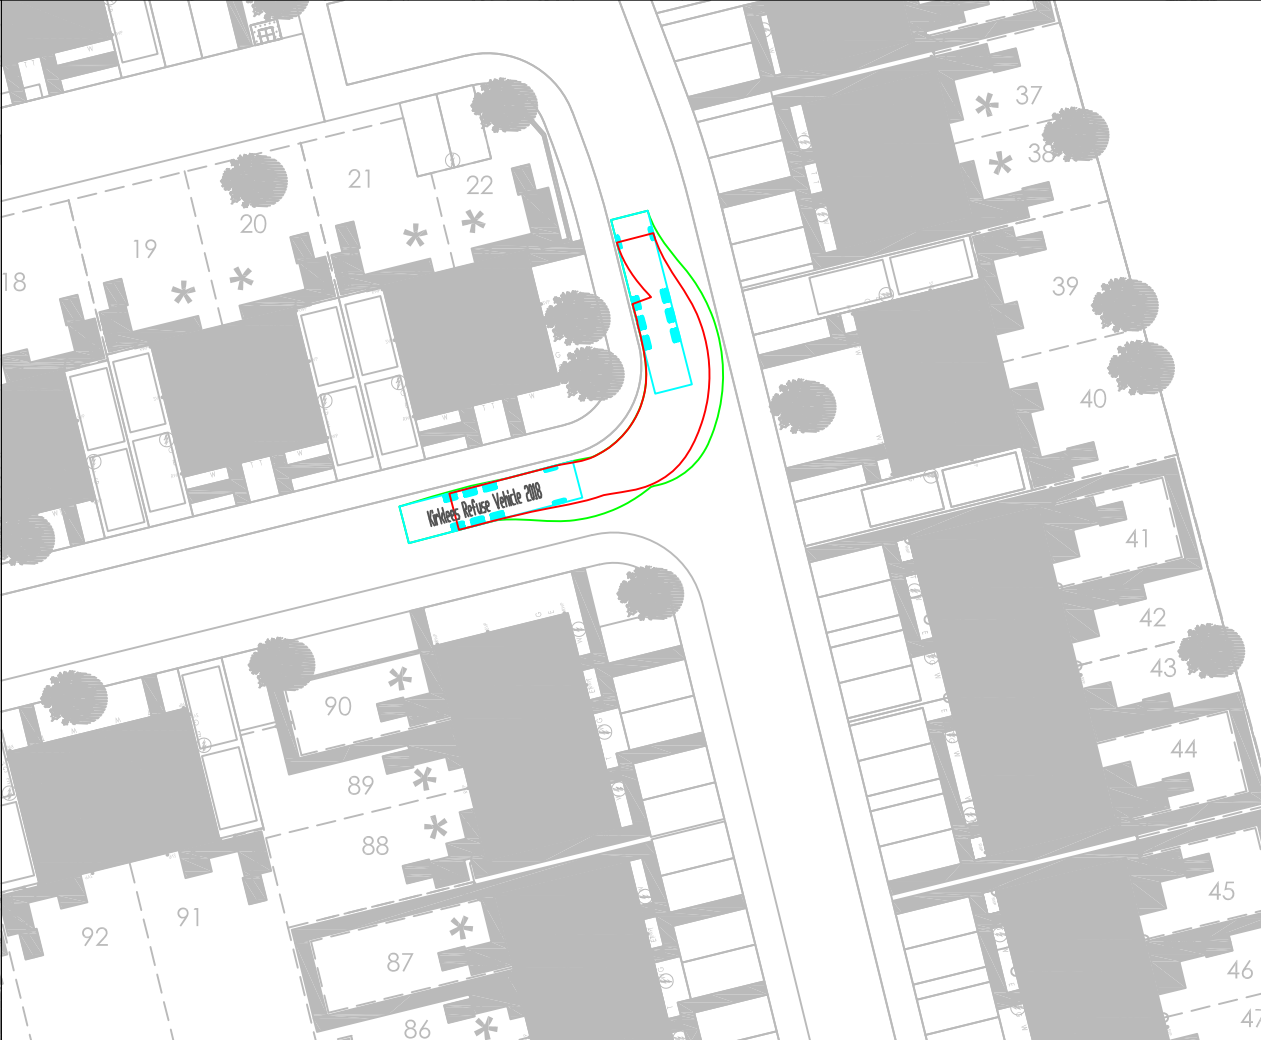
Drawing No. AMA/20664/ATR/006.2 Rev. -

Kirklees Refuse Vehicle 2018	11.850m
Overall Length	2.500m
Overall Width	3.749m
Overall Body Height	0.302m
Min Body Ground Clearance	2.490m
Track Width	6.00s
Lock to lock time	11.000m
Wall to Wall Turning Radius

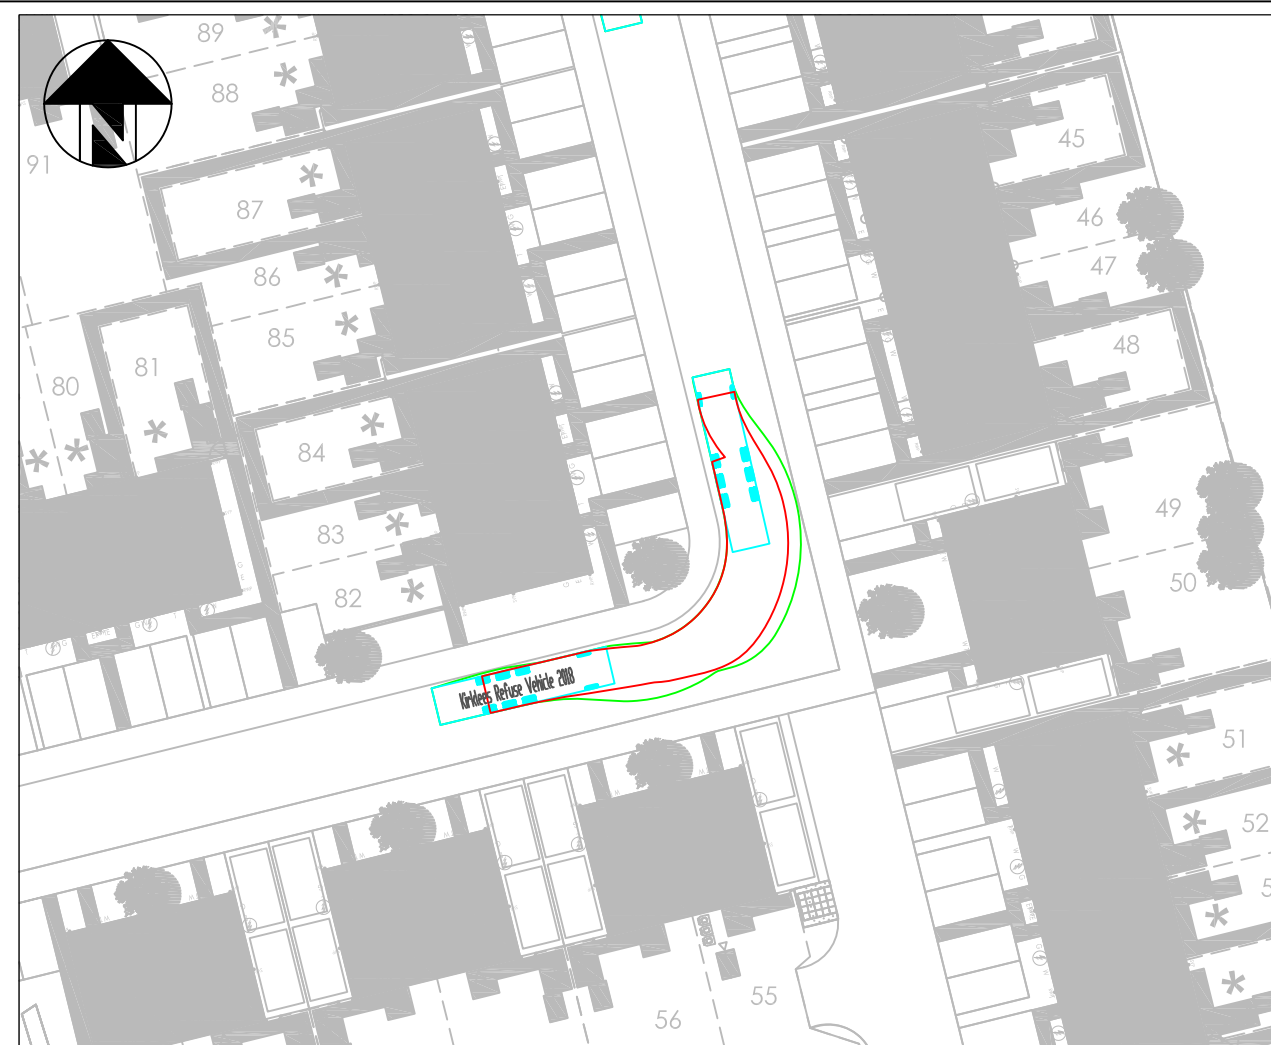
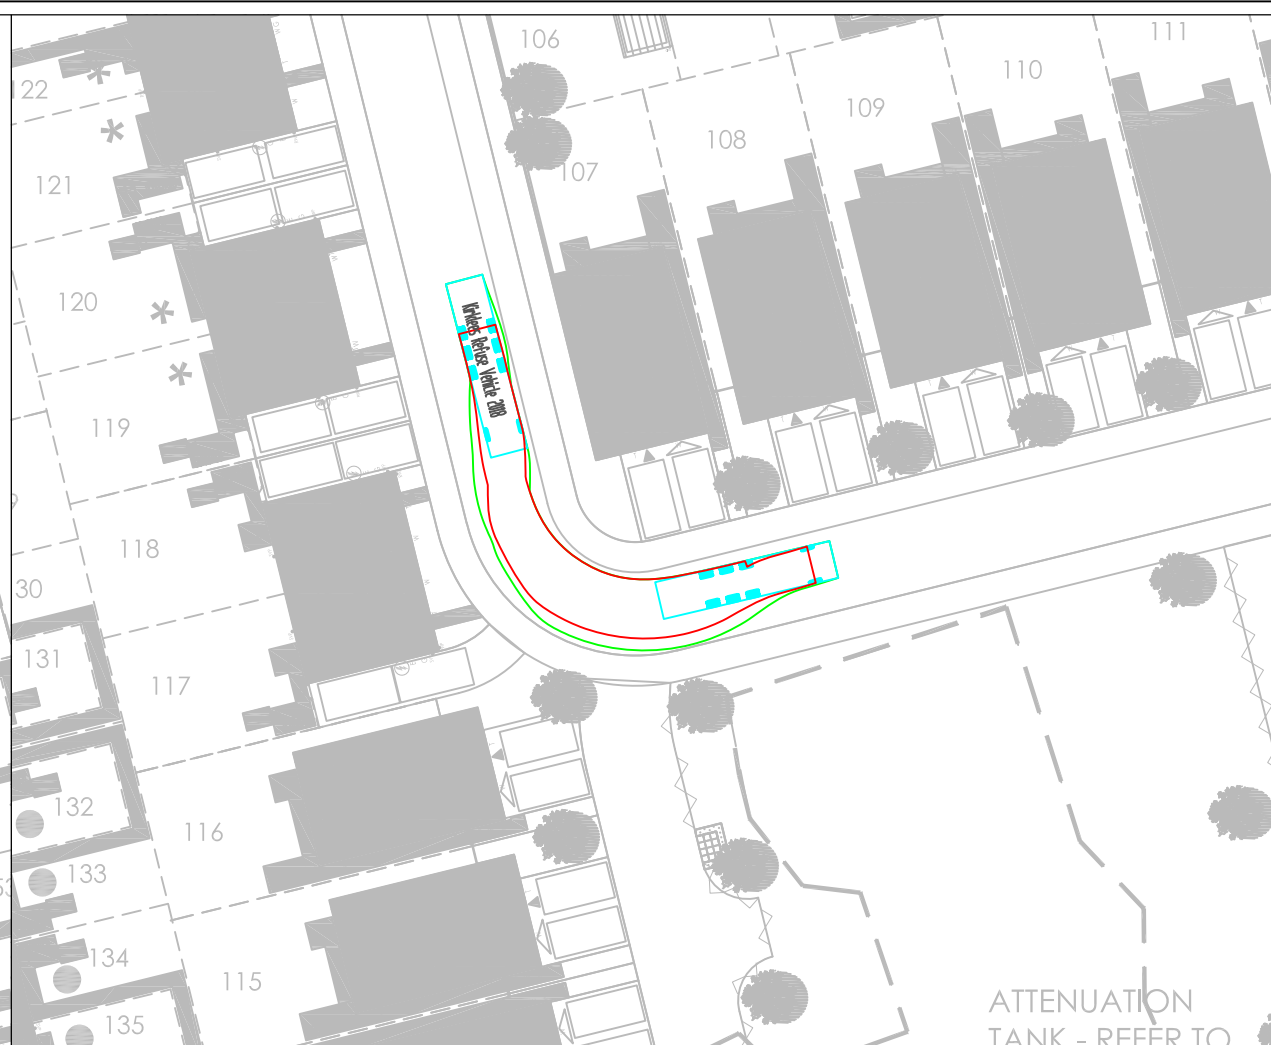
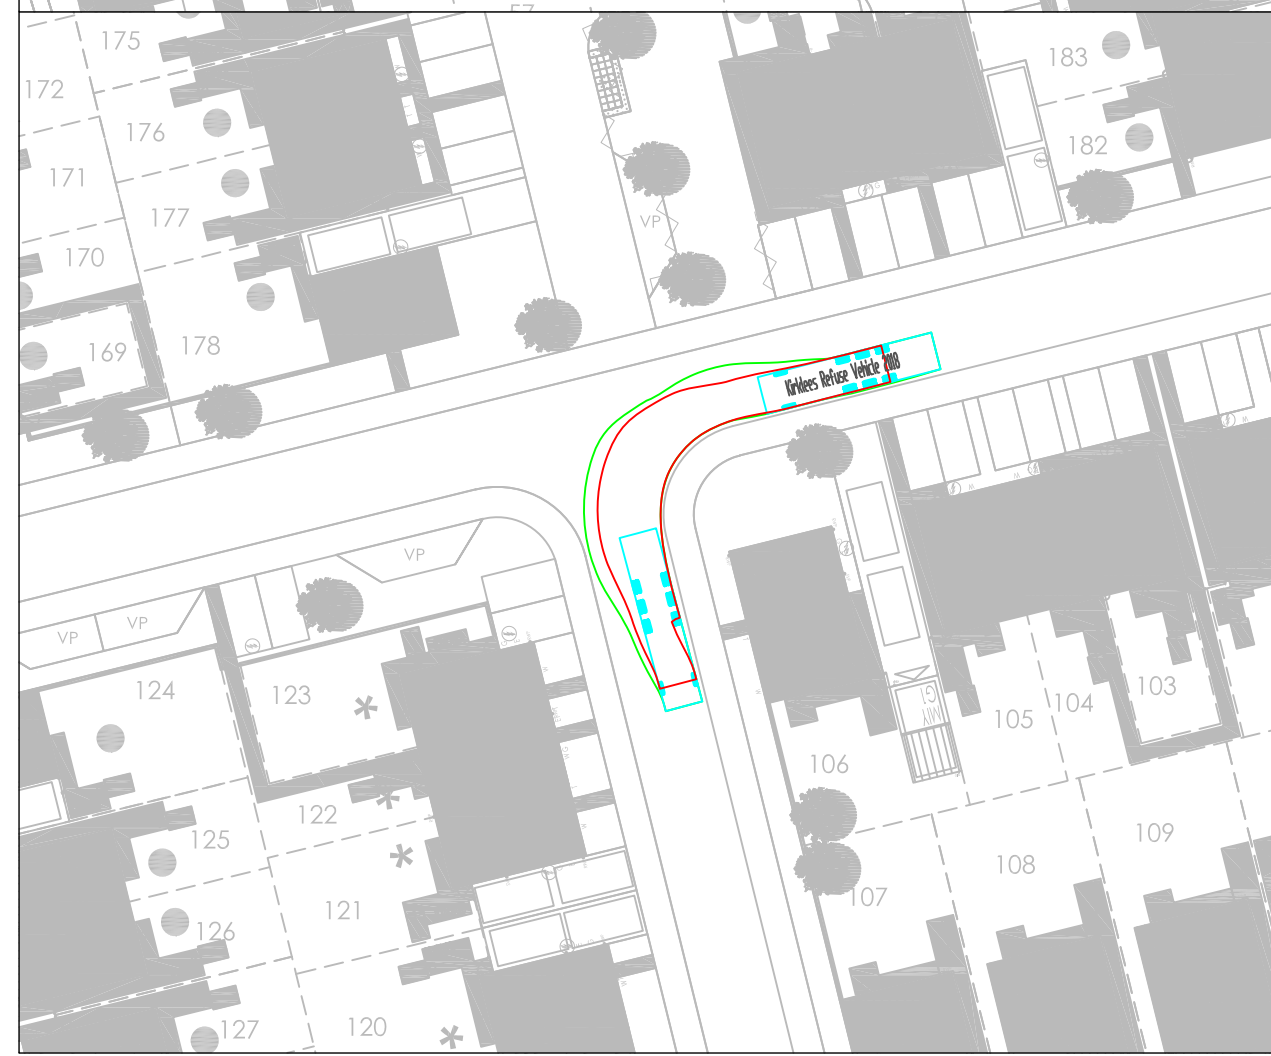
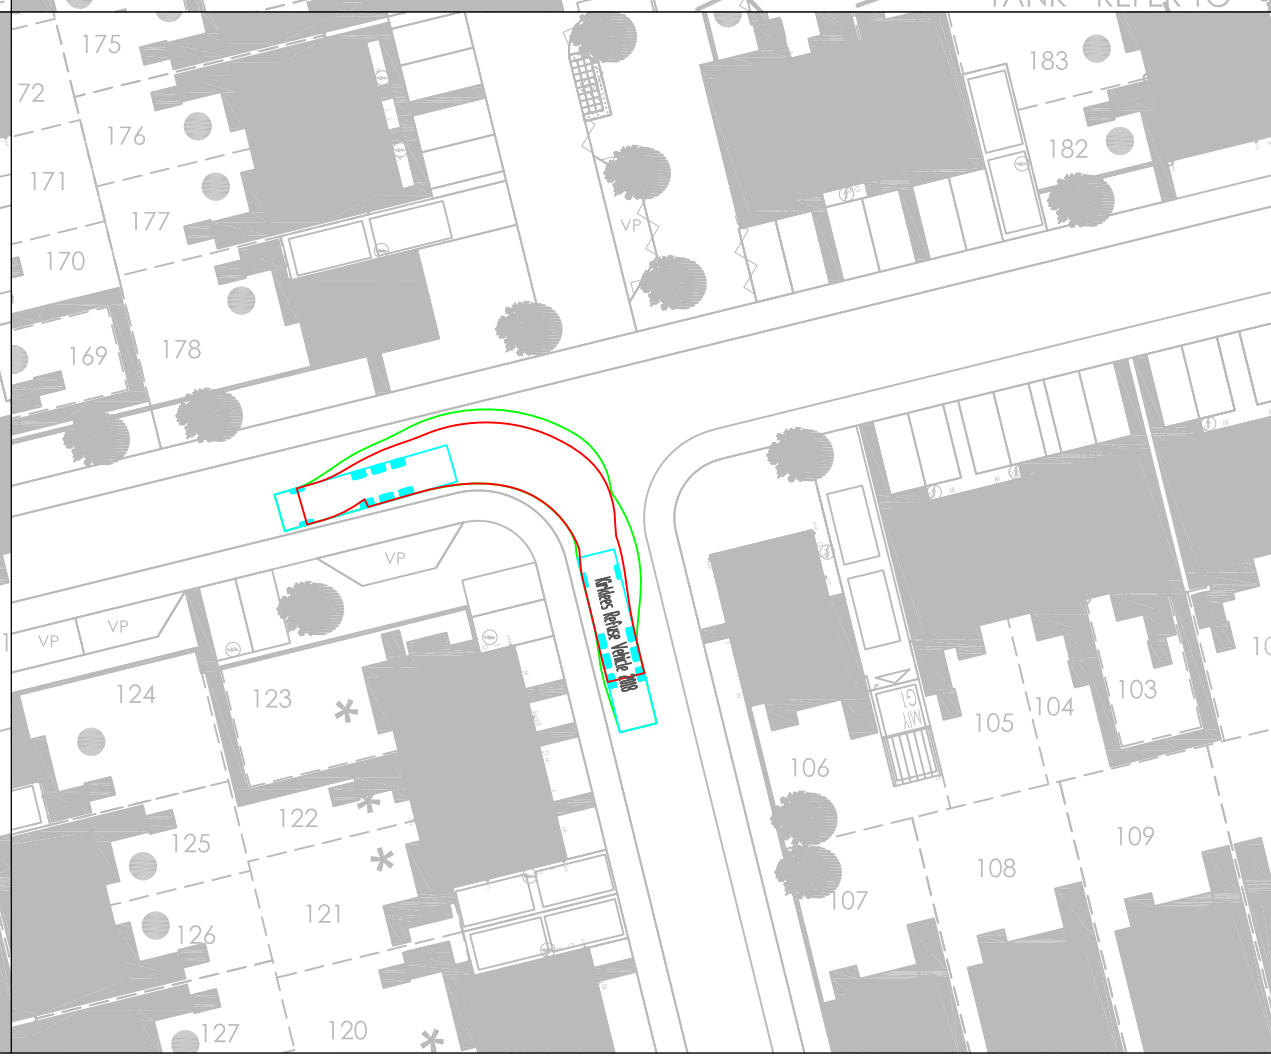
Drawn By: RID	Date: 23/02/2022	
Checked: RW	Scale: 1:500	A3
Drawing No. AMA/20664/ATR/006.3	Rev. -

Kirklees Refuse Vehicle 2018
 Overall Length 11.850m
 Overall Width 2.500m
 Overall Body Height 3.749m
 Min Body Ground Clearance 0.302m
 Track Width 2.490m
 Lock to lock time 6.00s
 Wall to Wall Turning Radius 11.000m
