AMA Designer's Response

Proposed Residential Development – Westgate, Cleckheaton

Proposed Housing Development
A643 Westgate Cleckheaton

Road Safety Audit: Stage 1-S278 and S38

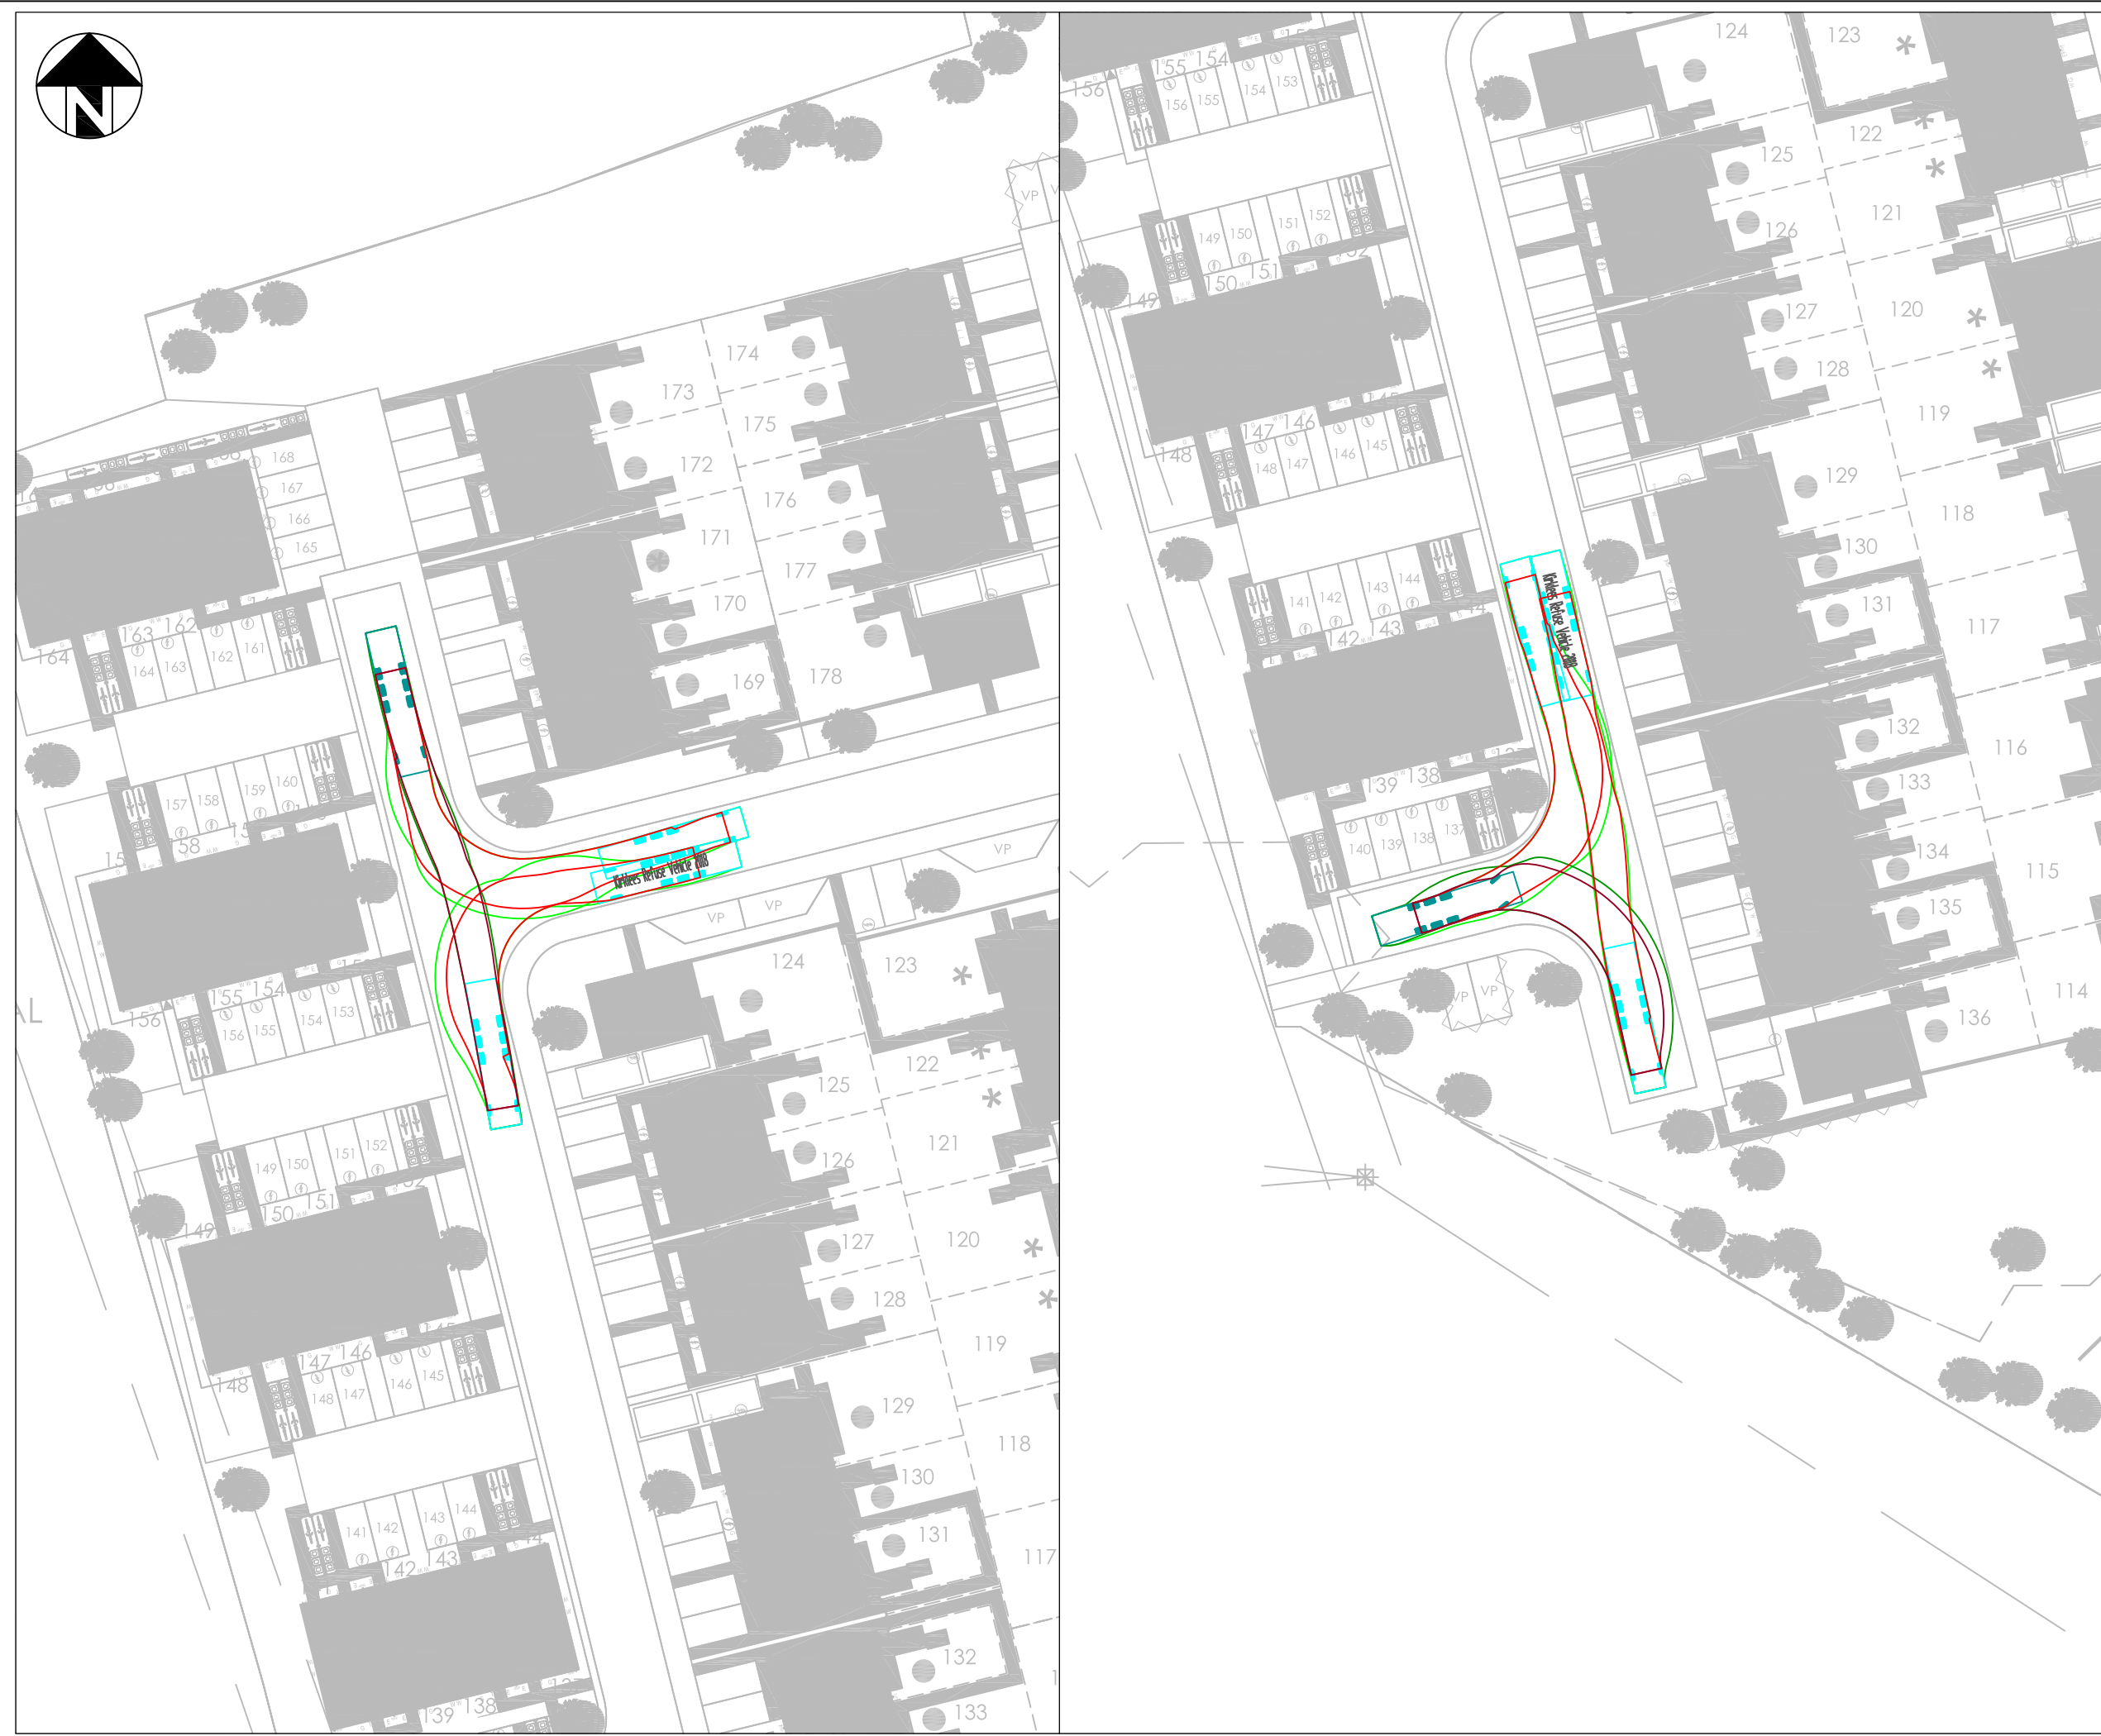
Drawn By: RID	Date: 23/02/2022	
Checked: RW	Scale: 1:500	A3
Drawing No. AMA/20664/ATR/006.4	Rev. -

Kirklees Refuse Vehicle 2018	11.850m
Overall Length	2.500m
Overall Width	3.749m
Overall Body Height	0.302m
Min Body Ground Clearance	2.490m
Track Width	6.00s
Lock to lock time	11.000m
Wall to Wall Turning Radius
