PROPOSED RESIDENTIAL DEVELOPMENT AT  
LAND ADJ. 178 DEIGHTON ROAD, HUDDERSFIELD HD2 1JJ

PHASE 1 DESK STUDY REPORT

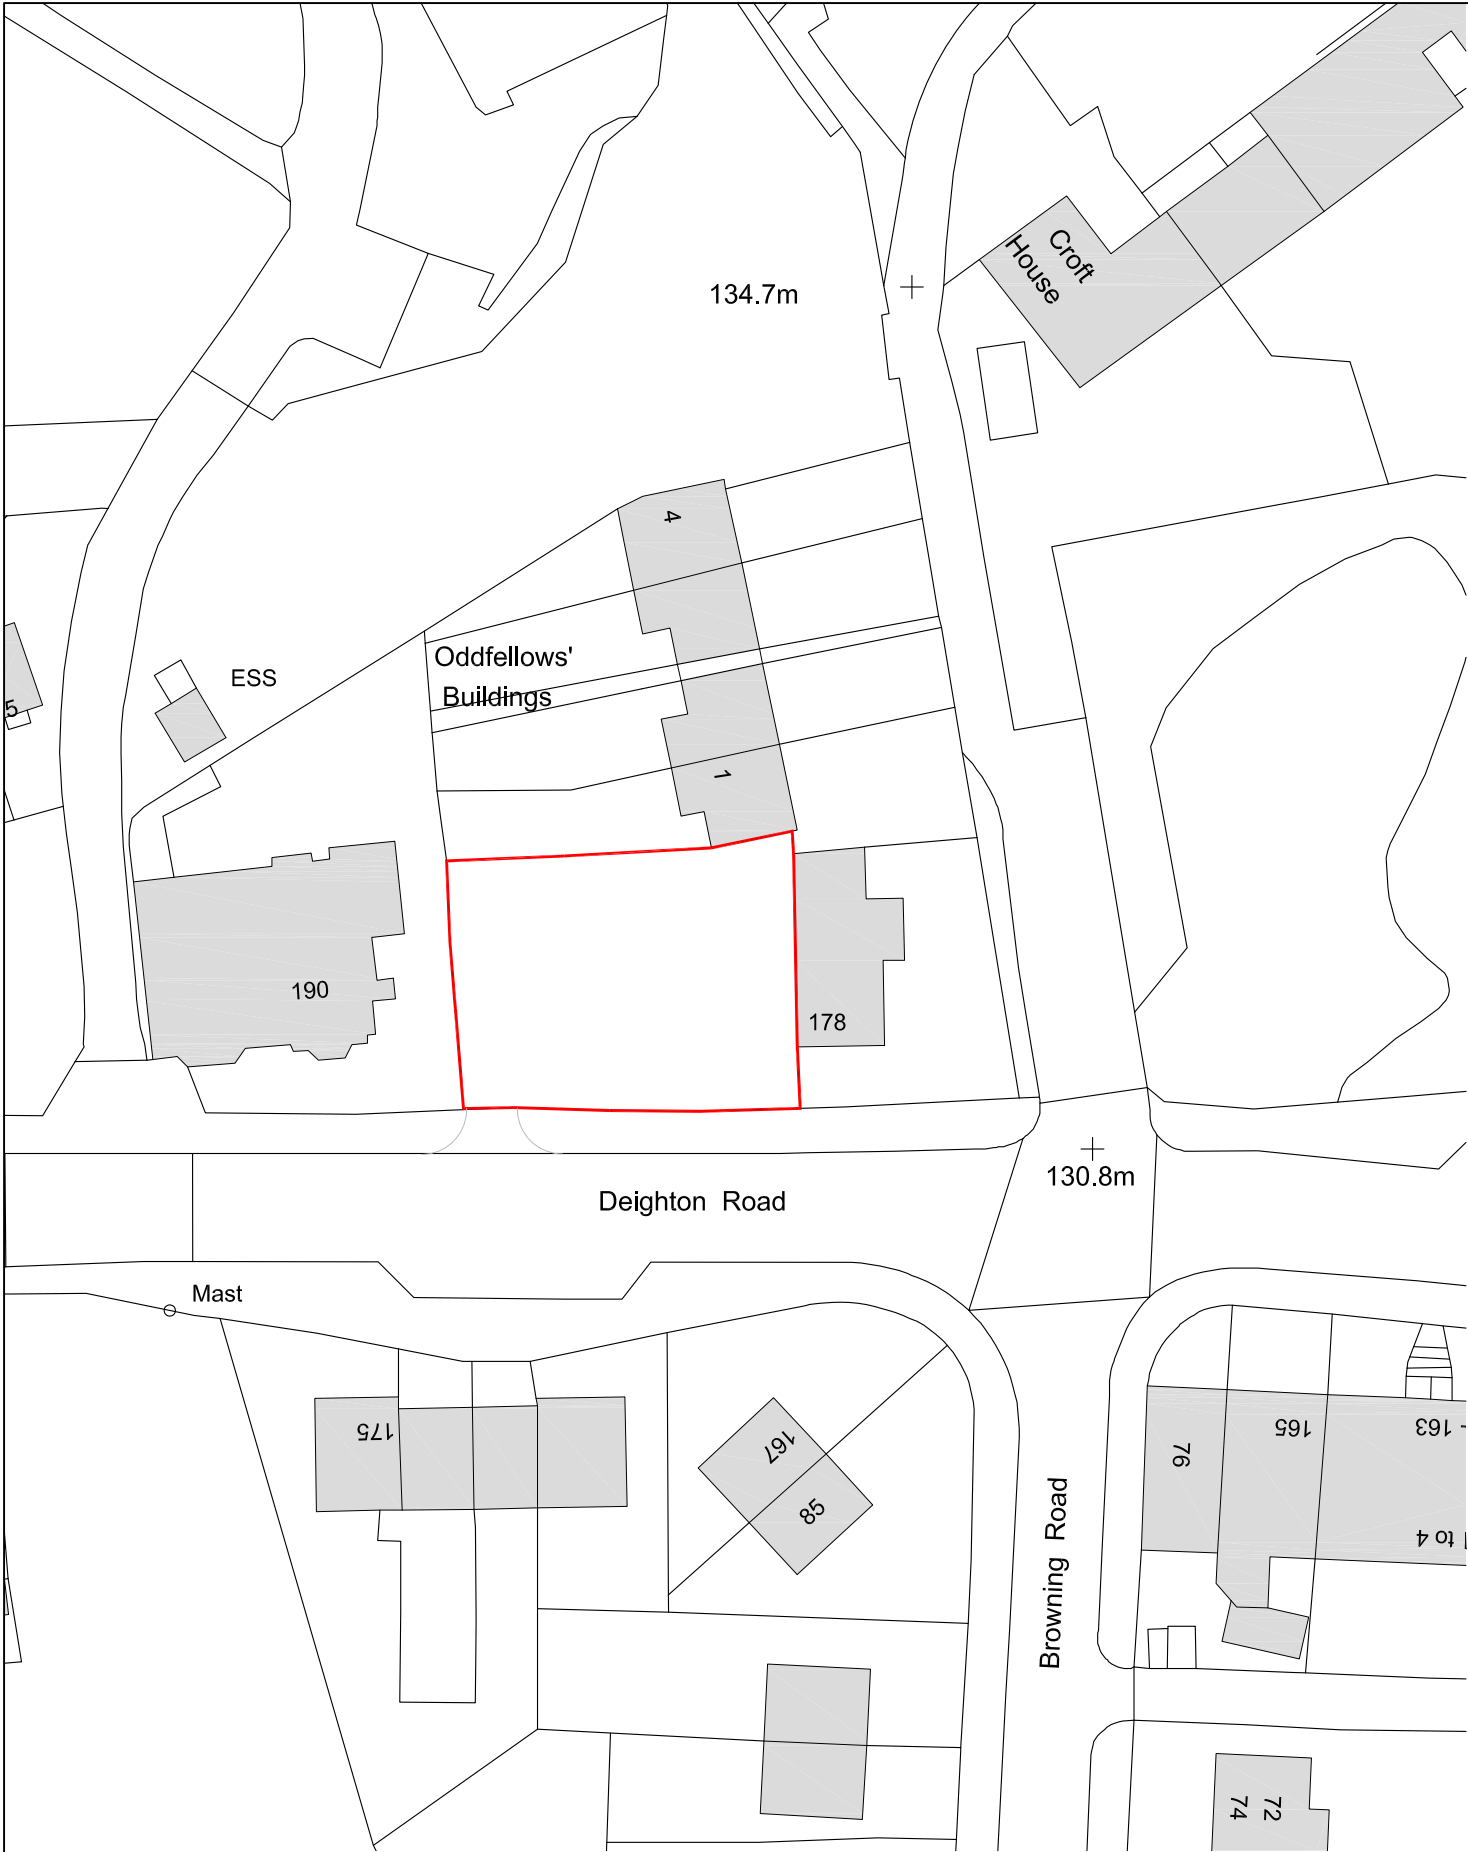
Location Plan (1.500 @ A3)

- 2.1.1 The site is located adjacent to no. 178 Deighton Road in Huddersfield as shown on the site plan enclosed in Appendix A.
