LAND AT LOW FARM GRANGE MOOR WAKEFIELD WEST YORKSHIRE

Results of a Heritage Assessment

South West Archaeology Ltd. report no. 210630

By F. Balmond & B. Morris
Report Version: FINAL
30th August 2021

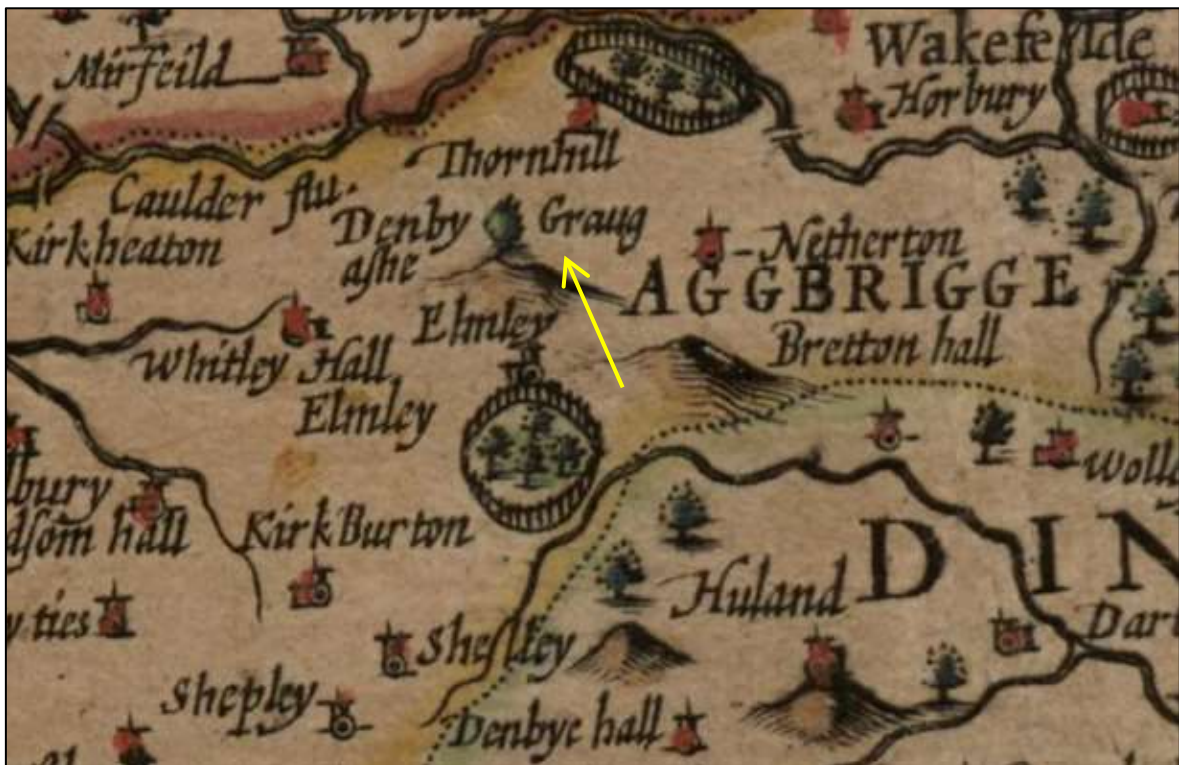
FIGURE 5: EXTRACT FROM AN 1610 PROOF MAP PRODUCED OF JOHN SPEED'S 'THE THEATRE OF THE EMPIRE OF GREAT BRITAIN', WHICH WAS PUBLISHED IN 1611/12 (UNIVERSITY OF CAMBRIDGE). THE APPROXIMATE SITE LOCATION IS INDICATED.

The earliest depiction of this area appears in the 1610 Speed map (Figure 5). It shows *Grang*, presumably Denby Grange, and a tree on a hill named 'Denby Ashe', presumably a prominent landmark at this date. A number of settlements and parks are shown in the surrounding area. The notable thing about this map is that it shows deer parks at Thornhill and Emley, but *not* at Denby.

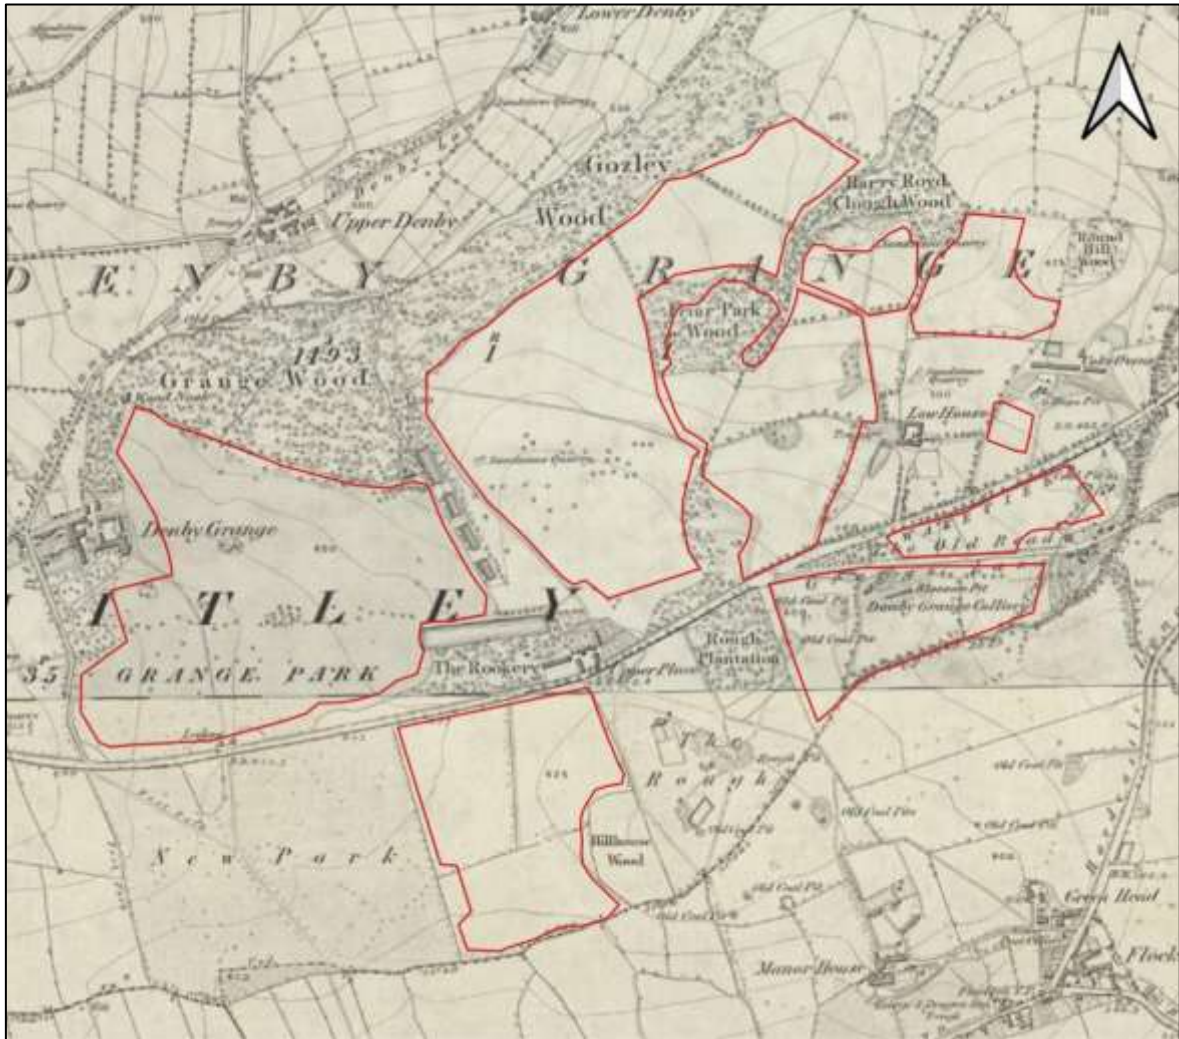
FIGURE 7: EXTRACT FROM THE OS 1ST EDITION 6" MAP SURVEYED 1849-51 (NLS). THE PROPOSED SITE IS INDICATED IN RED.

The First Ordnance Survey map to show this area is the 1849-51 First Edition 6-inch map (Figure 7). This shows little alteration to the Tithe map, being surveyed only shortly afterwards, however it gives more detail of the landscape as its purpose was not only related to land ownership. It gives some detail of the formal gardens surrounding Denby Grange and shows two lodges to the south, at the entrance to the estate from Wakefield Road. A number of sandstone quarries are recorded in the vicinity of Denby Grange. The area to the south of the large fish pond is named The Rookery on this map and the southernmost fish pond in the chain running down the valley appears to have been removed by this date. Low Farm appears to be named Low House at this date, although there appears to be little or no change to the buildings which comprise it from the Tithe map depiction.

Clear evidence of coal extraction is visible at the eastern end of the proposed development area with Hope Pit named and Coke Ovens depicted. Within the south eastern area of the proposed development further evidence of coal mining can be seen in the coal pits, old coal pits, blossom pit and Denby Grange Colliery labelled in this area. An area to the south of Grange Park is named New Park on this map and a footpath is shown running through it from the Denby Grange entrance lodges to Flockton. The small structure in the plot named Clover Lees on the Tithe map is no longer shown. This map gives an impression of an agricultural landscape which is becoming more industrial in character.

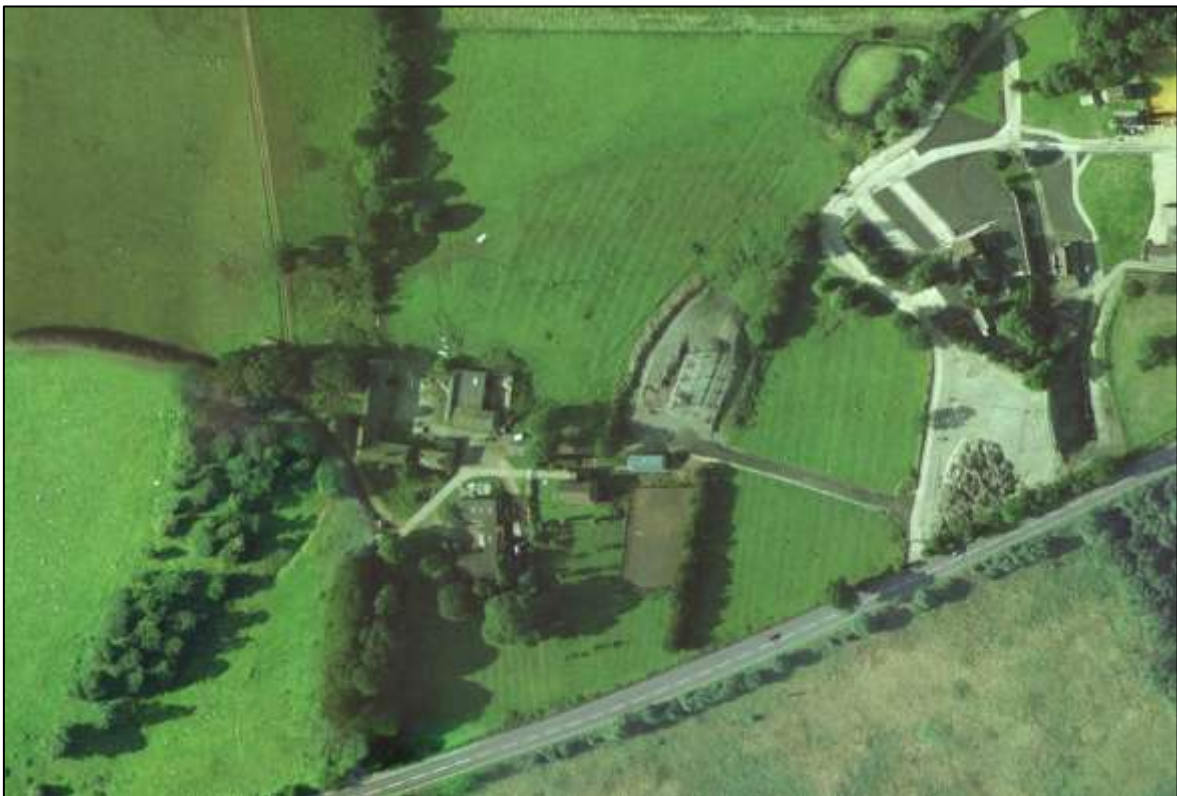
FIGURE 13: 2002 AERIAL PHOTOGRAPH SHOWING THE RIDGE AND FURROW AROUND LOW FARM; THE AP FOR 2018 ALSO SHOWS RIDGE AND FURROW IN THE FIELD IMMEDIATELY TO THE SOUTH-WEST OF THE FARM (© GOOGLE 2021).

mechanisms, and the enclosures around the farmstead contain the surviving earthworks of ridge and furrow cultivation (see Figure 13).

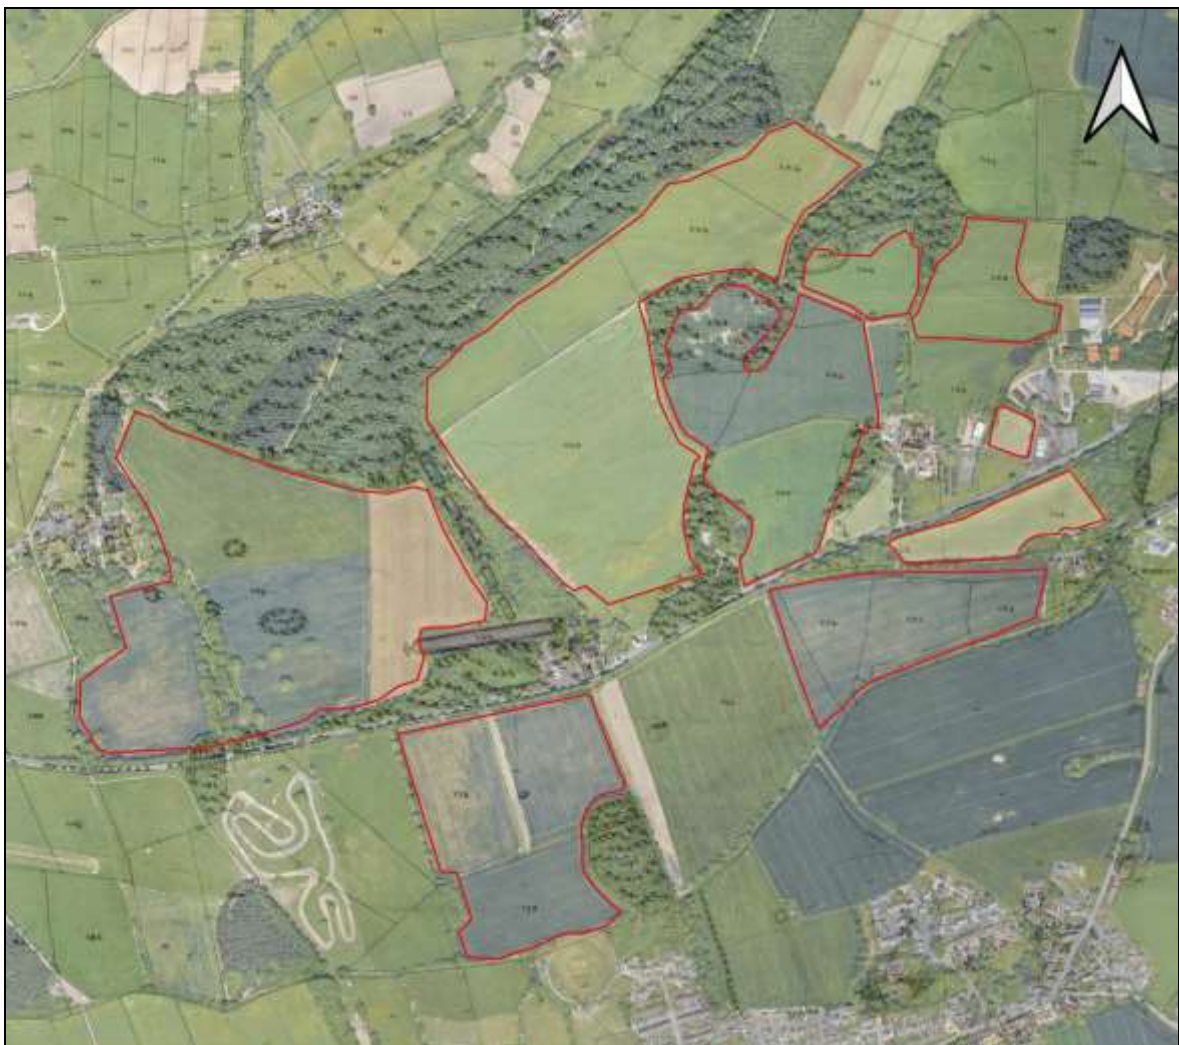
FIGURE 16: MODERN AERIAL PHOTOGRAPH OVERLAIN WITH THE TITHE MAP SHOWING LITTLE CHANGE IN THE STRUCTURE OF THE FIELDS, ALTHOUGH SOME BOUNDARY LOSS HAS OCCURRED (© GOOGLE MAPS 2021).

A review of readily available commercial aerial photographs shows little change of the area of the proposed development in the last 20 years. Many of the fields still conform to the boundaries shown on the tithe map, although there is evidence of recent boundary removal to amalgamate several smaller fields. There is no available LiDAR data for the survey area, but the earthworks of a limited area of ridge and furrow around Low Farm itself are visible on aerial photographs (Figure 13). The only other notable crop- or soilmarks visible on commercial aerial photography are shown in Figures 17-18.

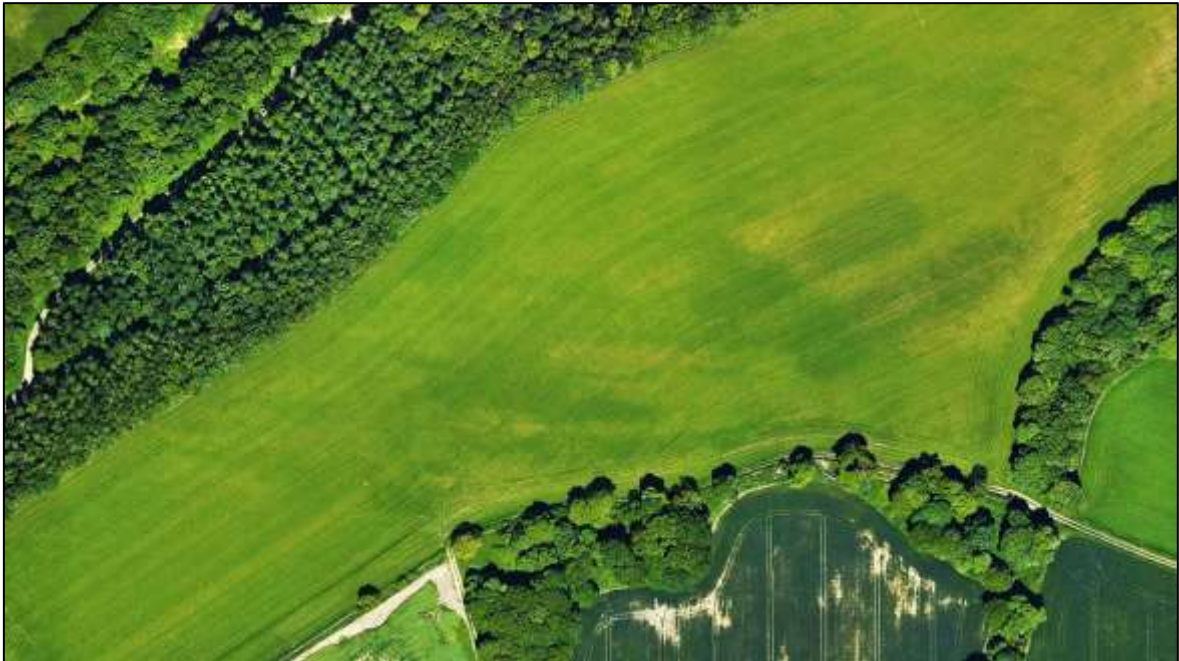
FIGURE 17: 2015 AERIAL PHOTOGRAPH OF FIELD E SHOWING THE CROPMARKS, PERHAPS ARCHAEOLOGICAL (© GOOGLE EARTH 2021).

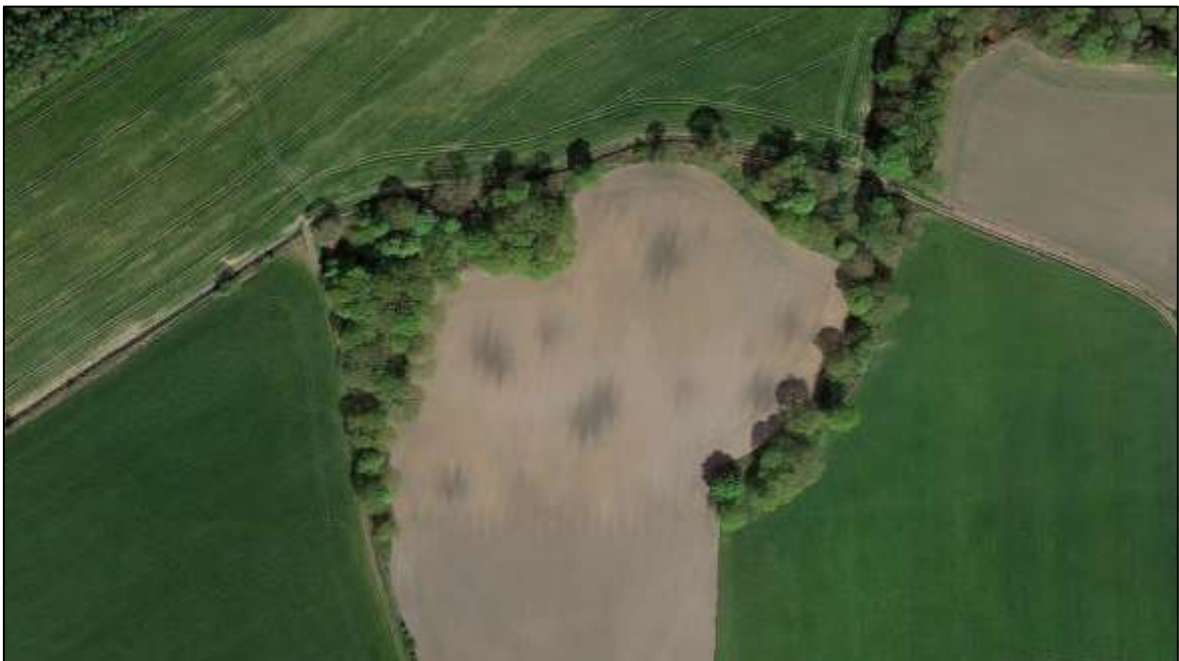
FIGURE 18: 2020 AERIAL PHOTOGRAPH OF FIELD F SHOWING DARK SOILMARKS, PRESUMABLY EXTRACTION PITS (© GOOGLE EARTH 2021).

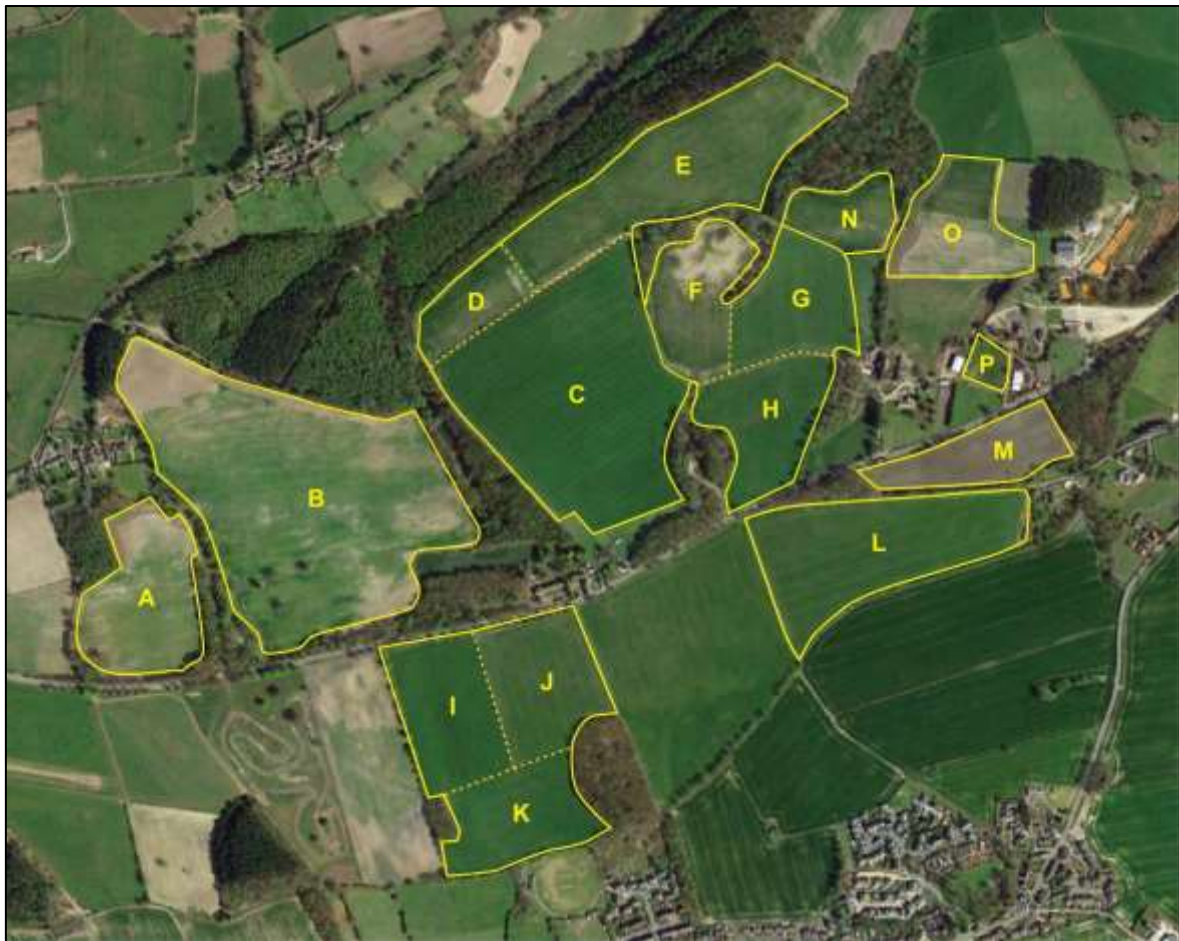
FIGURE 19: THE LAYOUT OF THE SITE, DIVIDED INTO THE 16 FIELDS/CROPPING UNITS (BASEMAP © GOOGLE EARTH).

Given the size of the site, in the following description the fields are listed separately. However, several general points can be made:

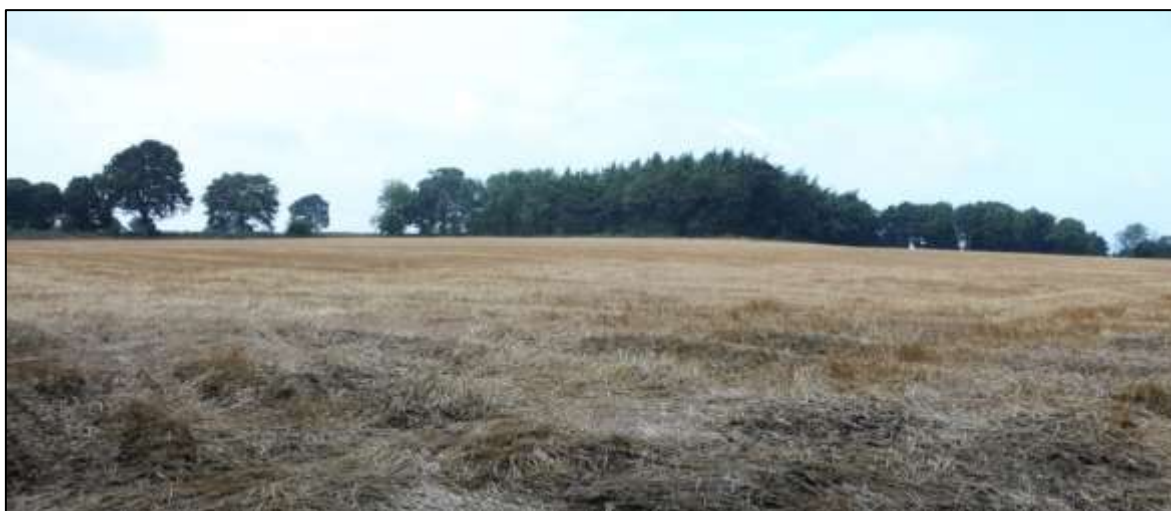
A small (4.7ha) irregular field forming one part of the park attached to the Grange. It is defined to the south and west by a Type 1b stone wall in varying states of disrepair, to the north by the former woodland (now plantation) attached to Denby Grange, the site of the former House, and by the double avenue leading to the house to the east. The level of the A642 and the lane leading to Denby Grange are elevated (by c.1m+) relative to the internal level of the field, and in places the walls have collapsed as a result. The coping from these walls has largely been lost. There is no distinct boundary between the field and the plantation. The boundary between the field and site of the House is marked by Heras fencing, and only in the east corner does traces of a ditch (perhaps a former ha ha) survive. The avenue is discussed below. The surface of the field undulates, although the undulations are broad and irregular and are probably geological. The northern half of the field was subject to opencast in 1942.

FIGURE 21: FIELD A; VIEWED FROM THE SOUTH-EAST.

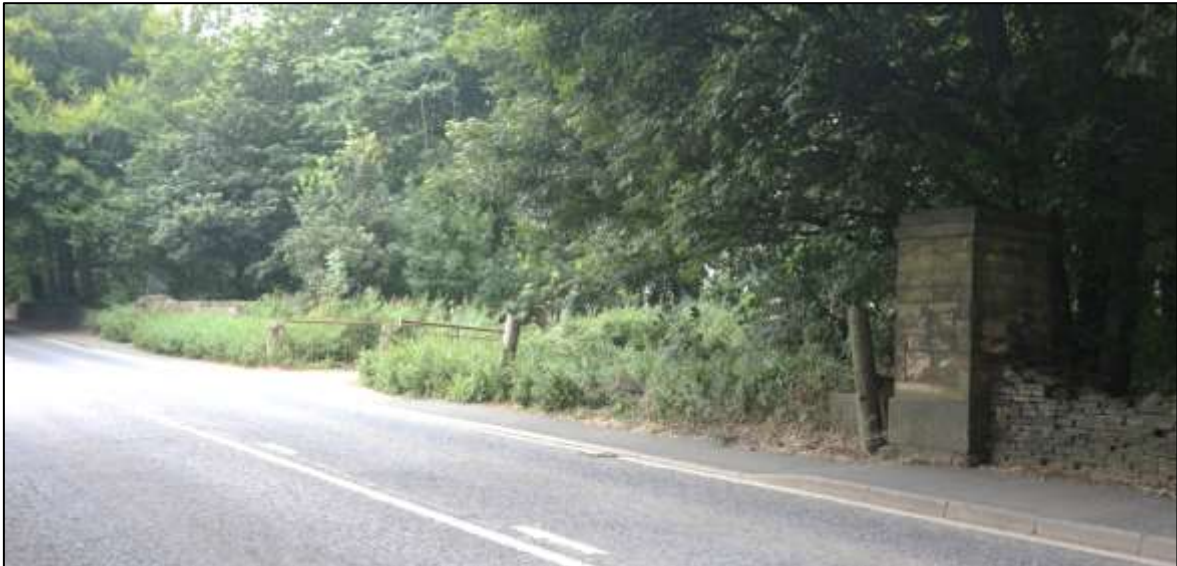
The principal entrance to the house was from the south. To either side of the roadside entrance is a pair of square piers of ashlar stonework, with wing walls that curved back to the location of two small octagonal lodges; the wing walls are now reduced in height and the lodges were demolished in the 1950s and little trace was observed. A small patch of large stone setts were observed in the former gateway. Across the road to the south the current gateway is still flanked by elaborate stone gate piers. The bulk of the track that leads toward the location of the house is comprised of fairly rough aggregate and will have been repaired since the 1950s (i.e. brick noted). Behind the site of the lodges are two small copses. Apart from a section of the avenue at the north-west end, a double line of mature trees survives to each side of the track. These trees are mainly beech and horse chestnut, but mature sycamores are also present.

FIGURE 22: THE FORMER ENTRANCE TO DENBY HOUSE; VIEWED FROM THE SOUTH-EAST.

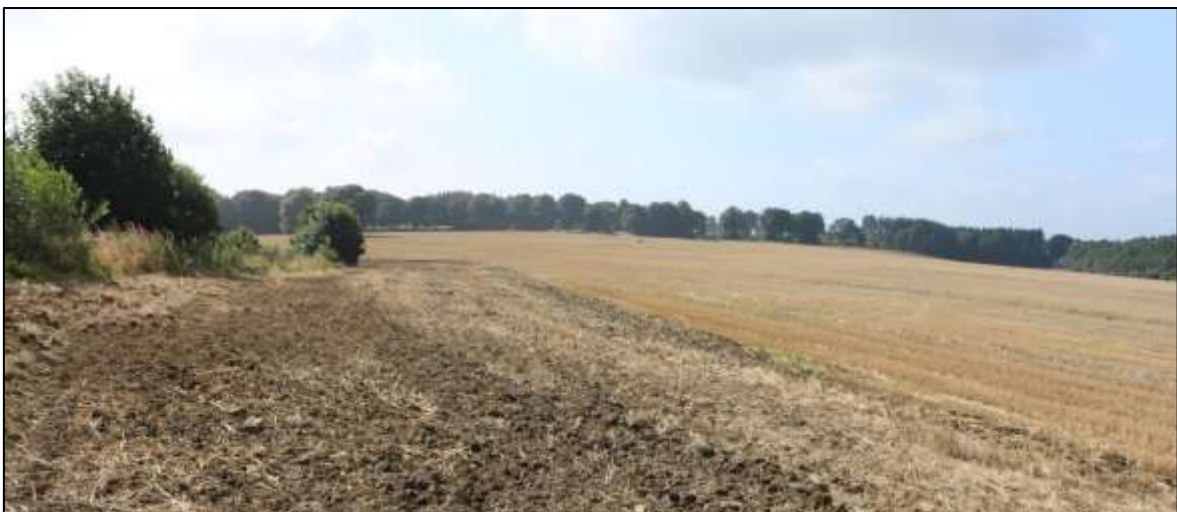
A large (18ha) irregular field forming the bulk of the park attached to the Grange. The field is defined to the south-west by the avenue (discussed above), to the south by a Type 1a wall and the woodland adjacent to Rookery Farm, and to the east by a large ornamental pond and a Type 1b wall. To the north the field is defined by a Type 1a wall that incorporates a (now roofless) open-sided shelter shed at its eastern end (deer shelter) and terminates at Wood Nook. The ground drops down to the walls along the east and north sides of the field; to the east this drop is natural, to the north it is deliberate and part of the park pale. Wood Nook is a small square two-storey house with an unusual pyramidal roof with long catslide roof to the north. Based on its location and appearance, this house is likely to have functioned as an eyecatcher and the deer keeper's cottage. To the north-west the field is bounded by a modern wood fence, with the historic orchard now a conifer plantation. The remaining section of the western boundary skirts the round the modern hamlet of Denby Grange and the site of the former house. The boundaries are largely modern hedge shrubs with scattered trees; along the site of the house is a length of steel-framed gabions. The level of the gardens to these houses is elevated relative to the level of the field. The surface of the field is fairly uniform, with a pronounced slope to the north. Most of the southern half of the field was subject to opencast in 1942, except for that area marked by parkland trees in the south-west corner; most of the northern half of the field was subject to opencast in the 1960s.

FIGURE 23: FIELD B; VIEWED FROM THE EAST (THE RECTANGULAR POND IS TO THE LEFT; DENBY GRANGE ON THE SKYLINE).

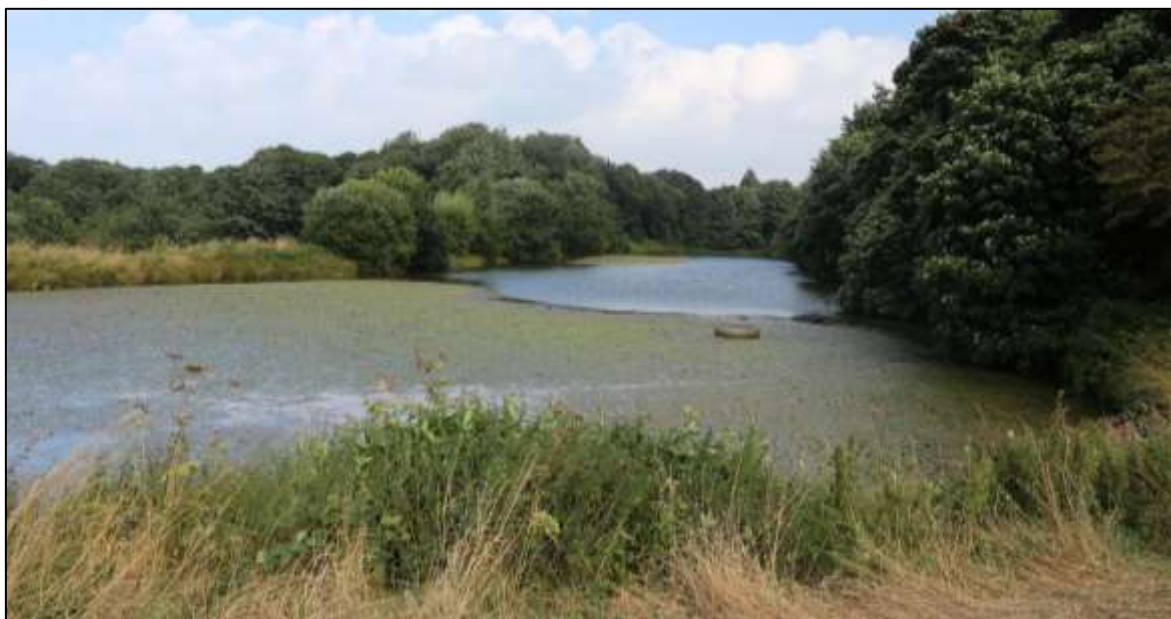
To the south-west side of Field B is a small area of young oak and sycamore woodland. There is a track that drops down from the A642 and runs parallel to the ornamental pond, and within this woodland are two clear features: a long and well-defined bank that runs roughly east-west, and a large mound. The bank is up to 2m high in places on its downslope side and has been identified as a former tramway (landowner *pers. comm.*) that carried machines/implements from the colliery at Grange Moor to a workshop at Rookery Farm for repair. The mound, at least 20m in diameter, c.6m high, and with a tail c.30m long to the west and is planted with yew trees. It is marked on the OS maps as an icehouse; the entrance was vandalised and collapsed (landowner *pers. comm.*). The ornamental pond is rectangularly and c.206m long and c.38m wide, with clearly embanked sides to the north-east sides. The semi-circular feature shown on the tithe map at its western end is not visible.

FIGURE 24: THE LARGE ORNAMENTAL POND; VIEWED FROM THE WEST.

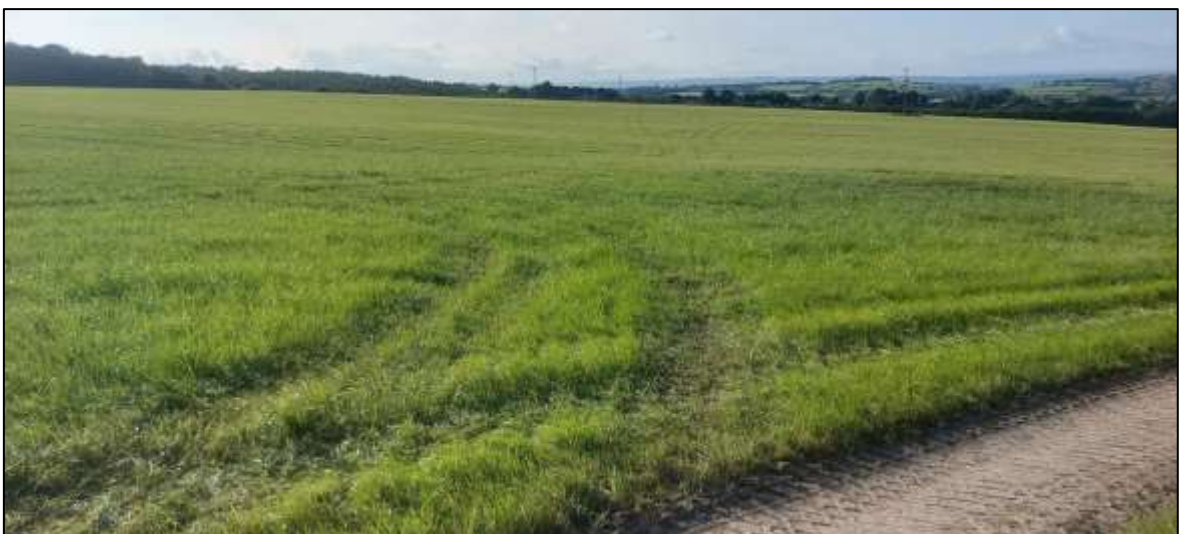
A large (12ha) and irregular field defined to the south by the modern wooden and post-and-wire fences of a series of small enclosures adjacent to Rookery Farm, by a Type 2 wall to the east around Pit Hill Plantation, and by a thin hawthorn hedge with evidence for hedgelaying to the north-east. The boundary with Fields D and E is marked by a Type 2 wall with scattered small sycamore trees, and the boundary to the west is defined only by concrete fence posts, most of the wire having rotted away or dropped. The surface of the fields is marked by some broad undulations but is otherwise very uniform. To the eastern side, adjacent to the gateway into Field H, is a deep rectangular pond, as shown on the tithe map. The southern half of the field was subject to opencast in 1942; the northern half of the field was subject to opencast in the 1970s.

FIGURE 26: FIELD C; VIEWED FROM THE SOUTH-EAST.

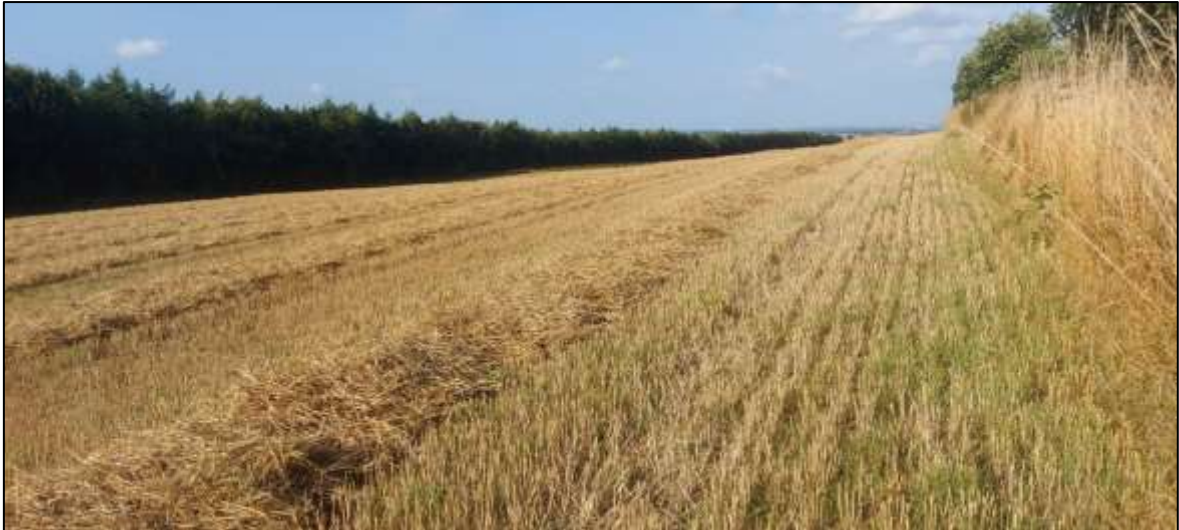
A small (2ha) sub-rectangular field defined by Type 2 walls to the south, east, and north. To the west, within the woods, there is a Type 1a wall. Grange/Denby wood to the north is coniferous, but there are scattered deciduous trees along the margin. Beyond the walls, the ground falls away sharply to the north and west. No earthworks were observed.

FIGURE 27: FIELD D; VIEWED FROM THE WEST-SOUTH-WEST.

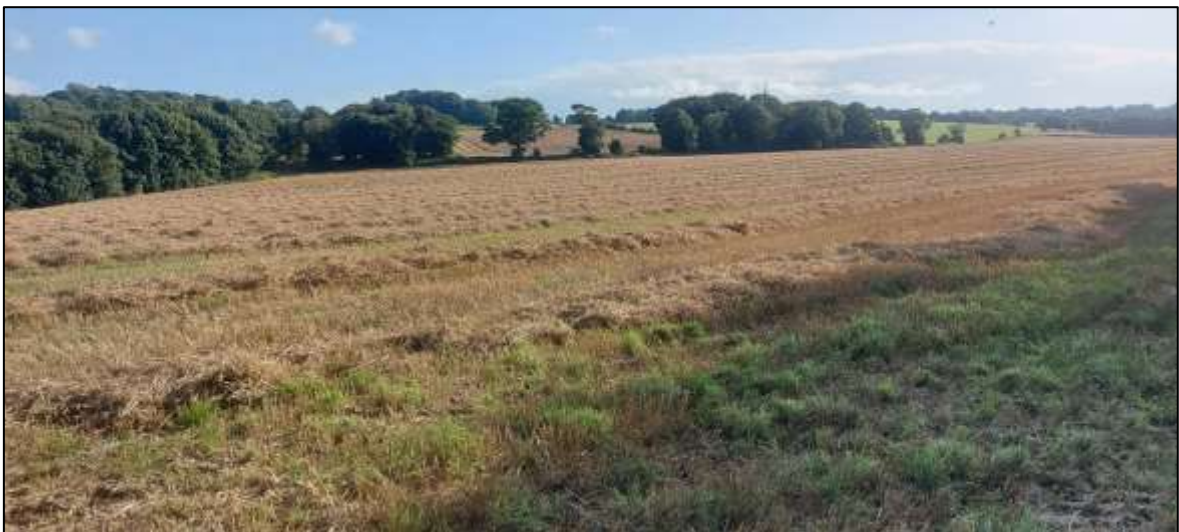
A large (8.3ha) long sub-rectangular field, defined on all sides by Type 2 walls. These walls are in varying states of repair, with long sections of the north wall partly collapsed, with some limited repairs made with a grey cement mortar; most of the south-eastern wall around Harry Royd Clough Wood buried up to the coping stones by hillwash/colluvium. Grange/Denby wood to the north is coniferous, but there is an almost continuous line of deciduous trees along the margin. The ground falls away sharply to the north within Denby Wood. The ground level is also lower to the north of the north-eastern boundary wall, and there is a large mature ash tree towards the western end of this wall. There is a small quarry in the northern corner of the field (marked on OS maps). Most of the field is fairly flat, but the eastern end slopes quite steeply down, almost to the base of Harry Royd clough. The surface of the field is fairly uniform, but some broad undulations were visible towards the western end which may correlate with the cropmarks noted on the HER.

FIGURE 28: THE NORTH-EASTERN END OF FIELD E; VIEWED FROM THE NORTH.

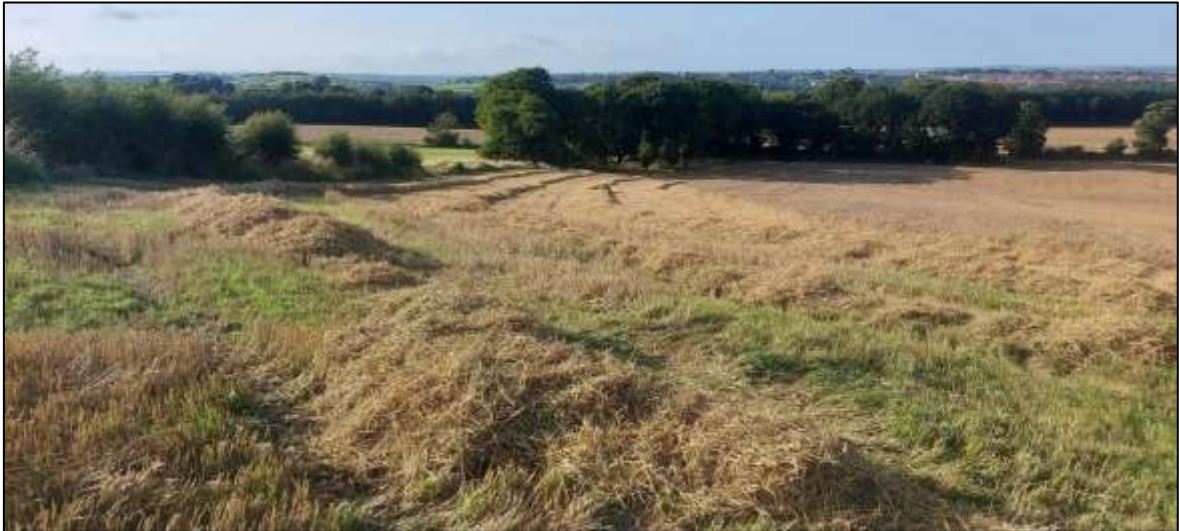
A smaller (3.2ha) more irregular field consisting of two tithe parcels, one of which was once a wood. It is defined to the south-west and south by a clear lynchet topped with a sparse hawthorn hedge and remnants of wooden rail fencing, it is open to Field G to the east, and it is bordered by a wooded clough to the north-east. To the north and north-west the remnants of Fryer Wood (removed after 1940) fringe the field, largely consisting of mature oak trees with a diameter of up to 50cm. The surface of the field slopes to the north-north-east and is fairly level. This field was subject to opencast in 1960s.

FIGURE 29: THE WESTERN HALF OF FIELD F; VIEWED FROM THE SOUTH.

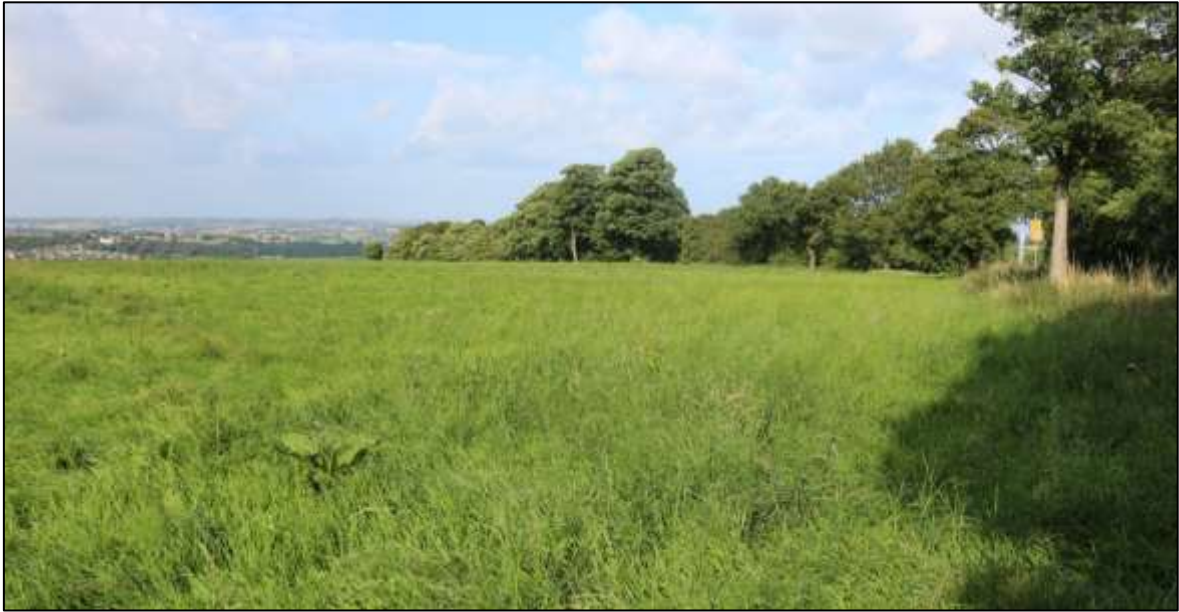
A small (3.7ha) irregular field, defined to the south by the Type 1a wall and wooden fencing flanking the A642, the remnants of a hawthorn hedge to the east, giving way to an open sycamore copse, and a clear lynchet topped with a sparse hawthorn hedge and remnants of wooden rail fencing to the north. To the east is a short stretch of hawthorn hedge, and then is open to the wooded Pit Hill Plantation. Pit Hill Plantation, of young oak, sycamore, and some silver birch, contains a large spoil hedge, quarried into on its south-eastern side revealing its dull reddish stony interior. The field slopes gently to the north and is fairly level. This field was subject to opencast in 1960s.

FIGURE 31: THE EASTERN UPPER PART OF FIELD H; VIEWED FROM THE SOUTH-SOUTH-WEST.

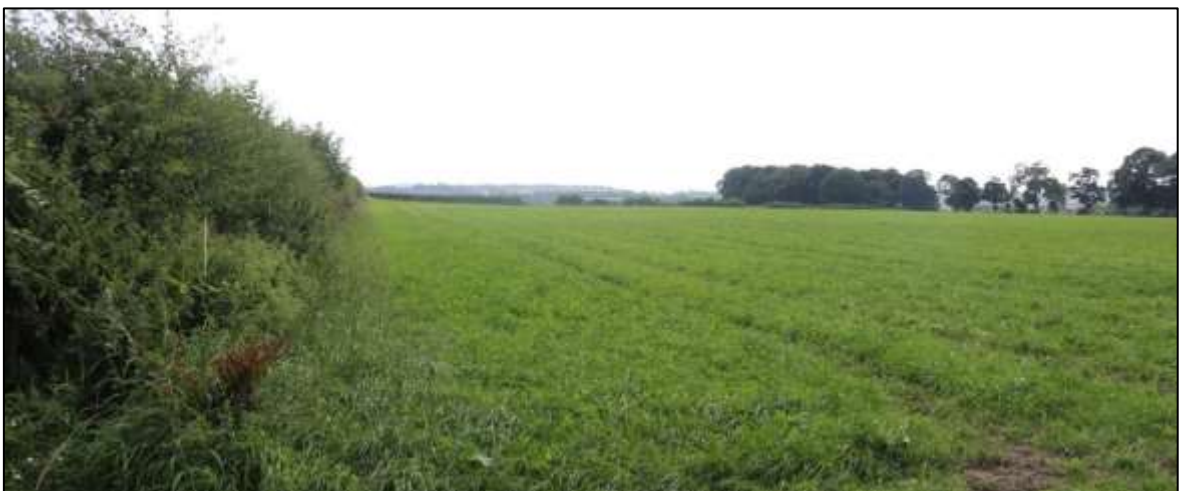
A small (3.5ha) rectangular field, defined by Type 1a stone walls to the north and west, and largely hawthorn hedges to the east and south. The boundary flanking the A642 is (or was) lined with mature trees, spaced c.15m apart; these trees are mainly oak and ash. The wall to the west features a line of evenly-spaced sycamore trees. The field slopes very gently to the south-south-east; these are several broad depressions to the southern part of the field. This field was subject to opencast in 1965.

FIGURE 32: FIELD I; VIEWED FROM THE NORTH-EAST.

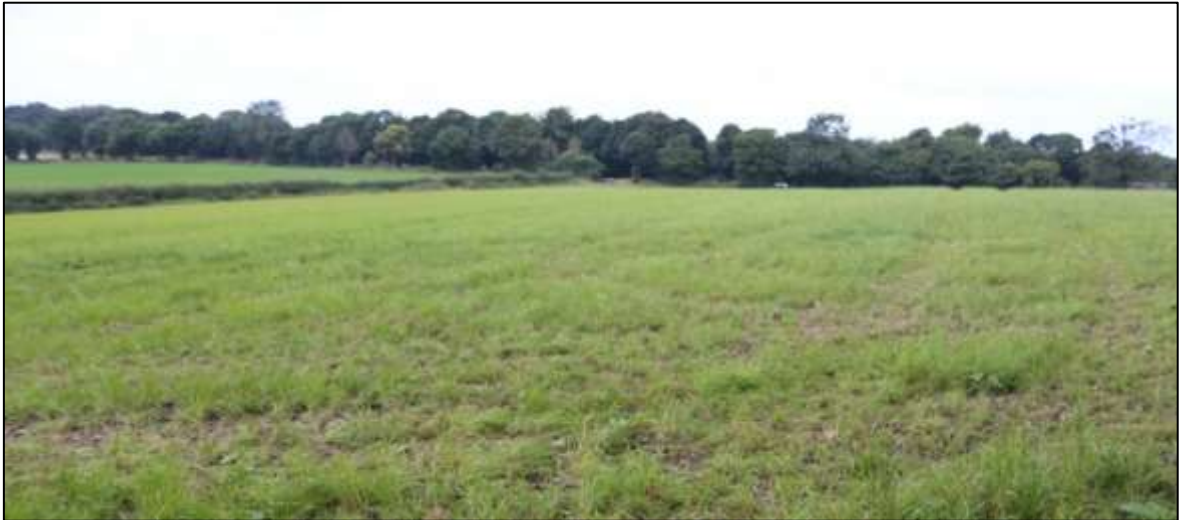
A small (3.5ha) rectangular field, defined by a Type 1a stone wall to the north and hawthorn hedges to the east, south and west. The boundary flanking the A642 is (or was) lined with mature trees, spaced c.15m apart; these trees are mainly oak and ash. The field slopes very gently to the north and west. Hillhouse Wood projects into the south-east corner of this field, and remnants of a wooden fence survive here. Within Hillhouse Wood a broad bank on the line of the southern hedgerow was observed. This field was subject to opencast in 1965.

FIGURE 33: FIELD J; VIEWED FROM THE SOUTH-SOUTH-EAST.

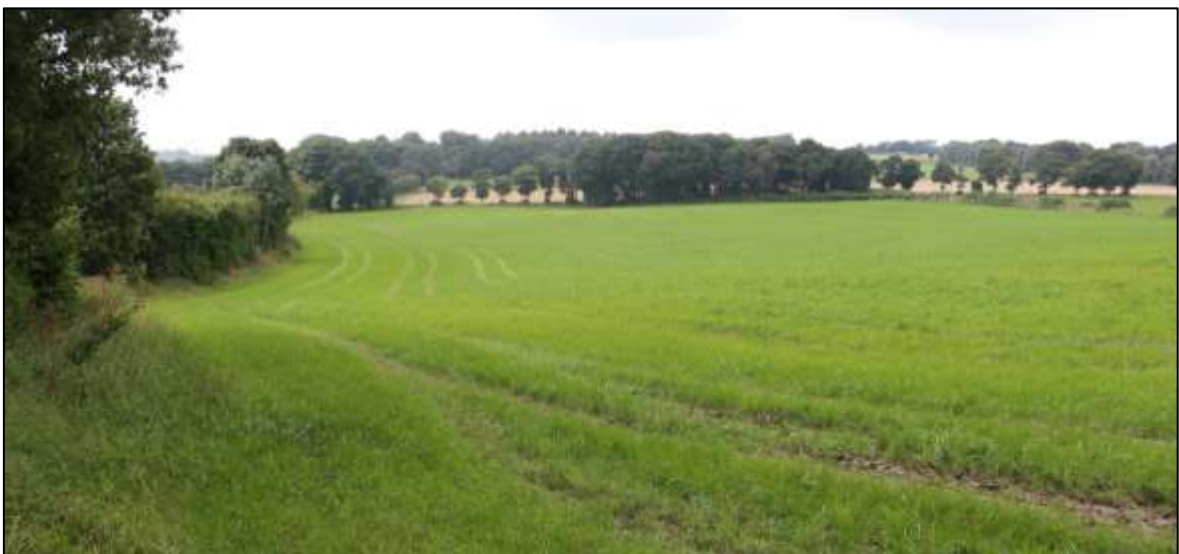
A small (3.5ha) rectangular field, defined by Type 1a stone wall to the west, a hawthorn hedge to the north, the edge of Hillhouse Wood to the east, and a more mixed species (and therefore older) hedge to the south, with blackthorn, elderberry, ash, and hazel. The wall to the west features a line of evenly-spaced sycamore trees. There is a small copse of young oak trees to the north-west corner of the field, and a stand of Japanese Knotweed to the northern end of the copse. This is presumably invasive in this context. Most of the field slopes gently to the south, but the eastern end of the field slopes down from Hillhouse Wood. The surface of the field is fairly level. This field was subject to opencast in 1965.

FIGURE 34: FIELD K; VIEWED FROM THE EAST.

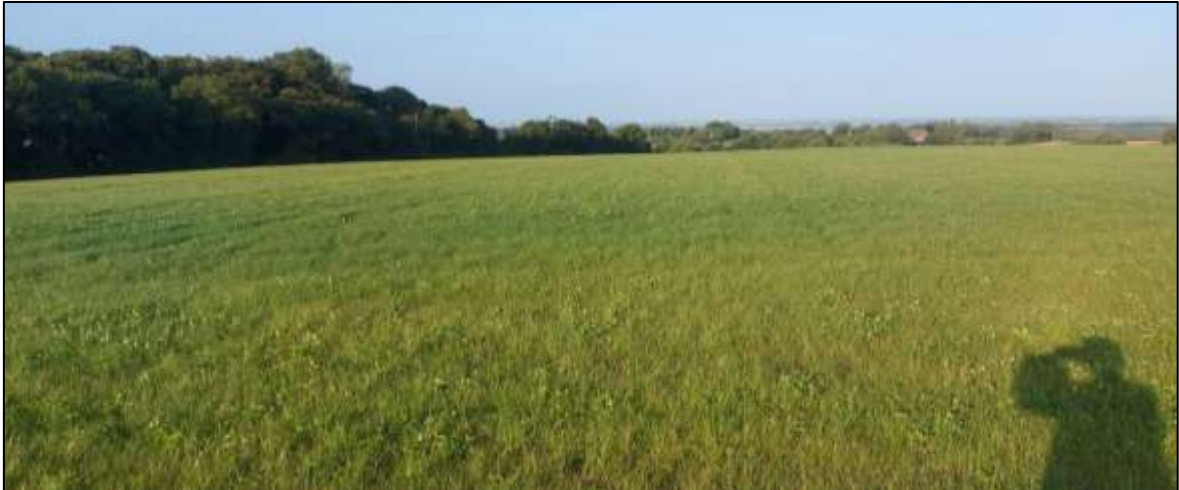
A larger (6.5ha) sub-triangular field with traces of Type 1a walling to the north-west corner, but otherwise defined by largely hawthorn hedges growing through wooden fencing. The boundary to the west lacks the hedge shrubs and is reinforced with a post-and-wire fence. The hedge along Grange Lane has been allowed to grow up, and contains some young trees, particularly to the western end, and some ash and holly. The eastern corner of the field has been allowed to revert to scrubby woodland. Just beyond the north-east corner of the field is a small later 19th century brick cottage, rather out of place in this location as it is the last surviving unit of a terrace demolished after 1961. The field slopes to the east and the surface of the field is very level and there is no trace of the colliery and claypits that were once located here. This field was subject to opencast in 1965.

FIGURE 35: FIELD L; VIEWED FROM THE WEST.

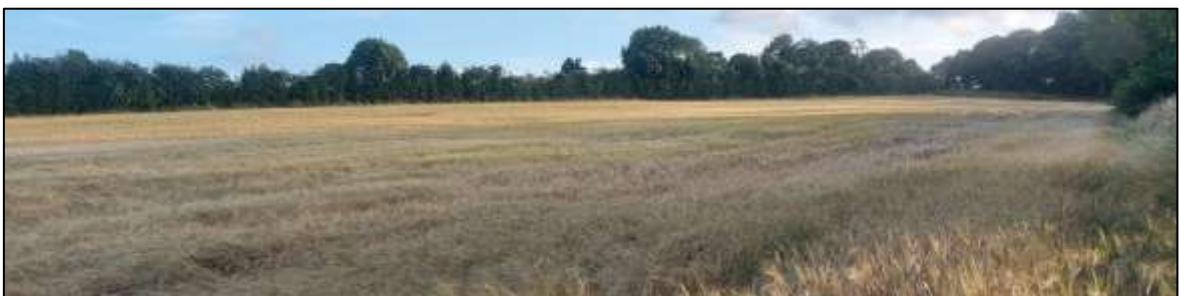
A small (2.5ha) triangular defined by largely hawthorn hedges growing through wooden fencing. The level of the A642 to the north is much higher than the field for much of its length, and there are traces of Type 1a walling along the western stretch of this boundary. The westernmost corner of the field flanks a rough track and only a few hedge shrubs form this boundary. To the south-east corner there are a series of recently repaired stone-walled enclosures; the larger enclosure contained a dwelling until after 1955, and they would have formed gardens to neighbouring properties. The topsoil in the field immediately adjacent to these enclosures contained common to frequent 19th century industrial whitewares (pottery). Beyond the wooden fence to the east, and within the woodland here, is a very deep cutting, a surviving part of the mineral railway that addressed Caphouse Colliery. The field slopes to the east and the surface of the field is generally fairly level although there is a possible level area to the south-east corner and a pronounced tapering linear hollow roughly parallel with the A642 to the north. This field was subject to opencast in 1965.

FIGURE 36: FIELD M; VIEWED FROM THE EAST.

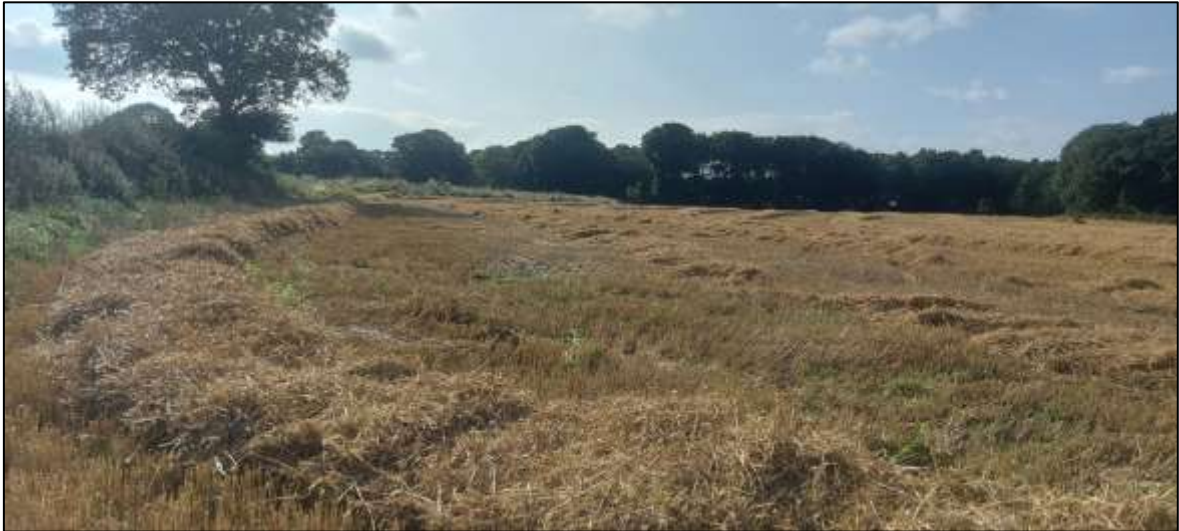
A small (1.8ha) irregular field defined, to the west, north and east, by the two narrow but deep cloughs that form Harry Royd Clough. This boundary is defined by short Type 2 walls, although to the centre there is a large stone quarry (marked on the tithe and OS maps). Just beyond the north-east corner of this field, within the woodland, is the large conical mound with deep central depression marking the location of a shaft (and indicated as such on BGS mapping). The southern boundary of the field is defined by the track that drops down from Low Farm, with its post-and-wire fencing. To the south-east there is a short stretch of hawthorn hedge. The surface of the field is fairly level, and slopes gently to the north.

FIGURE 37: FIELD N; VIEWED FROM THE EAST.

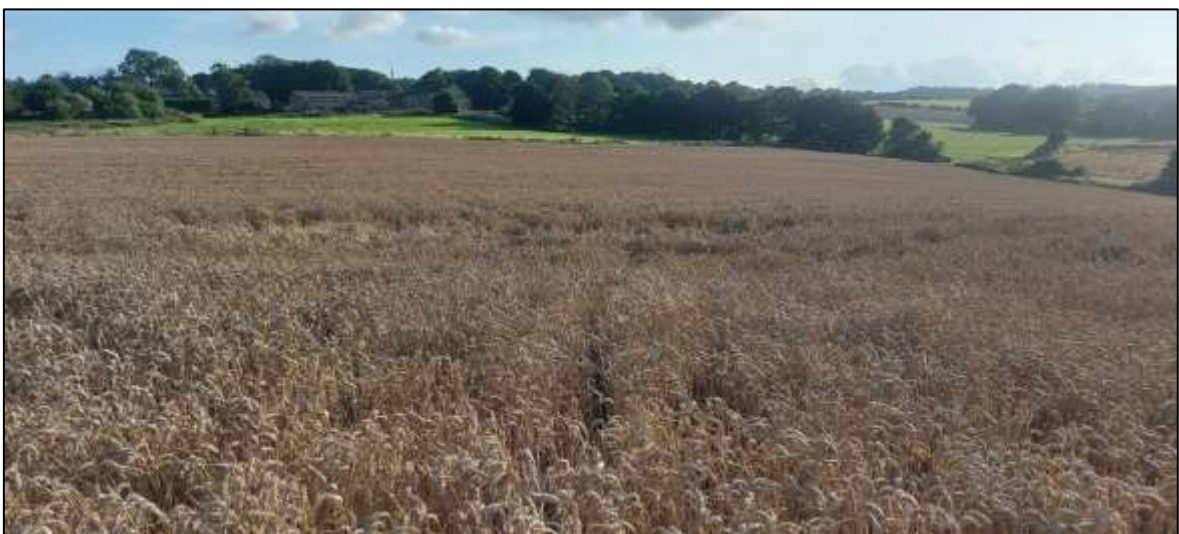
A small (3ha) sub-rectangular field, with an area to the north-east corner set aside to paddocks. It is defined to the south by a weathered wooden fence, to the south-east corner by the remains of a chainlink fence (only the concrete posts survive) around a reservoir, and to the east by a Type 2 wall. The paddocks are defined by modern wooden fences. To the north the field is bounded by a tall hawthorn hedge, and to the west by Harry Royd Clough. The field slopes down to the west, and the surface is fairly level. This field was subject to opencast in the 1960s.

FIGURE 38: FIELD O; VIEWED FROM THE NORTH-EAST.
