LAND AT LOW FARM GRANGE MOOR WAKEFIELD WEST YORKSHIRE

Results of a Heritage Assessment

South West Archaeology Ltd. report no. 210630

By F. Balmond & B. Morris
Report Version: FINAL
30th August 2021

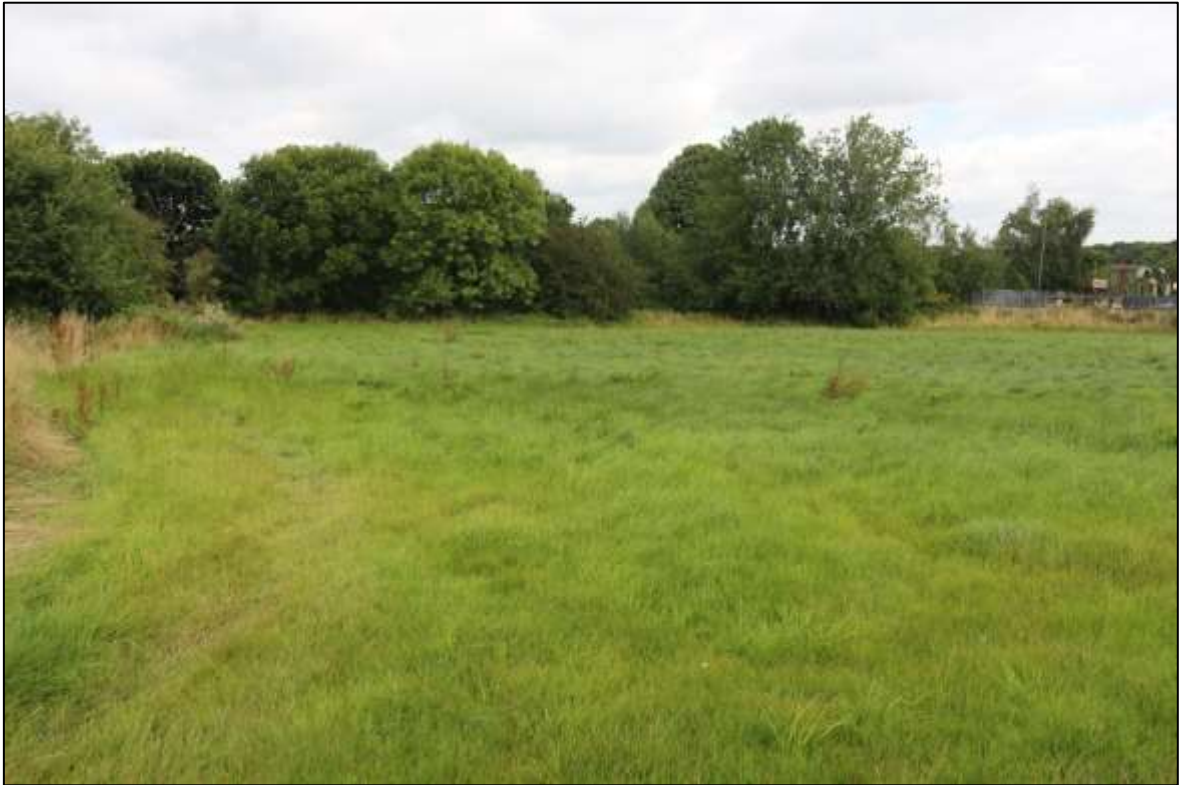
The smallest field (0.4ha) is the rump of a much larger enclosure steadily encroached upon from three directions. It is defined by a tarmac road to the south, mixed fencing to the east with stretches of surviving Type 2 walling and trees, and overgrown modern wooden fencing with trees to the north. To the west ground levels have been raised to build an agricultural barn. Materials – mainly architectural spolia – are being stored along the southern and western sides of this field. The field slopes gently to the north and clear ridge and furrow is visible.

FIGURE 39: FIELD P; VIEWED FROM THE SOUTH-SOUTH-WEST.

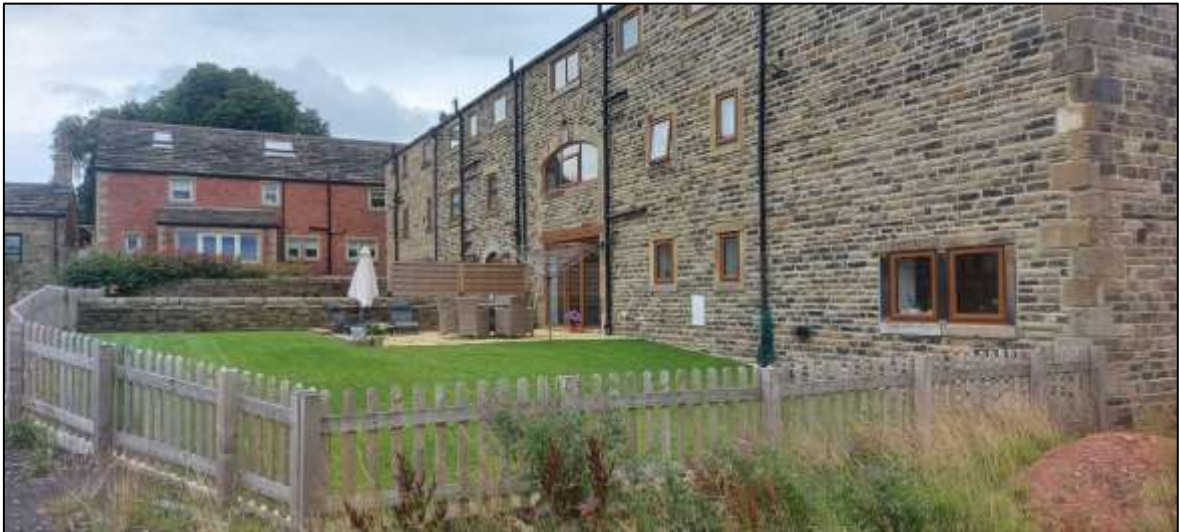
FIGURE 40: THE WESTERN SIDE OF THE COURTYARD AT LOW FARM; THE 'FARMHOUSE' FACED IN BRICK TO THE LEFT; VIEWED FROM THE NORTH-NORTH-EAST

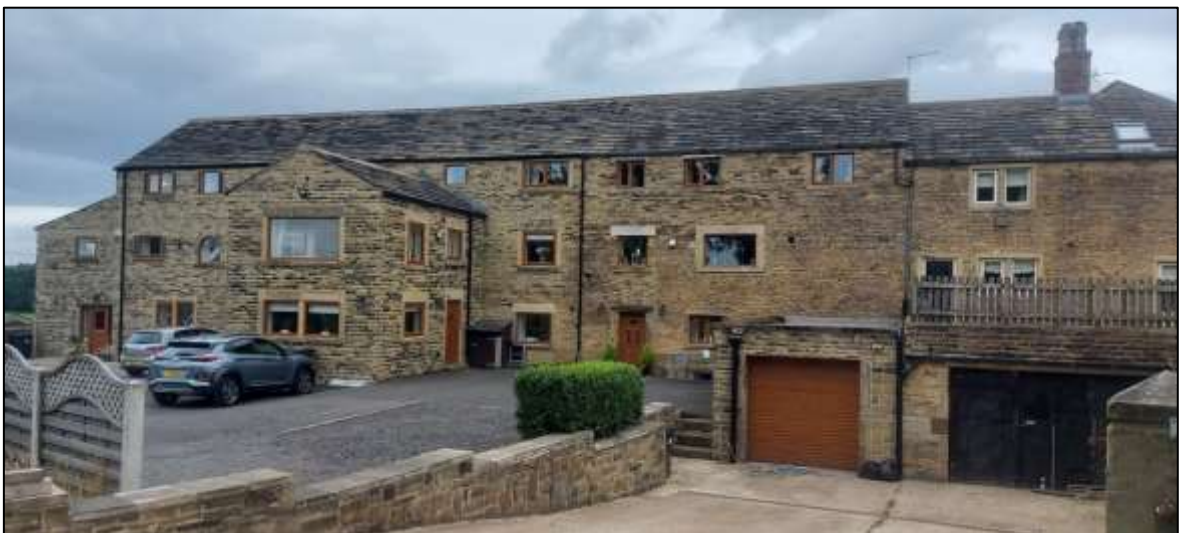
FIGURE 41: THE EASTERN SIDE OF THE U-SHAPED RANGE, ALL NOW CONVERTED TO RESIDENTIAL USE; VIEWED FROM THE WEST.

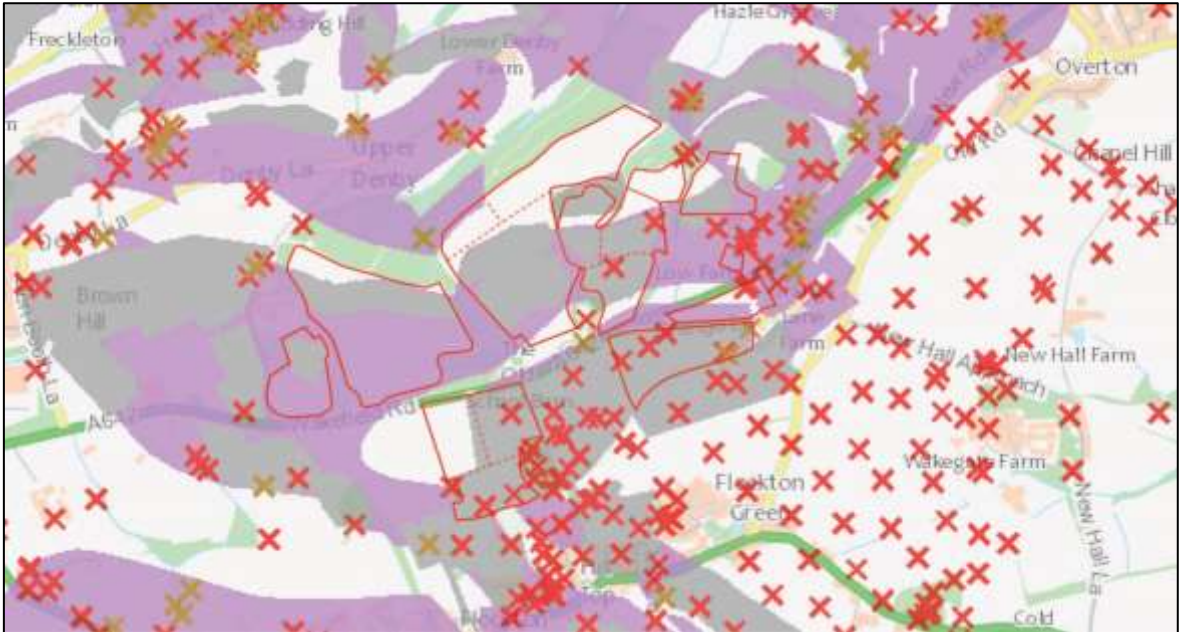
FIGURE 42: IMAGE DERIVED FROM THE COAL AUTHORITY INTERACTIVE VIEWER (SEE REFERENCES). KNOWN SHALLOW WORKINGS IN GREY, AREAS LIKELY TO HAVE BEEN SUBJECT TO SHALLOW WORKING IN PURPLE; MINE ENTRY MARKED AS RED (SHAFT) OR BROWN (ADIT) CROSSES. THE SITE IS INDICATED.

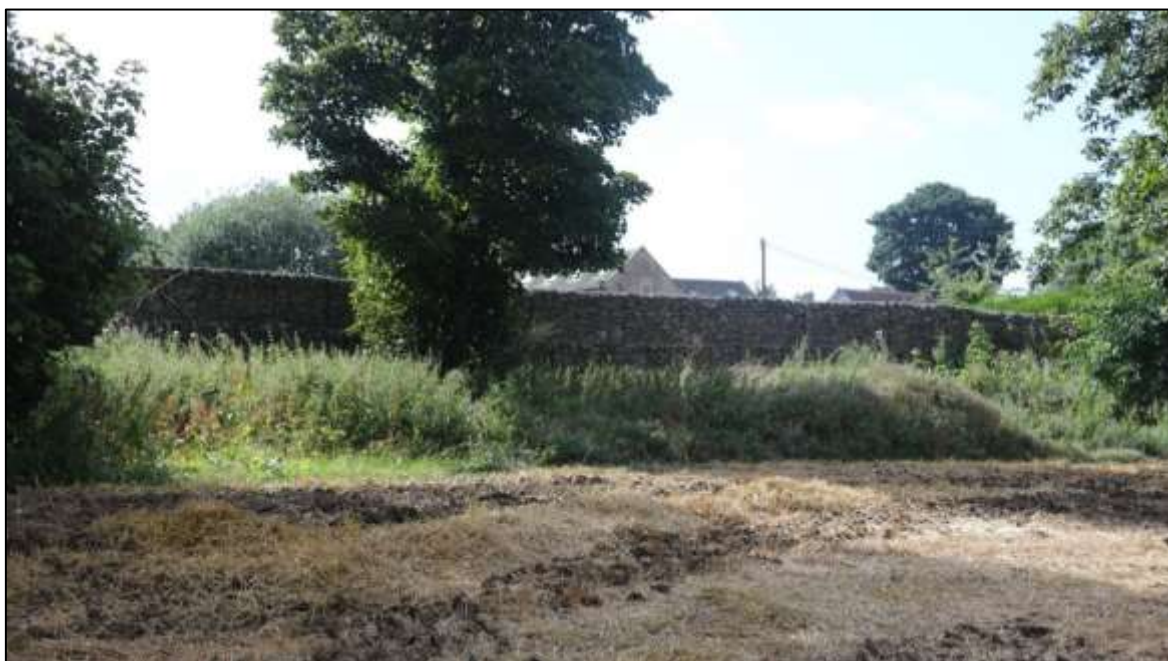
| <p><i>Magnitude of Impact:</i> Minor change + Medium value asset = Slight impact</p> |
| <p><i>Overall Impact Assessment:</i> Negative/Minor</p> |

FIGURE 43: THE LISTED BARN, AS VIEWED FROM FIELD B OVER A WALL OF GABION BASKETS; VIEWED FROM THE EAST.

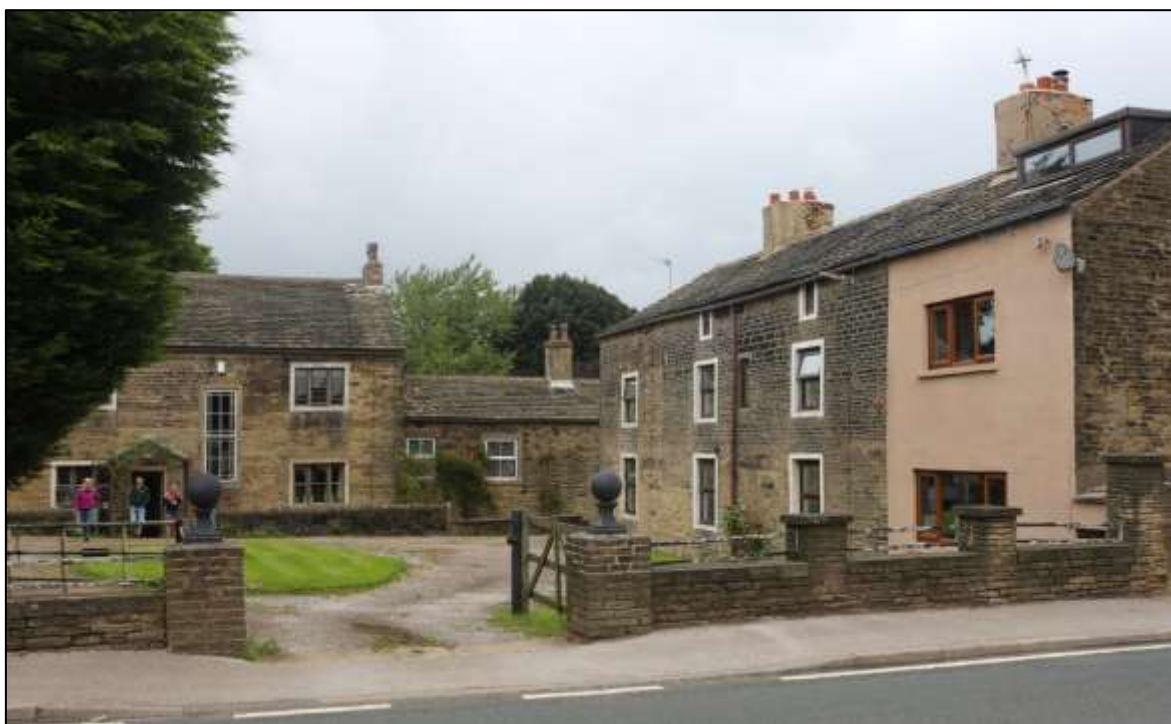
| <p><i>Conservation Value:</i> The farm is historic in character with interesting architectural details observed; it has aesthetic value in this regard. As a potentially early holding predating the parkland landscape it may hold some local historical value but no known associational value. It has no communal value but is expected to have high evidential value.</p> | |
| <p><i>Authenticity and Integrity:</i> The farmhouse is still a single dwelling, and the cottages are still in multiple occupancy. The barns have been converted into dwellings, many repaired and restored using stone reclaimed from other local buildings that have been demolished. Whilst the site is historic in character overall therefore, there is no guarantee of the historical authenticity of some features and the barns will of course have been stripped out internally before conversion.</p> | |
| <p><i>Magnitude of Impact:</i> Minor change + Medium value = Slight impact</p> | |
| <p><i>Overall Impact Assessment:</i> Negative/Minor</p> | |

FIGURE 44: ROOKERY FARM; VIEWED FROM THE A642 TO THE SOUTH.

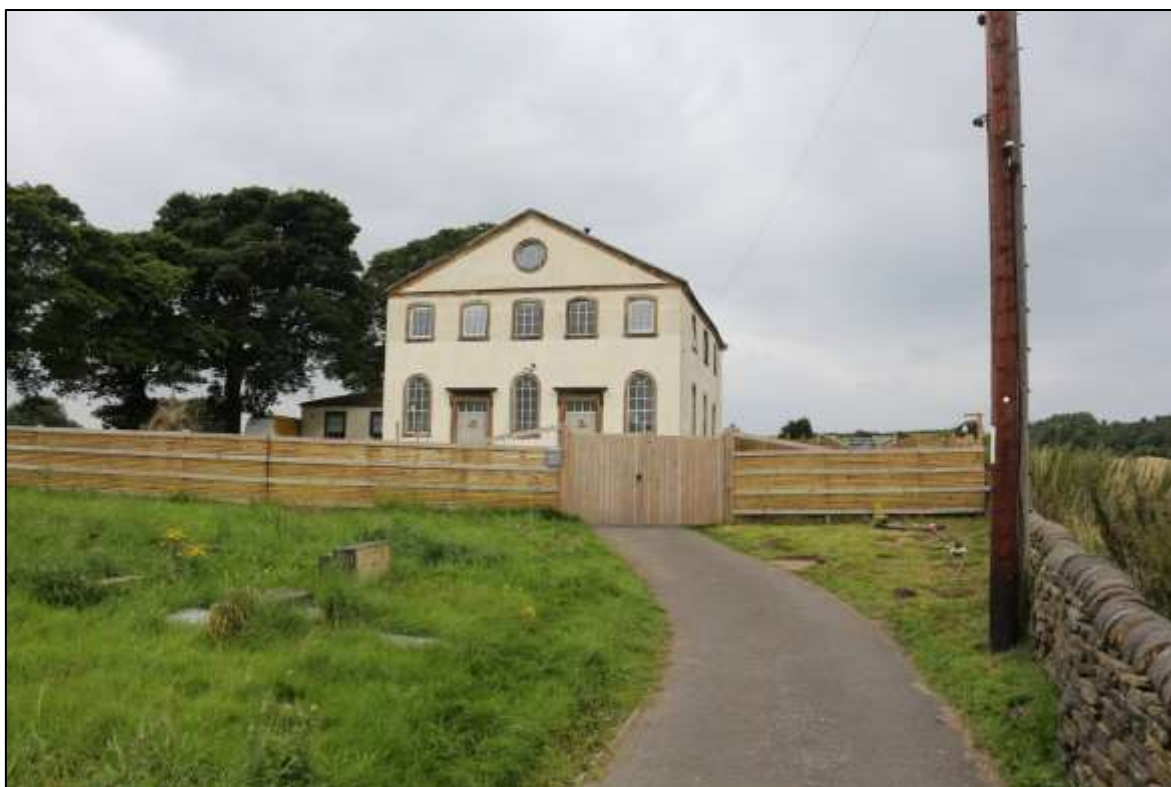
| <i>Magnitude of Impact:</i> Negligible change + Medium value = Neutral/Slight impact |
| <i>Overall Impact Assessment:</i> Negligible |

FIGURE 45: THE SOUTH FRONT OF THE CHAPEL; VIEWED FROM THE SOUTH.

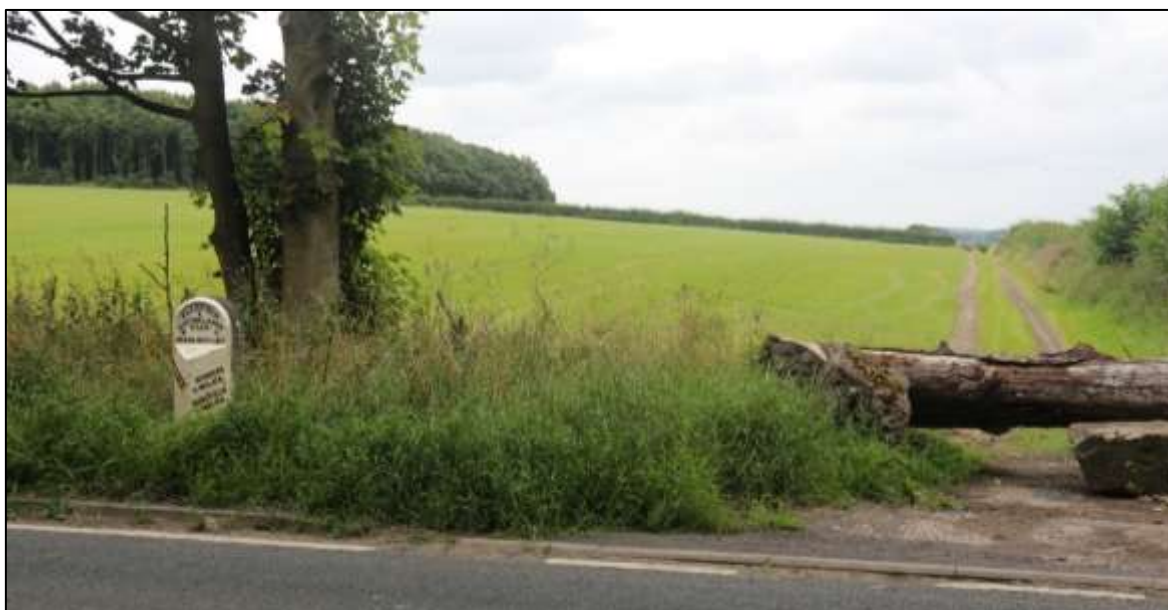
| Asset Name: 6.25 milepost, 0.25miles west of Junction with Grange Lane | |
|---|---|
| <i>Magnitude of Impact:</i> Moderate change + Medium value = Moderate impact | |
| <i>Overall Impact Assessment:</i> Negative/Minor | |

FIGURE 46: THE LISTED MILESTONE JUST TO THE NORTH OF FIELD J; VIEWED FROM THE NORTH.

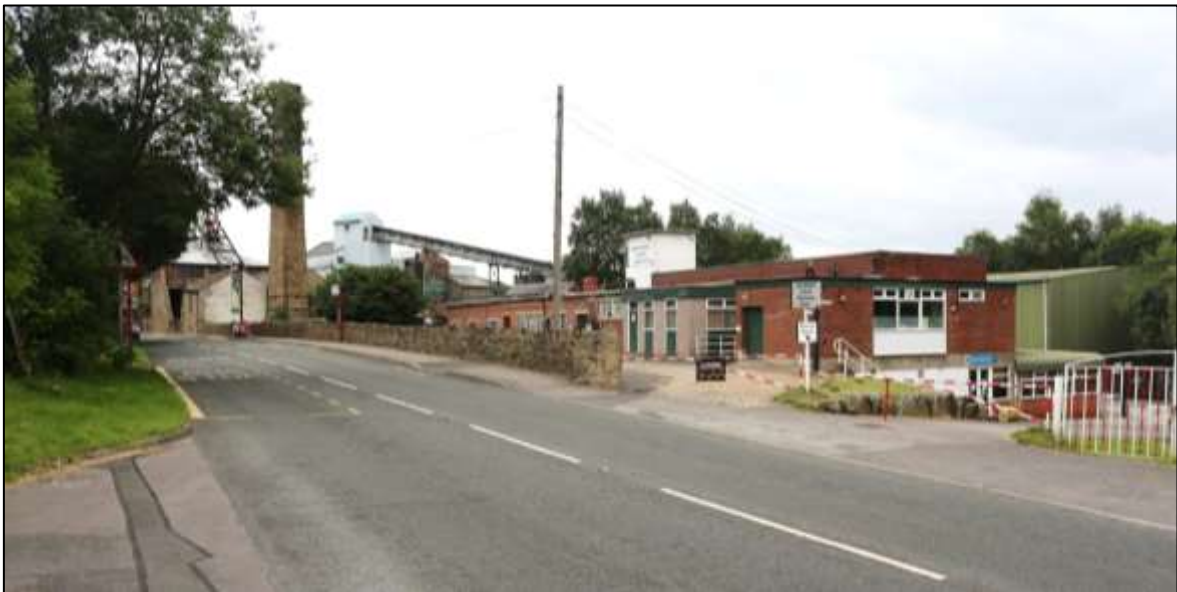
Magnitude of Impact: Negligible change + High value = Slight impact

Overall Impact Assessment: Negligible

FIGURE 47: THE COLLIERY; VIEWED FROM THE A642 TO THE EAST.

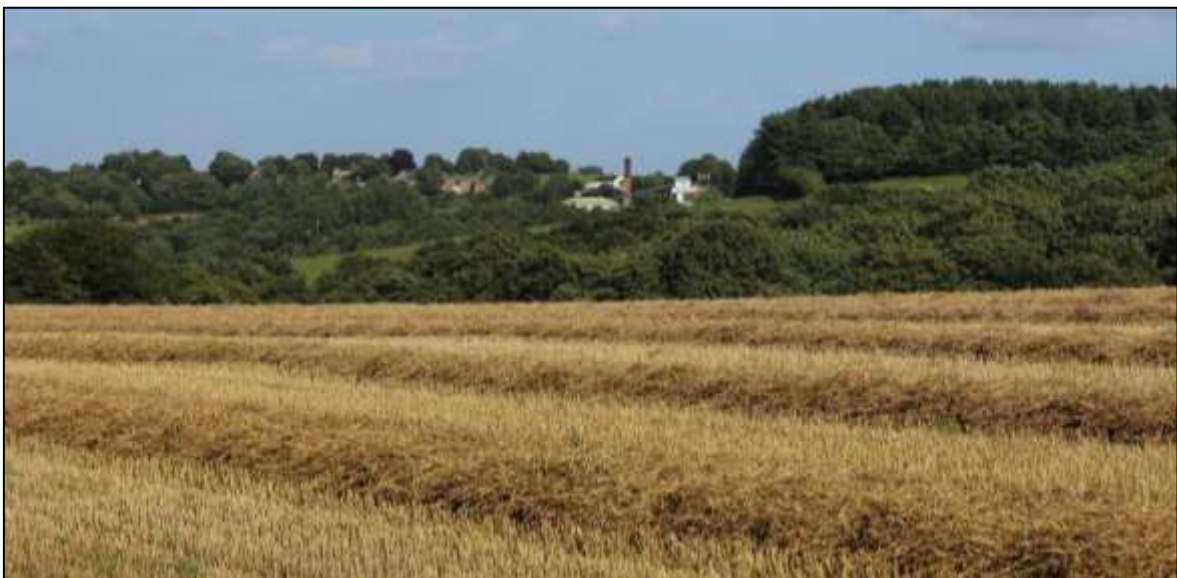
FIGURE 48: VIEW ACROSS THE FIELDS FROM THE NORTH-EASTERN END OF FIELD E TO THE LISTED COLLIERY BUILDINGS; VIEWED FROM THE NORTH-WEST.

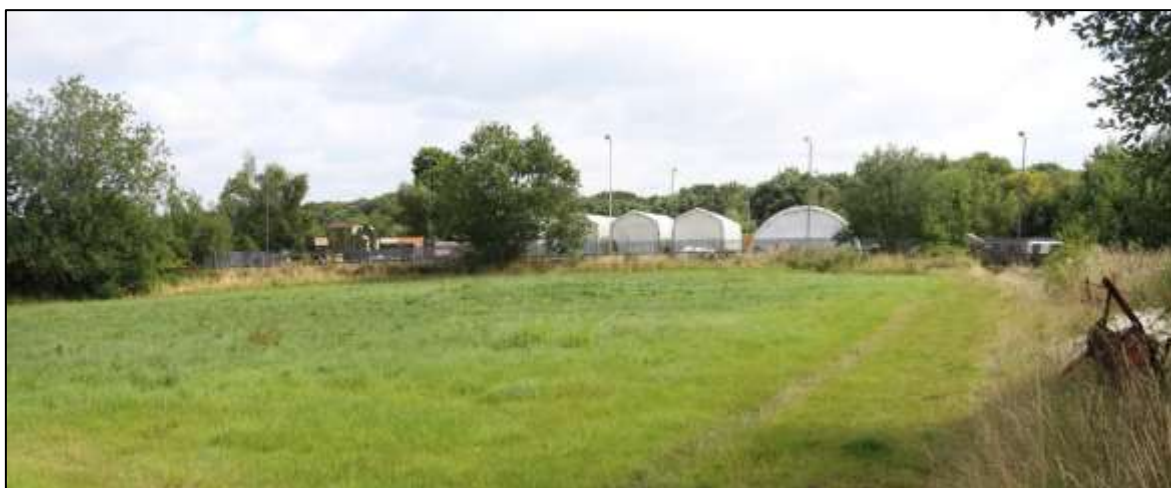
| <p><i>Magnitude of Impact:</i> Moderate change + Medium value = Moderate impact</p> | |
| <p><i>Overall Impact Assessment:</i> Negative/Minor to Negative/Moderate (i.e. there would be a physical impact)</p> | |

FIGURE 49: THE WESTERN EDGE OF THE CONSERVATION AREA WITH FIELD P IN THE FOREGROUND; VIEWED FROM THE WEST.
