# Greenhead College

## Phase II Geotechnical and Geoenvironmental Assessment

Dunelm Geotechnical &  
Environmental Ltd on Behalf of  
Galliford Try Building Ltd.

Doc Ref: NE8659-CDL-ZZ-XX-RP-GE-60200

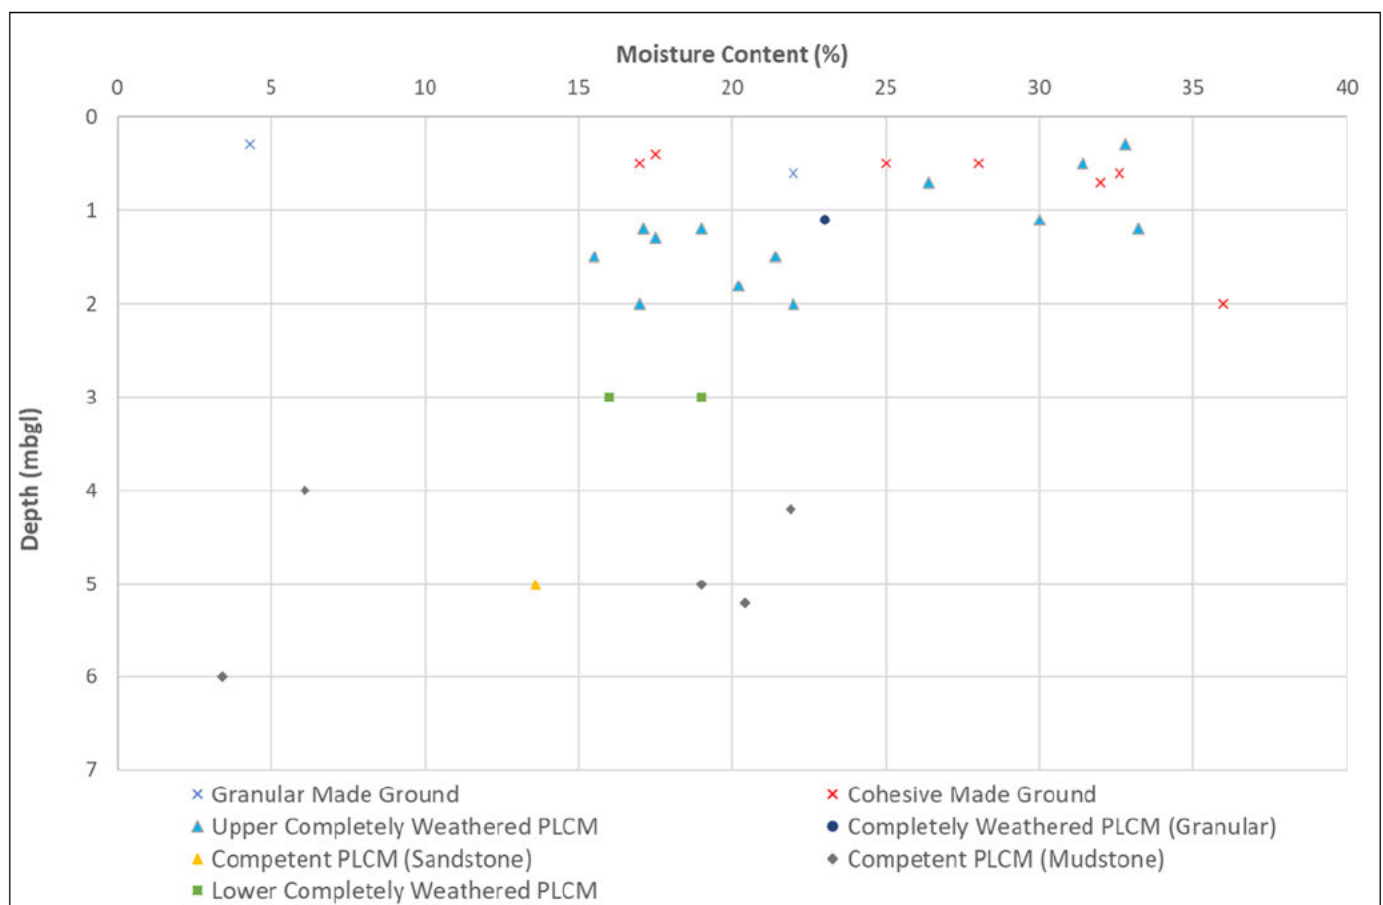
Figure 3: Moisture Content against Depth

A plot of the moisture contents of all strata encountered is presented as Figure 3 with each stratum discussed separately in the following sections.

Two tests were undertaken on the granular made ground and recorded moisture contents of 4.3% and 22.0%. The moisture content of 4.3% was recorded on a sample described as sandy gravelly cobbles and is not considered representative of the site wide granular made ground.

Seven tests were undertaken on the cohesive made ground and recorded moisture contents ranging from 17% to 36%.

13 tests were undertaken on the upper weathered PLCM and recorded moisture contents ranging from 15.5% to 33%. A further two tests were undertaken on the granular deposits and these both recorded a moisture content of 23%.

Two tests were undertaken on the lower unit and recorded moisture contents of 16% and 19%.

Six tests were undertaken on the competent PLCM, five of which were undertaken on mudstone and one on sandstone. The moisture contents of the mudstone ranged from 3.4% to 21.9% and a moisture content of 13.6% was recorded on the sample of sandstone.

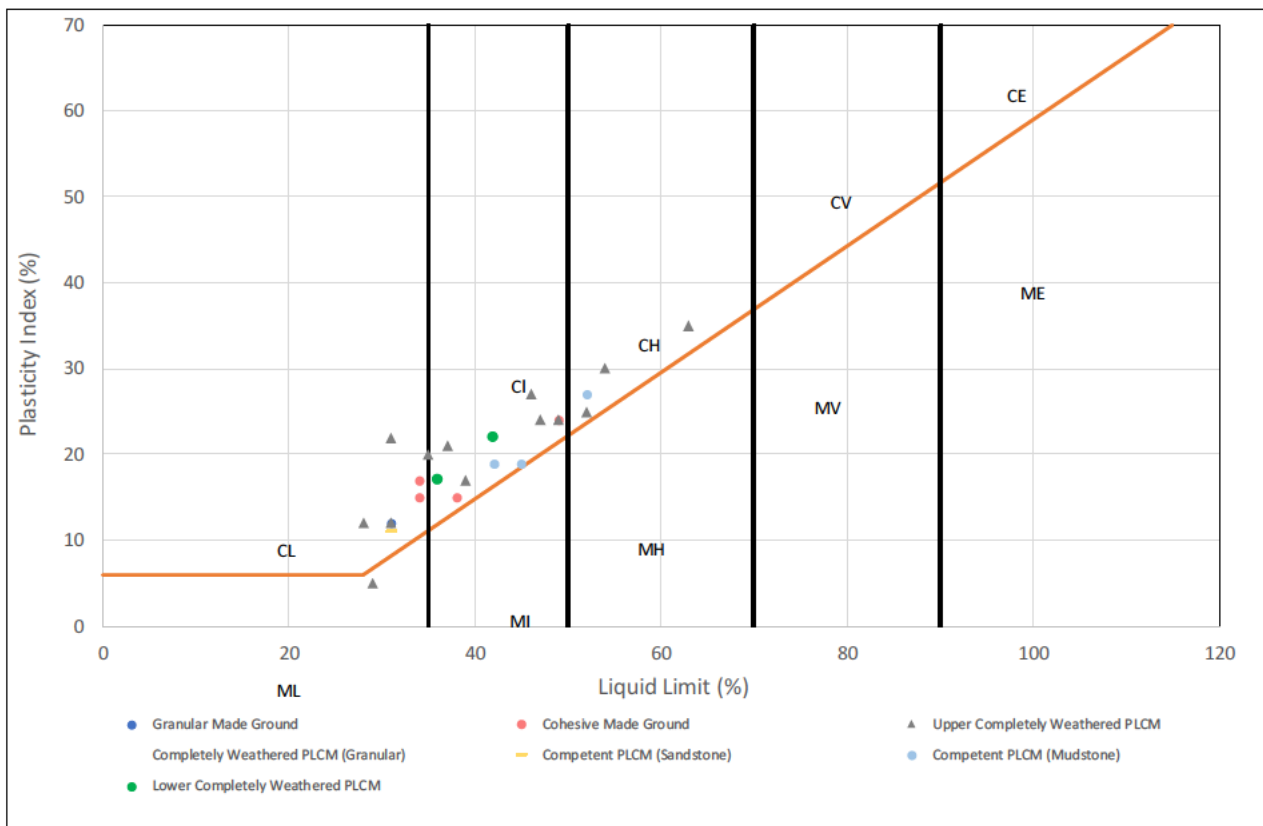
Figure 4: Modified Plasticity Indices for Strata Encountered

Atterberg Limits testing was scheduled within all cohesive strata encountered and a small number were undertaken in material described as cohesive which proved to be granular in nature during testing. The testing results (modified to account for percentage passing a 425um sieve) is shown in Figure 4 and results are subsequently discussed for each strata.

Atterberg Limits testing was completed on four samples of cohesive made ground and returned modified plasticity indices between 8% and 18% indicating it to be a low plasticity clay or silt of intermediate plasticity.

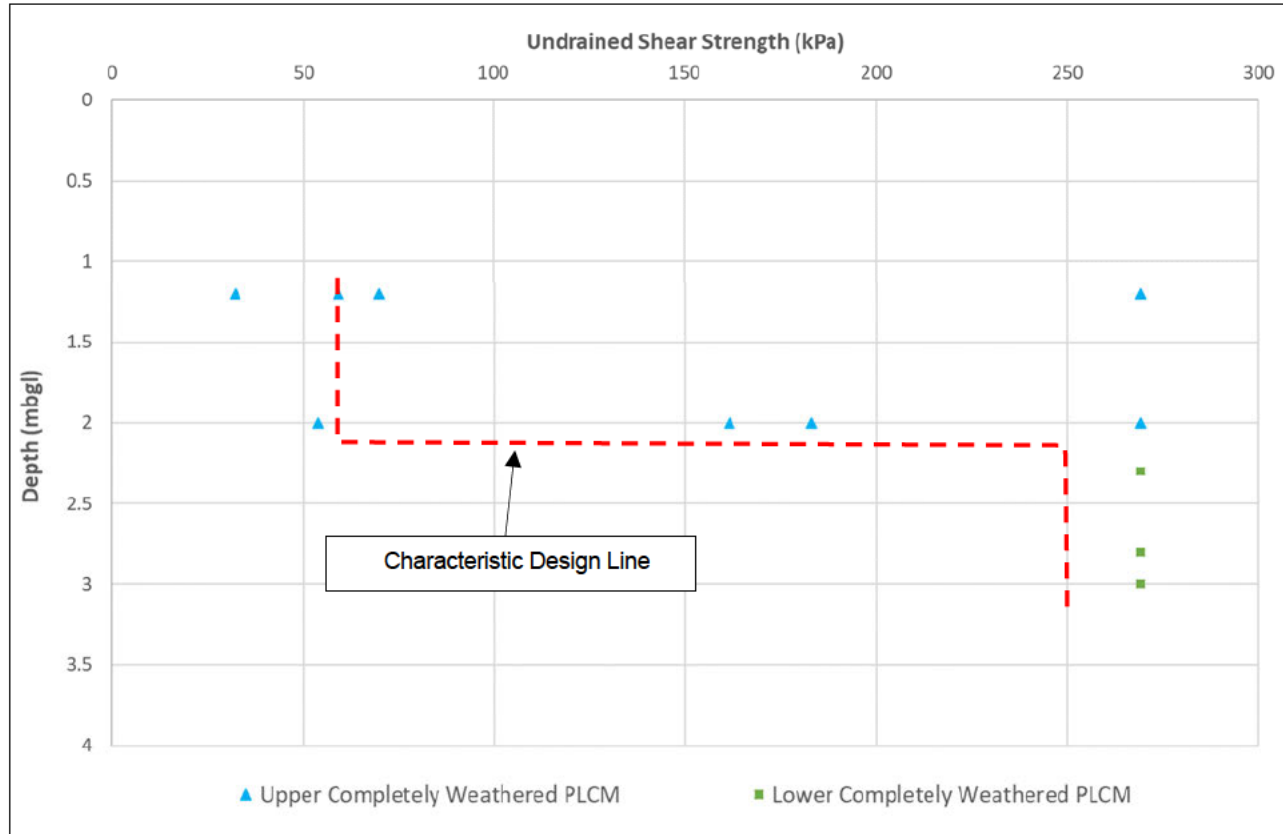
Figure 6: Undrained Shear Strength Against Depth

Based on Stroud, M. A., 1975, SPT 'N' values may be used along with Plasticity Index to estimate undrained shear strength, values derived in this way are plotted in Figure 6 below.

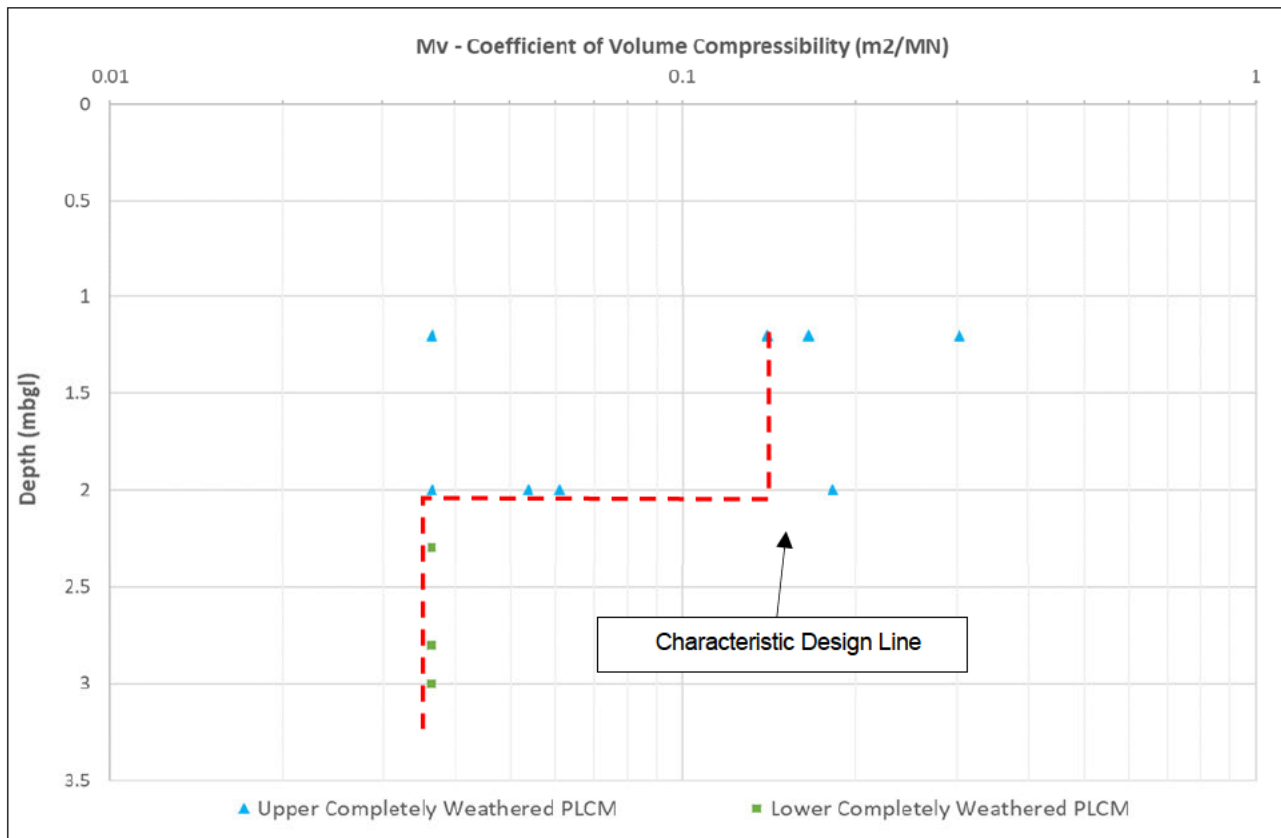
Figure 7: Modulus of Volume Compressibility ( $M_v$ ) versus Depth / Elevation

Using Stroud, M. A., 1975, SPT 'N' values may be used to derive the modulus of volume compressibility ( $M_v$ ) using factors  $f_1$  and  $f_2$ , determined from the characteristic plasticity index. Based on this relationship,  $M_v$  values have been derived from the available data and plotted in Figure 7 below.

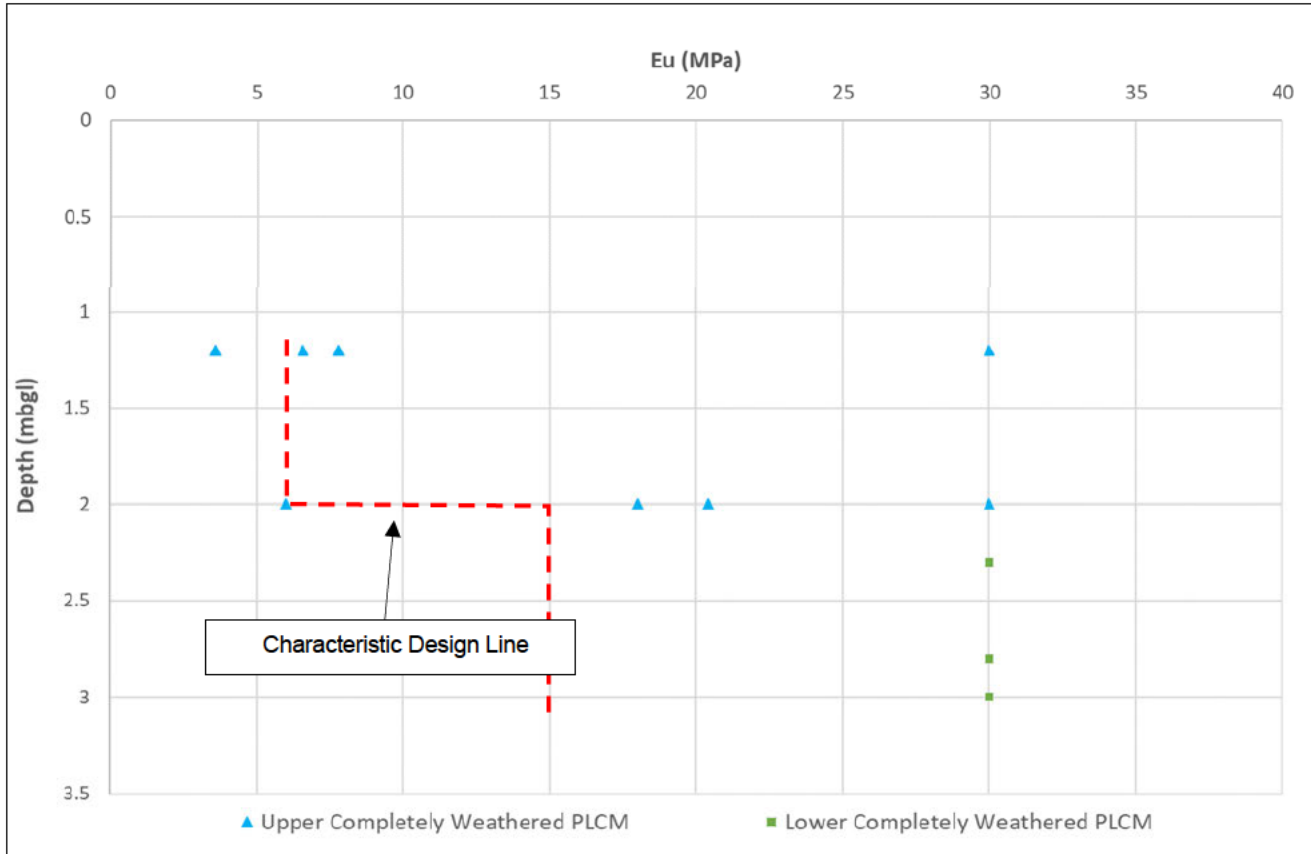
Figure 8: Young's Modulus Vs Depth

$$E_u = (0.6) \cdot N$$

The derived stiffness values range from 3.6MPa to 30MPa.

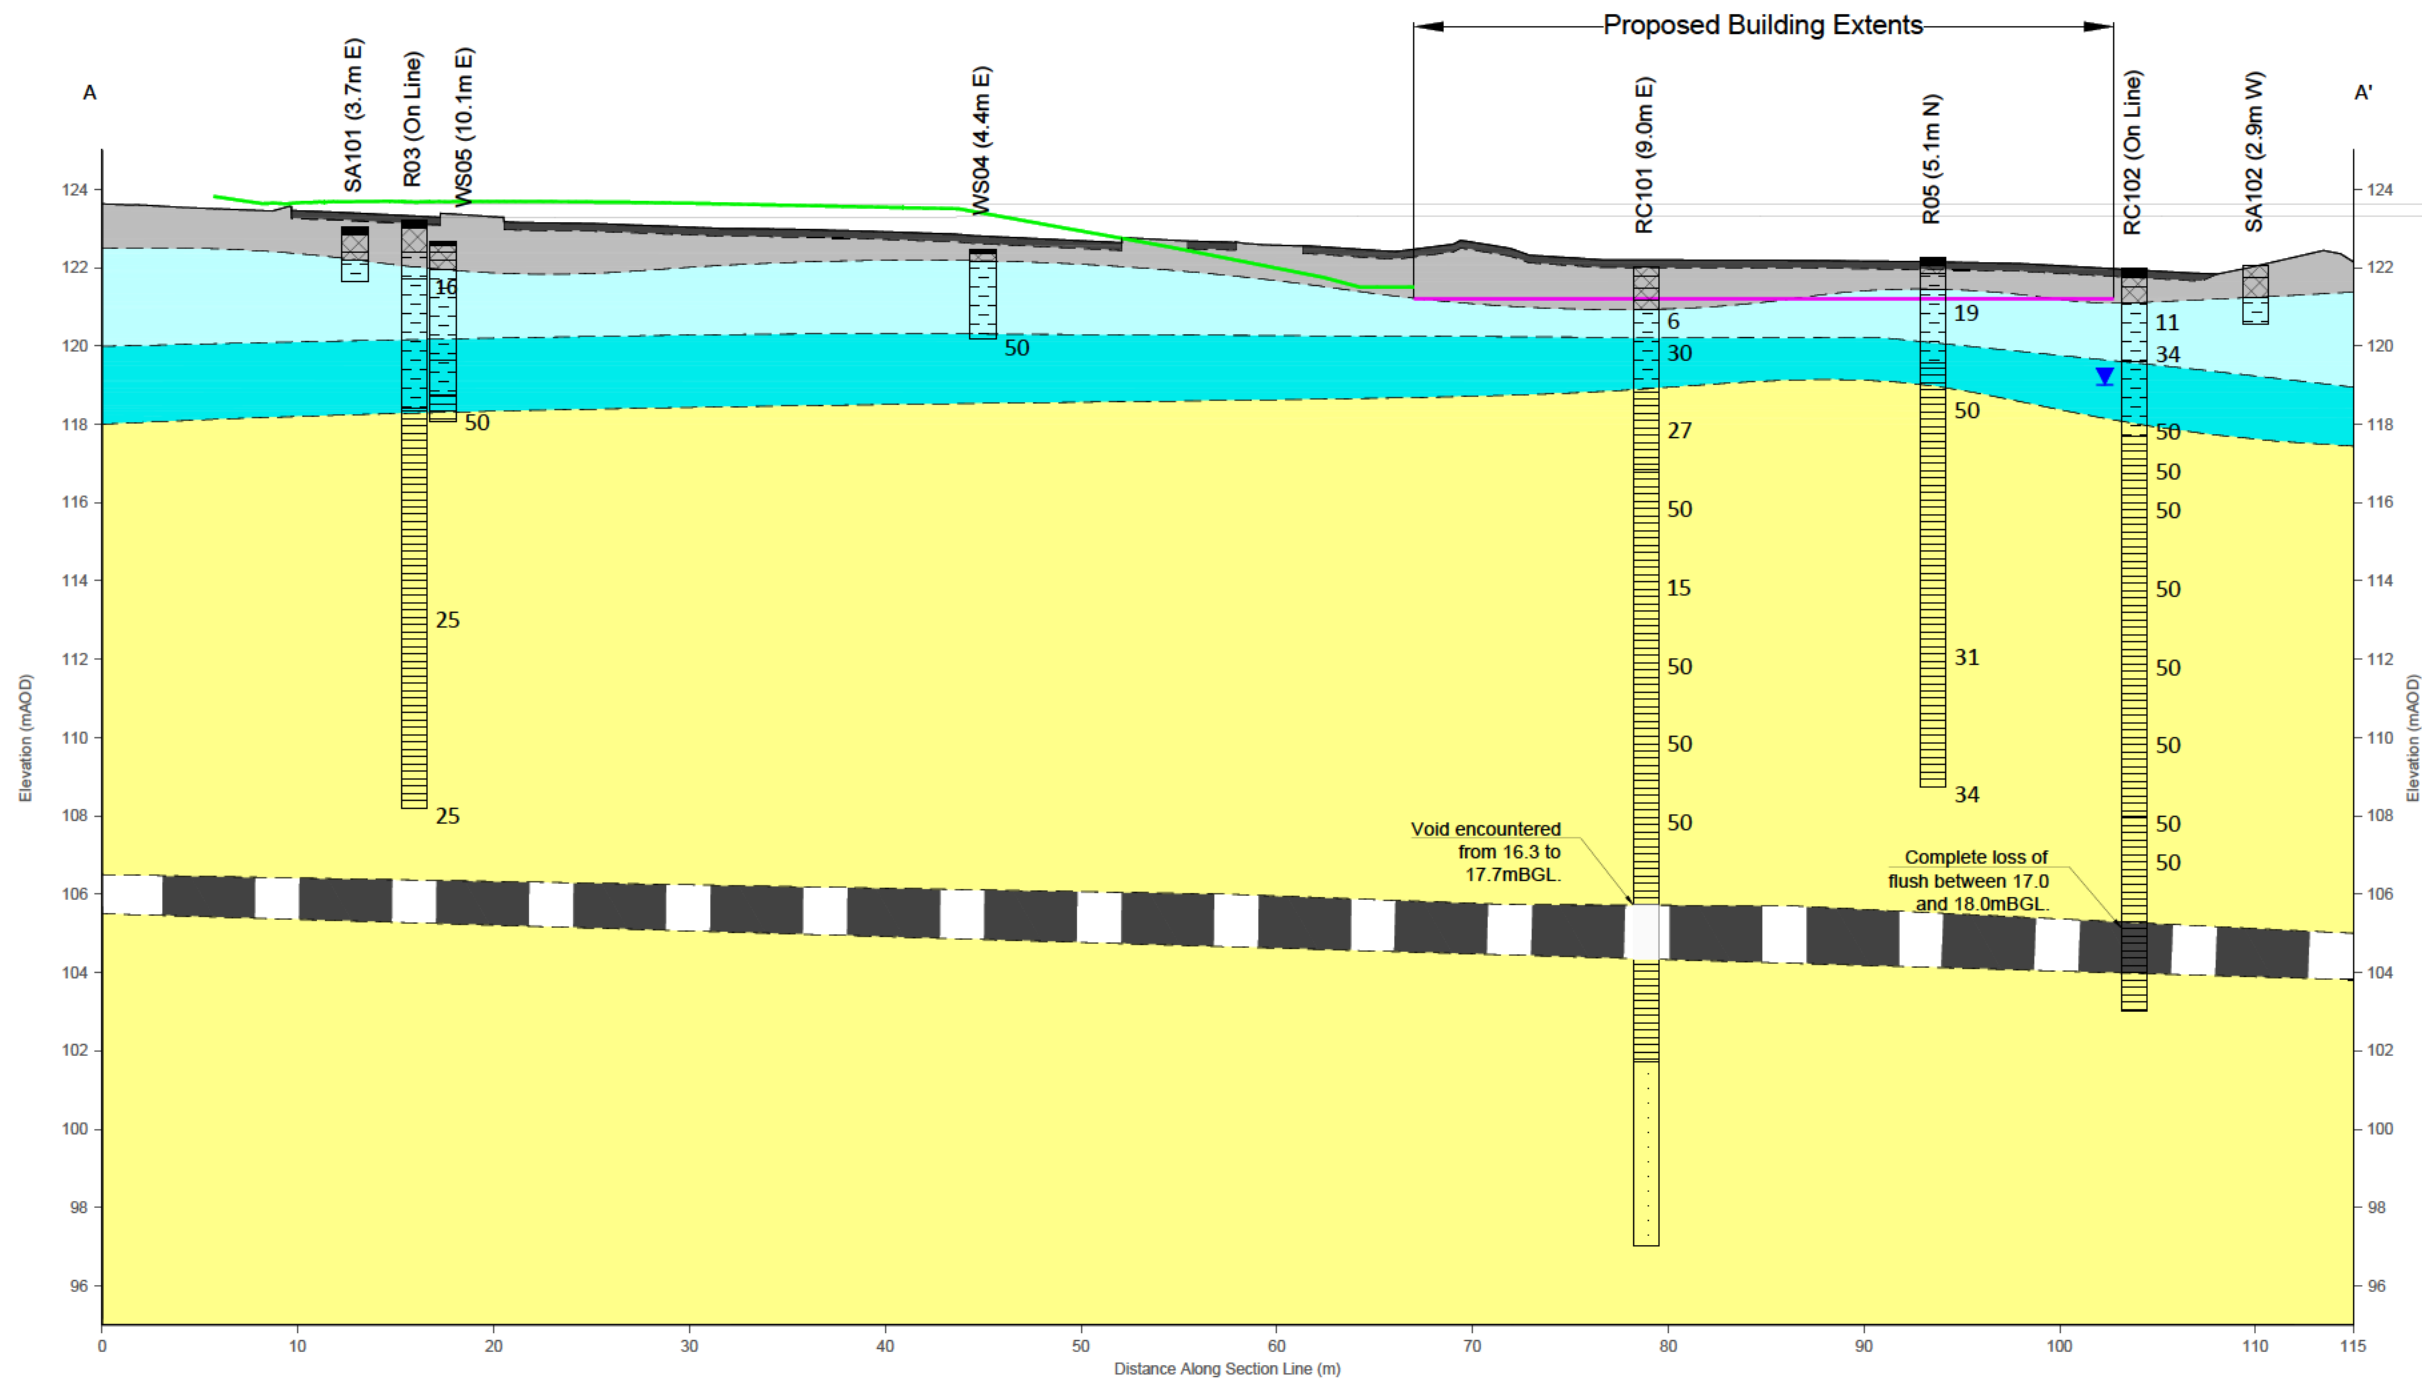
Cross Section A-A'  
2x Vertical Exaggeration

- Inferred Geological Boundary
- Proposed Finished Development Level
- Proposed Formation Level
- Water Strike
- (X)m Denotes Offset From CS Line
- 14 SPT N Value
