**Proposed Highway Works
Associated with Dewsbury
Riverside Development**

Stage I Road Safety Audit

November 2022

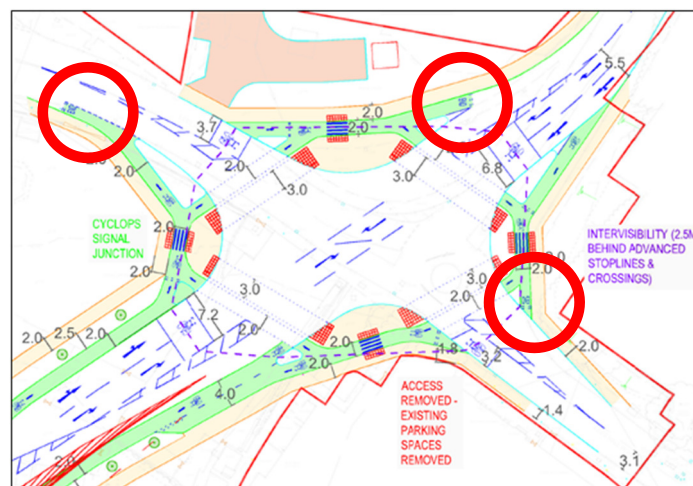
Location: Ravensthorpe Road / Forge Lane / Lees Hall Road / Link Road traffic signal junction

Summary: Risk of vehicle/cyclist collisions due to discontinuation of cycle facilities at the junction exits

Although the traffic signal junction provides dedicated facilities for cyclists around the junction, on three of the four exit arms (northern, eastern and western) cyclists are required to exit the junction directly onto the carriageway and share road space with motorised users. It is acknowledged that constraints on existing roads are likely to limit the ability to continue with protected cycle facilities, but in attempting to re-join the carriageway, cyclists are likely to be vulnerable to side-swipe collisions from vehicles travelling through the junction. The northern and eastern cycle slips bring cyclists onto the carriageway very close to the controlled area of the junction. The western cycle slip would bring cyclists onto carriageway close to a location where on-street car parking takes place and is likely to require cyclists to make sharp movements to avoid the parked vehicles, which may bring them into conflict with other road users.

It is recommended that the arrangements which require cyclists to re-join the carriageway upon exiting the junction are reviewed, with suitable design enhancements made which offer improved safety benefits for cyclists.

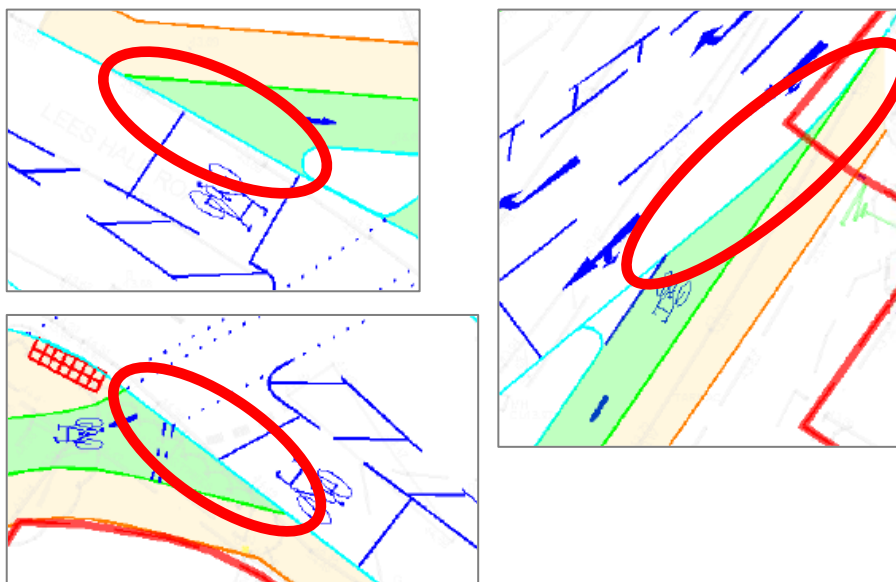
Location: Locations on Ravensthorpe Road / Forge Lane / Lees Hall Road where cyclists transition from the carriageway to off-road provision

Summary: Risk of cyclists losing control and falling from their bicycle as they negotiate a kerb upstand at an acute angle

At a number of locations across the scheme, cyclists will be required to transition from on-road to off-road cycle provision. At these transition points a generally acute angle of approach is provided and if even a minimal kerb upstand is provided, it is likely to form a loss of control hazard for cyclists (particularly those on narrow wheeled bicycles). Kerb check at the transition points is referenced as being half height. A cyclist negotiating an upstand at an acute angle would be likely to fall from their bicycle and potentially sustain injury.

It is recommended that a flush kerb arrangement is provided at all locations where cyclists transition from on-road to off-road areas.

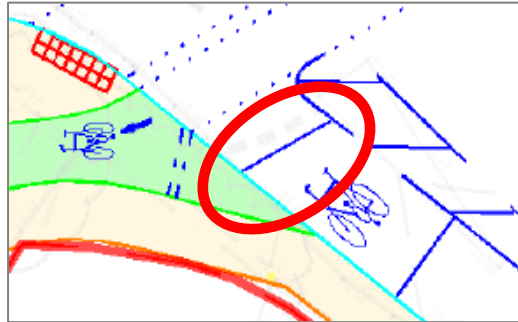
Location: Lees Hall Road approach to the Ravensthorpe Road / Forge Lane / Lees Hall Road / Link Road traffic signal junction

Summary: Increased general collision risk due to alignment of the traffic signal stop line

The stop line on the Lees Hall Road approach to the Ravensthorpe Road / Forge Lane / Lees Hall Road junction is shown as not being perpendicular to the kerb. This could be confusing for road users and increase general collision risk.

It is recommended the design is amended to show the stop line as being perpendicular to the kerb.

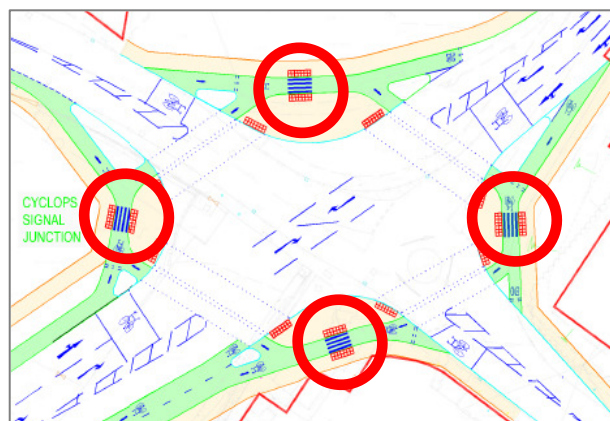
Location: Ravensthorpe Road / Forge Lane / Lees Hall Road / Link Road traffic signal Junction

Summary: Risk of pedestrian/cyclist collisions due to tactile paving arrangements at the crossing facilities

'Cyclops' junctions are relatively new junction designs and tactile paving layouts at these junctions are generally not well defined. Tactile paving crossing points are provided across the cycle facilities at the junction. However, on the outer tactile paving, no stem is provided to guide blind/visually impaired pedestrians to the crossing. This may mean that blind/visually impaired pedestrians are unable to locate the crossing effectively, therefore increasing their risk of unintentionally walking out into the cycle facility where they would be at increased risk of collision with approaching cyclists. Generally, at 'Cyclops' junctions, the use of 'L' shaped tactile paving (i.e.; tactile paving with a stem) shows the start and end points of a complete crossing of the junction, with the remaining tactile points being 'uncontrolled'.

It is recommended that the design is suitably amended to include stems on the outer most tactile paving at the cycle facility crossings.

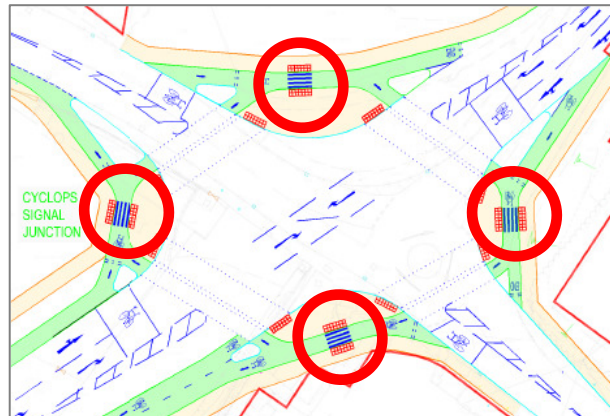
Location: Ravensthorpe Road / Forge Lane / Lees Hall Road / Link Road traffic signal Junction

Summary: Risk of pedestrian trip/fall injuries when crossing the cycle facility

A half height kerb is shown at the pedestrian crossing points and is likely to represent a trip/fall hazard for pedestrians attempting to cross the cycle facility.

It is recommended that flush kerbs are provided at all pedestrian crossing points.

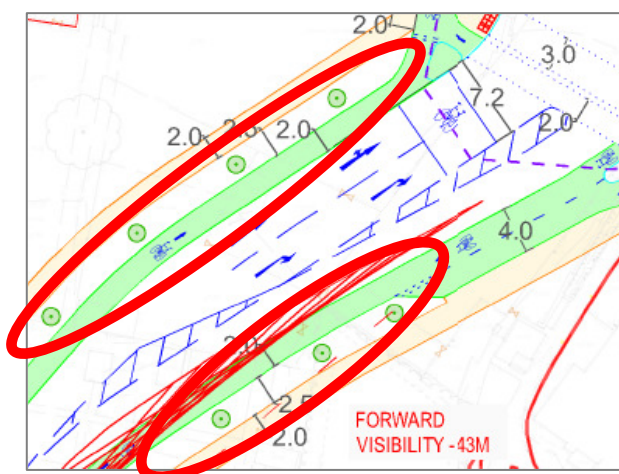
Location: Link road (full extents) and roads leading off the proposed roundabout

Summary: Risk of cyclist skid/loss of control collisions due to the presence of leaves within the cycle track

The proposals show indicative planting locations for trees within the verge area between the footway and cycle track. When the leaves fall from the trees in autumn/winter, they are likely to gather within the cycle facility and could form a skid/loss of control hazard for cyclists.

It is recommended that, once constructed, a suitable highway maintenance regime is implemented to maintain the cycle facility free of leaves and gathered debris.

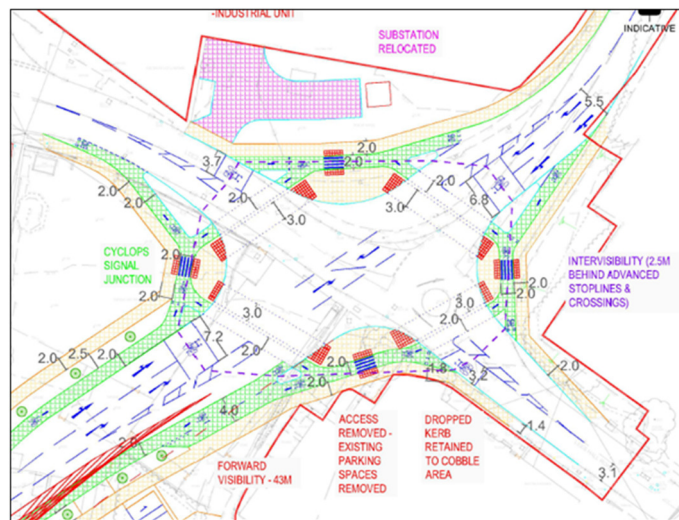
Location: Ravensthorpe Road / Forge Lane / Lees Hall Road / Link Road traffic signal Junction

Summary: Risk of collisions involving maintenance operatives at the junction

The proposed traffic signal junction is likely to require occasional maintenance. There are no facilities shown to allow traffic signal maintenance vehicles to safely park during such maintenance visits. Parking vehicles on the carriageway risks obstructing the junction and potential collisions with other vehicles, with the possibility of injury to vehicle occupants. Additionally, maintenance operatives walking in the carriageway or crossing the carriageway would be at risk of collision with passing vehicles.

It is recommended that appropriate facilities for maintenance vehicles are provided as part of the scheme.

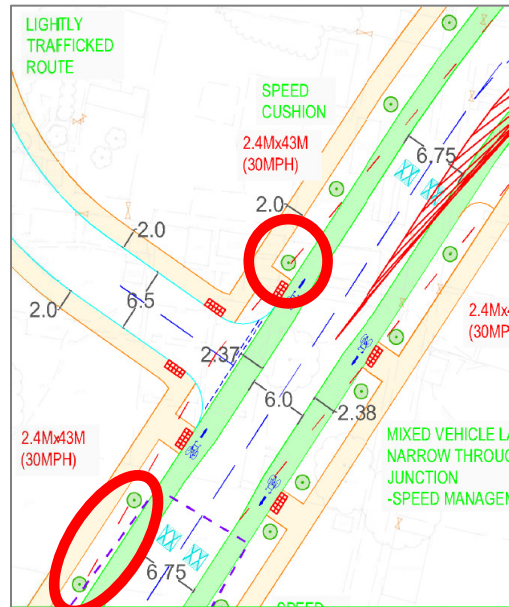
Location: Link road / side road junction

Summary Risk of failure to give way collisions due to restricted visibility

The scheme proposals show 2.4 x 43m visibility splays from the side road junction. However, the visibility splays run through/behind proposed trees and approaching vehicles/cyclists are likely to be masked. This is likely to increase the risk of failure to give way collisions within the vicinity of the junction.

It is recommended that trees are located outside of the visibility splays and away from the junction.

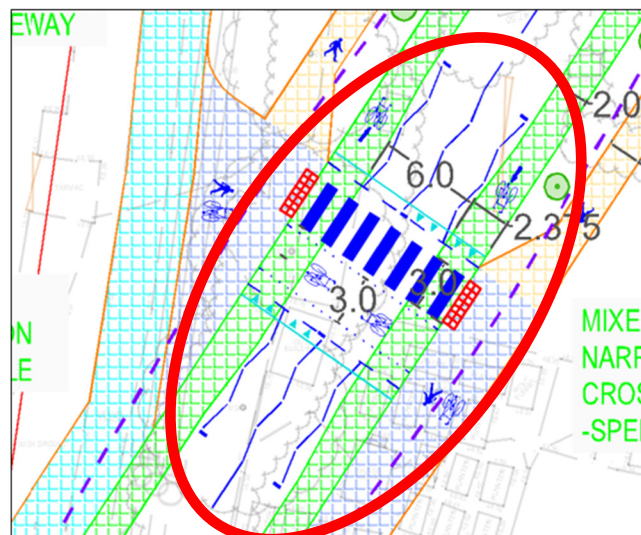
Location: Northern parallel crossing on link road

Summary: Risk of various collision types due to the design of the crossing facility

A raised parallel crossing is proposed approximately mid-way along the link road. As it is a controlled crossing, a tactile paving stem on the pedestrian section of the crossing should extend to the back of the footway so as to guide blind/visually impaired pedestrians to the crossing. A stem has not been provided and may mean that blind/visually impaired pedestrians are unable to locate the crossing effectively, therefore increasing their risk of unintentionally walking out into the carriageway where they would be at increased risk of collisions with approaching vehicles/cyclists.

The carriageway ramps either side of the raised crossing appear to be the same length as those on the cycle track. This suggests that an excessively steep ramp could be provided for vehicles, increasing the risk of loss of control collisions.

The link road cycle facilities also run straight through the parallel crossing facility, with no requirement for cyclists to give way to waiting pedestrians/cyclists. As such, it is likely that some pedestrians/cyclists waiting to cross the link road would wait within the extents of the link road cycle facility. In doing so, they would be at an increased risk of collision with approaching cyclists.

The kerbing arrangement at the crossing facility is also unclear. The crossing appears to be flush (as is on a raised facility) but a half height kerb is shown on the cycle facility and is likely to represent a trip/fall hazard for pedestrians attempting to cross the cycle facility.

The crossing proposals also only show four zig zag markings instead of the standard eight marks.

It is recommended that the design of the crossing is suitably amended taking into account the identified points.

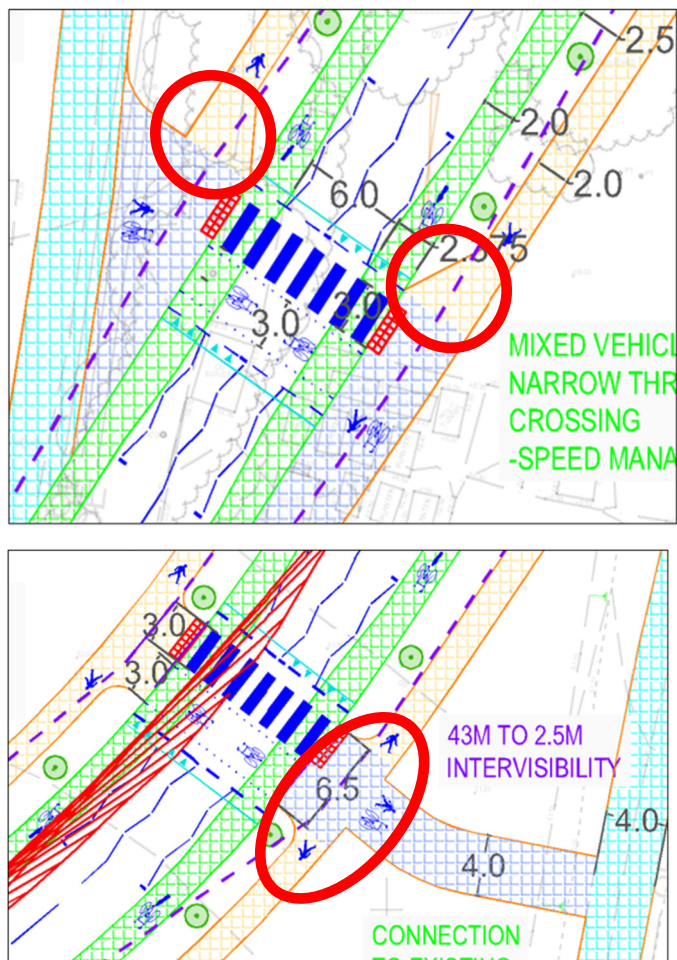
Location: Bridleway diversion along the link road

Summary: Risk of cyclist/pedestrian collisions as pedestrians are unaware that they are entering shared pedestrian/cycle areas

At a number of locations, footways join unsegregated shared use pedestrian/cycle areas. No tactile paving is provided at the transition points to inform blind/visually impaired pedestrians that they are entering an area used by cyclists. The absence of tactile paving could therefore be expected to increase the risk of cyclist/pedestrian collisions as blind/visually impaired pedestrians are unlikely to be aware that they have entered a shared use area.

It is recommended that appropriate corduroy tactile paving is provided where footway areas meet unsegregated pedestrian/cycle shared areas.

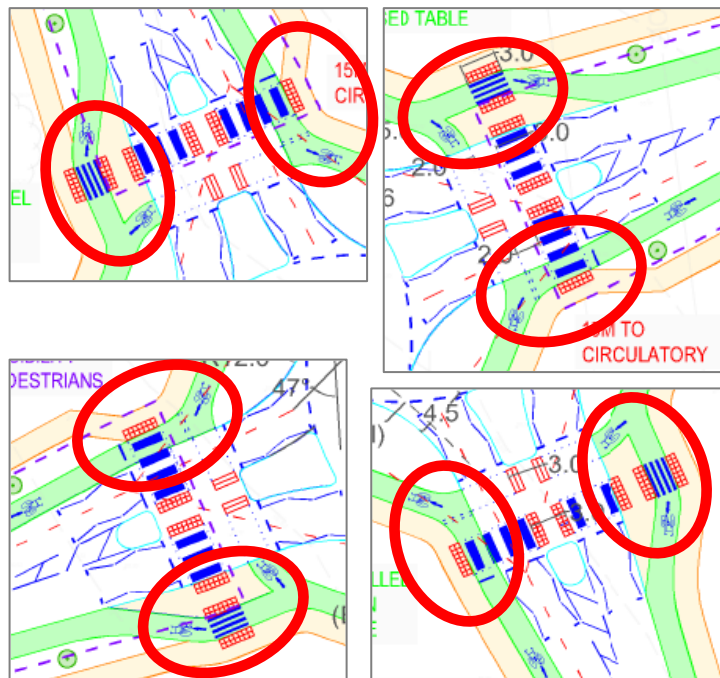
Location: Parallel crossings on approaches to the link road roundabout

As previously outlined, the half-height kerbs where pedestrians cross the cycle track would form a trip/fall hazard.

It is also noted that the offset distance between the pedestrian and cyclist parts of the parallel crossing appears excessive. This may lead to motorists considering the second half of the crossing as a separate facility or not to see it. TSRGD shows the layout of a parallel crossing (Schedule 11, Part 2 Item 53) with 0.4m offset between the two crossings.

It is recommended that the design of the proposed crossings are suitably amended taking into account the points identified above.

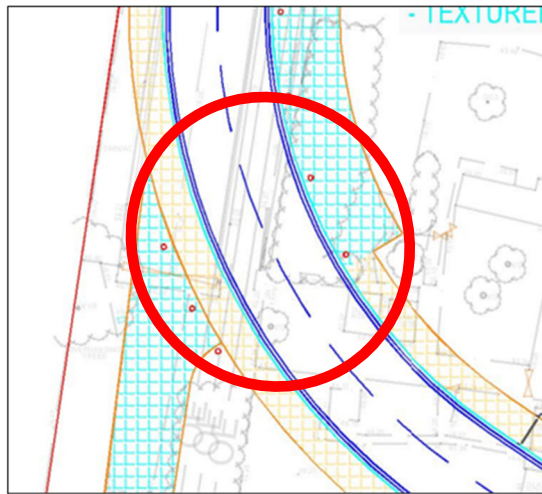
The scheme proposals show the Bridleway joining the Ravensthorpe Road / Link Road connection at an acute angle. At the transition point between carriageway/Bridleway, a generally acute angle of approach is provided and if even a minimal kerb upstand is provided, it is likely to form a loss of control hazard for cyclists (particularly those on narrow wheeled bicycles). It is noted that kerb check at the transition is referenced as being full height kerbs. There is also no crossing point between the two sides of the Bridleway. This is likely to result in an increased risk of pedestrian trip/fall injuries and cyclists losing control as they have to 'bump' up and down kerbs.

- 1) It is recommended that a flush kerb arrangement is provided at all locations where cyclists transition from on-road to off-road areas; and
- 2) It is recommended that a suitable crossing facility is provided to connect both sides of the Bridleway.

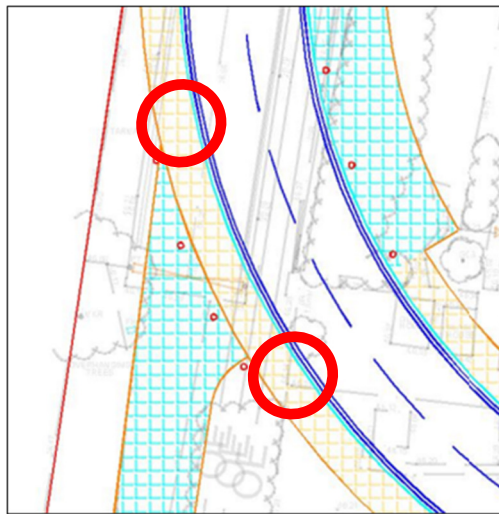
No tactile paving is proposed where the shared use path forming the Bridleway joins the footway provision along the link road. The absence of tactile paving could therefore be expected to increase the risk of cyclist/pedestrian collisions as blind/visually impaired pedestrians are unlikely to be aware that they have entered a shared use area.

It is recommended that appropriate corduroy tactile paving is provided within the footway to warn of the shared use route ahead.

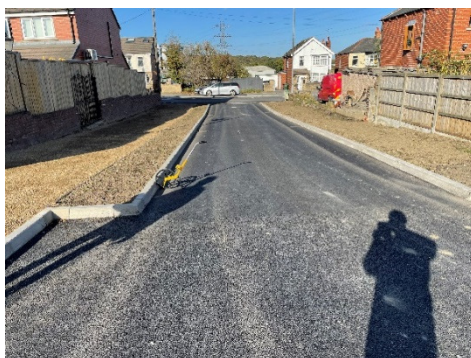
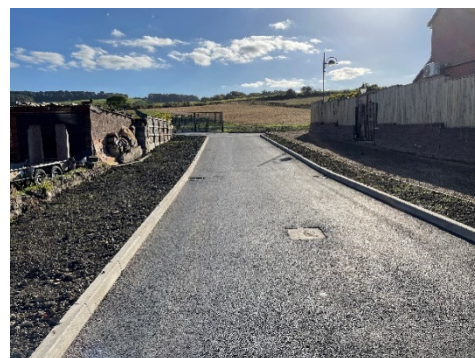
The eastern access link from Ravensthorpe Road has been provided on site. It is assumed that the carriageway is to be used on a two-way basis, but it measures only 4.0m in width and is without radii at its junction with Ravensthorpe Road. This is not considered a sufficient width to comfortably cater for two-way vehicle flows and, as such, an increased risk of vehicle side-swipe collisions is expected. Although an area which could be used as a passing place has been provided at the southern end of the link, it is some distance from Ravensthorpe Road and is likely to be of limited use due to limited visibility of vehicles turning in from Ravensthorpe Road.

It is recommended that, if the access road is intended to be used on a two-way basis, it is suitably increased in width to accommodate such use.

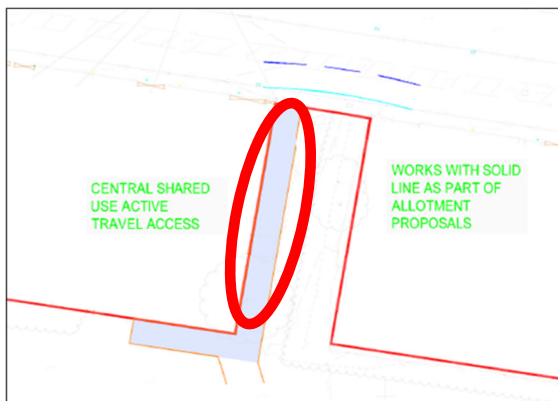
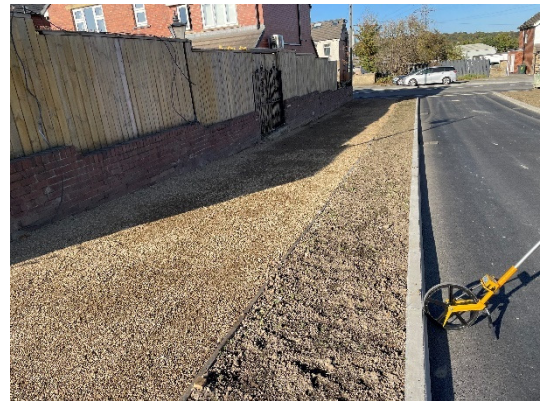
Summary: Risk of cyclists losing control and pedestrians slipping/falling due to surface conditions

The surface that has been provided for active travel users (the area closest to the wall/fence) consists of loose stone and is considered to form a potential loss of control risk for cyclists and a slip risk for pedestrians. The risk is greatest in the south-to-north direction given the downhill gradient. The surface is also likely to deteriorate over time and form a greater road safety risk in wet conditions.

It is recommended the loose stone surface for pedestrians/cyclists is replaced with a bound surface.

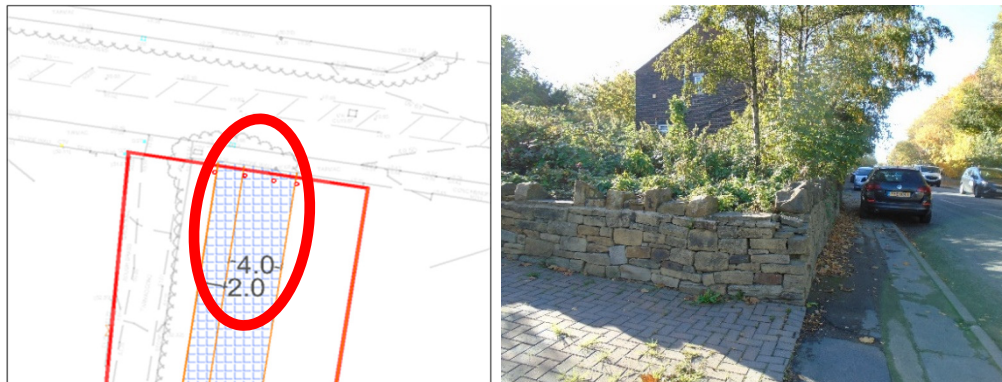
Summary: Risk of collisions involving cyclists exiting the link failing to give way to motorists on Ravensthorpe Road due to potentially restricted visibility

The proposed active travel link appears to be provided through an existing wooded area. It is unclear if sufficient visibility will be provided out of the link for cyclists due to adjacent vegetation and the stone wall. If insufficient visibility is available then an increased risk of collisions involving cyclists exiting the link and failing to give way to motorists on Ravensthorpe Road could be expected.

It is recommended that an appropriate level of visibility from the active travel link onto Ravensthorpe Road is provided.

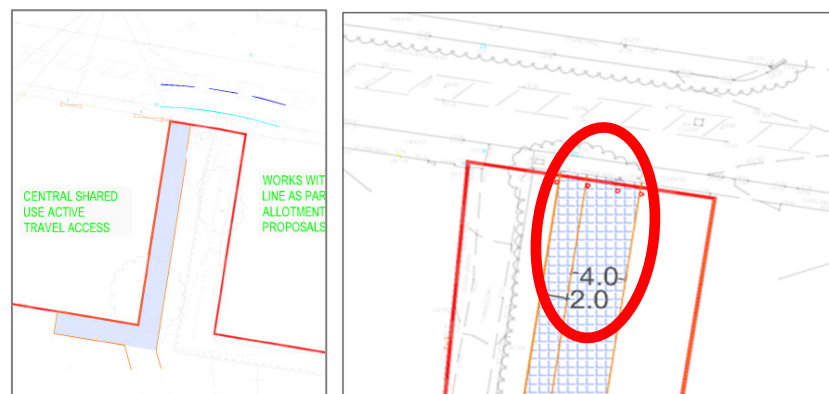
No tactile paving is proposed where the active travel links join the footway provision along Ravensthorpe Road. The absence of tactile paving could be expected to increase the risk of cyclist/pedestrian collisions as blind/visually impaired pedestrians on Ravensthorpe Road are unlikely to be aware that they are entering an area that also accommodates cyclists.

It is recommended that appropriate corduroy tactile paving is provided within the Ravensthorpe Road footway to warn of the shared use route ahead.
